# TAILEM BEND TOWN PARK & STREET TREES

Tree Inspection – March 2021

**Tailem Bend Town**

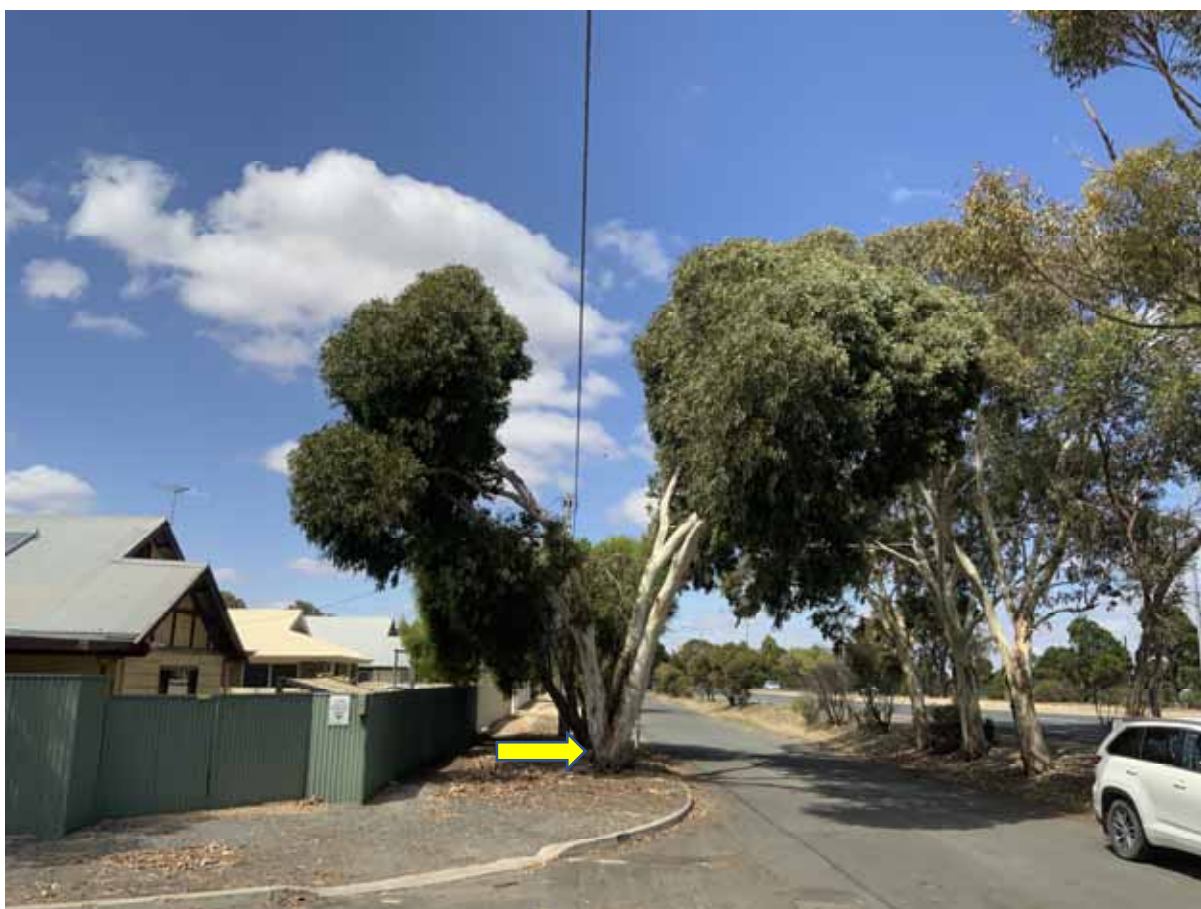
# 1. Eucalyptus leucoxylon

This SA Blue gum bifurcates approximately 1.2 metres from ground level, the attachment points are sound and don't show any indication of defects or included bark within the attachment points. The tree has been butchered by the utility company which they didn't need to do because this is bundled line and does not require clearance to the extent that it has been carried out. The branches above the verge should be pruned to allow access, this will also need to be carried out with the Melaleuca armilaris next to it to allow easy access through the verge

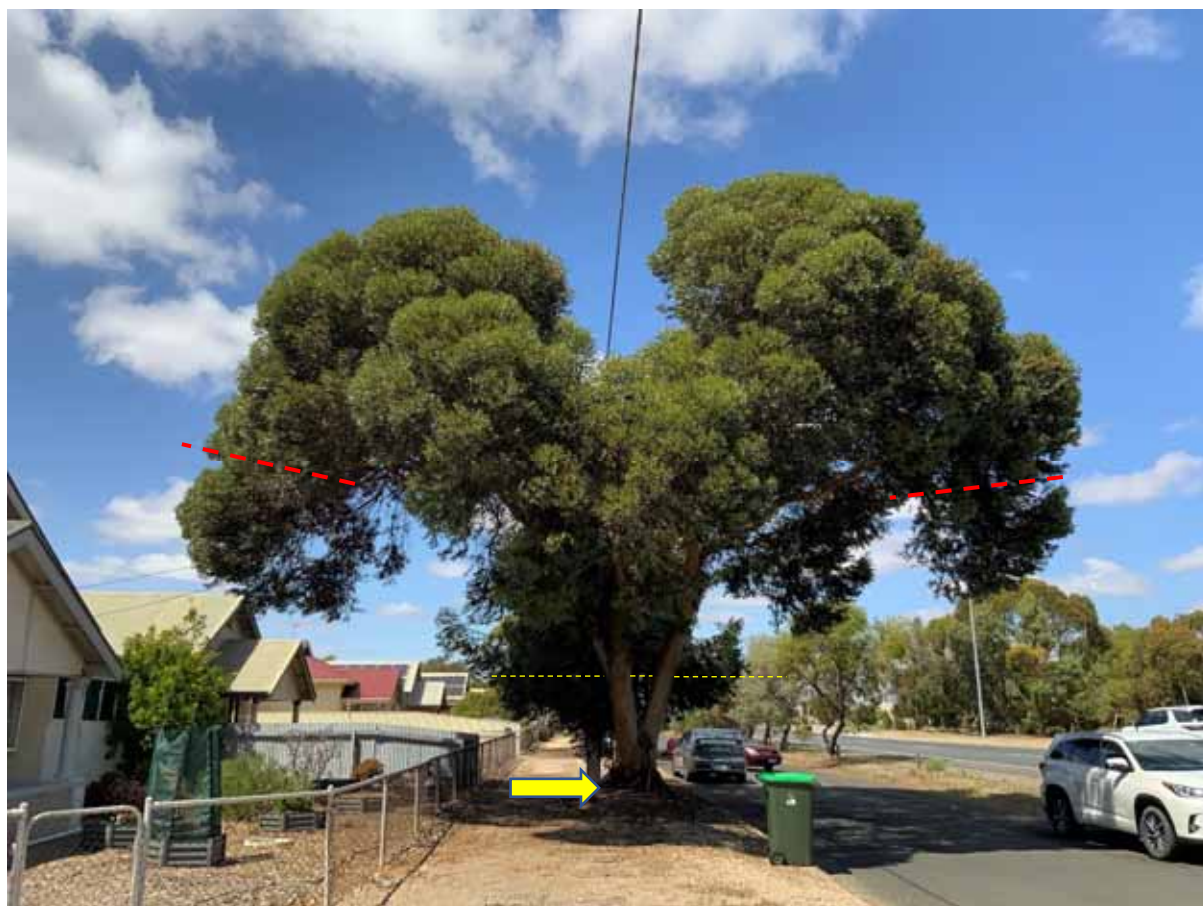
## 1. Eucalyptus platypus

This Platypus gums root plate has heaved the soil area surrounding it due to a solid base where the roots can only grow in an upward manner, this tree is also a large specimen that has grown quite well, the tree is growing into the stobie pole and the lower branches specially on one side will need to be lifted and any branches coming into contact with the pole will require pruning back to not cause damage to the tree. There are branches which are overhanging the property and the roadway which will require pruning. The area between the Stobie poll in the tree will need lifting as there is a lot of foliage within this area that has accumulated and will require pruning to lift the tree to a height to allow public access.

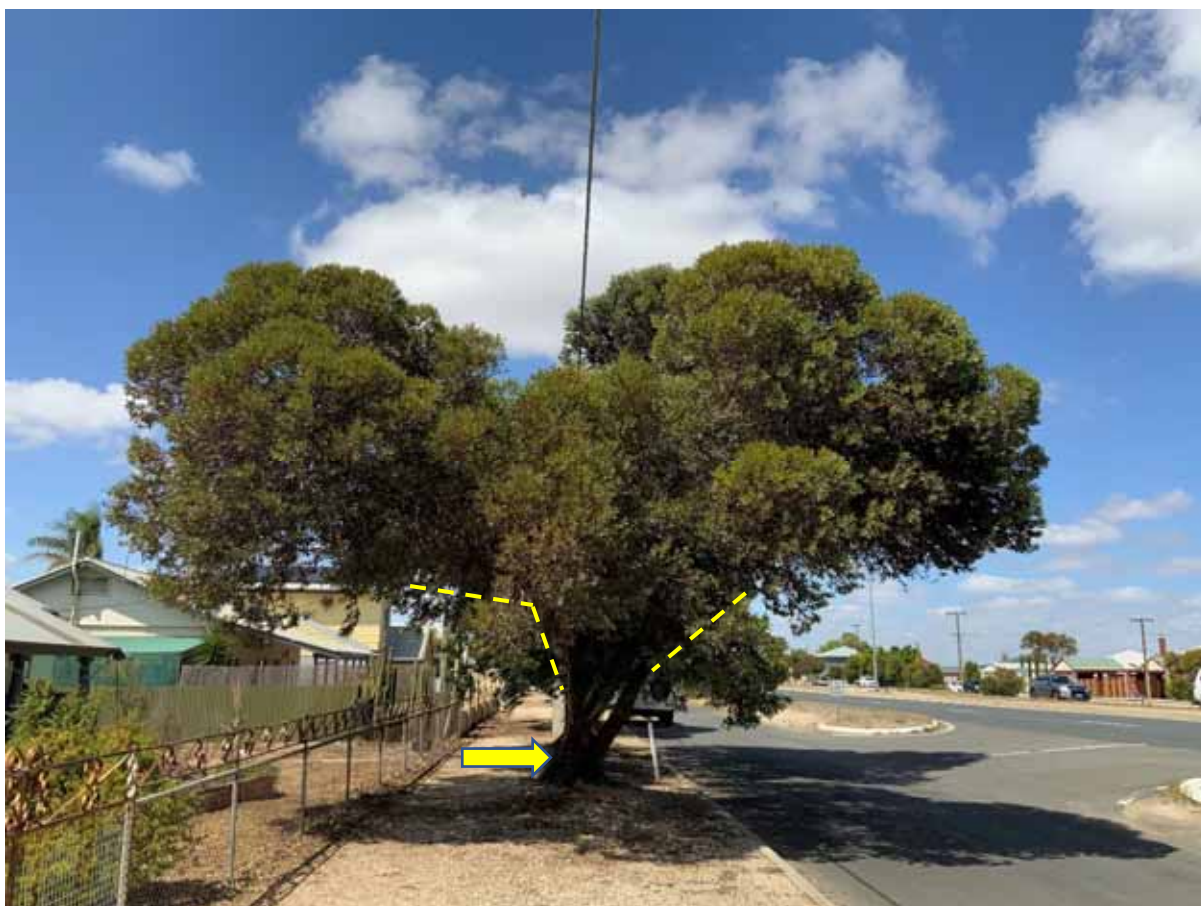
## 1. Eucalyptus platypus

This Platypus gum has heaved the area around the root plate due to hard bed rock underneath. It also has lost one of the trunks due to included bark, all the rest of the attachment points are sound, with this tree and the next tree I would recommend lifting the canopy to allow for clear access for people that make use of the verge.

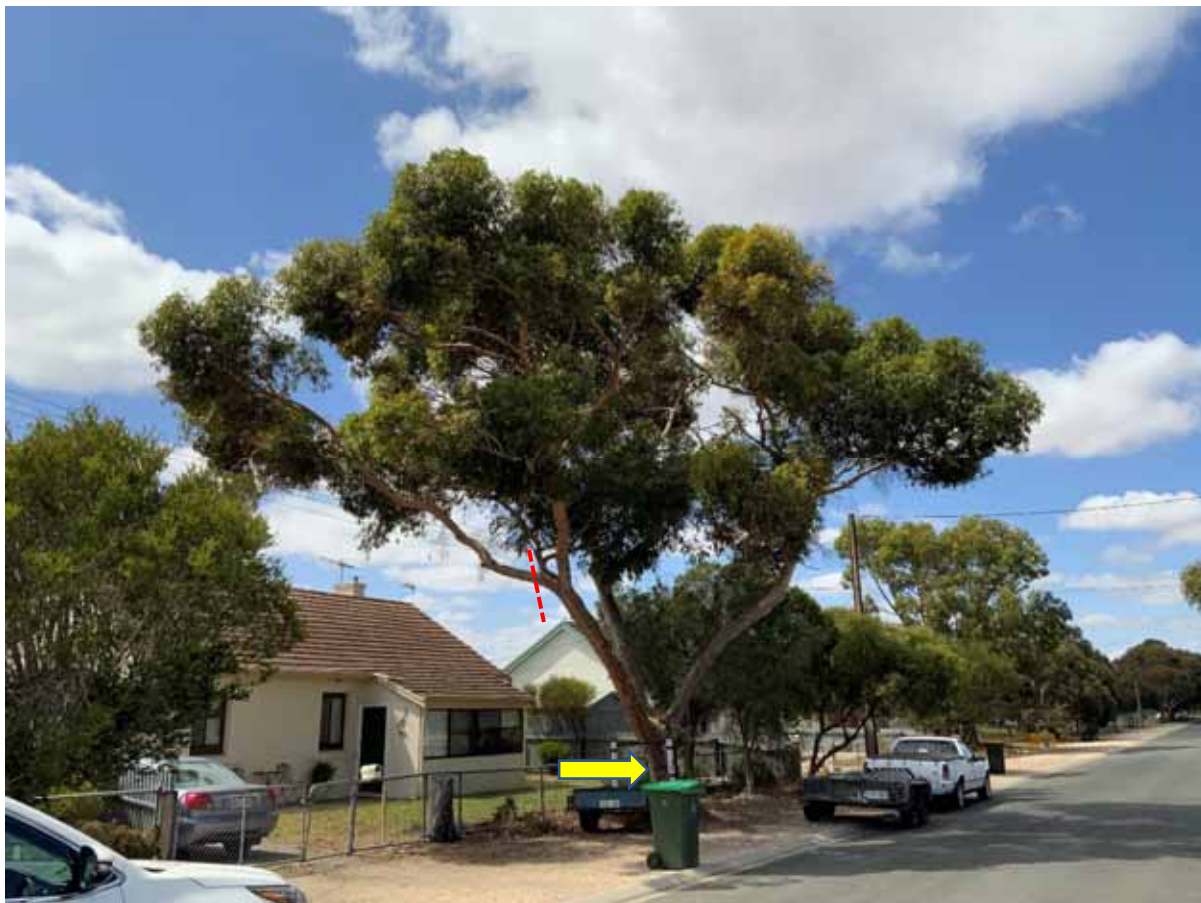
## 1. *Eucalyptus cladocalyx*

The Sugar gum is only a small specimen, there is a large limb growing over the driveway of the property number 160 this large limb should be removed also any deadwood within the upper canopy in the centre and also hanging over onto the property at number 160 will need to be pruned out.

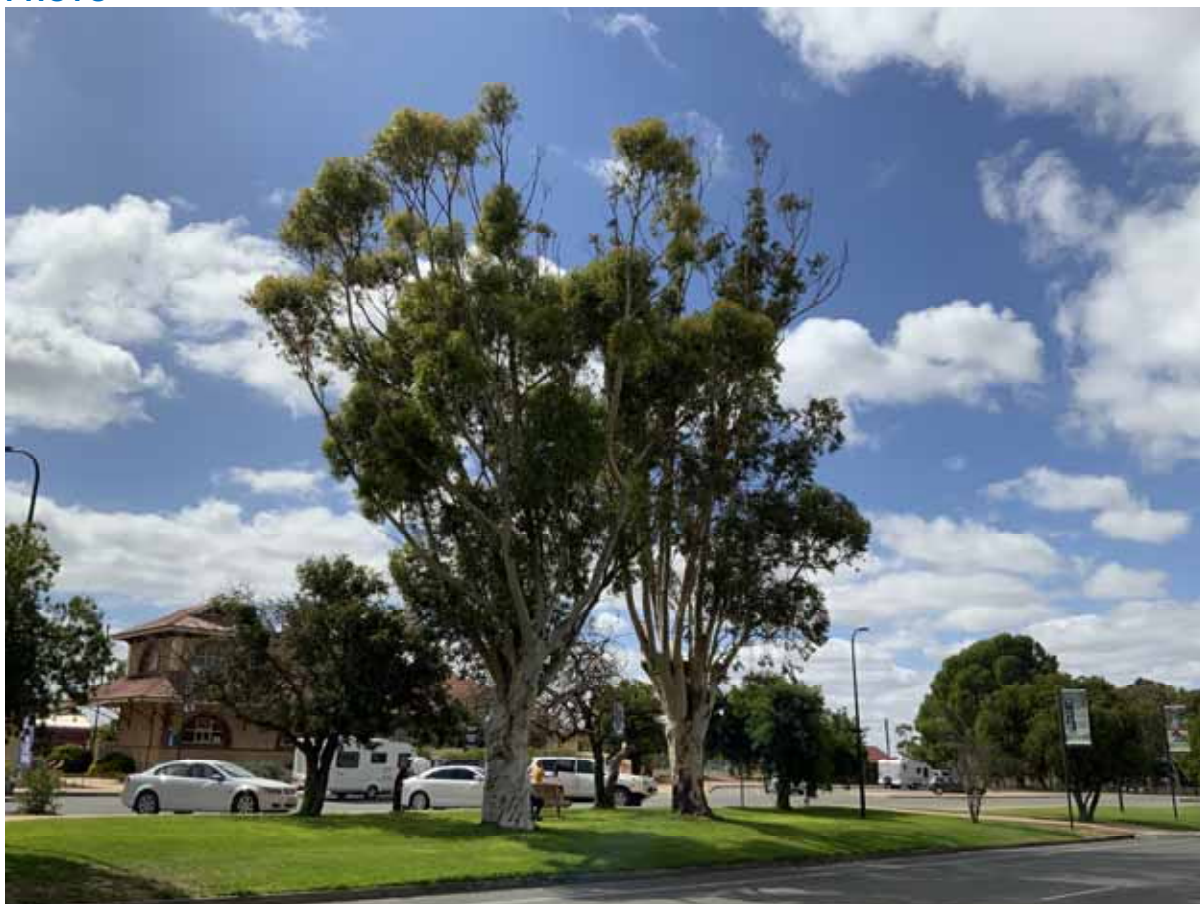
## 1. *Eucalyptus cladocalyx* x 2

This first of two Sugar gums has a scar around most of the tree with only a small section that remains. Even though it is almost around the entire trunk and almost ringbarked the tree is still in good growth cycle and surviving quite well and while it is surviving well there is no need to remove this tree.

The tree has been lopped in the past and the canopy is all made up of epicormic growth, this growth is not sound growth as it will often fail due to the attachments being only through the outer of the old cut marks, basically the cut points are the collective site of high sap after its cut, the high sap accumulation enables blind buds to take shoot as a reaction to the removed limb, this shoot will usually grow to the height of the old limb, it also grows in an upright form like it has on these two trees.

because they have already been lopped, I am recommending that the growth maintenance be continued now rather than run the risk of limb failure in a high use area. All epicormic growth need to be removed and the cut points need to be below the old cut points but they need to be of uniform height as the trees are now only an aesthetic feature. This will remove all of the canopy on both trees and leave trunks only, the regrowth will cause the tree to look like a ball on a stick for a while, once the canopy gets to first tier, lopping will need to be carried out again to keep the chance of branch failure low.

It is rare that I would recommend lopping and regular maintenance however as the trees are a feature and of historic value, the reduction in risk needs to be undertaken without removing the trees, lopping is also a historic activity that was undertaken and because it has already been undertaken, it will not take away from the historic feature of these feature trees.

Lopping is recommended below the old cut points but uniform in proportion. Maintenance lopping will need to be carried out when the foliage starts to grow beyond first tier canopy level, at this stage the trees regrowth limbs will be on average 10cm in diameter and failure will begin where the limbs are a high risk.

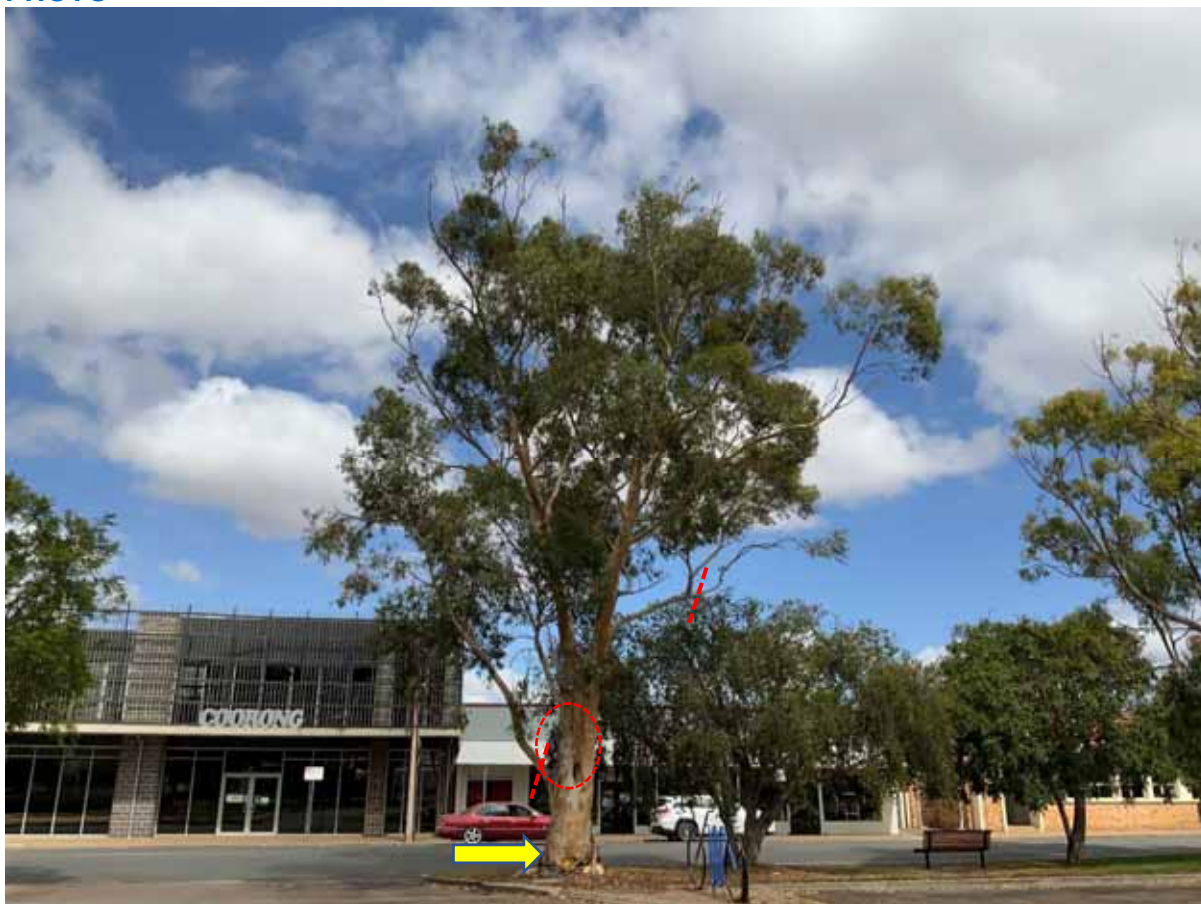
## 1. *Eucalyptus cladocalyx*

This Sugar gum has minor areas of deadwood but is in a good growth cycle with new growth throughout the canopy. I am recommend removing the lowest stub, the branch going out to the side over the end exit from the car park and the deadwood stub which has epicormic growth, remove the limb over the bottlebrush and remove deadwood throughout the canopy due to it being in a high use area.

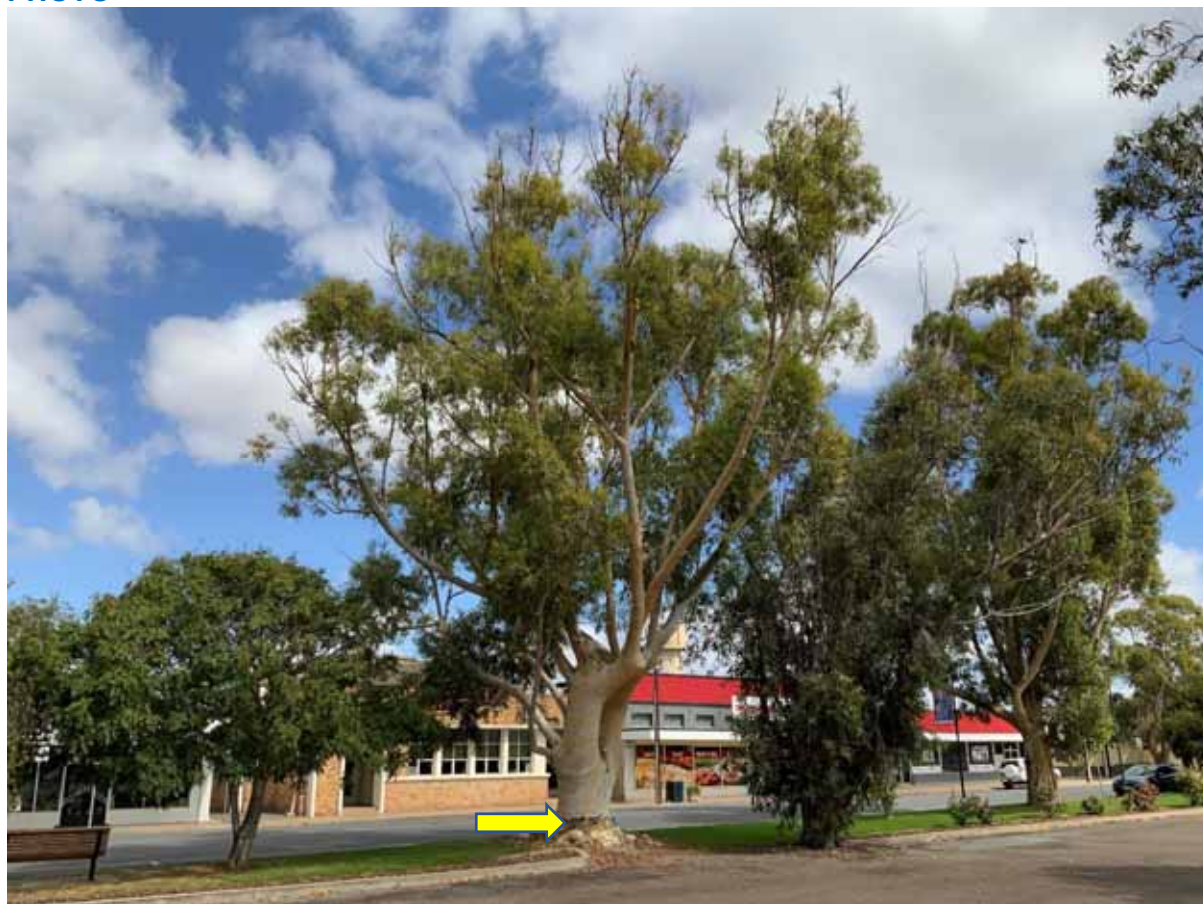
This Sugar gum is still quite sound and the tree is restricted in the way that its root systems populate the area, I would recommend removing the Tuart tree next to it to allow the tree to continue to grow into this tree rather than having a tree in the middle of a carpark. This will allow this tree to continue to grow without the close competition of the Tuart tree, I am recommending the removal of the deadwood within the canopy due to it being in a car park.

Pruning out of the deadwood is recommended.

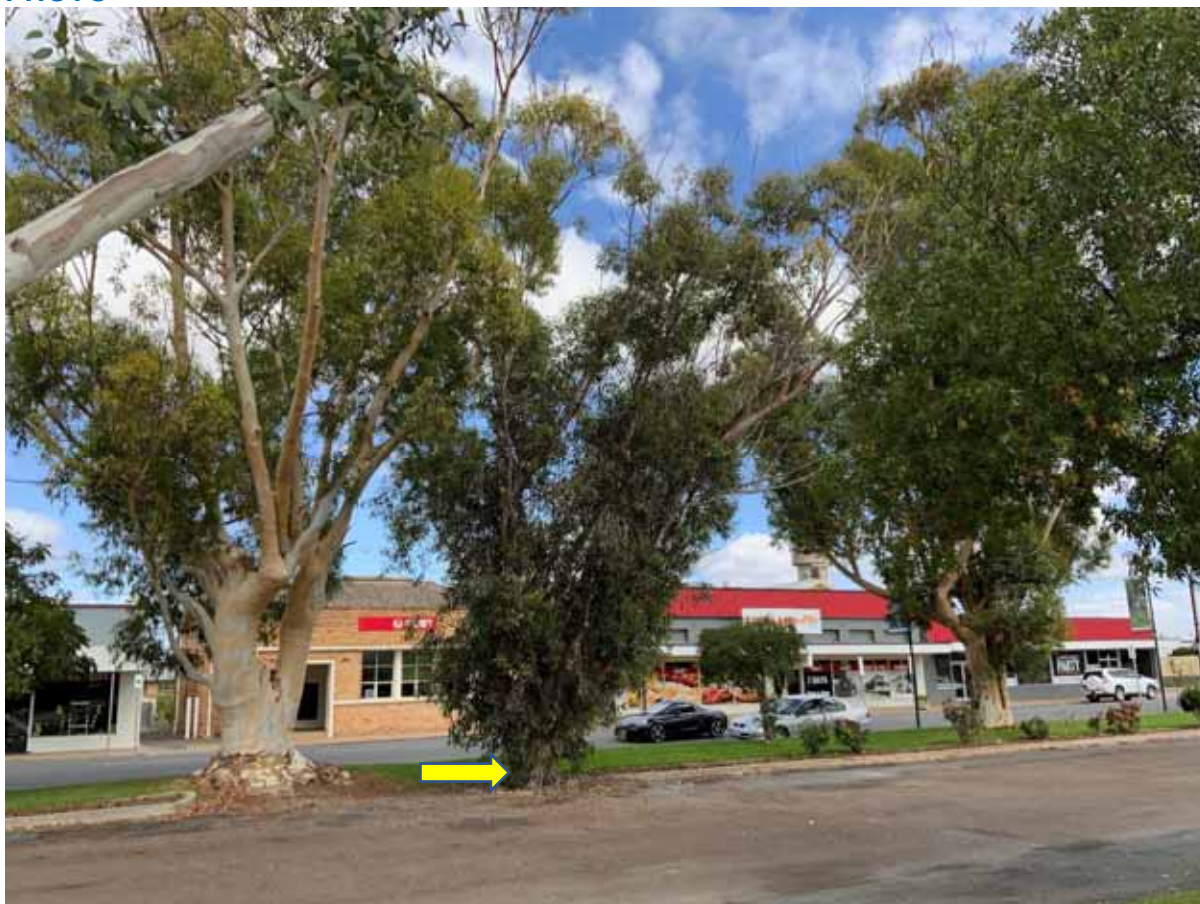
The Tuart tree has suffered in the past and the tree is now all regrowth, it has grown in a carpark area and is currently causing damage and will cause further damage in the future as its roots progress into the car park area, the tree also takes away from the large Sugar gum with approximately 1/4 of the nutrients and moisture etc. going to the sugar gum. Removal of this tree is recommended as it should not be planted so close and is most likely a tree that was not meant to be in its current position.

Removal is recommended.

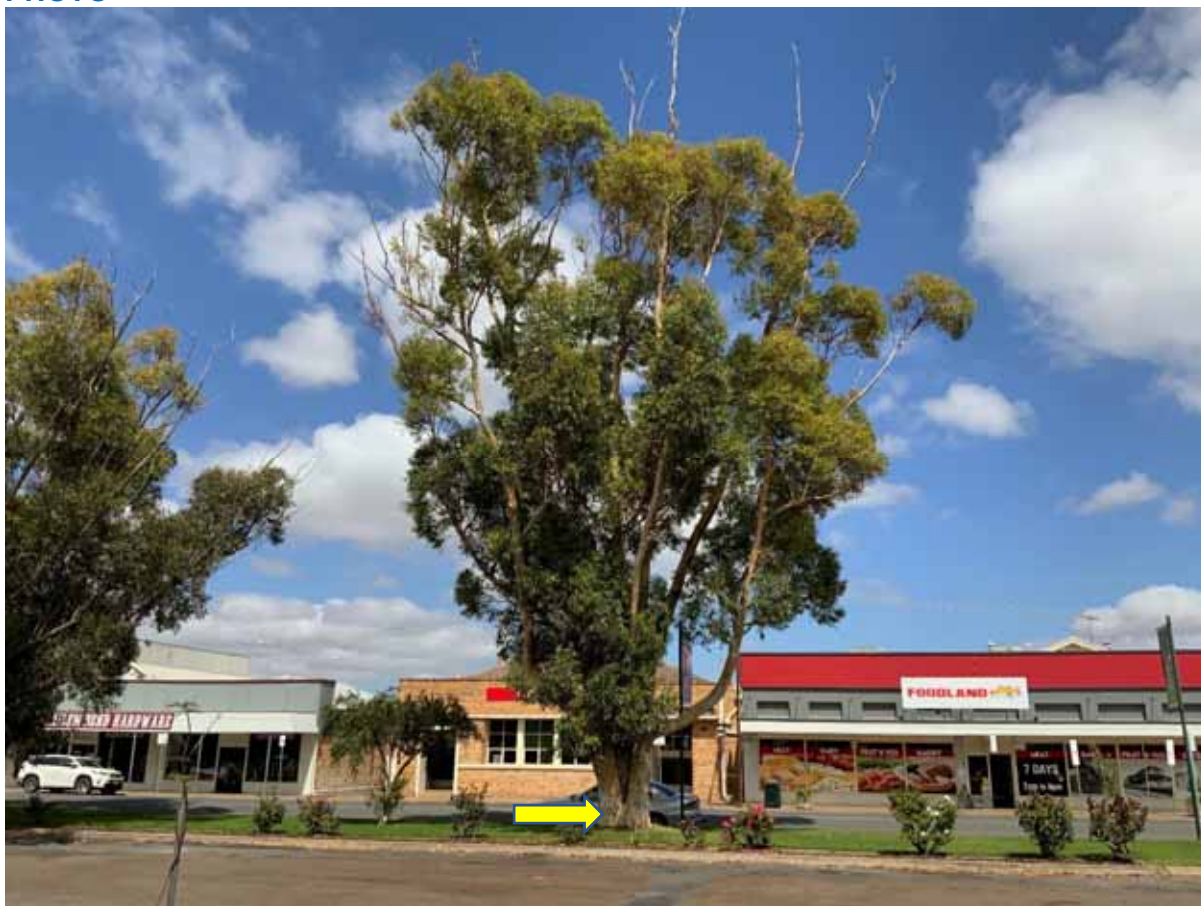
This large Sugar gum has areas of decay in one side where a large limb has been removed in the past and the deadwood is now causing decay within that area which has caused decay to move up through the front trunk approximately 3 metres from ground level. The area of deadwood is soft and hollow however this does not remove all the strength from the tree. Within the upper canopy there are areas of bird damage mostly due to either cockatoos or Corellas. This area of growth is epicormic growth where the tree has been locked before and branches have grown from the cut points and is of weak growth with most of it already weakened growth failed in the past. This being a feature tree they had to be left and the chance of failure is there but it is only low. I'm recommending the removal of the staghorn branches up through their top back to growth points that are stable and green. The tree may only have 10 to 15 years of safe useful life remaining, succession planting should be undertaken before the tree is removed to avoid the area having voids when its removed.

Removal of deadwood is recommended.

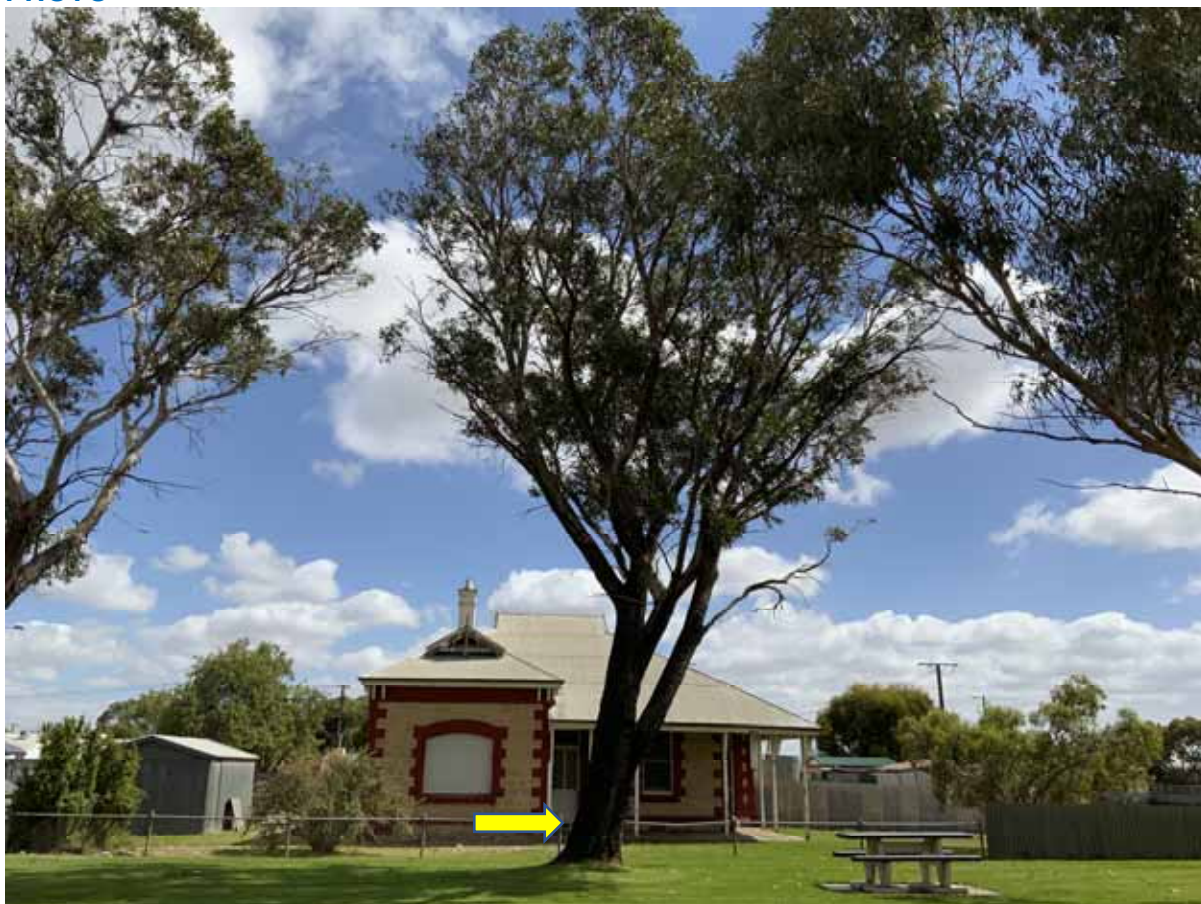
This tree does have minor areas of deadwood throughout the tree and is in good condition but with there being a seat and table below I would recommend removing the larger of the deadwood throughout the canopy of this tree, most likely is tree is suffering from wet feet which causes the limbs to die back much like it does when in a drought.

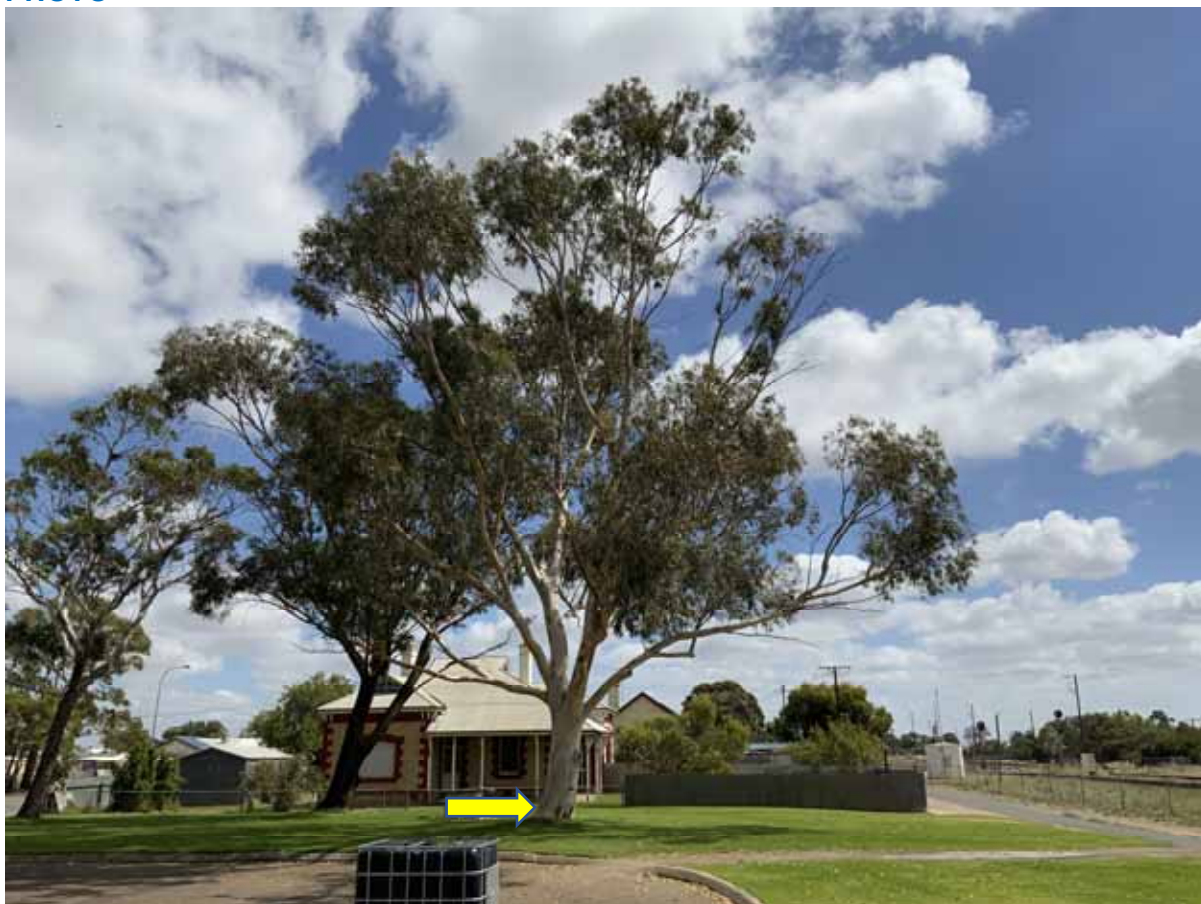
This Sugar gum is in good condition and does have one area of hollow void within the attachment however, Sugar gums don't have a tendency to fail at these points and this habitat hole does not pose a high risk. There are only minor areas of deadwood, most is small and is in an area where there is not a great risk.

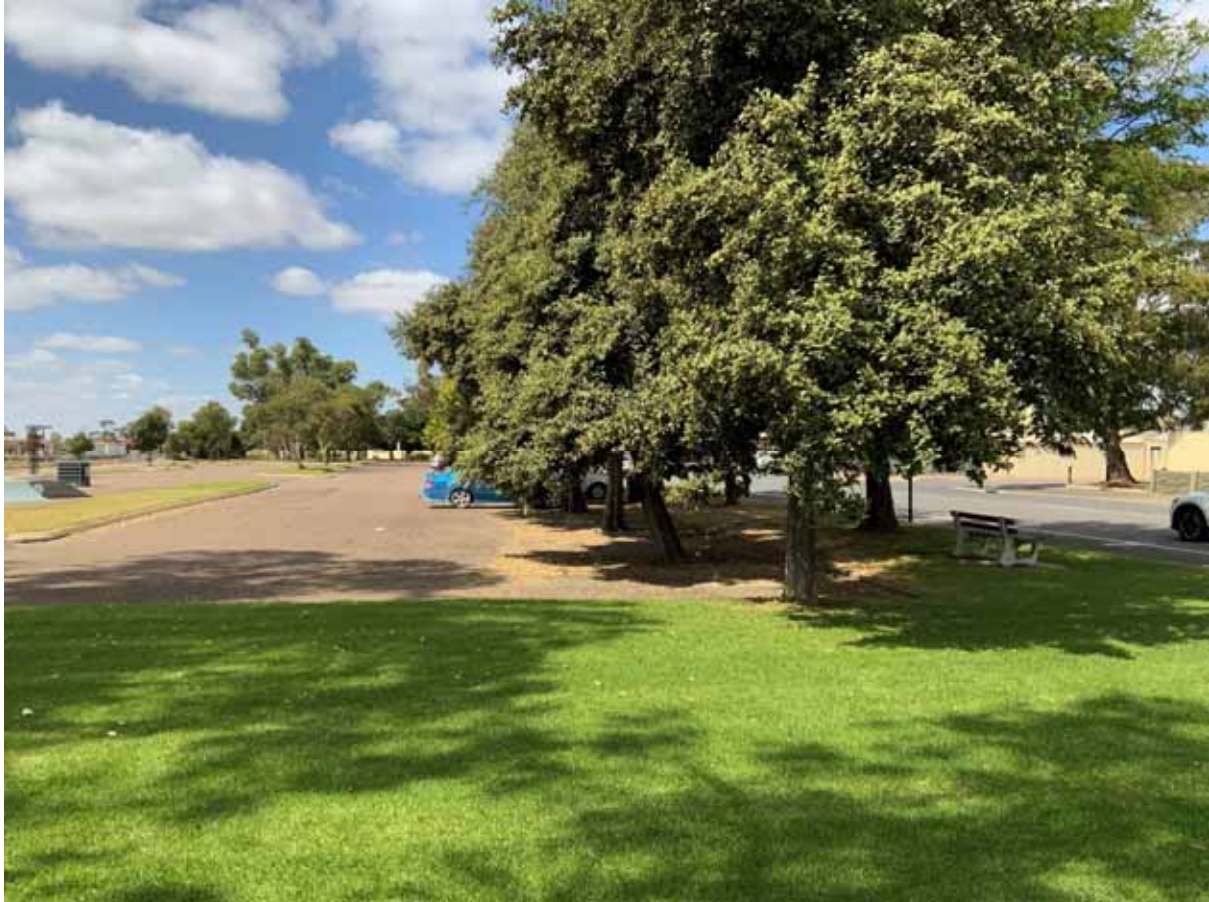
The Itchy Pod trees growing along this car park should be lifted to a height of 2.1 metres, these trees become more fibrous as they mature and with people parking under the trees some people may get the fibres on them and like the name implies become very itchy and will require removal from a physician, many trees like this have been removed as they can become very irritating.

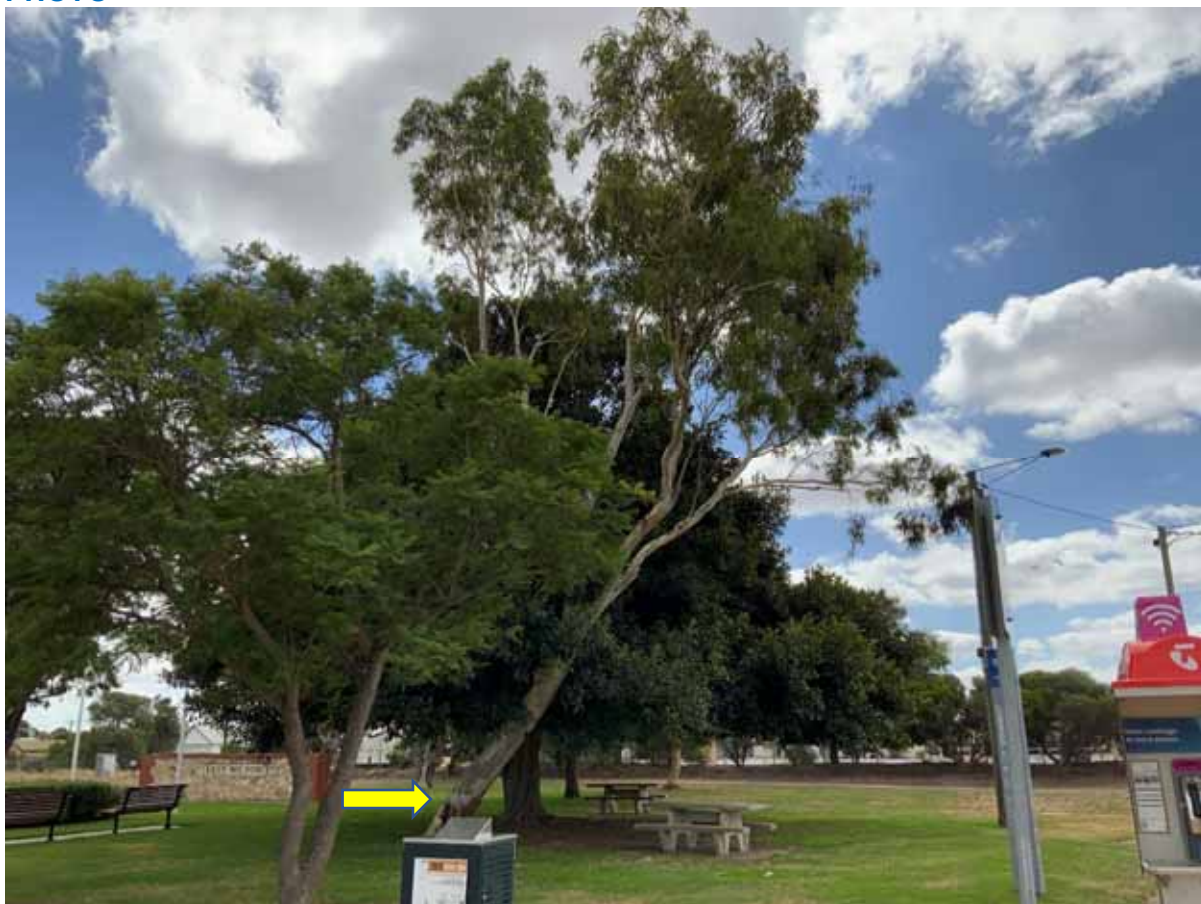
## 1. Eucalyptus camaldulensis

This River Red gum has grown on a lean due to phototropism causing the tree to grow out of the way of the neighbouring Port Jackson fig and into better light. The tree is not a risk as the root plate has no indication of movement, the tree has canker fungus near the base but it has overcome this and is growing back around the old area of infestation. The upper canopy is sound and is self-correcting as it matures.

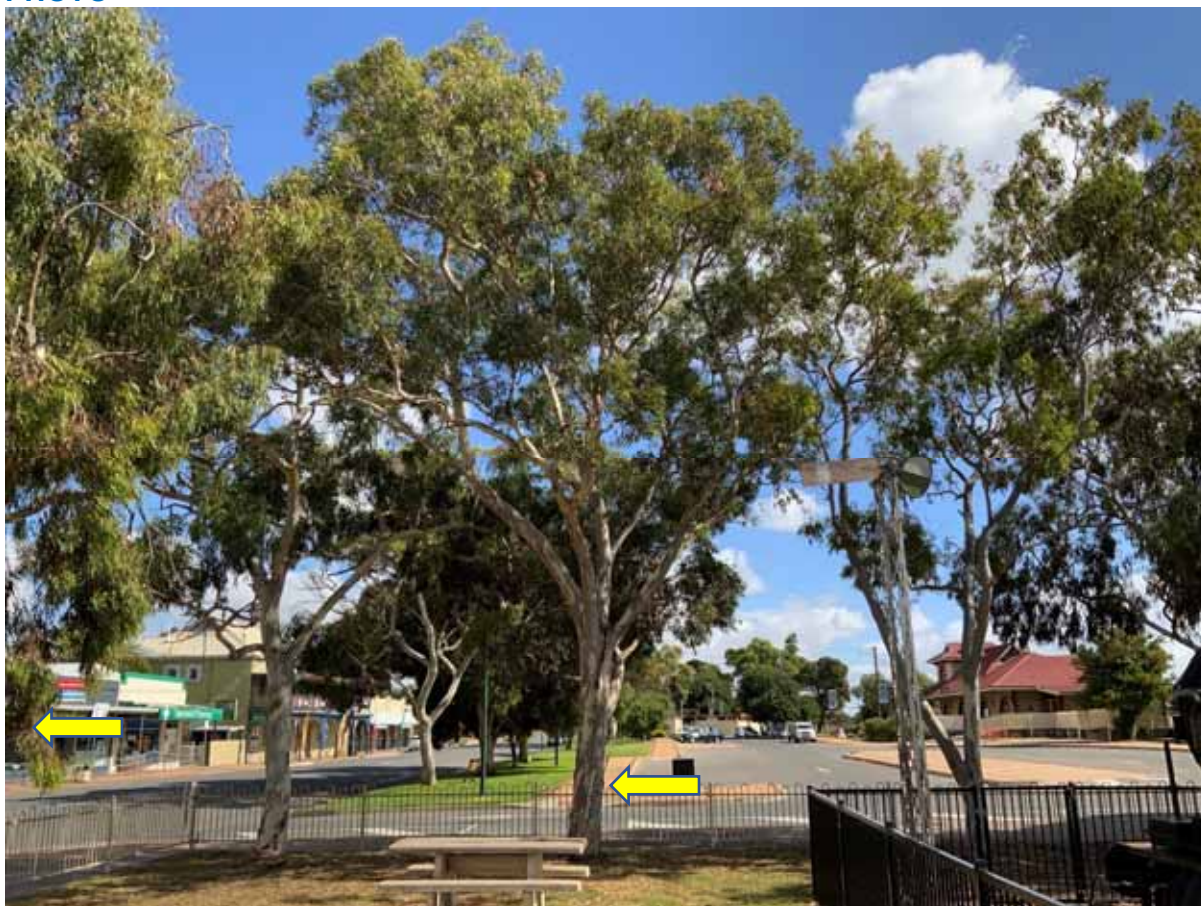
## 1. Eucalyptus species

The small eucalypt Sample is in good condition and is in a line of trees all of the same species. The branch on the fence side is growing out on an angle where all the rest of the trees do not have that type of growth to that one side. The tree is in good condition with only minor amounts of deadwood and I would only recommend the one minor area of deadwood screens one side opposite the park, the one opposite that growing out over the car park I would remove back to the third attachment point which is the lower of the branch.

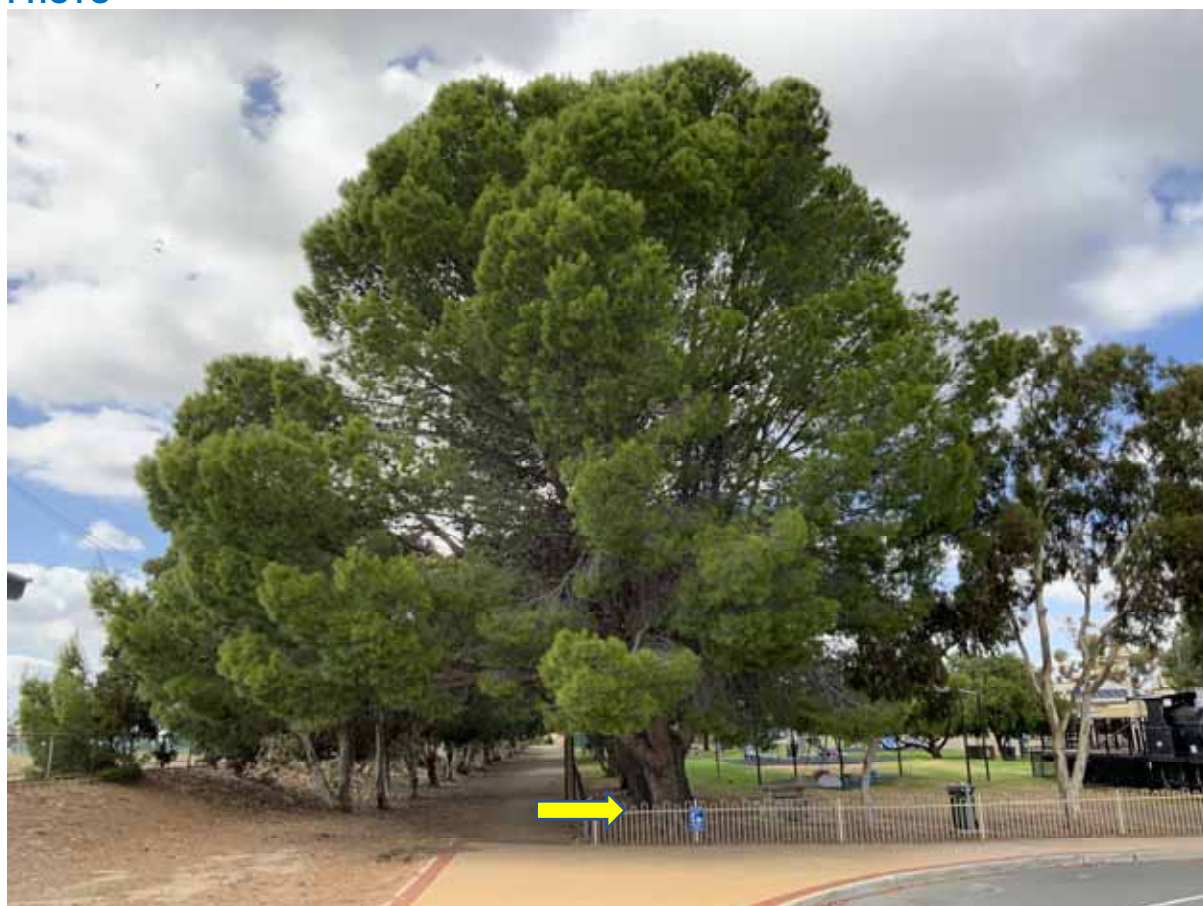
This large Aleppo pine is in good condition and the attachment points have ribbed in the areas where they are or have grown not as sound, this has caused some sap to extrude within these areas but this is normal for these trees. Most of these species have good flex within the wood itself and the canopy is high enough to allow for people to pass underneath. There is no need to lift the canopy as it is not a medium or high risk.

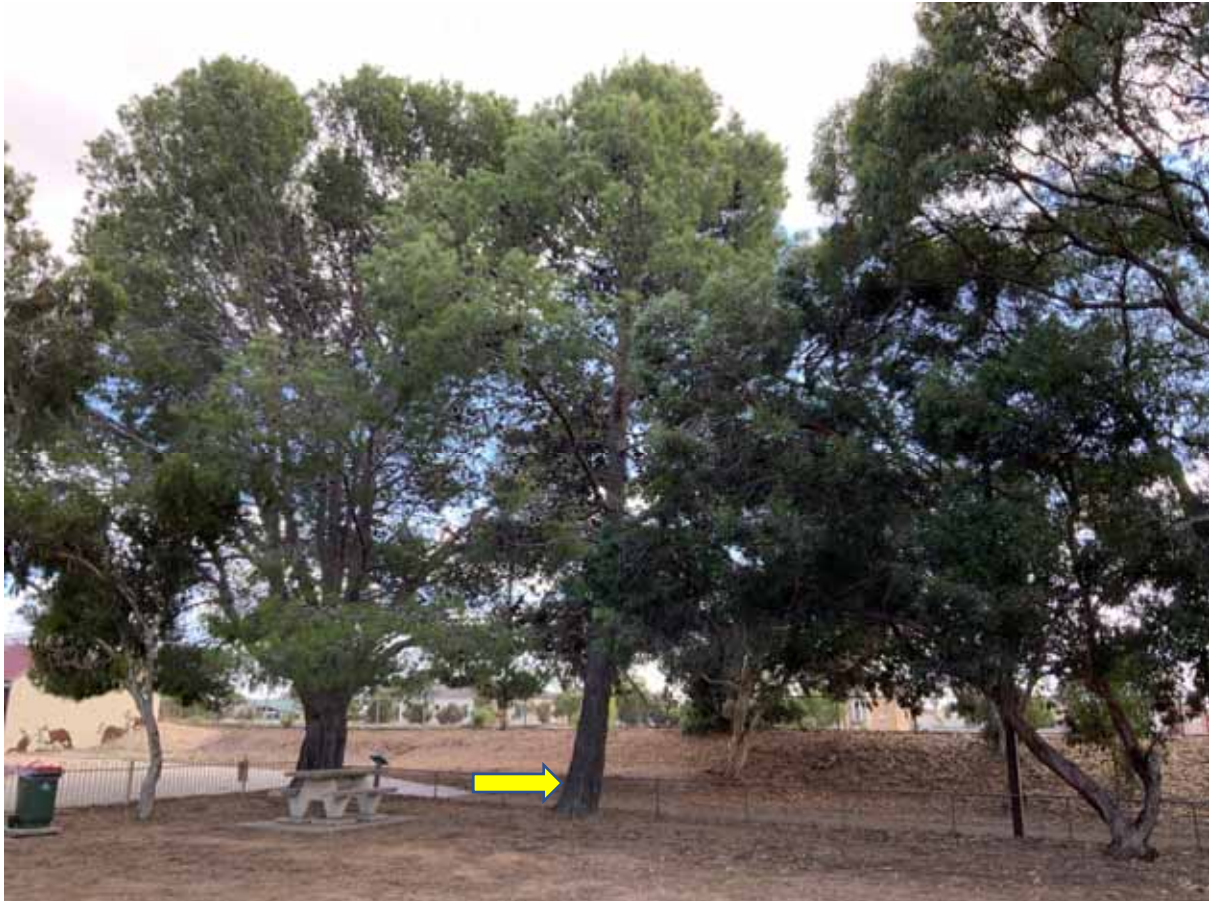
This tree is a forest form tree due to the close proximity of the trees surrounding it. The pines of forest plantings usually have sparse foliage on the side and lower canopy and make up the most of the foliage within the terminal canopy. This is much the same and it's still sound and does not pose a risk at this stage. This tree is of good structural make up and is in good condition.

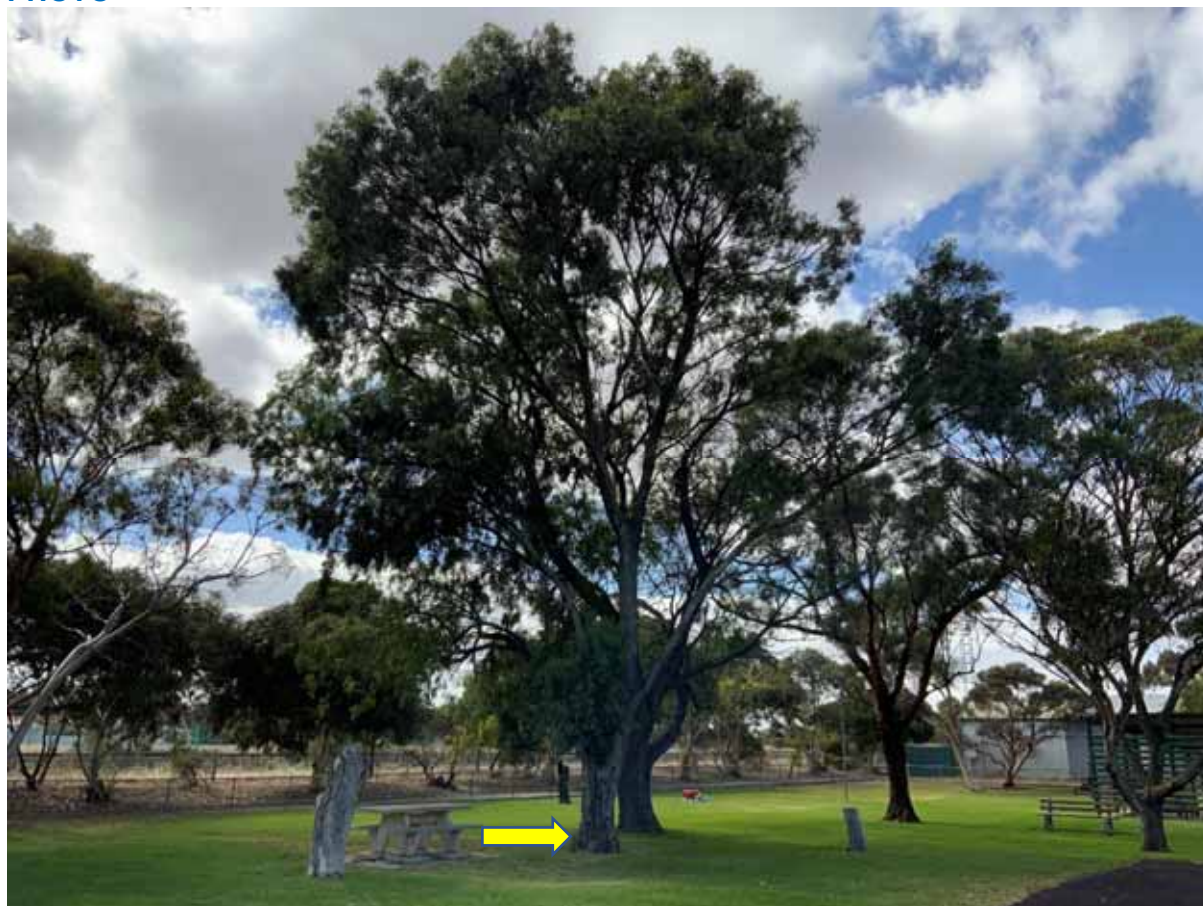
This Grey Box has had one large limb fail at the side and has caused epicormic growth to start sprouting from the edge of the breakpoint. This growth will need to be removed as it will be weak and it will pose a problem in the future. Because the tree is so close to a playground the deadwood within this area will need to be removed which is only minor, most of its canopy is free from deadwood.

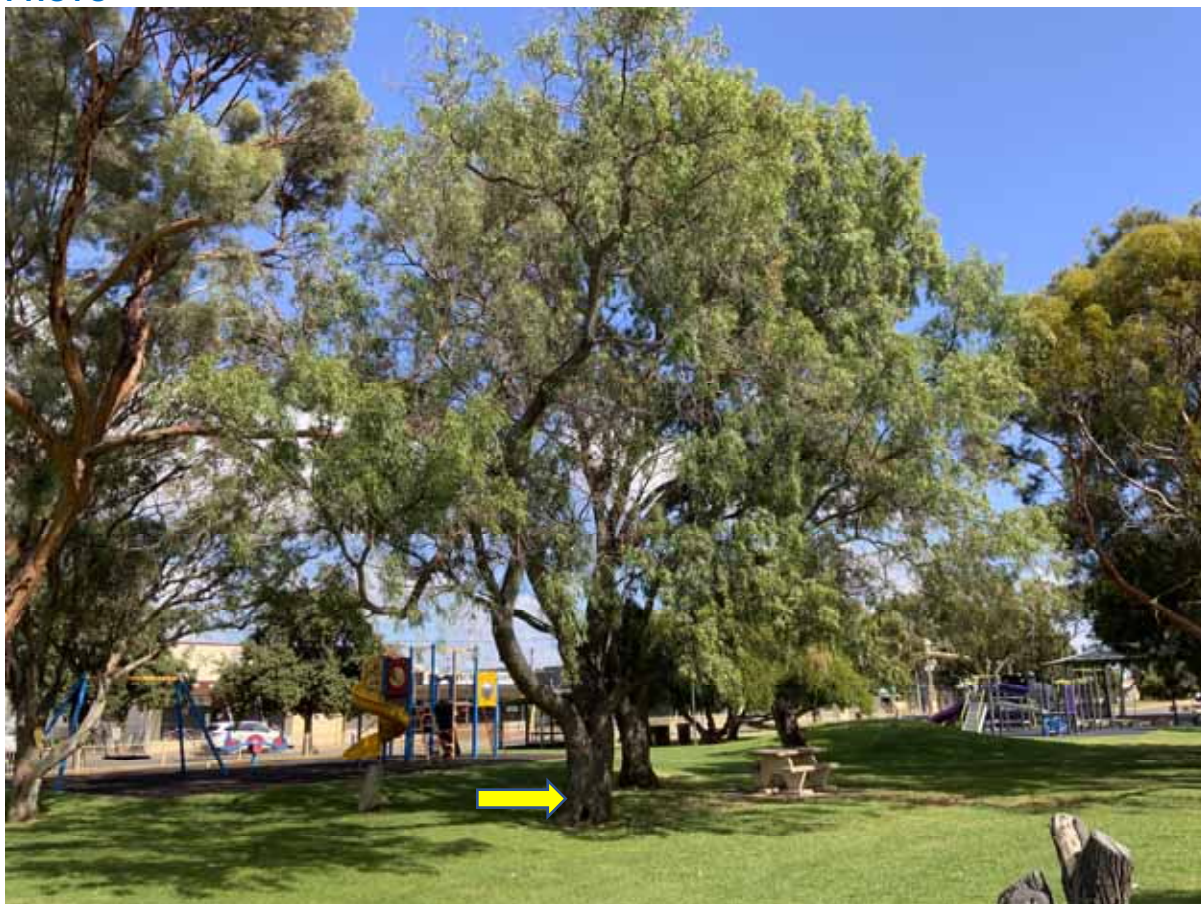
This Wattle is an upright specimen that has grown to the size which is most likely some of the largest it will become. This tree is healthy and in a good growth cycle, most likely due to the water from the irrigation, deadwood within this tree will need to be removed of which there is not a great amount, but will need to be undertaken due to the area being close to the playground.
