# TAILEM BEND TOWN PARK & STREET TREES

Tree Inspection – March 2021

**Tailem Bend Town**

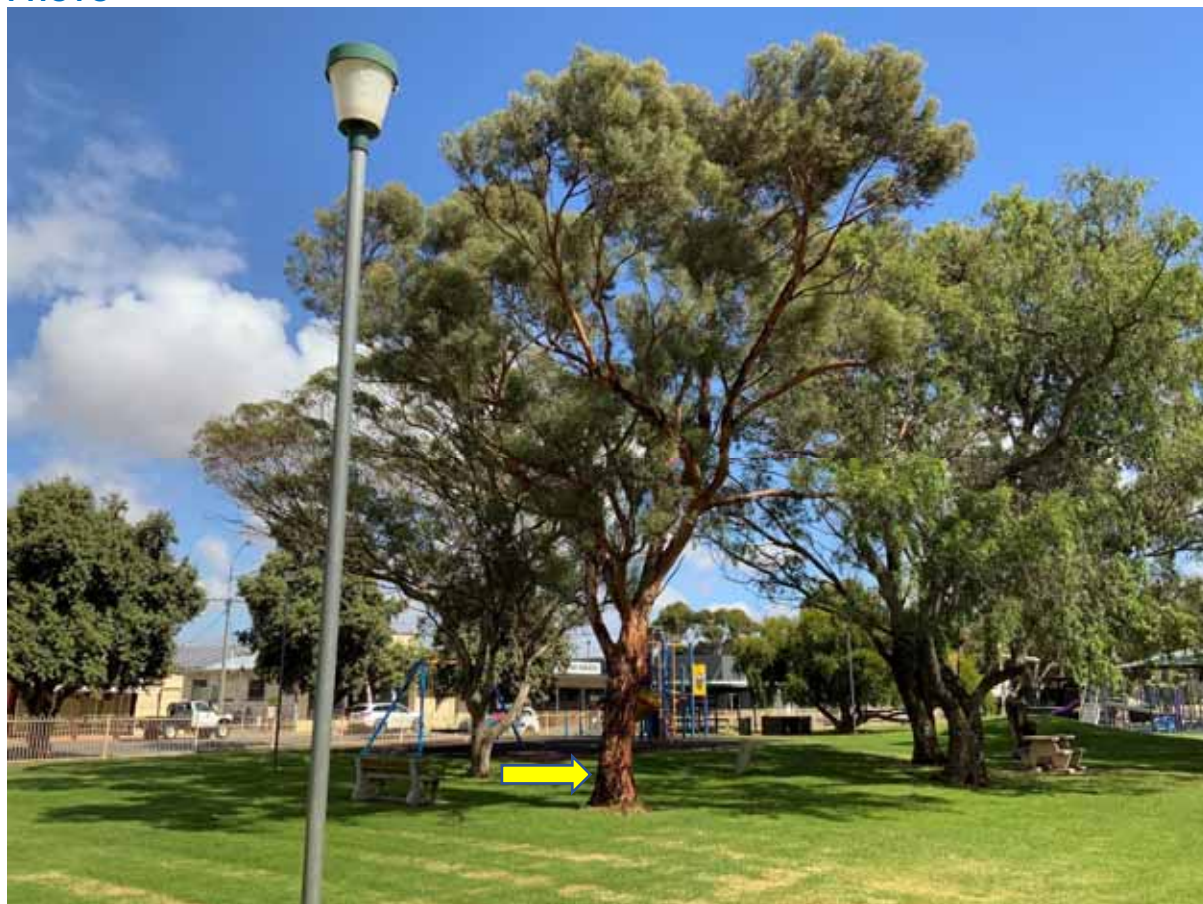
This Swamp Mallet has canker fungus which is cause lesions to burst out from the cambium layer resulting in Kino weeping as a result of trying to seal the wounds. This can be seen in the trunk and into some of the scaffold brunch system. Usually, eucalyptus will overcome this in some cases they don't however this is only a young tree and it should survive. The tree does not have a great deal of deadwood and is mostly small and does not require removal.

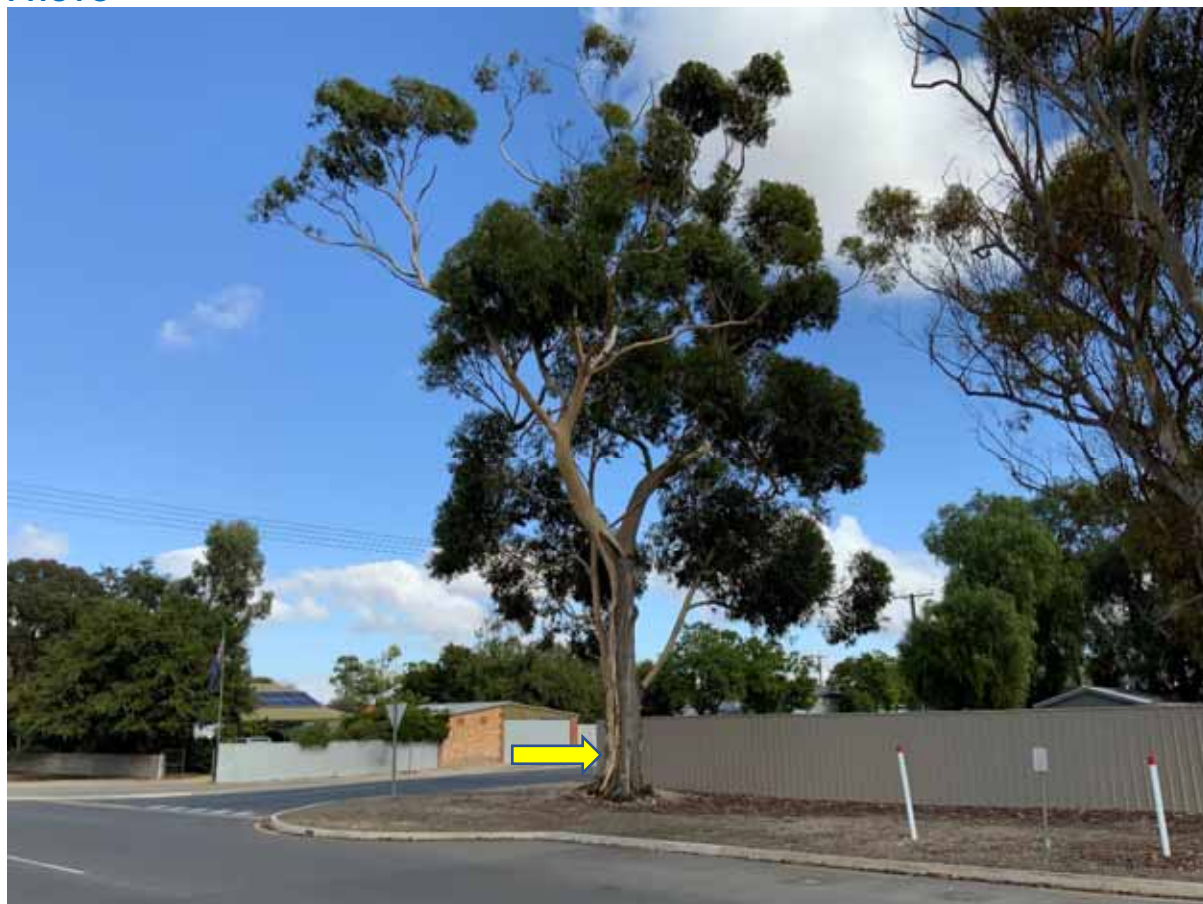
## 1. Eucalyptus cladocalyx

This large Sugar gum is dead on one side and the base is rotting out with large conks in the area as well as visual decay on this one side. The wound wood has no ribbing to strengthen around the area of deadwood and it also means that half the root system is likely to be missing also. As the area of decay softens and the area of root plate is no longer attached half the tree will be susceptible to failure with no structural capacity. As a tree does have large areas of upper canopy limbs and also quite weighted canopy the chances of failure is high and whole failure is highly likely in a storm event or high winds that will act on the trees safe area causing the tree to virtually tip over with no structural attachment to the soil on one side.

Removal of this tree is recommended.

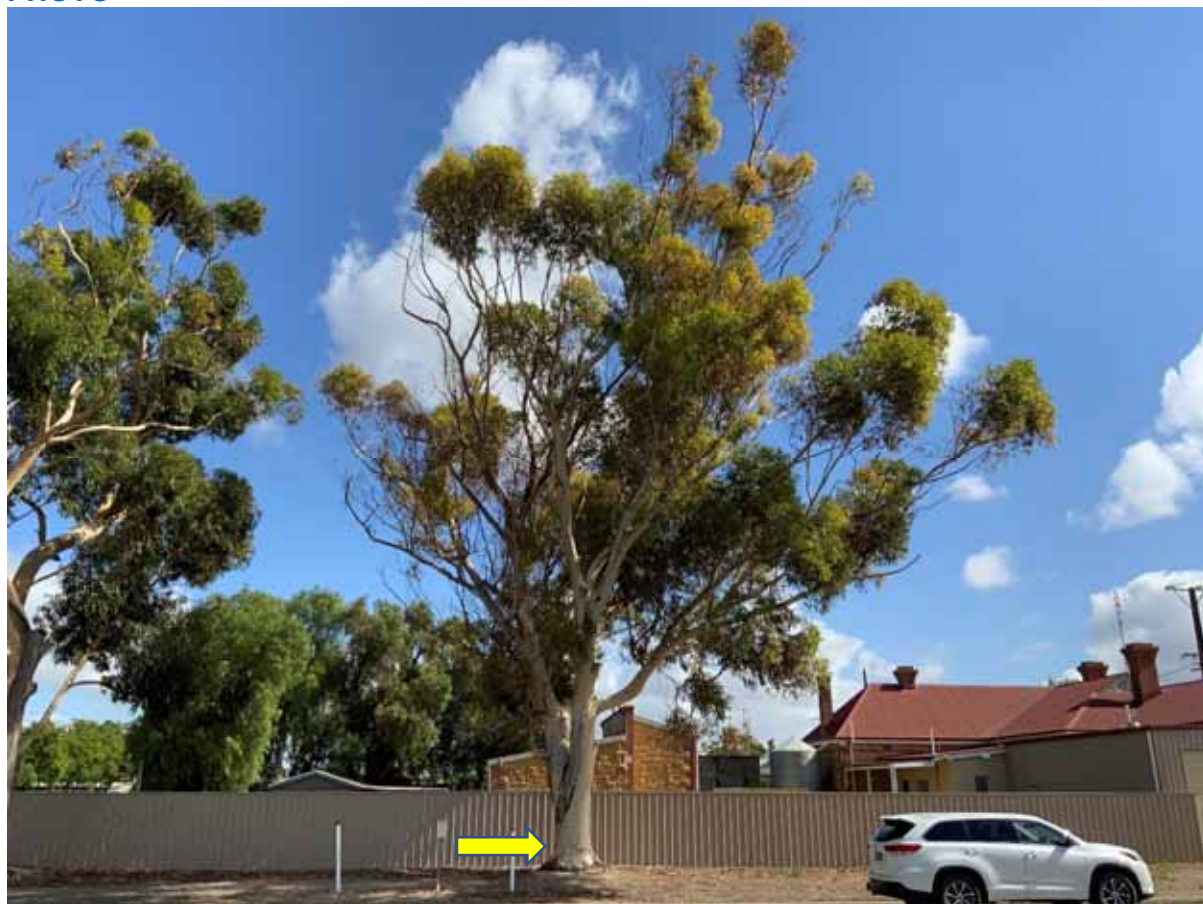
This Sugar gum is quite sound and in a good current growth cycle, it does have areas of deadwood and the attachment points are sound with no areas of defects that would be seen as a risk. Over the police station side there are areas of deadwood which will require removal but only need a larger dead wood removed with no areas of regrowth on them. The upper canopy is still in good condition

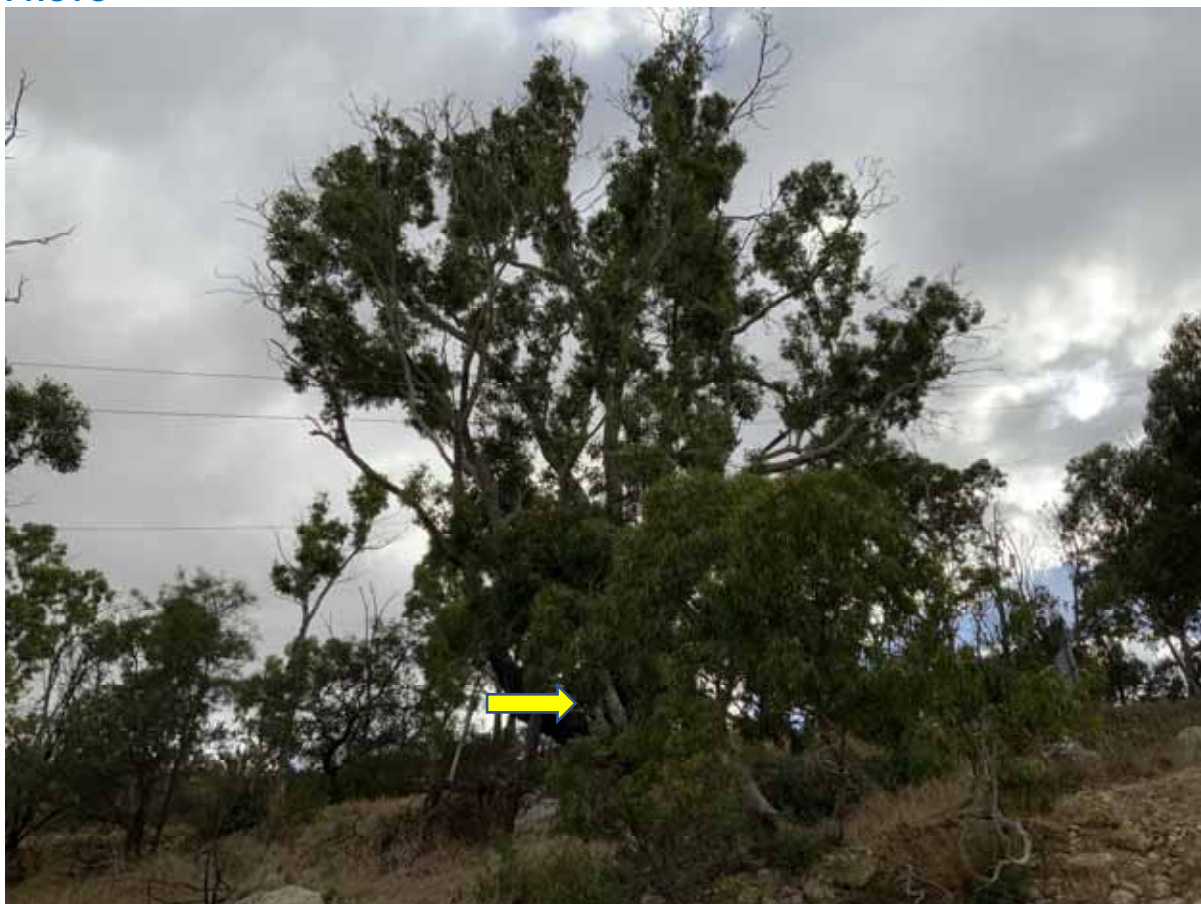
## 1. *Eucalyptus gomphocephala*

This large Tuart has grown as a multi trunk tree but is more likely to have been a tree with shoots near the base that have developed into much large branches but not as large as the main trunk itself. One of the branches is growing back down into the ground, but none of this is classed as a risk. Multiple areas of new growth are prolific throughout the tree itself, the tree has minor areas of deadwood which are above the area where no one can walk or no one walks and very often. This includes the bank and not the bitumen road at the base of the bank. I would not recommend any pruning of this tree as the amount of regrowth shows that the sap wood is present throughout the tree and the tips are only minor in size for a low use area.

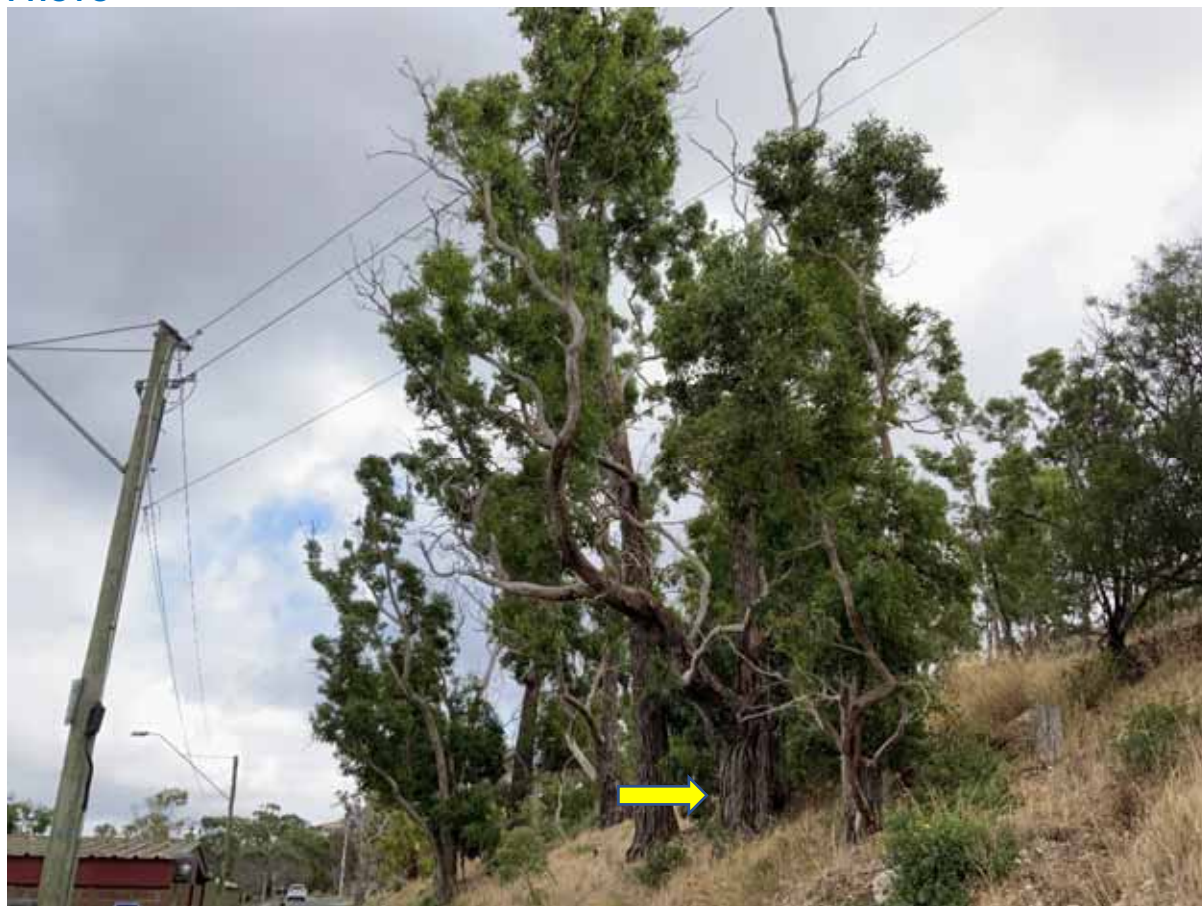
The Tuart has suffered from water stress in the past causing dieback through the main upright allowing the offshoot to develop into a more sustainable growth. There is one branch on the upright which is becoming dominant within the tree and will most likely become the dominant branch of the tree itself. The dead part of the main branch should be removed as well as the partially dead branch overhanging the roadway and dead branches that are above the bitumen area. Even though the large area over the bitumen does have a new green shoot this needs to be removed to reduce the weight within the branch to allow the tree to mature without any failure within this area.

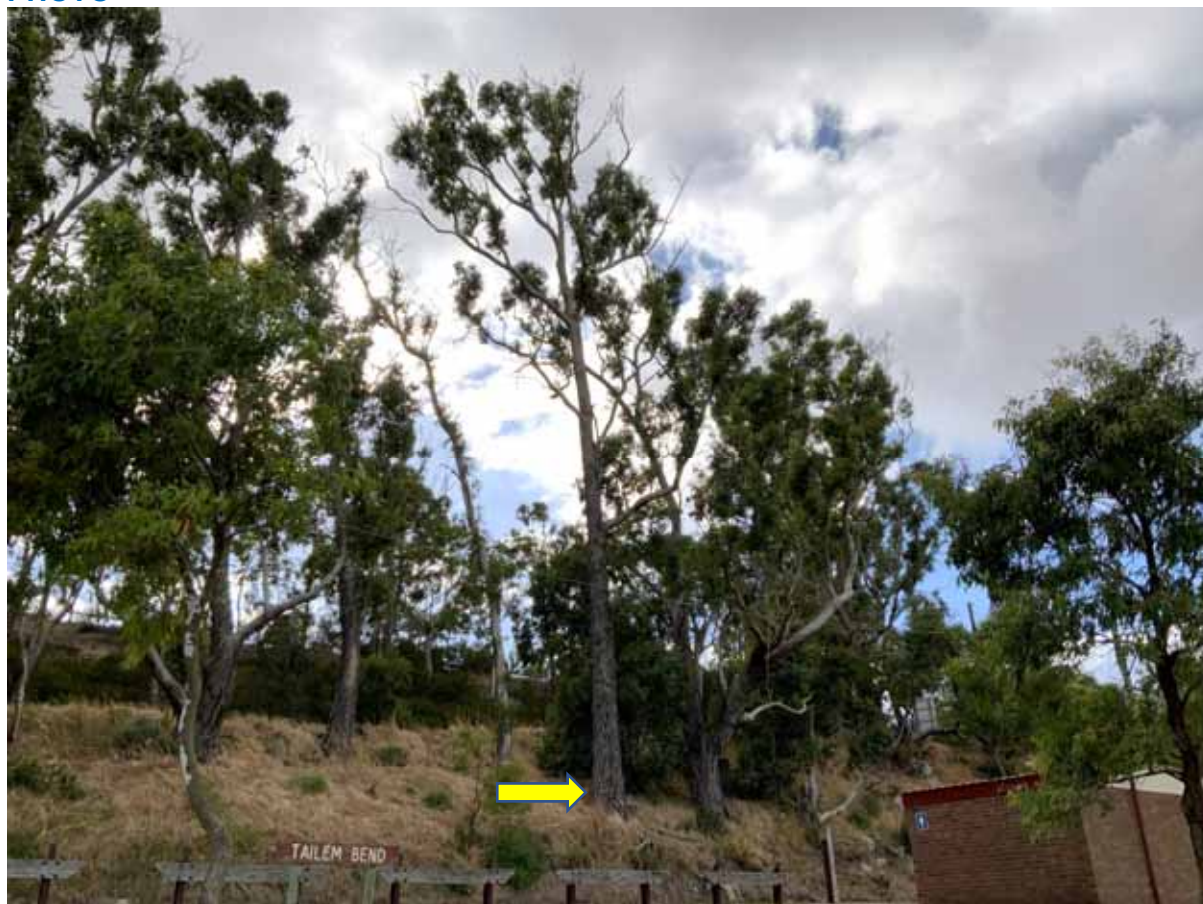
This Tuart is very close to the second tree and is mostly of an upright form much like a forest form tree. The tree has a small area of new generated growth, this growth will eventually mature out into a much better canopy than it is now, this will also allow for better growth within the tree itself with enough foliage producing enough energy for the tree to be sustained.

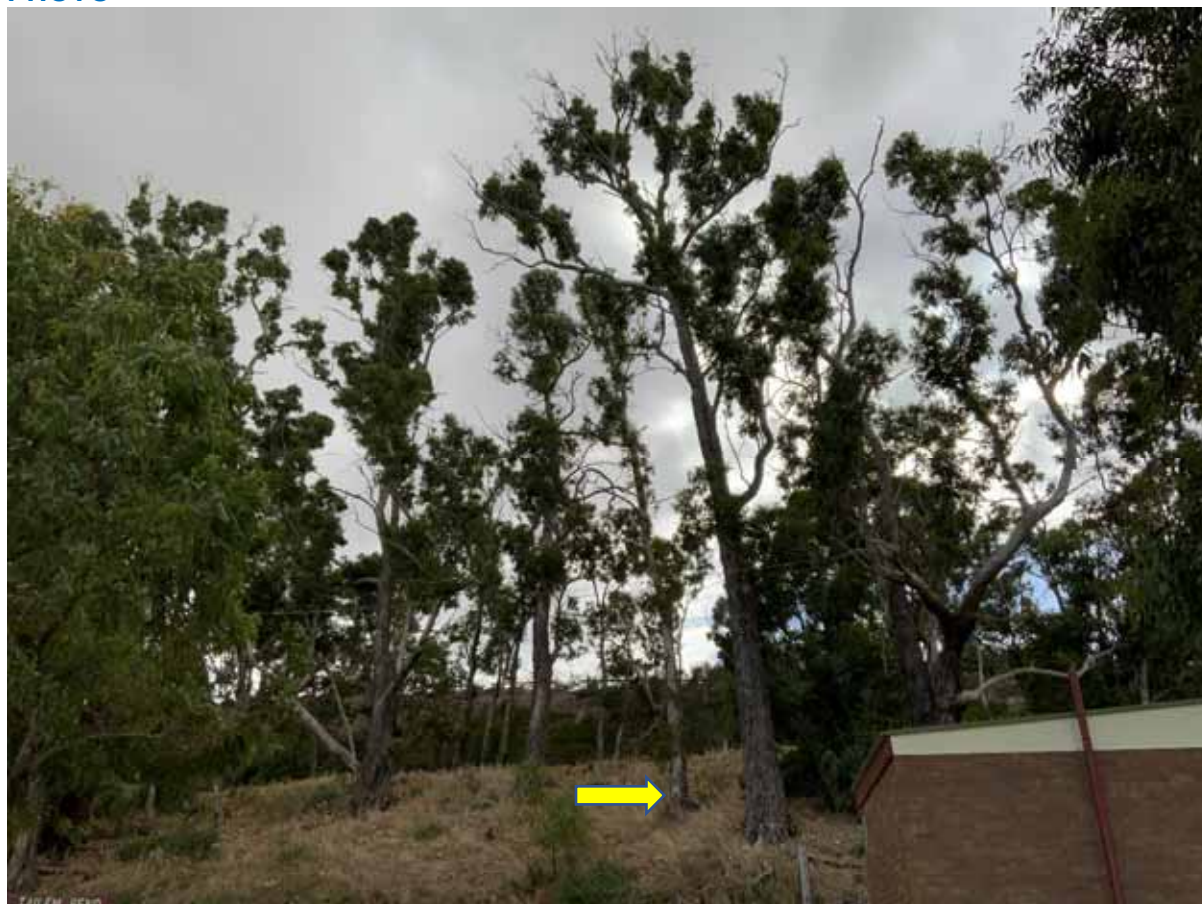
This Tuart has a confined area of growth. The tree has foliage sprouting from the lower portions of the main trunk up through into the terminal canopy. Being a forest form tree with restricted growth, it will be a tree that will become susceptible to wind forces as the growth matures and places pressure on the tree that it has not been conditioned to and will most likely fail.

Removal is recommended.

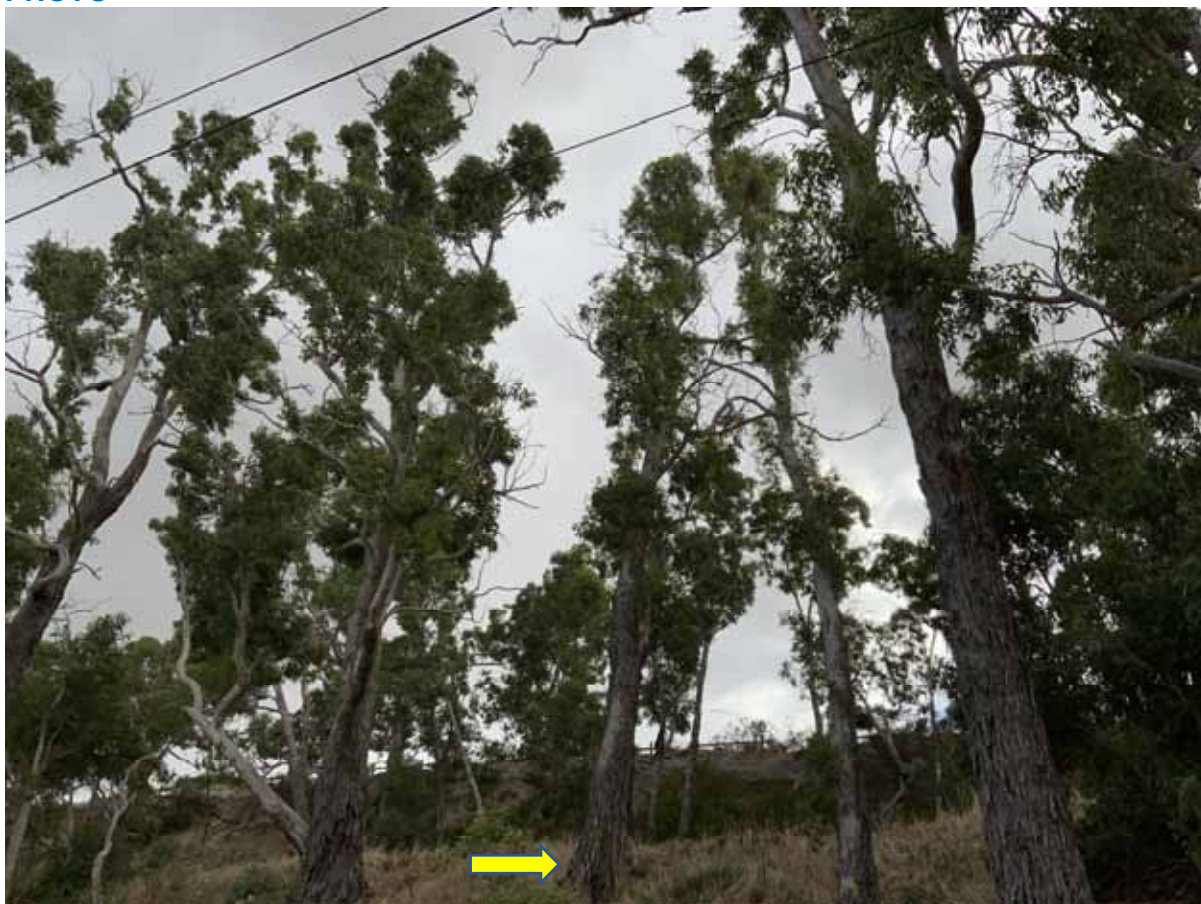
This Tuart is better developed than the last with a better canopy and is also developing new growth through rebound mechanism of past stress. The tree is centralized between the bank and will only require dead Wooding of the largest size back through the area over the main road leading down to the ferry.

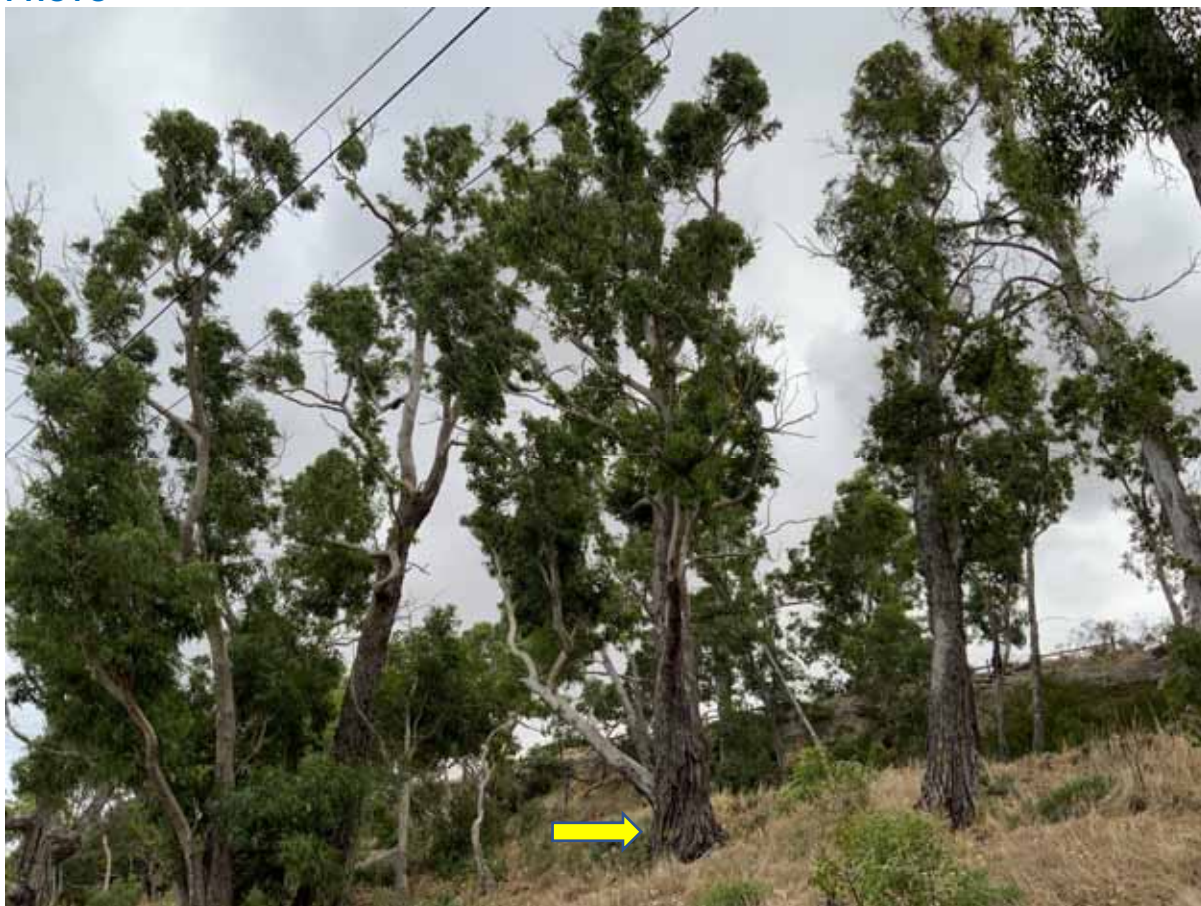
This Tuart has grown quite well and while there are some areas of deadwood, this tree does not require deadwood removal at this time, if deadwood did fail it will fall on the bank area where no one walks. The tree does have a good form and does or has developed a canopy that will be of good stand once it has filled out after the regeneration throughout the canopy.

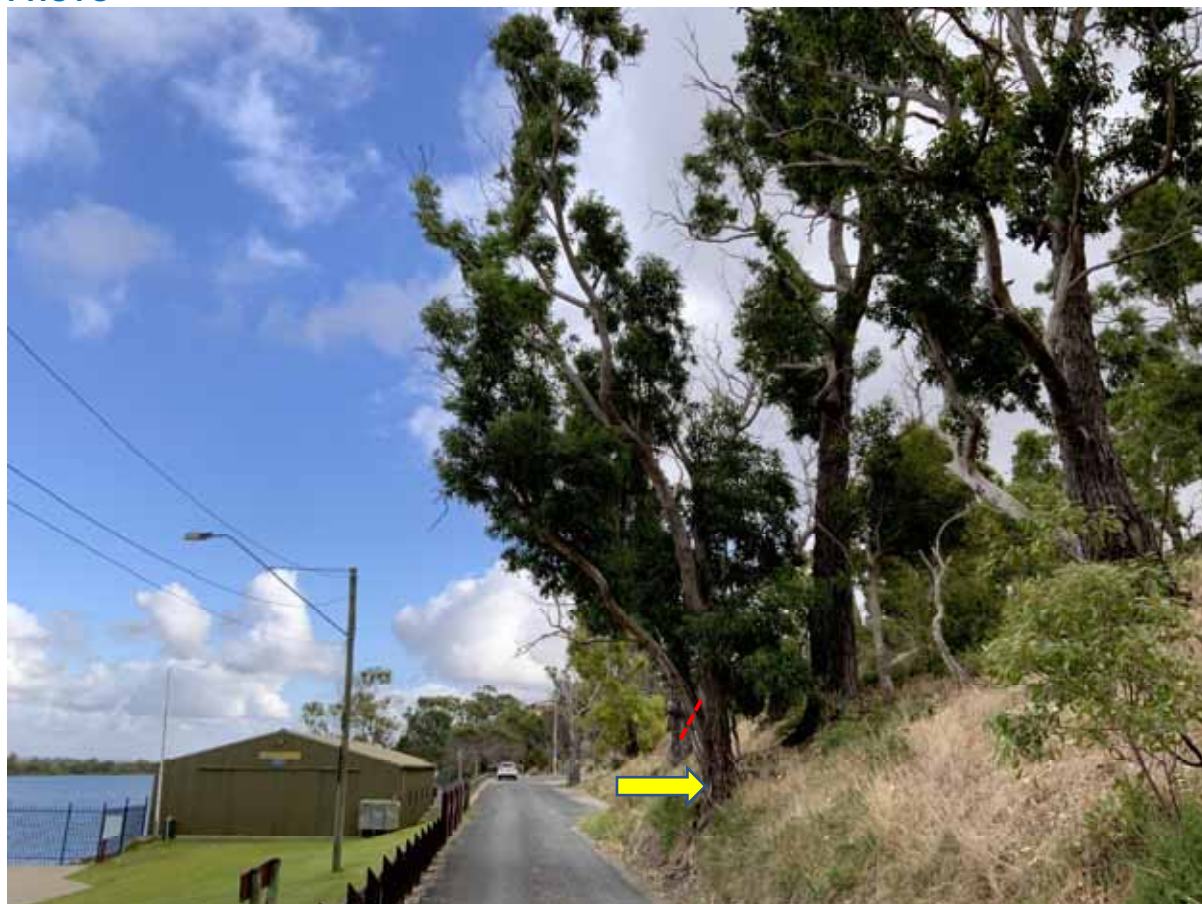
This Tuart has a large branch that has grown out from under the canopy and over the road. I'm recommending that this branch leaning over the road be removed, this will also take some of the stress away from the tree as it grows out on a lean away from the other tree next to it, the tree itself has put on quite good growth after being water stressed for so long, the amount of deadwood is negligent and does not require removal at this point.

Removal of the limb growing over the road is recommended.

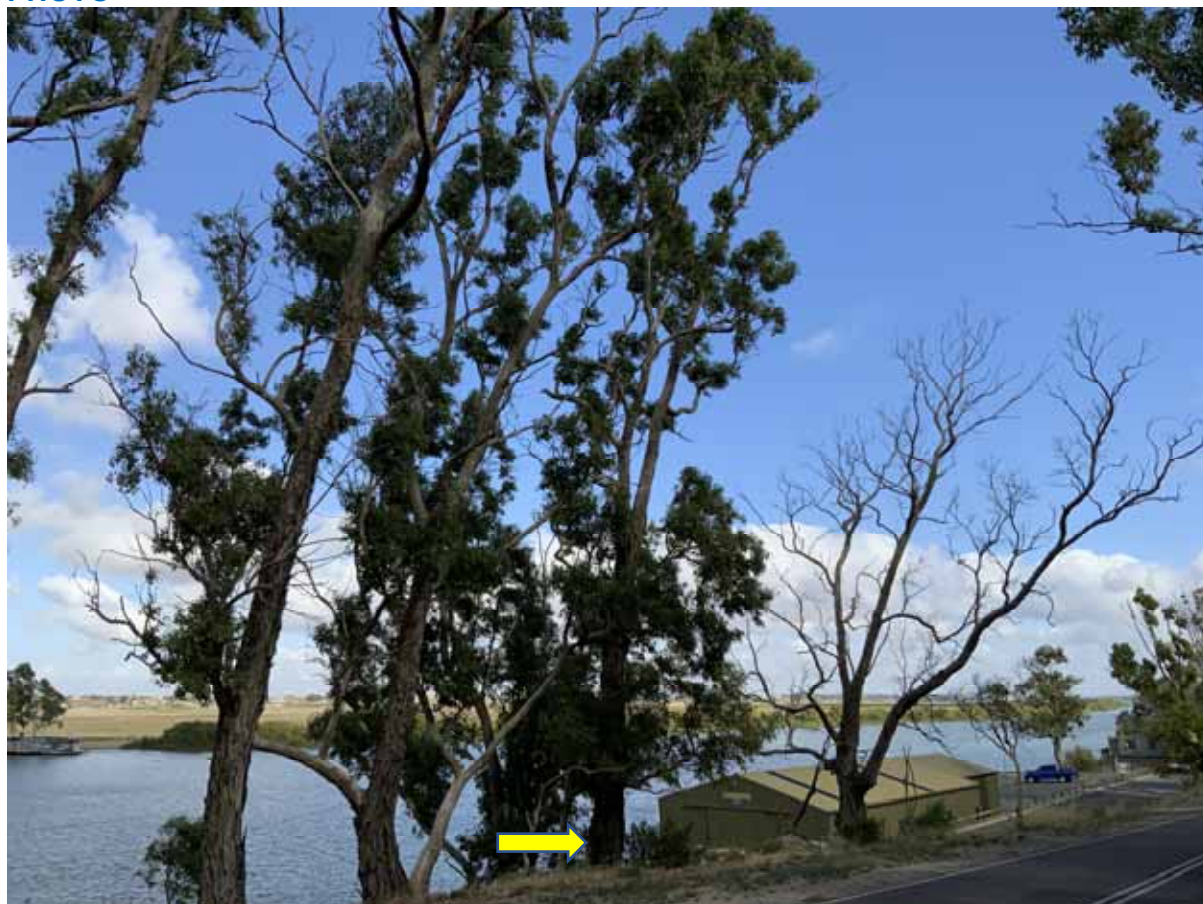
This tree is behind tree number seven and it is mostly an upright form tree that is within the confines of the bank area and has very few areas of deadwood, this tree has regrowth which is to the terminal canopy and most of the other branches including scaffold branches as throughout the tree.

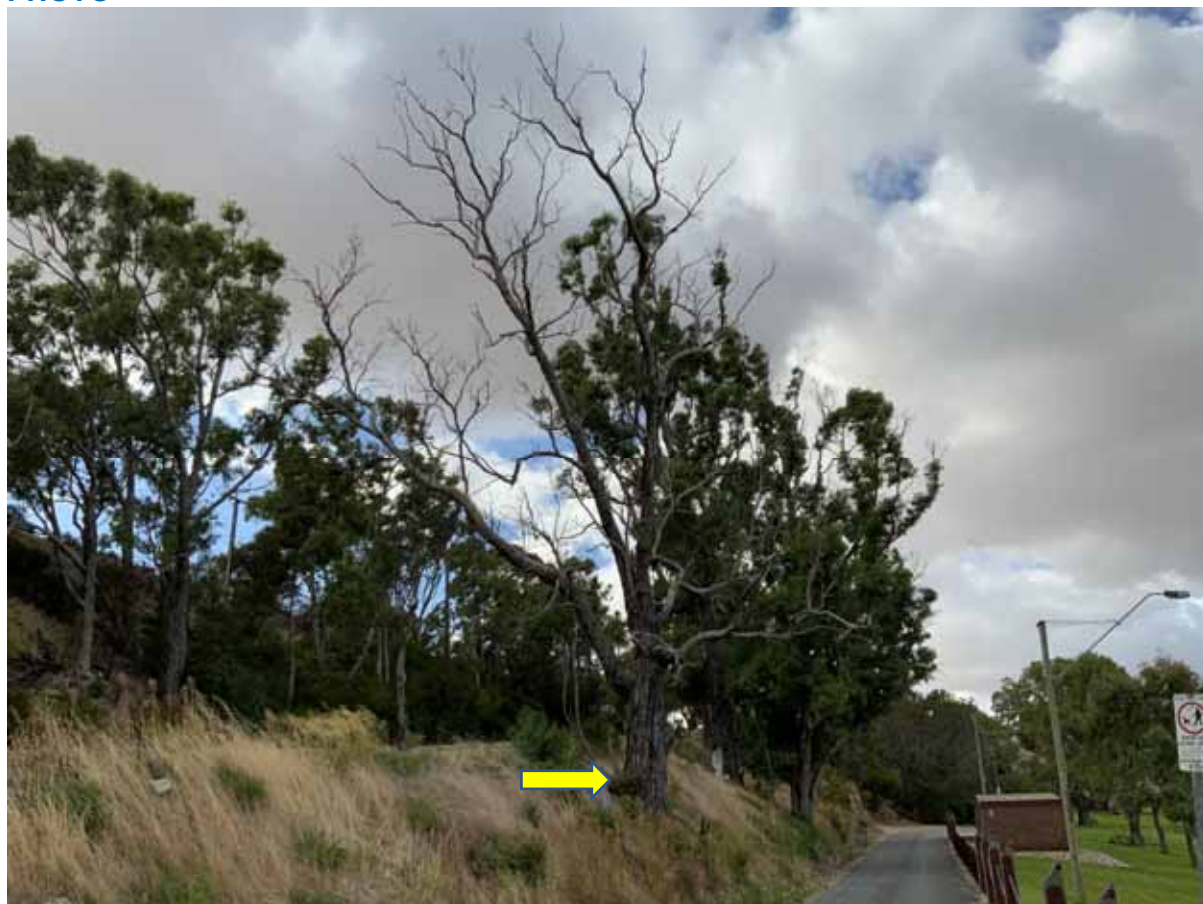
This tree has died right back when it does not show any signs of regrowth, the tree does have large limbs none of which have habitat hollows within them I would recommend removing this tree as it will start to fail as it dries and the strength reduces until it does fail.

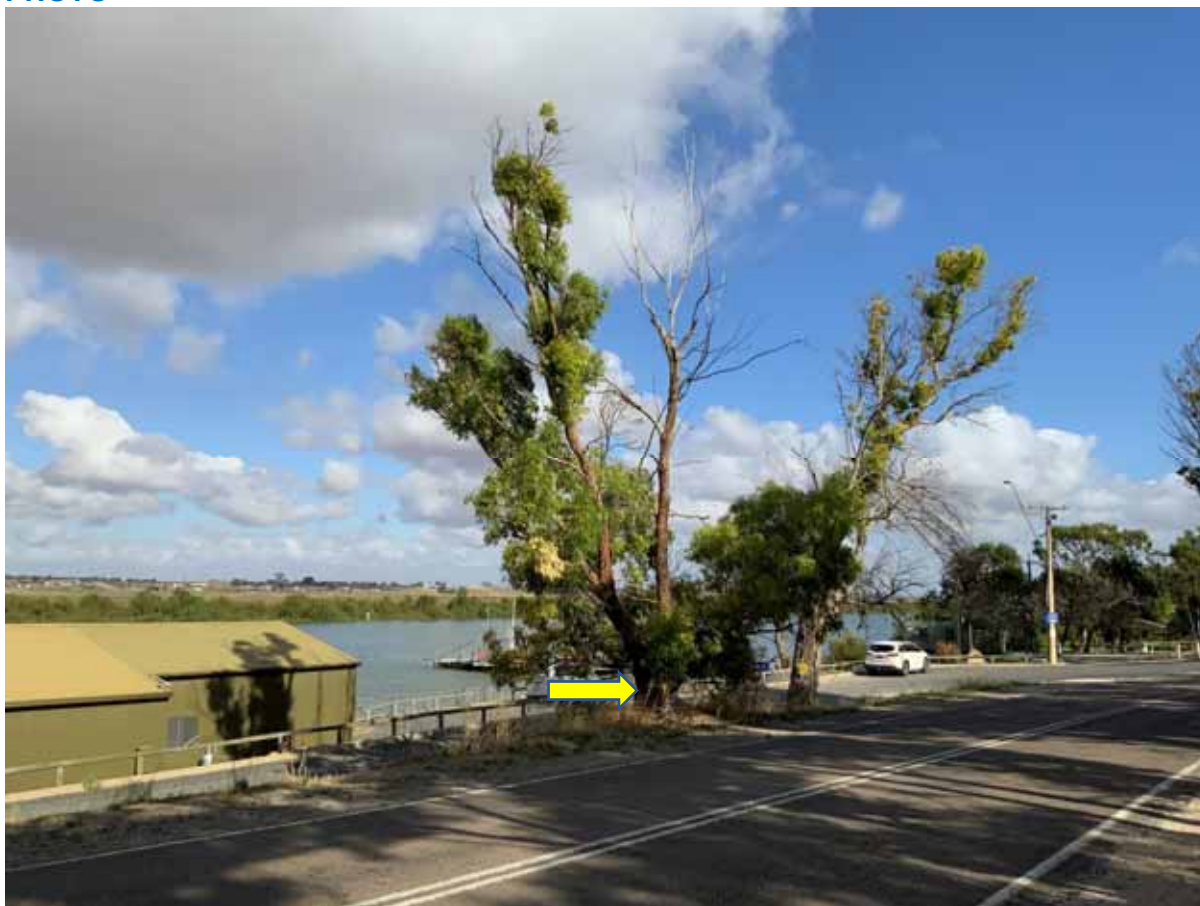
This is another Tuart tree which is more into the lower limestone area that is showing the effects of yellowing leaves. This tree has rebounded since the drought caused it to die back and the upper branch on one side has grown the most and the other has not. As this tree is in an area where the area is narrow between both roads, I am recommending that this tree be removed as just removing the deadwood is going to leave the tree leaning outwards on 3 sides, this is an unbalanced tree which could fail as the foliage matures and creates a larger sail area.

Removal is recommended.

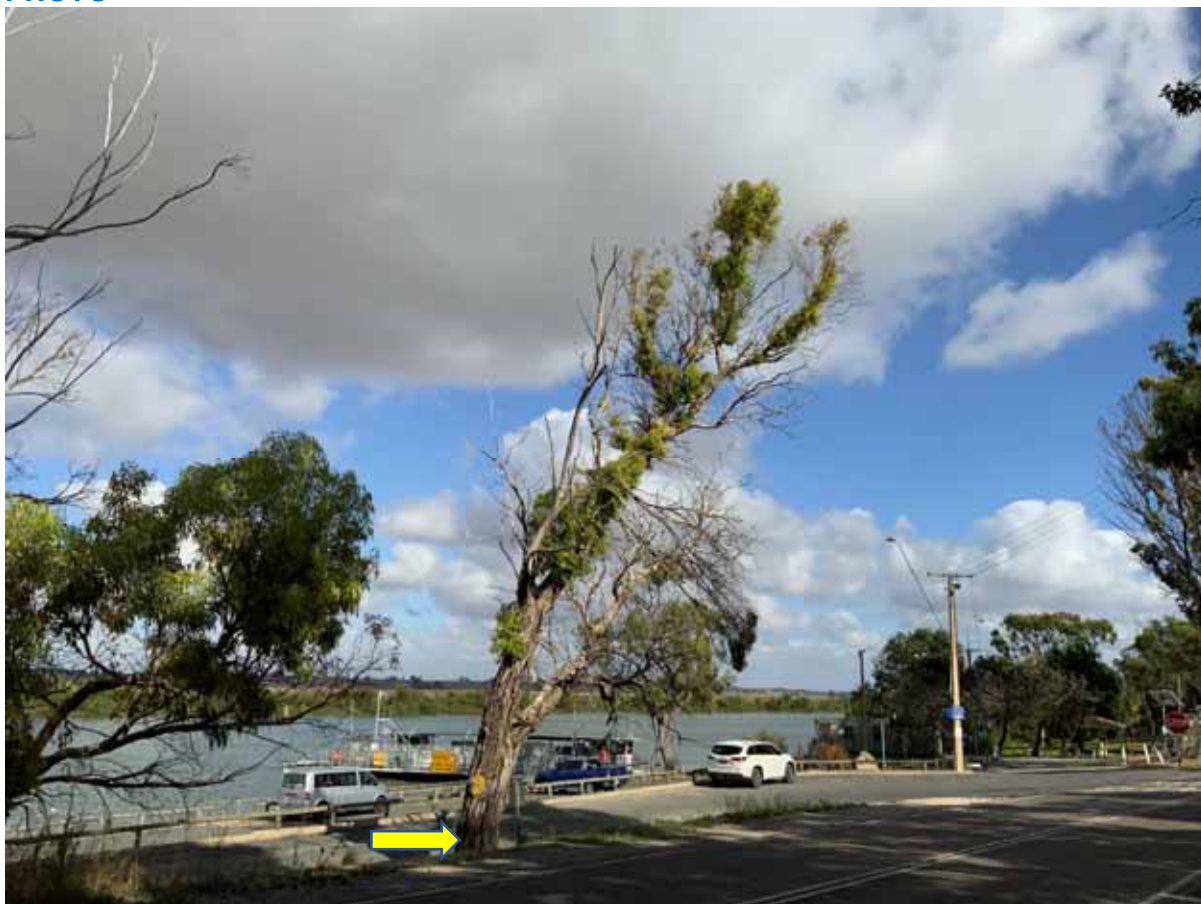
This Tuart has one main leader that is rebounded within new growth, the two outer branches have died off and they are hanging out of the tree, as this tree is deficient in its regrowth and is in a high limestone area that is recovering very slowly, I would recommend removing the tree altogether as the tree will most likely return to a good form tree and will be susceptible to dieback in future dry periods.

Removal is recommended.

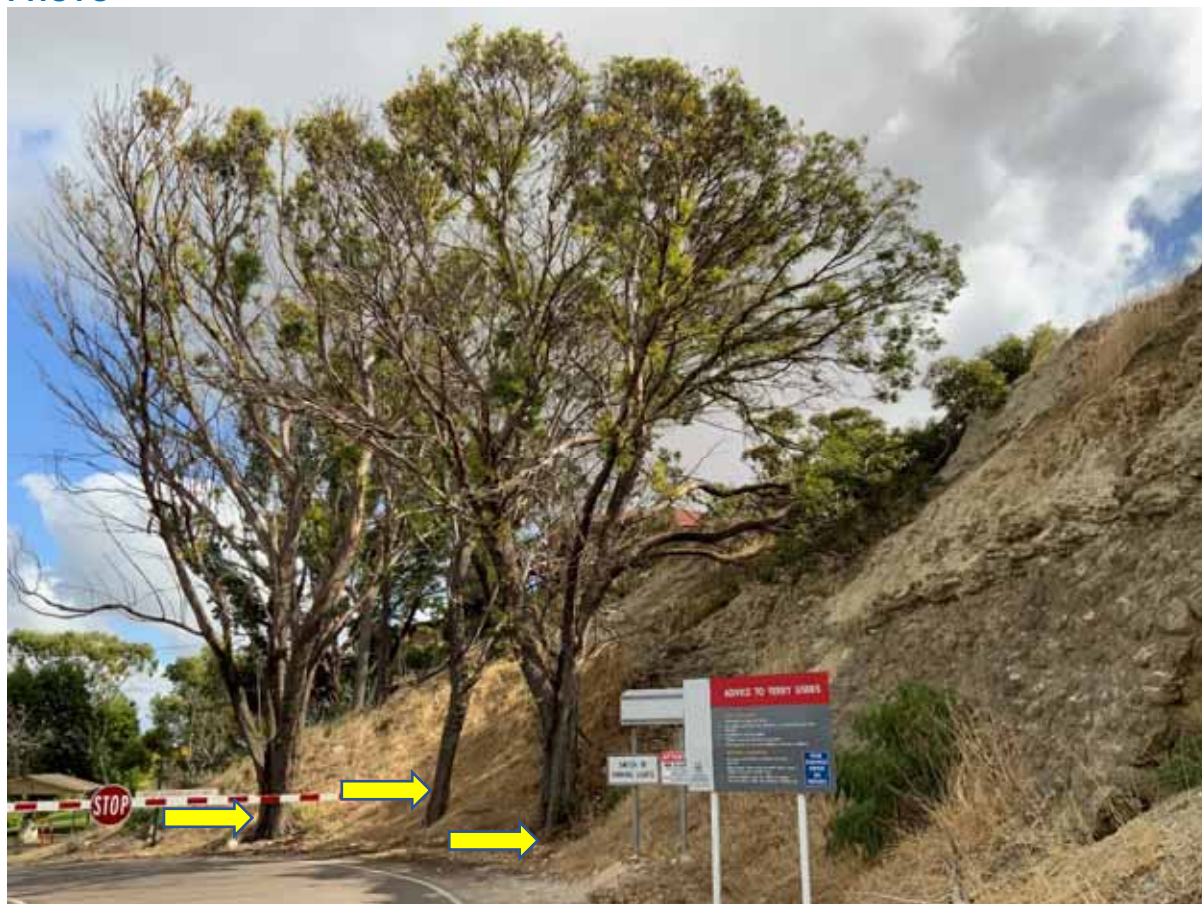
These three Tuart trees are all recovering with regrowth that is currently light in areas of foliage but it is rebounding uniformly, I am recommending removing dead branches that are overhanging the roadway and also the branches that are leaning against the bank they should be removed also any large deadwood that has not rebounded through the centre will need to be removed and this tree will need to be assessed in a years' time, I will inspect the trees when I'm in the area for visual assessment as I'm in the area quite often whatever does not rebound will need to be removed however the trees are quite large and they are starting to come back slowly.

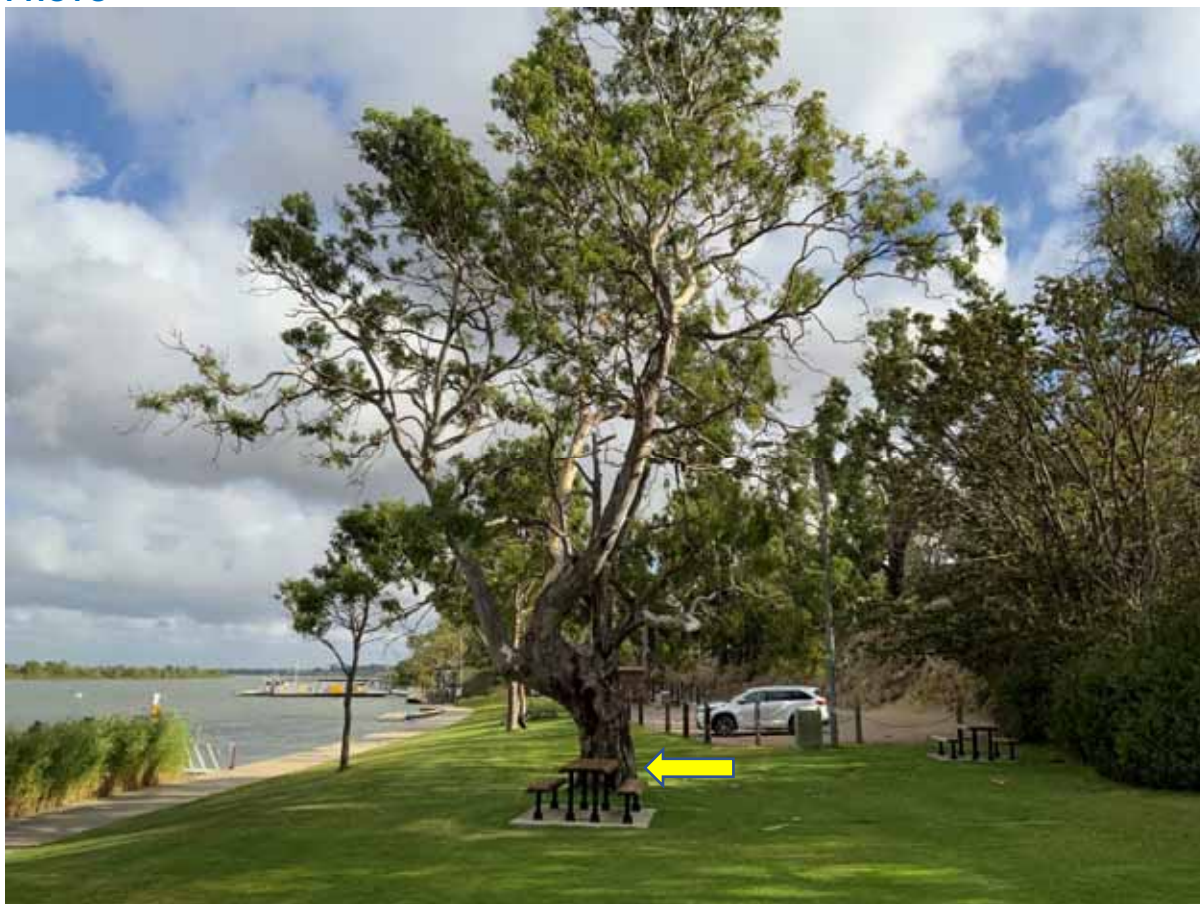
## 1. *Eucalyptus camaldulensis*

This large River Red gum has grown quite well within this area, the tree is of entire foliage that is a good grade but sparse throughout the canopy. This indicates that the tree has suffered from water stress which in this case would seem unreasonable being close to the river and being located in an irrigated area. As the tree has deadwood, I am recommending it being removed as the area is used as an encouraged area of stationary rest with seats and tables underneath the canopy.

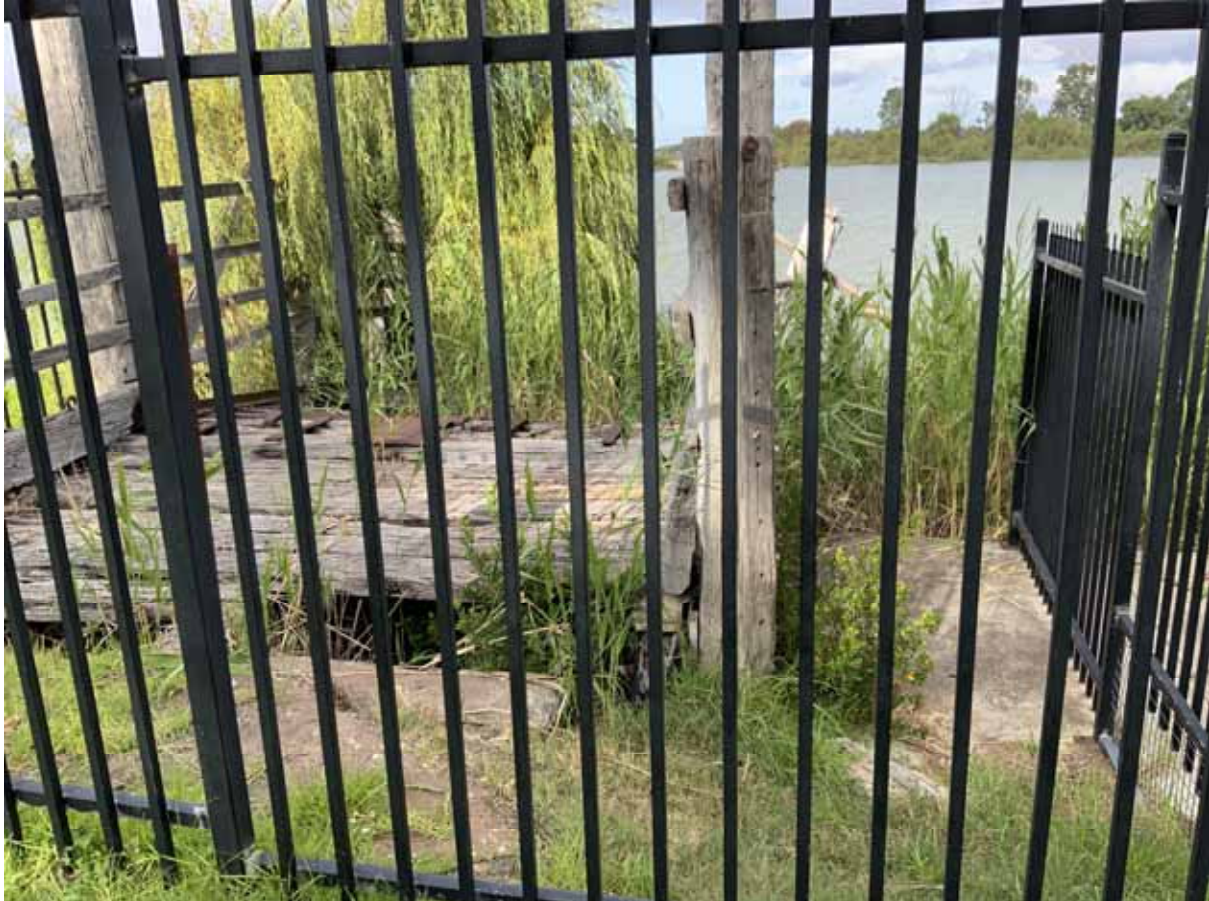
The old Ferry landing is becoming engulfed with the *Arundo donax* (Reed) and also there is a *Ramnus* growing underneath one side of the old Ferry landing and also the *Salix babalonica* (Willow) should also be cut away from the actual structure itself and it will grow and cause the wood to rot out. The *Ramnus* needs to go otherwise it will overrun the area and become a shrub that is allowed to spread along the river when it seeds, the *Arundo* and *Ramnus* should be poison with bioactive roundup so it doesn't affect any of the water. The *Arundo*, *Rhamnus* and *Salix* are all pest plants, if the area is left and the vegetation grows, there will be nothing to see but gated weeds.

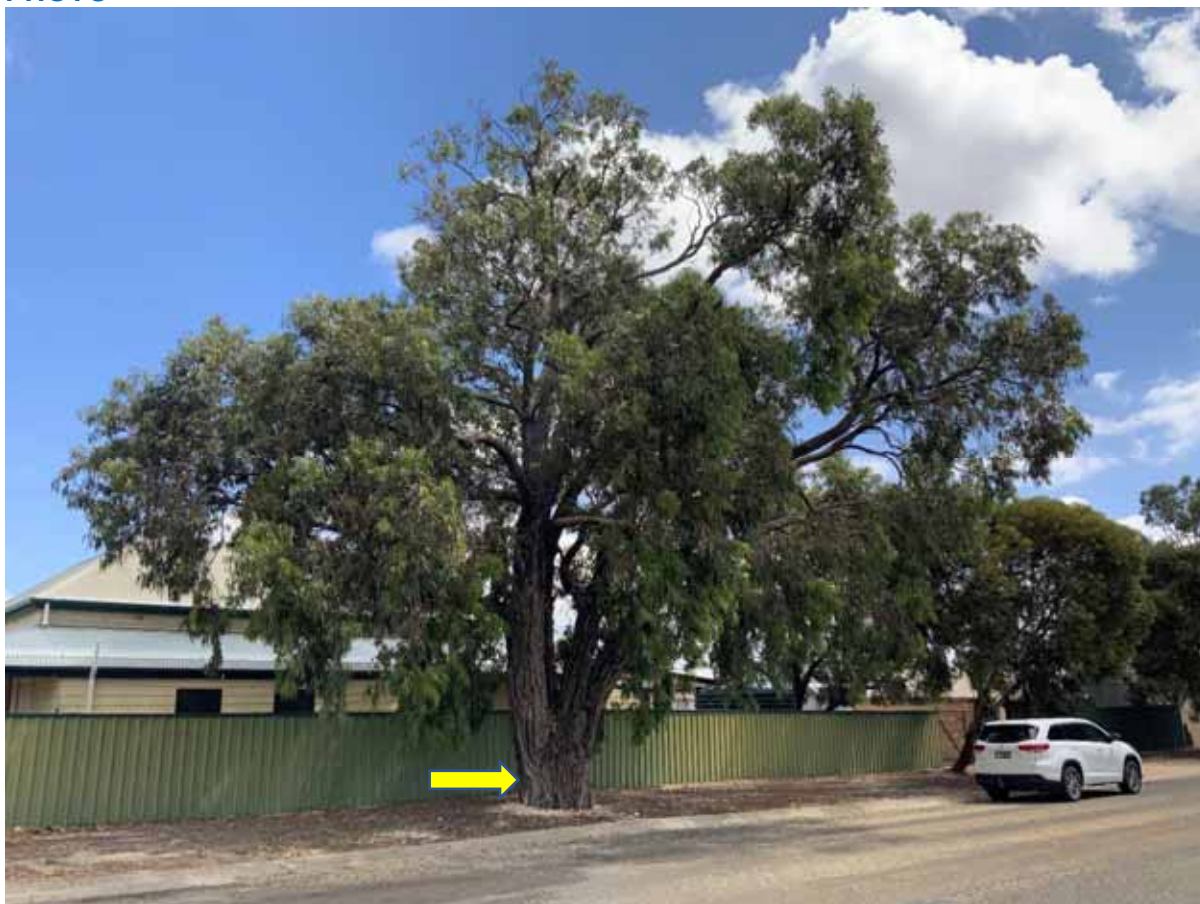
## 1. *Eucalyptus gomphocephala*

This large Tuart has good attachments at the base with no areas of defects or such things as included bark etc. The tree is a semi drooping habit which is quite normal for this species. I would recommend lifting the foliage up to at least 2.1 metres to allow for pedestrians and on the road it needs to be at 3.5 metres for access for vehicle access.
