# TAILEM BEND TOWN PARK & STREET TREES

Tree Inspection – March 2021

**Tailem Bend Town**

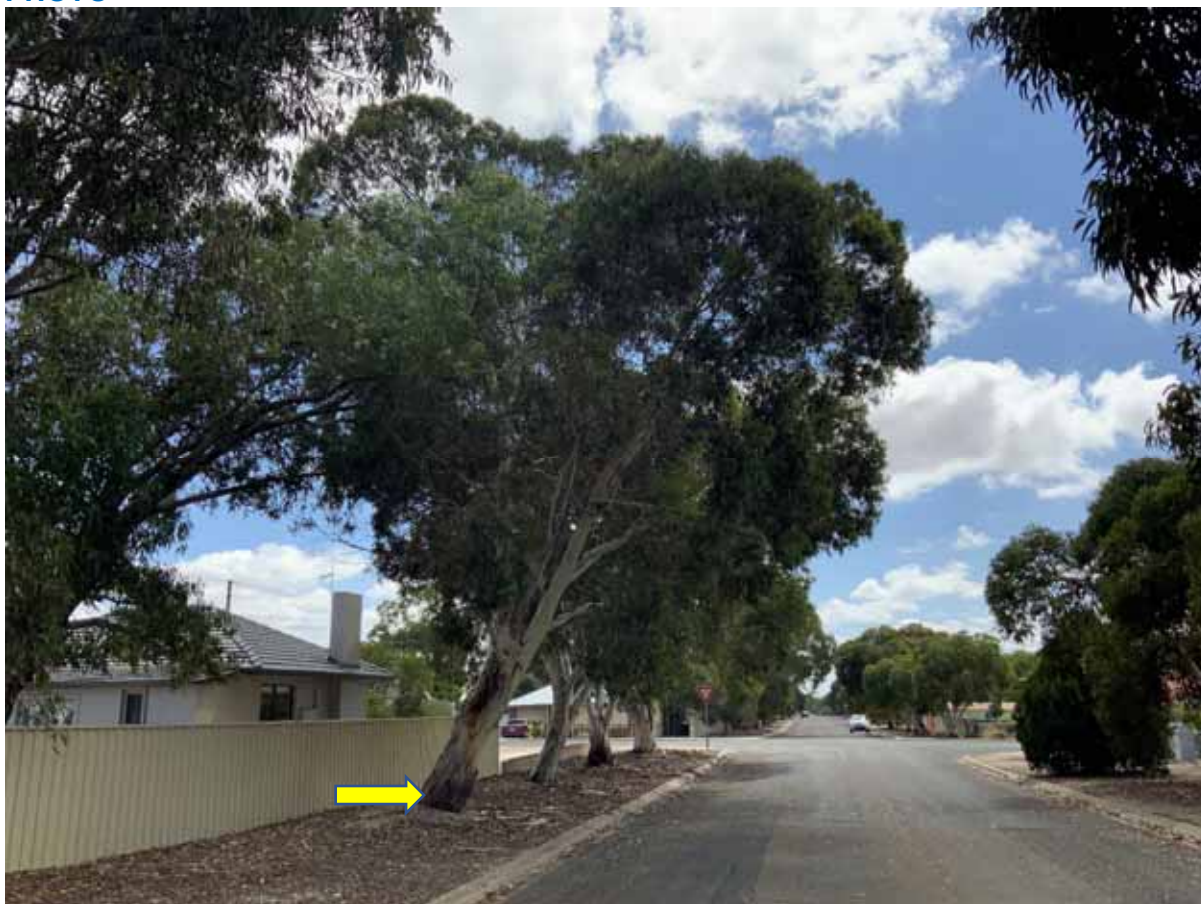
## 1. Eucalyptus leucoxylon

This SA Blue gum is also heaving the verge due to limestone sheet rock bellow; this has caused the tree to lift in this fashion however the tree is in good condition even with past Borer activity in the attachment point. The tree is on a lean out into the road area and the foliage is low due to this growth form, I am recommending pruning the road foliage to 3.5 metres for vehicle clearance.

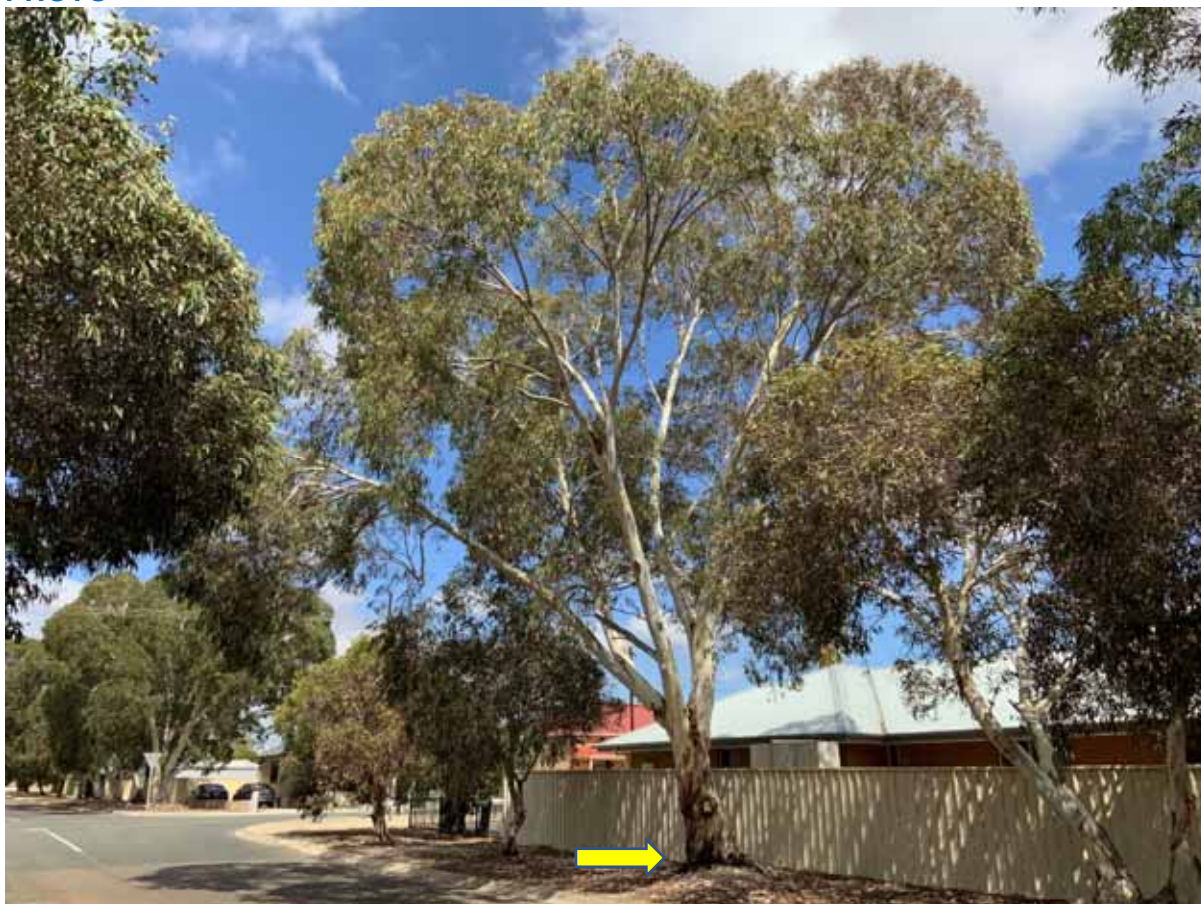
## 1. Eucalyptus leucoxylon

This SA Blue gum has had one failure in the upper canopy but only been small compared to the rest of the tree however it may have been due to the drooping nature of the tree over the roadway. I'm recommending the limb growing out over the road needs to be removed and also the limbs drooping down at the curb should also be removed which is on a different leader. The tree has reached its platform of rock beneath and has heaved the verge area above.

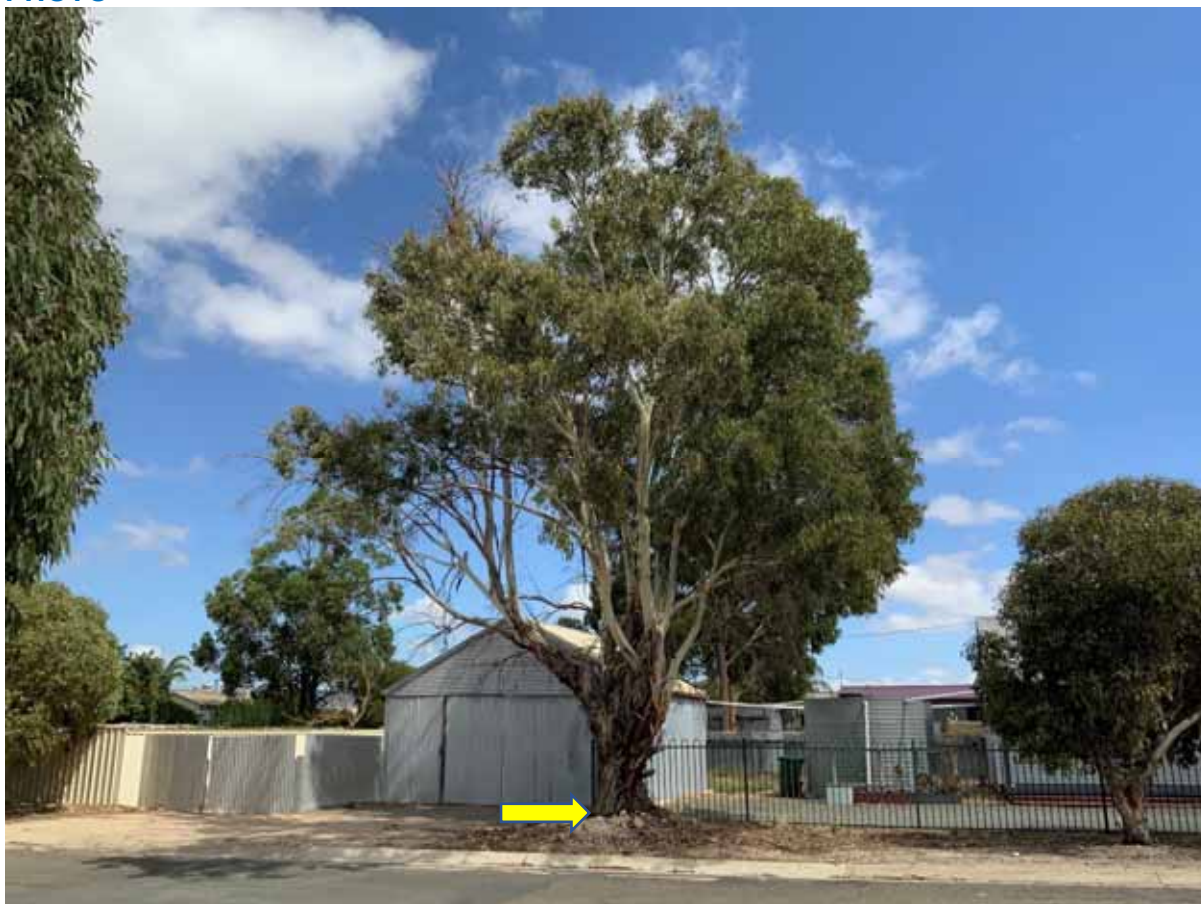
## 1. Eucalyptus leucoxylon

This large specimen has caused heaving within the verge, this is mostly due to the root system sitting on a rock ledge or rocks which intern causes the growth to expand on the upper side only pushing the soil into a mound over the larger structural root flare. There is one limb and that projects across the driveway in front of the shed which is mostly dead, this limb needs to be removed along with the larger deadwood throughout the tree, the shed driveway side will have a void but in time will naturally balance and fill out the voids.
