# Open Space Services

## MENINGIE PARK & STREET TREES

Tree Inspection – February 2020

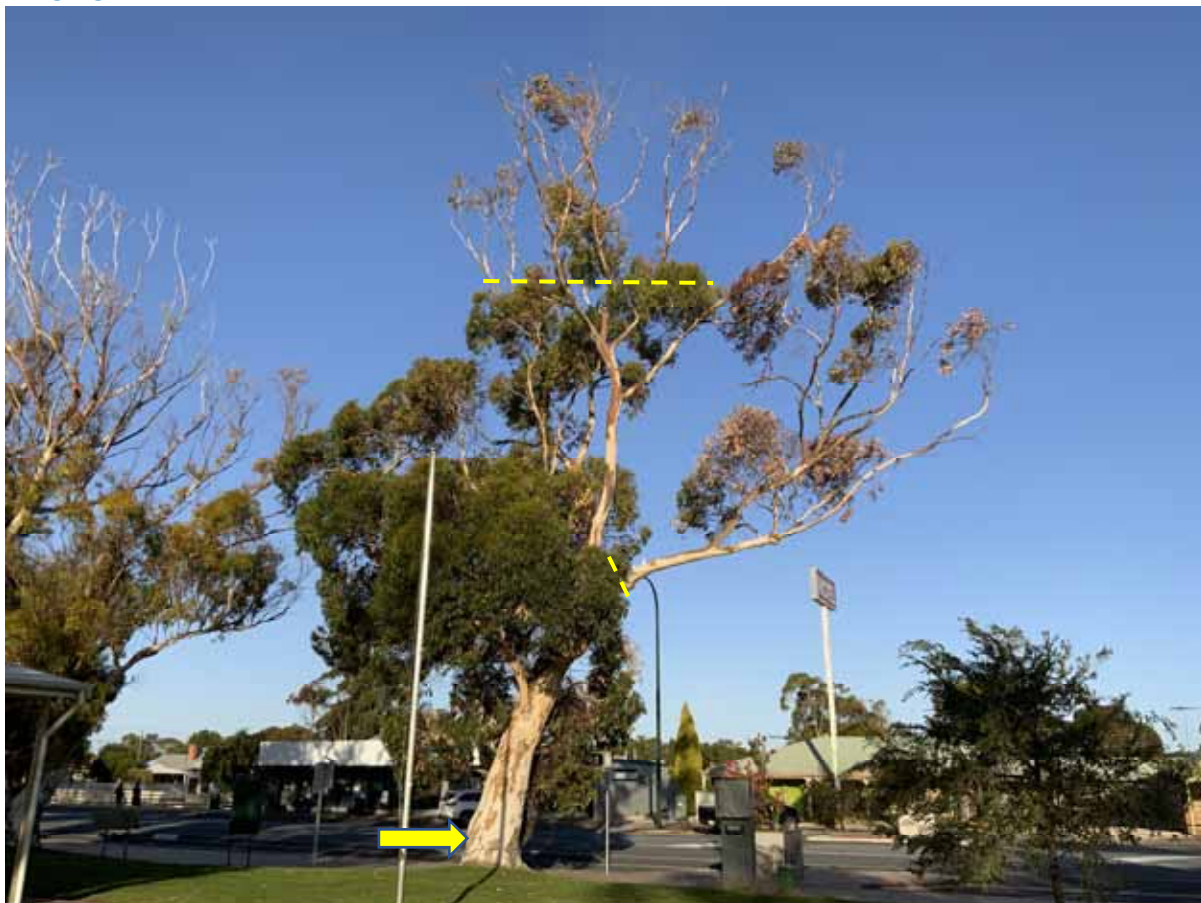
# 1. *Eucalyptus cladocalyx*

MEDIUM RISK

This large Sugar Gum has areas throughout the canopy that have died back from high mineral content in the soil, and being in an area of high use, this deadwood will require removal. I would also recommend that the lower growth be removed to allow for better sap movement into the upper canopy, this will allow better growth in the terminal canopy and it shoots starting to go back to continue to mature.

Prune out dead wood and also remove the terminal canopy extended branches as indicated by the yellow dotted lines on the photo.

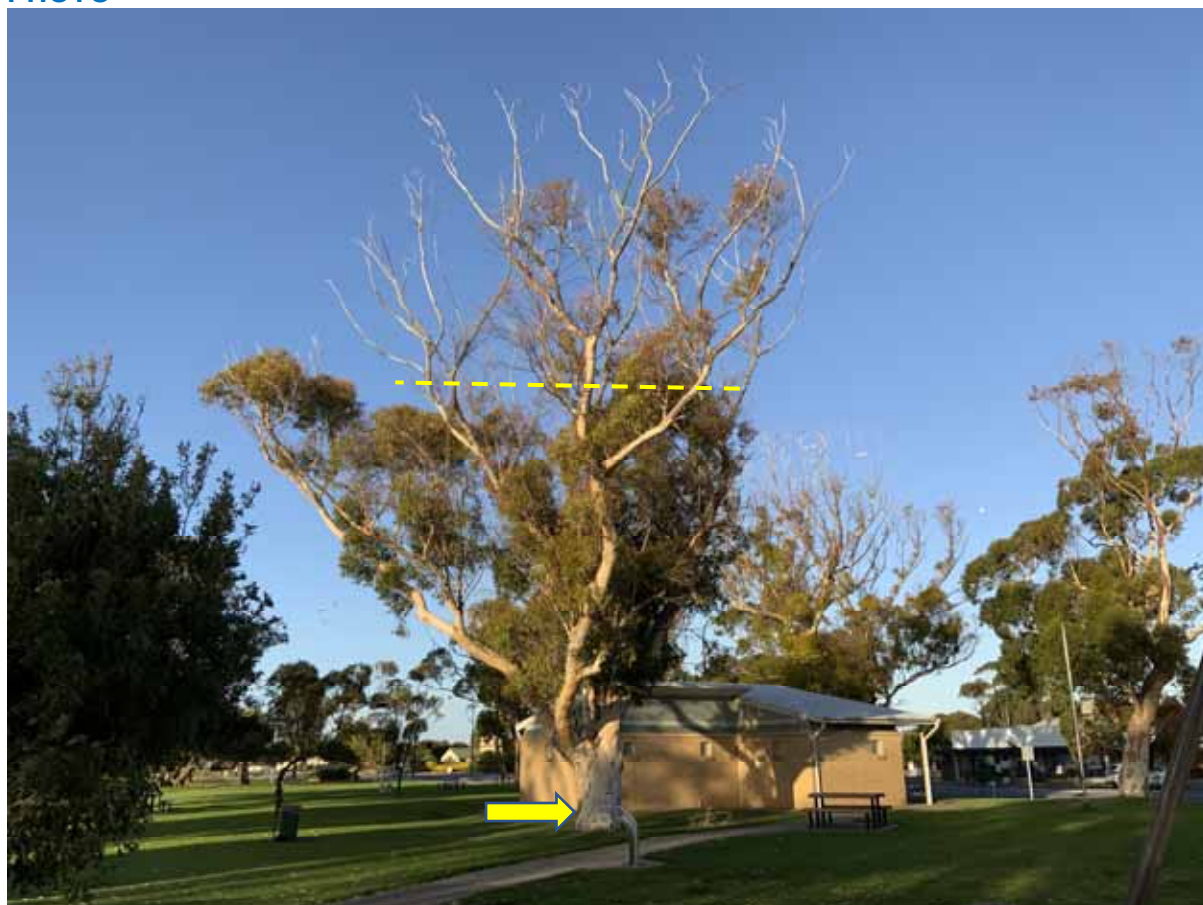
## 2. Eucalyptus cladocalyx

MEDIUM RISK

This Sugar gum has developed a large trunk structure, the attachment points coming off the large trunk has good developed tapered trunk system however, the die back in the tree indicates that the tree is suffering effects of high mineral content in a place where the surrounding soil is irrigated, the tree has regrowth which indicates that the mineral content is getting lower allowing the growth to emerge. If the problem was too much irrigation then the River Red Gums would be in full canopy, however the irrigation is contributing to the problem and a greater drying period is needed with less water used for the grass as the grass is flourishing and is over watered. Pruning of the upper canopy will be required to both reduce the deadwood and to remove the hyperextended branches, deadwood removal will be required throughout the rest of the canopy.

Prune off the large extended limb that is drooping.

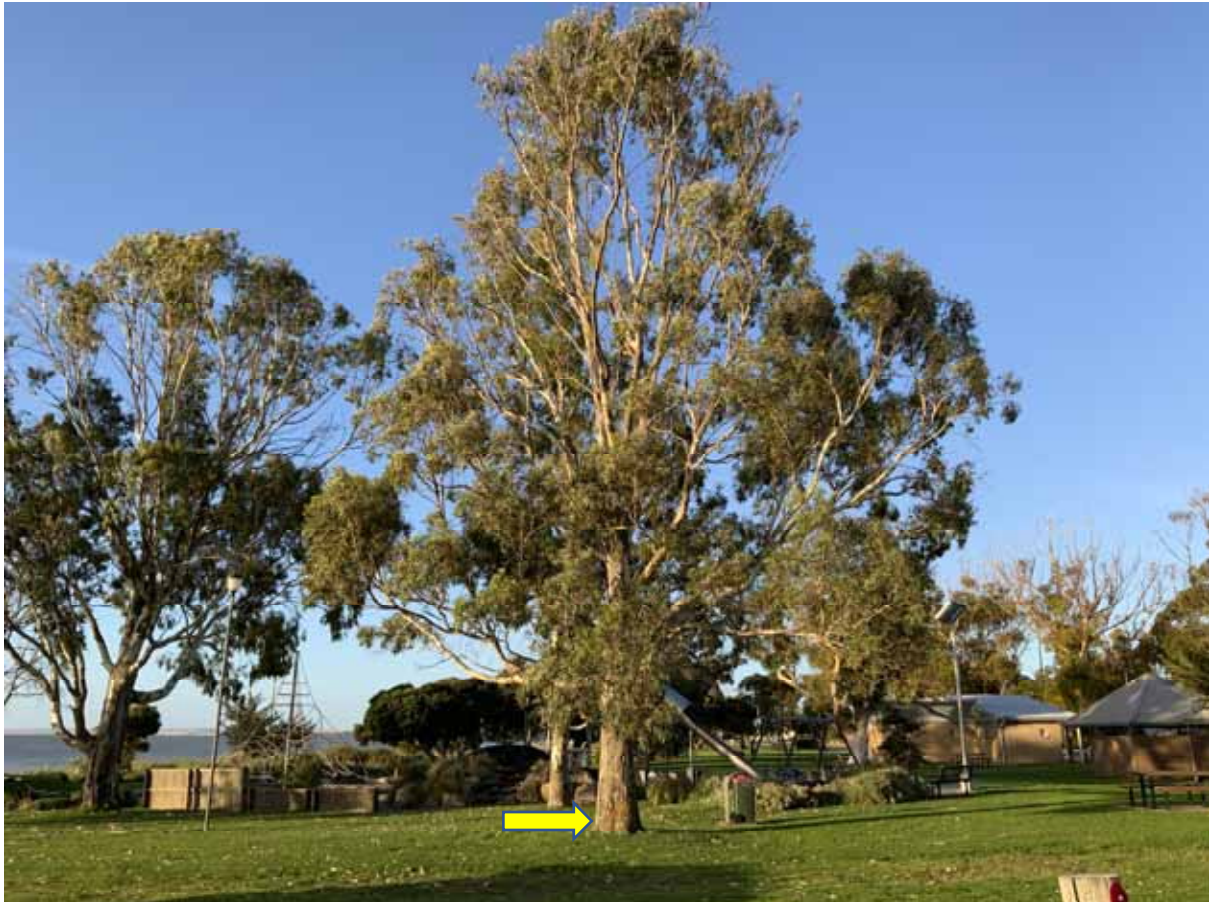
### 3. *Eucalyptus camaldulensis*

LOW RISK

This young River Red Gum is growing much better than the Sugar gums because of the root system which allows the tree to survive better in areas of high moisture content tree and some tolerances to higher mineral content within the underground aquifers. This tree does have small areas of deadwood however the tree is healthy and does not require any works this year.

No work required.

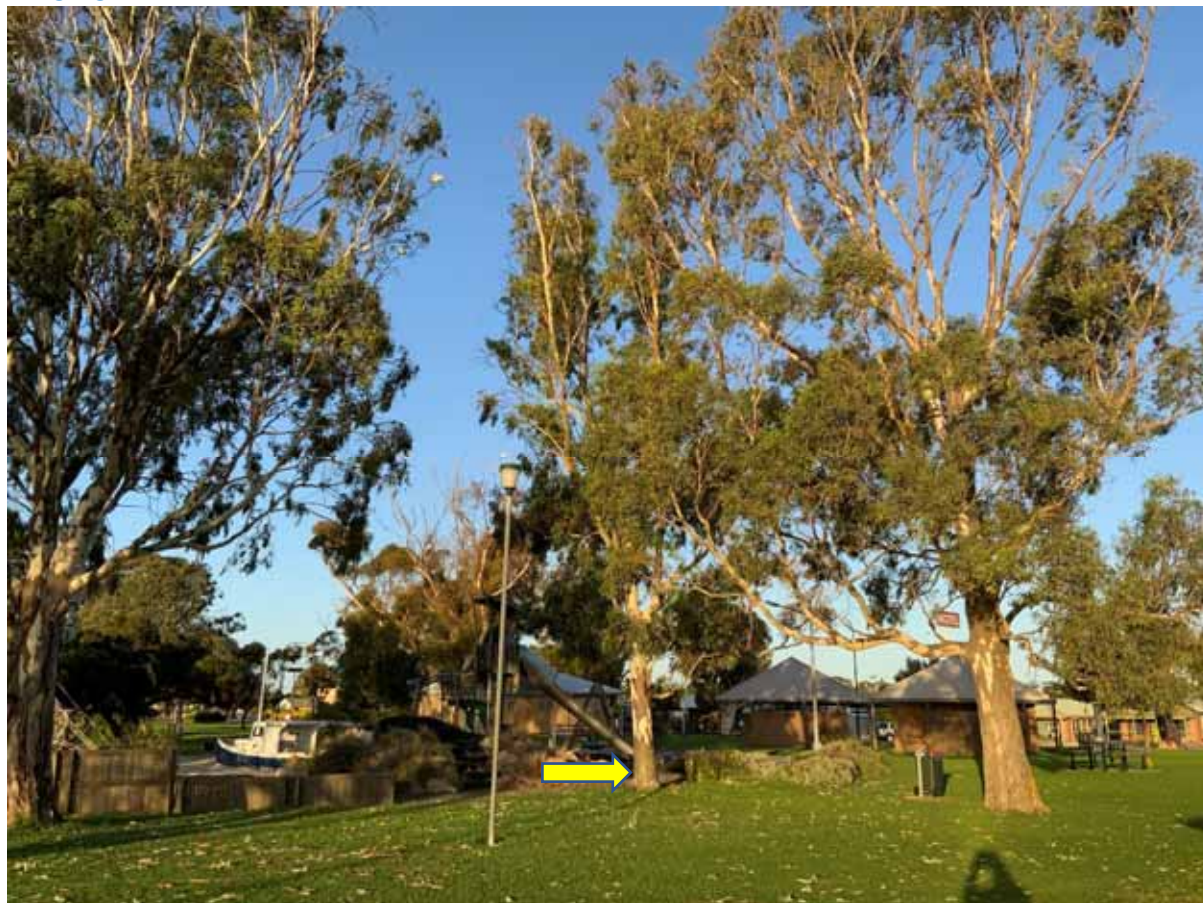
## 4. Eucalyptus camaldulensis

LOW RISK

This River Red gum is much like the first River Red gum and both of these are a distance away from the lake, they are also higher up within the landscape allowing for a higher horizon of soil profile than being lower down. River Red gums also have a better root system when it comes to water around the roots, these trees can survive under water for periods of flooding and the root system can still function, the other trees don't have this capability. The groundwater below a certain area has much more mineral content, this includes saline factors which contribute to foliage dying back. The Sugar gums should also be thriving however they are more intolerant to saline water this causes die back of the leaves in certain areas, the saline affects the growth of the tree and coupled with the bird damage is taking a toll on the tree.

No work required.

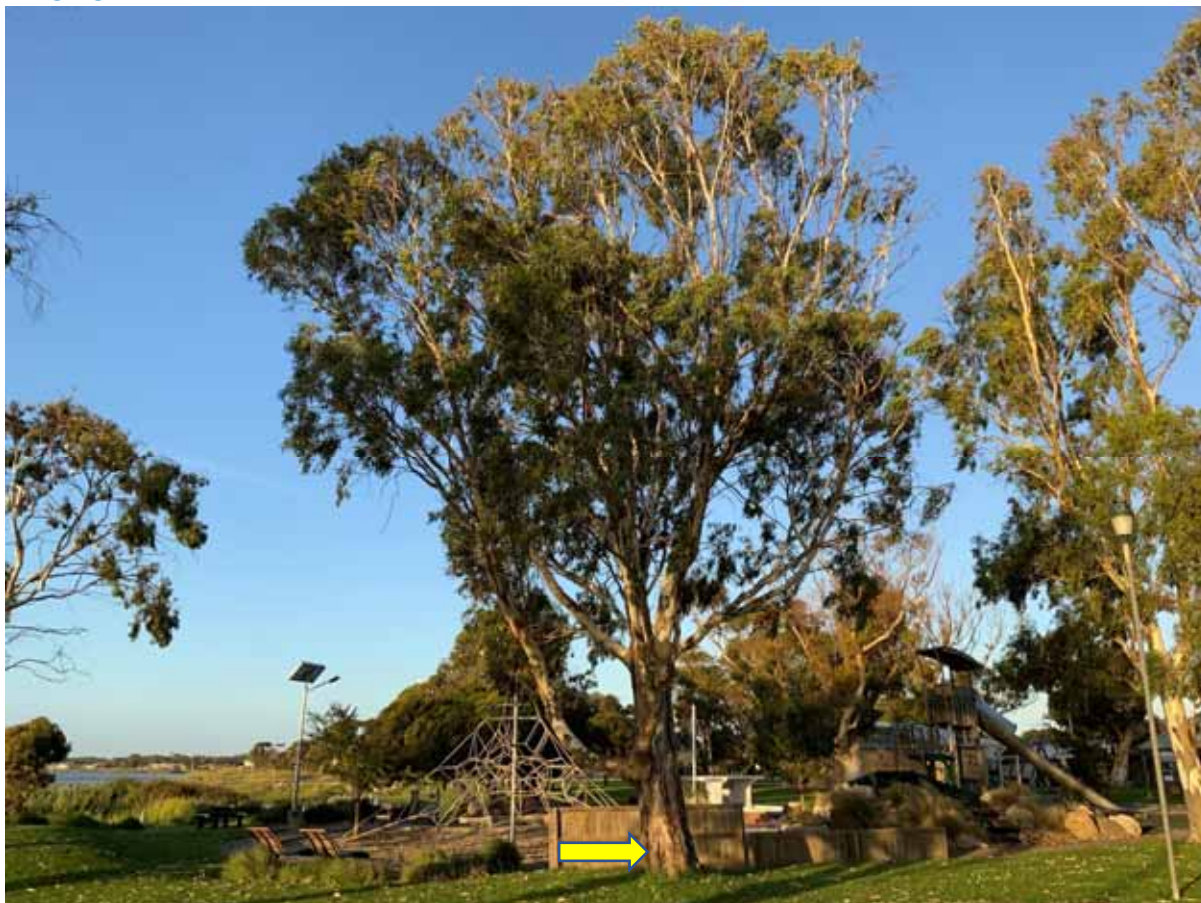
## 5. *Eucalyptus camaldulensis*

LOW RISK

This River Red gum is in good condition. This tree has had Canker in the past with some random areas near the base but the cambium is forming a new bark and removing the old affected bark. The tree has minor areas of deadwood but I am not recommending removal as these are minimal and of low risk.

No work is required.

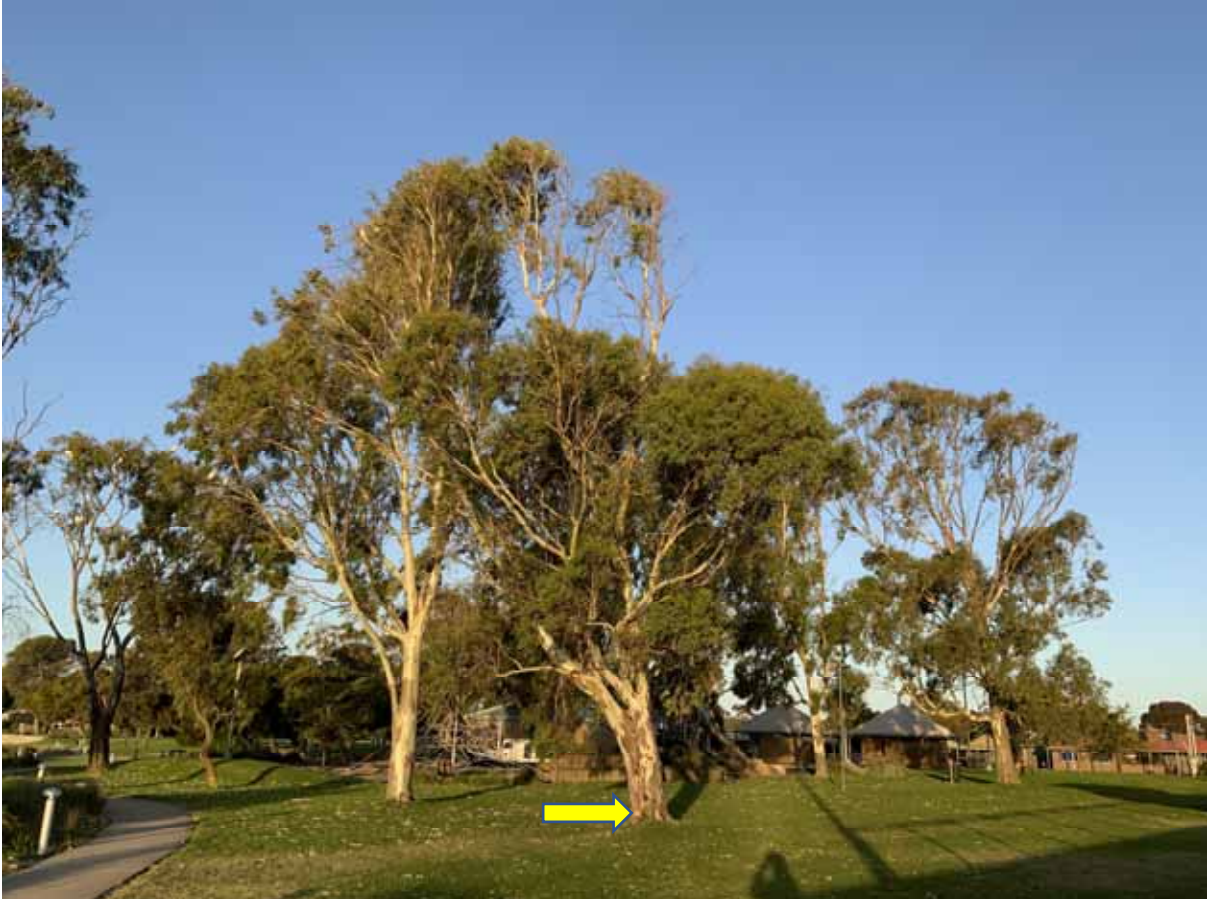
## 6. *Eucalyptus camaldulensis*

LOW RISK

This River Red gum while still being a healthy specimen is starting to show signs of high mineral content in the soil. with some of the other terminal canopy becoming sacrificial just like it does happen in drought situations, the tree does not require any works at this time. The tree is on a bit of a lean and I would say that it was due to a tree that may have been removed in the past that was close by, however this does not affect the health of the tree and the tree is structurally sound.

No work is required on this tree.

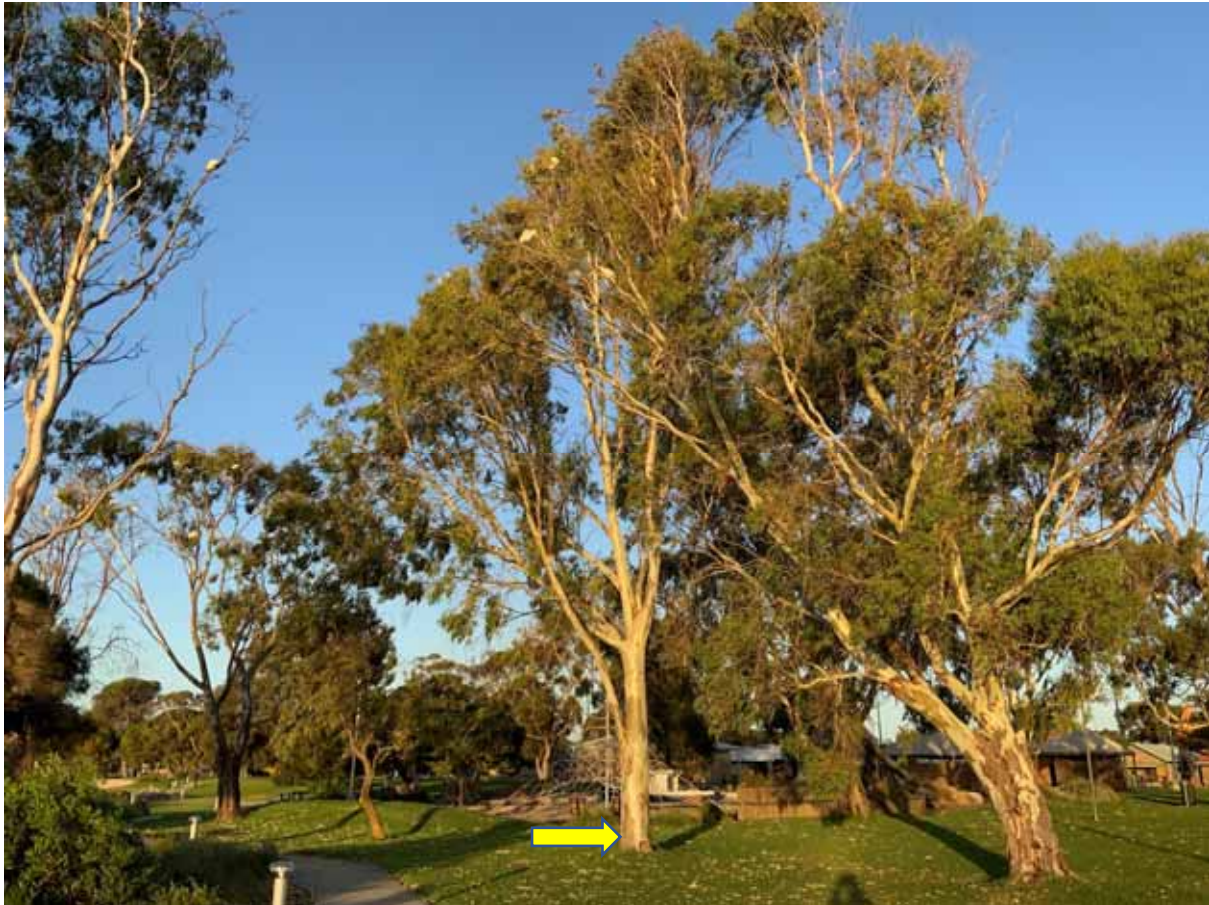
## 7. *Eucalyptus camaldulensis*

LOW RISK

This River Red gum is also starting to show signs of mineral buildup within the soil however this tree has also suffered from bird damage to the extent as the sugar gums. History maybe more protected from the surrounding trees then the others which is allowing it to still grow as it should.

No work is required in this tree.

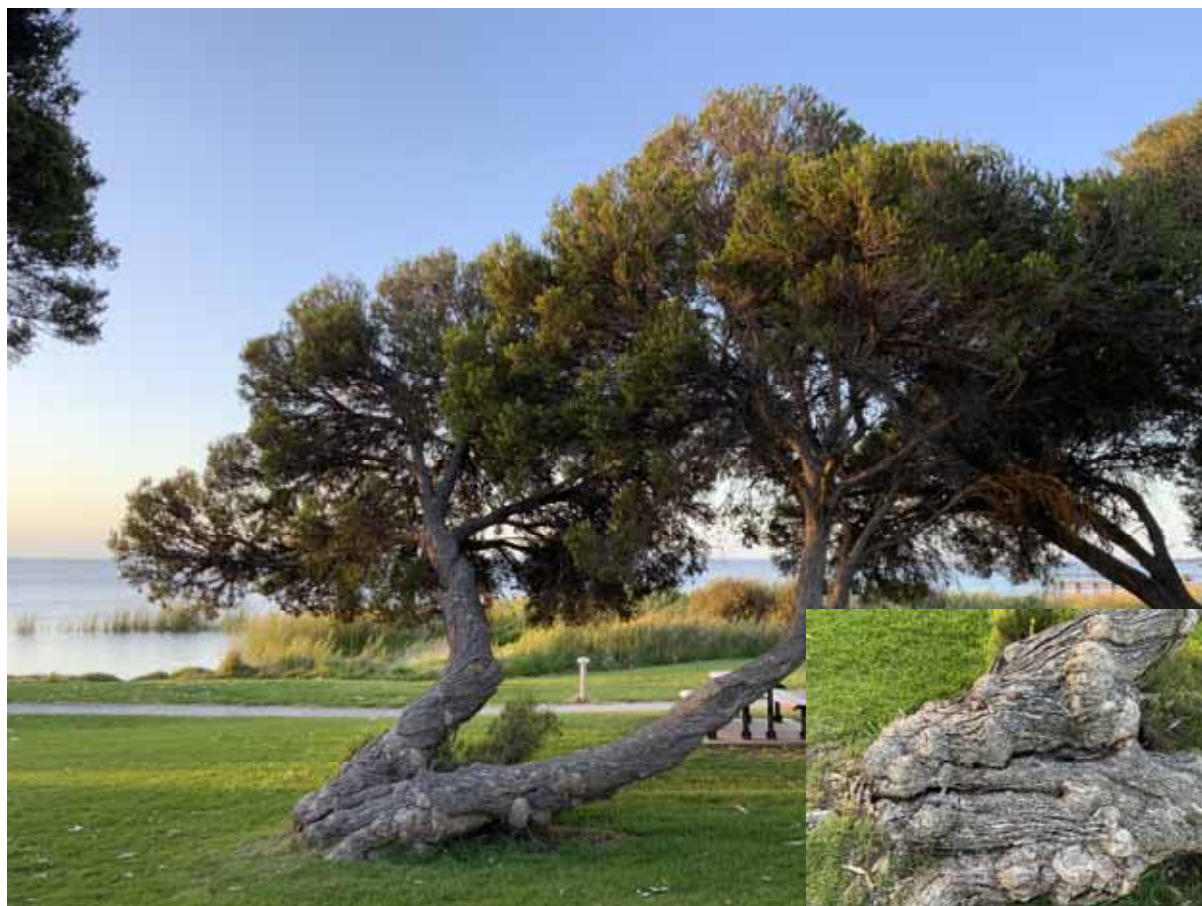
## 9. *Eucalyptus camaldulensis*

MEDIUM RISK

This Melaleuca has started to crack within the folds, this is due to the weight being imposed from one side of the tree. To mitigate this full separation of the tree I would recommend lifting the foliage on the lean side up to at least 2.5 meter to reduce a lot of the weight to one side. This should allow for the tree to get a reprieve from the weight not from the weight as static but as a weight from storms or winds forces that would cause the pressure on the tree itself. I would also recommend pinning the tree, using a large threaded pin drilling through the centre to attach both limbs and making them rigid, this will reduce the chance of the tree splitting in half and falling off the top and it will also prolong the life of the tree.

Prune to reduce end weight, pin the attachment point to stop the tree failing.

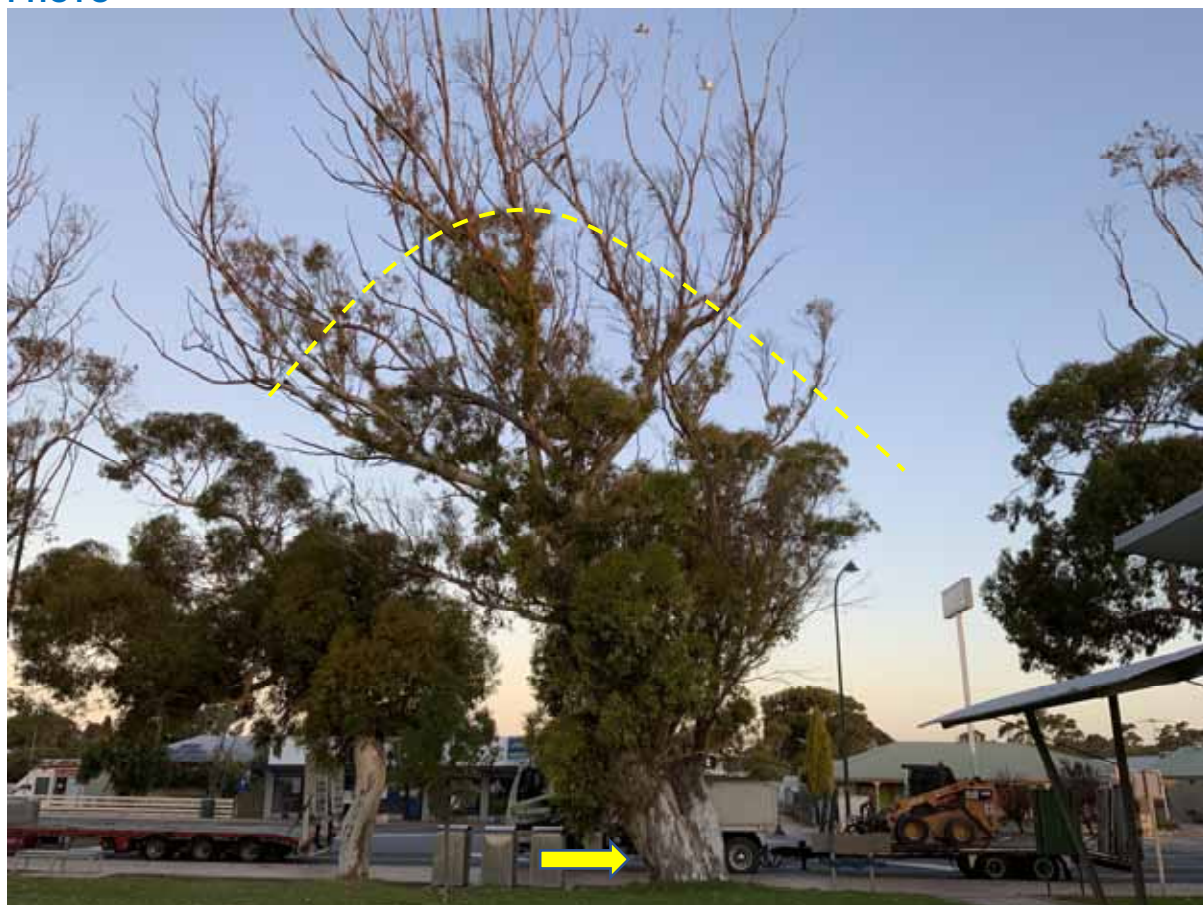
## 10. Eucalyptus cladocalyx

MEDIUM RISK

This large Sugar gum has a very good structural base and developed scaffold branches throughout the canopy. The canopy does have areas of deadwood and it also does have areas of epicormic growth in the lower parts of the tree. These lower areas of epicormic growth will need to be removed to approximately 4 metres approximately from ground level which will allow for better grow throughout the canopy which is starting to rebound from the effects of the high mineral effects on the tree. The staghorn deadwood in the upper canopy will require pruning along with keeping the canopy much more compact in its rebound growth, in areas the regrowth in the upper canopy will need to be removed with some of the extended branches to reduce the canopy height and concentrate the regrowth and sap movement to where the canopy can fill out properly.

Prune off staghorn deadwood, prune off epicormic growth approximately 4 metres from ground level, Prune out large deadwood throughout the canopy.

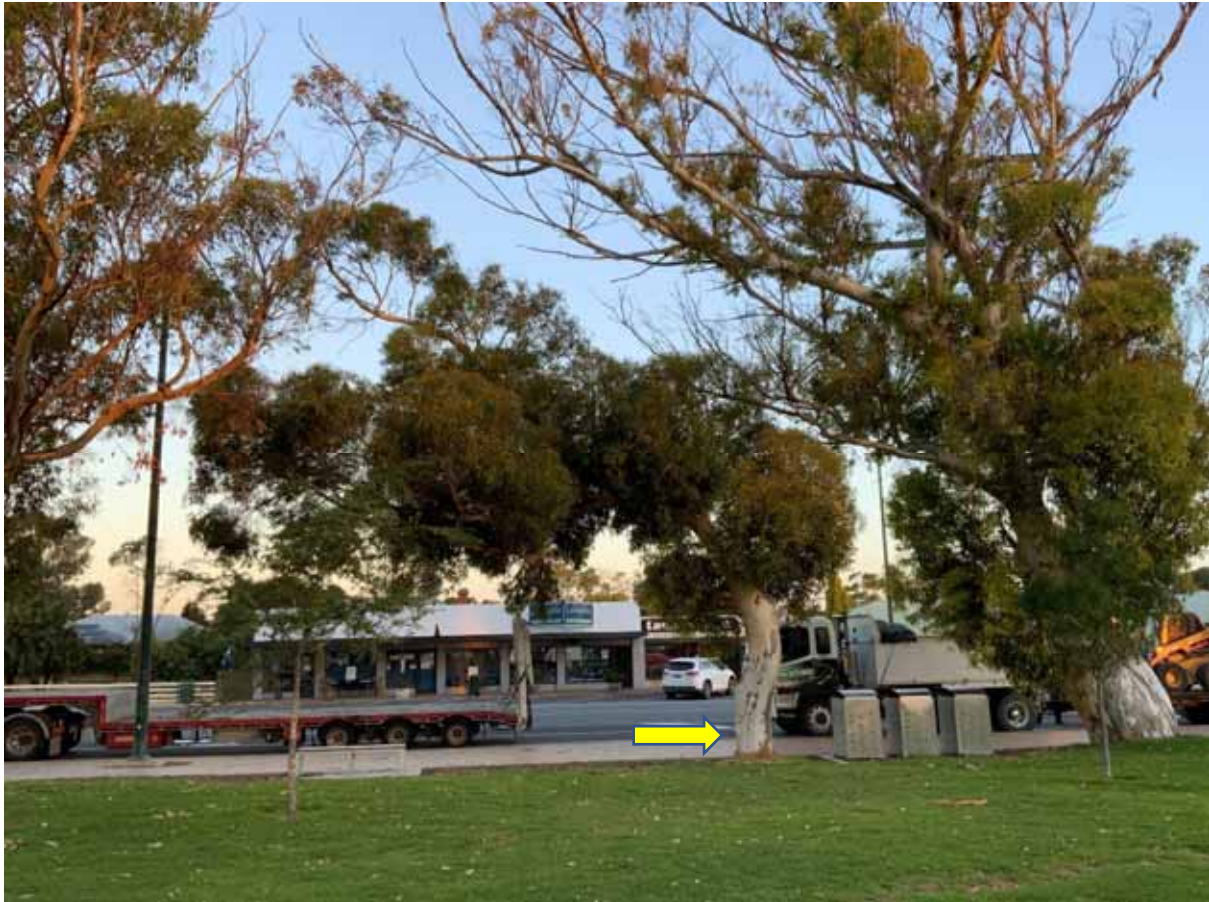
## 11. Eucalyptus cladocalyx

LOW RISK

This Sugar Gum has good foliage growth and very few areas of deadwood, this is due to the young root system not yet populating the areas of high mineral soil water which has allowed the tree to remain a healthy specimen. The tree is growing on an angle this is due to the overcrowding affects within this area, the trunk is structurally stable and showing no signs of weighted defects or root plate movement.

No work is required for this tree.

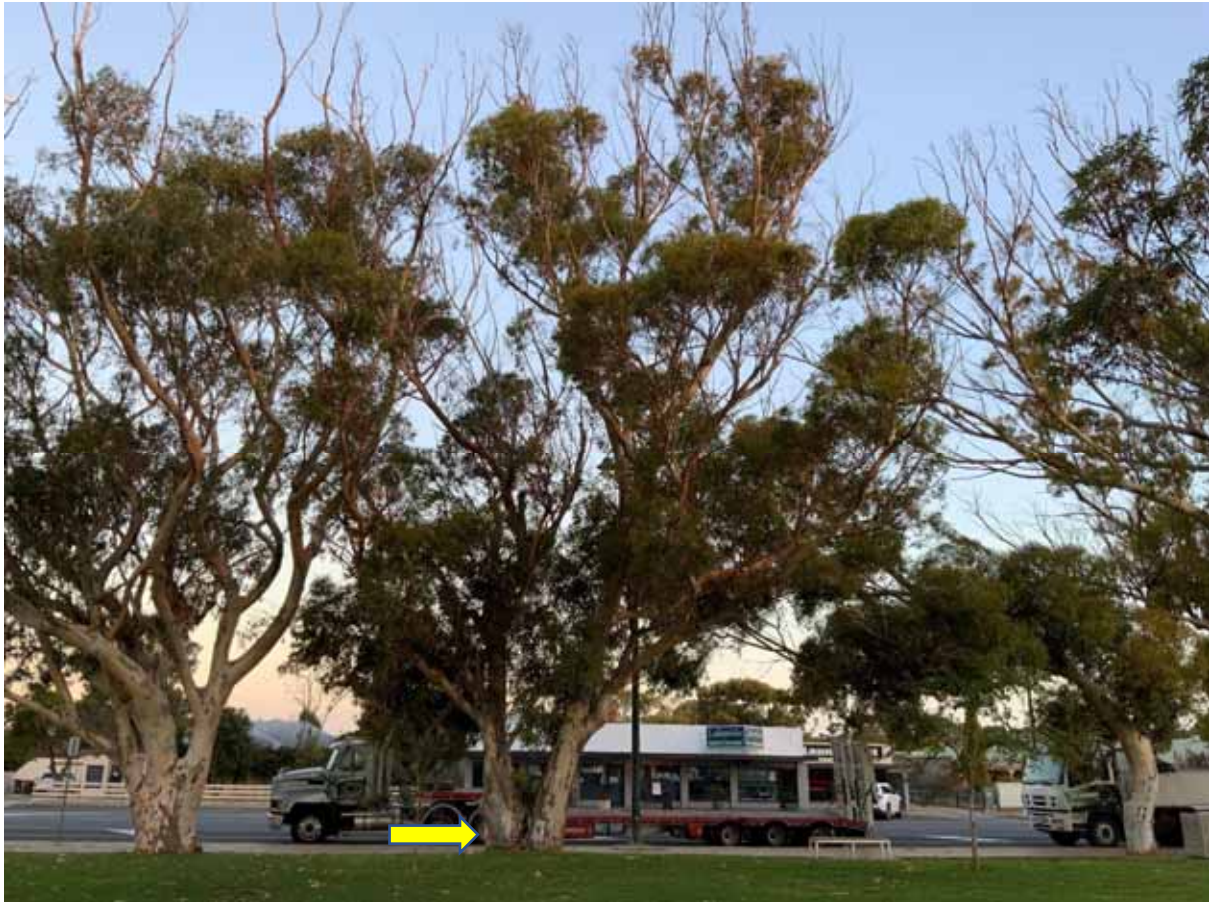
## 12. Eucalyptus cladocalyx

MEDIUM RISK

This Sugar gum has also suffered from high soil mineral content causing die back. The tree is stable within his trunk and up into its leaders through to the upper scaffold branching system. This tree does have areas of dieback from high mineral soil contents and also damage from birds. When pruning this tree, the smaller deadwood can be left but the large branches of deadwood will need to be removed. Also remove the lower small area of epicormic growth and change the extent of sap movement into the canopy.

Prune out the large deadwood.

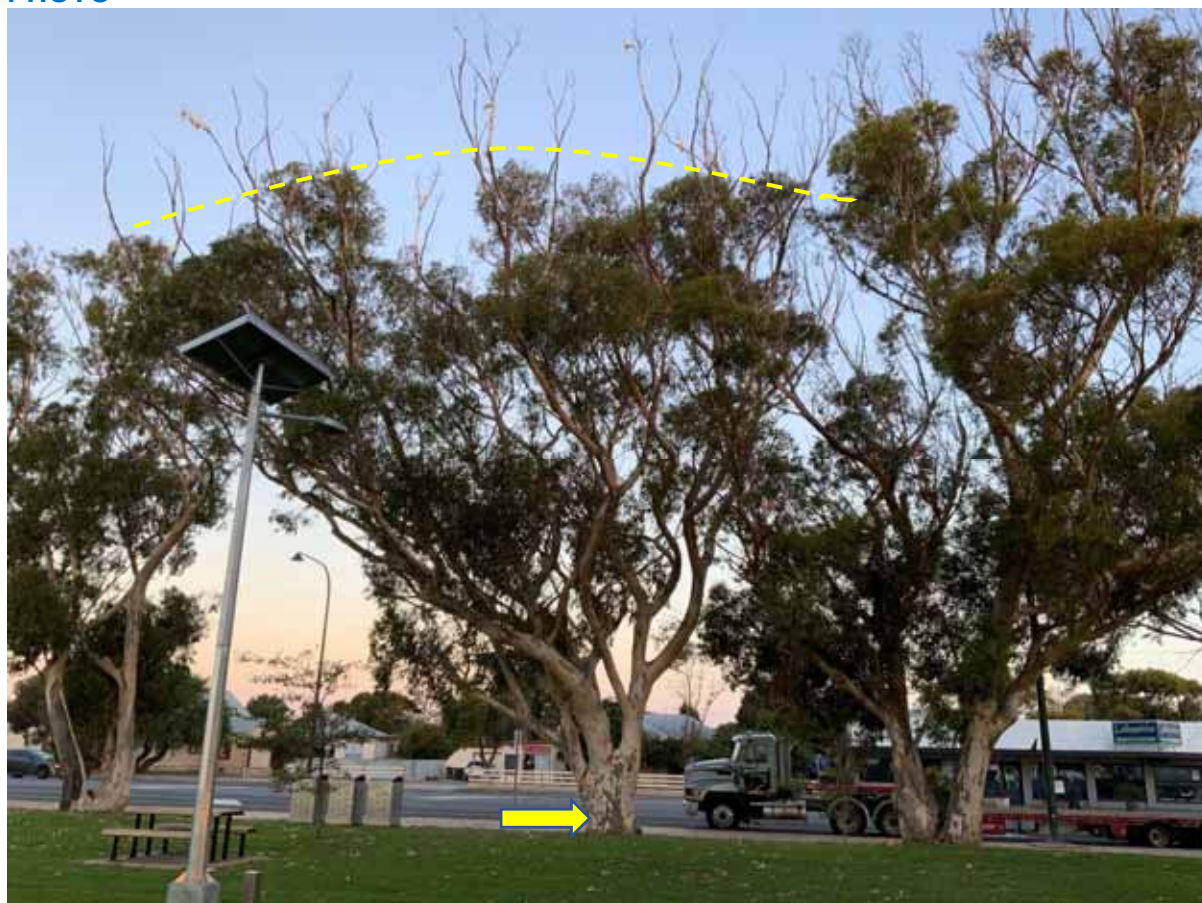
## 13. Eucalyptus cladocalyx

MEDIUM RISK

This large Sugar gum is a single trunk specimen that has grown in a good upright form scaffold branches. The terminal staghorn wood at the top of the canopy will need to be removed, there is a dead branch in the street direction that will need to be removed, after it is removed an inspection of the rub mark needs to be made to see if so, the branch will need to come right off at the attachment point. Any remaining large deadwood that is within the canopy will need to be removed.

Prune out deadwood, remove stag horning and remove limb that is rubbing.

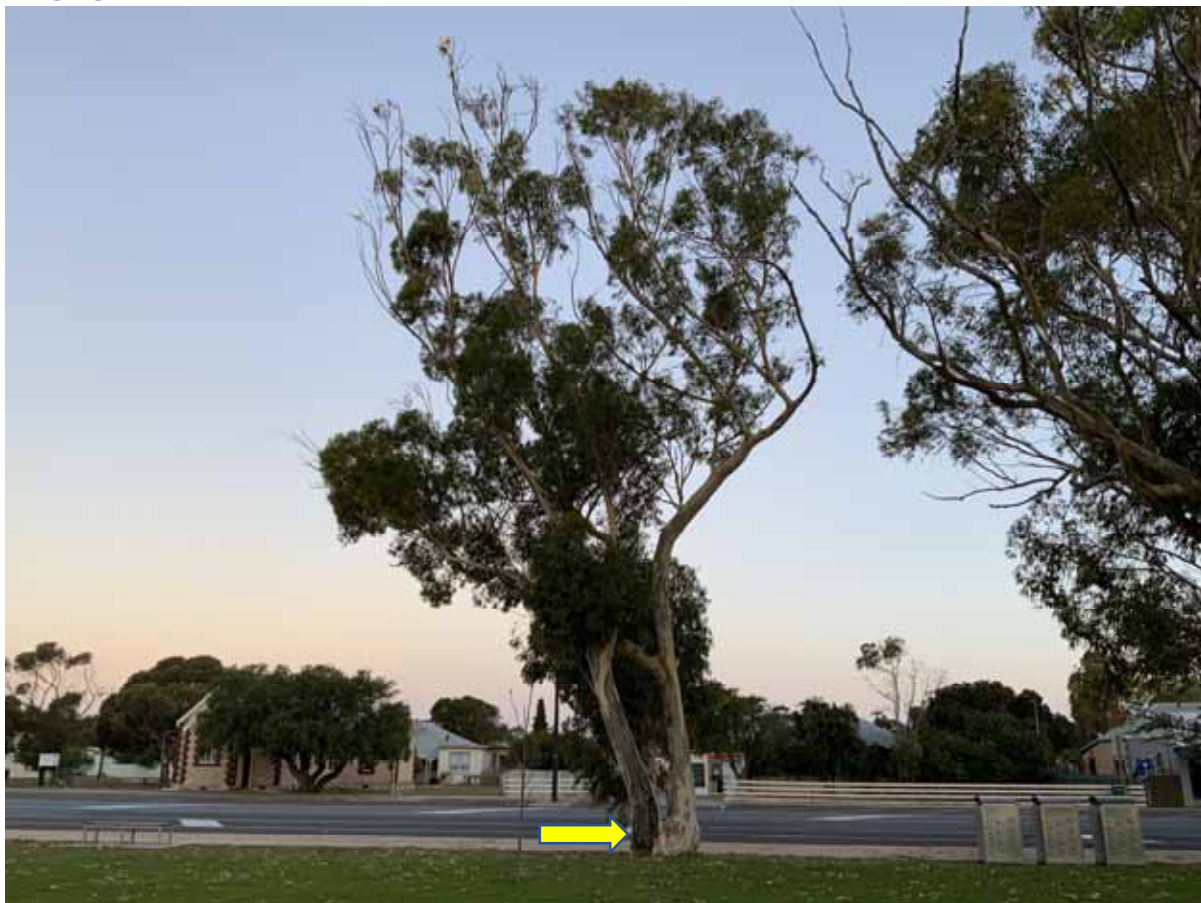
## 14. *Eucalyptus cladocalyx*

MEDIUM RISK

This Sugar gum was most likely injured when it was young, the upright form tree has a large limb on one side, within the deadwood it has multiple areas of fungus throughout, this area will need to be removed the number of bacteria within the tree that is decaying will eventually reduce the strength of this limb and the surrounding live wood is not enough to supply enough strength to uphold the area of rotting wood. The rest of the tree will need dead wooding throughout the canopy with some larger dead limbs that will need removal.

Removal of the large leader that is mostly deadwood on the lawn side, Prune out deadwood in the canopy.

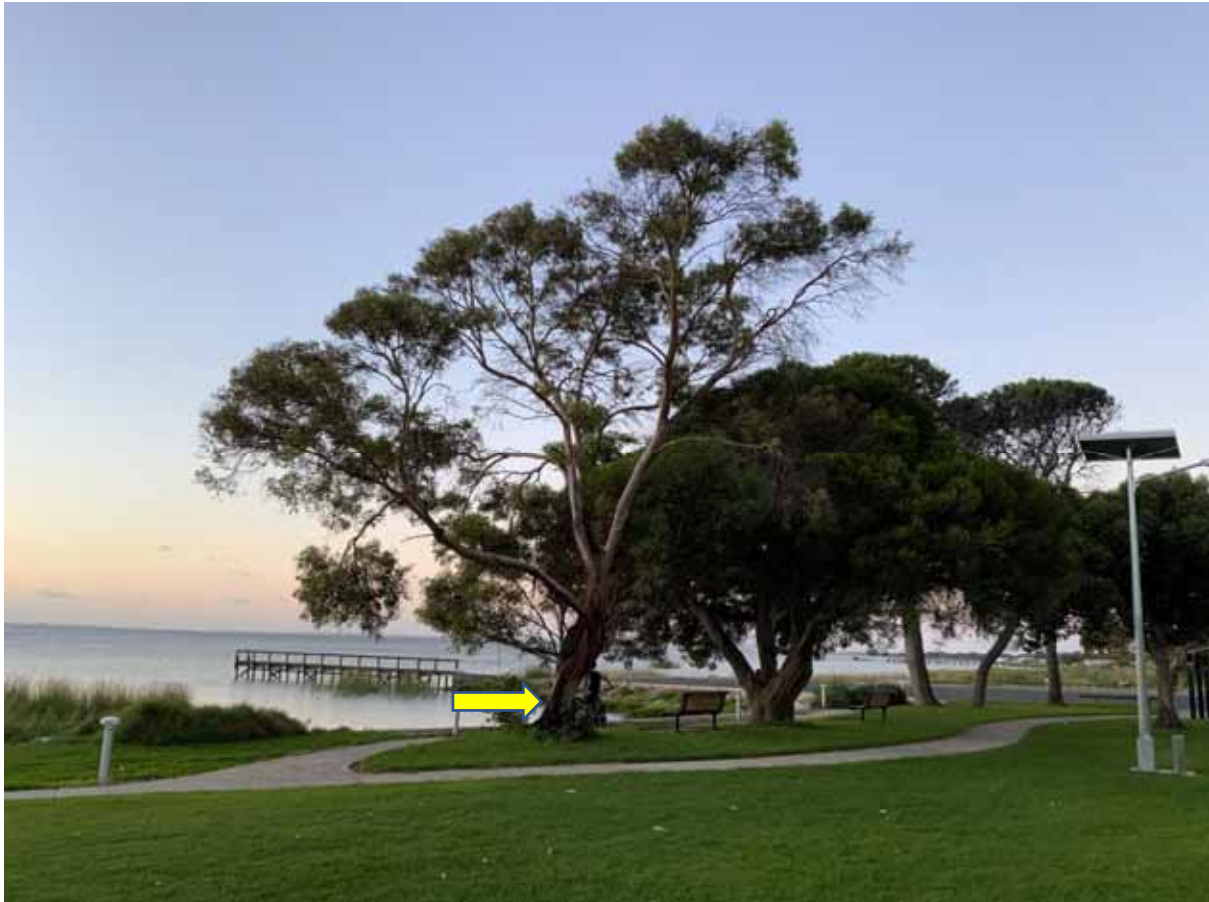
## 15. *Eucalyptus socialis*

MEDIUM RISK

This Mallee tree has also suffered from being grown in the irrigation zone from both saline and having too much moisture around the root system, this tree is a dry land drought tolerant tree that is struggling with the ground water. There are some quite large areas of deadwood throughout this tree and they will need to be removed as it is in the middle of the twin paths. The basal shoots will need to be removed they are a sign that the tree is recovering and within a year or two with the saline soil being flushed this tree should return to its natural state of growth.

Prune out the large deadwood and remove basal growth.

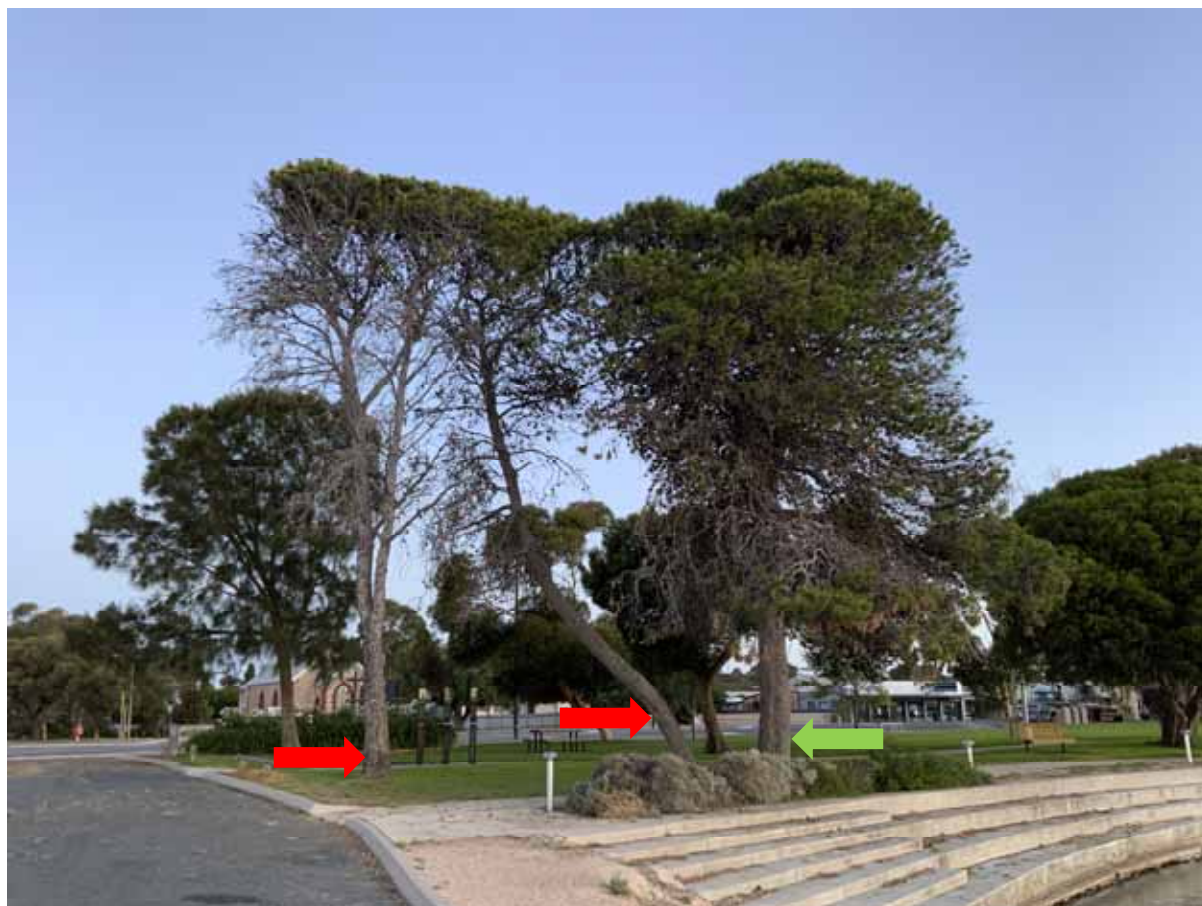
## 1. *Pinus halepensis* x 3

MEDIUM RISK

These three Aleppo Pines within this area are the favorite food source for Little Corella, they are one of the trees that attract and keep the birds returning in a feeding loop from food trees to roosting trees to nesting sites. Usually when the birds eat the Pines, they will travel to trees such as Sugar gums and chew those trees, after many years of watching them the birds look as though they are cleaning their beak with the Sugar gums and leave debris below the trees. The two hyper extended trees are not healthy and they have died back in the lower canopy where the tree is now void of foliage, the terminal foliage is end heavy and places pressure on the trunk. I am recommending the removal of the two hyperextended trees and leaving the larger of the three trees, no work is required for the tree that remains.

Remove the two skinny trees and leave the larger tree.

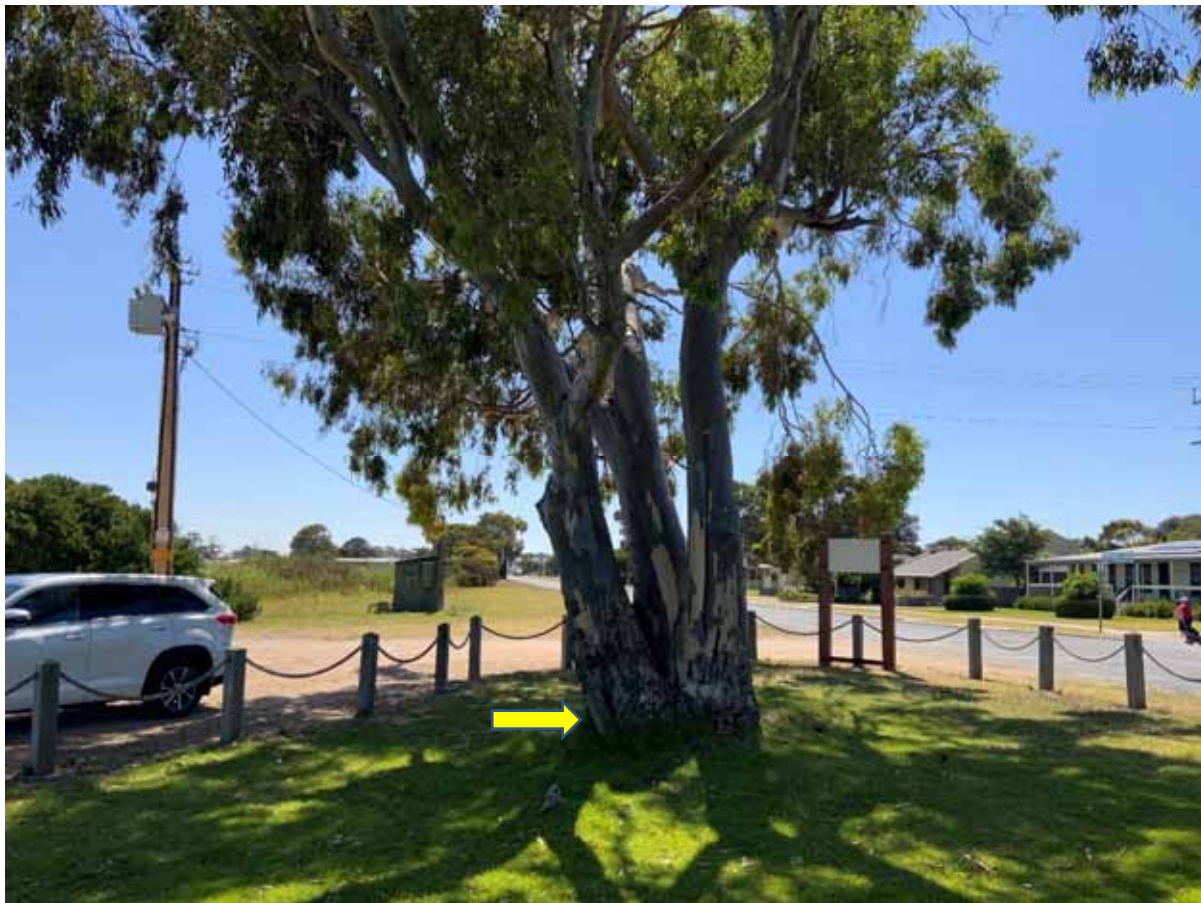
# 1. *Eucalyptus camaldulensis*

LOW RISK

This tree is a healthy mature specimen, it does have splitting in the sides and the cambium from water uptake that has expanded the sap wood causing the areas to split within the cambium. The tree has some areas of deadwood however the location would not be of high risk and I would not recommend pruning out the deadwood as it is very minimal risk of hitting someone. The tree is a multi-trunk specimen with all attachment points at the base which are sound with no areas of included bark. The area of lost limb on one side towards the boat ramp is starting to engulf through wound wood, the lower areas also have covered over with wound wood. There are no areas of canker fungus within the tree which is quite good.

No work required.

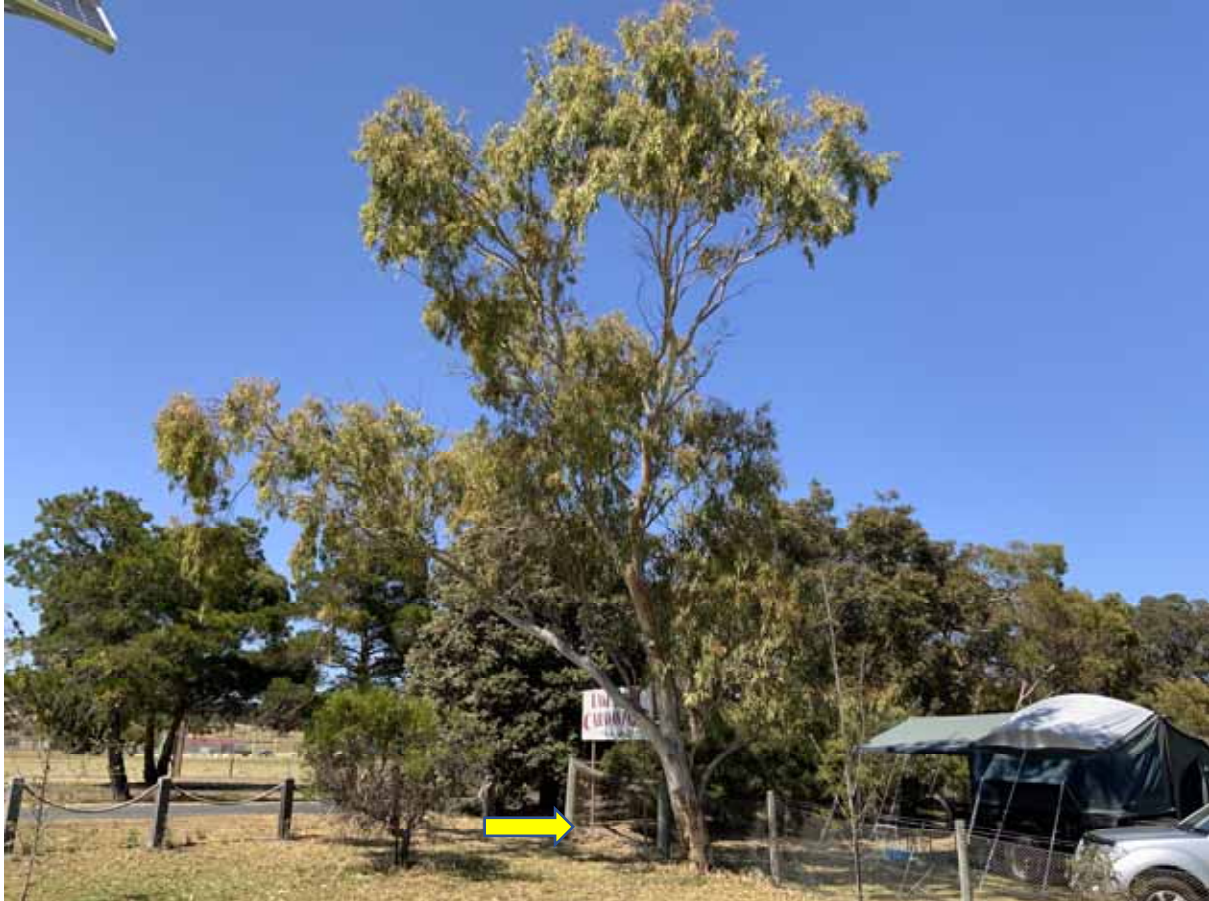
## 2. Eucalyptus leucoxylon

MEDIUM RISK

This tree is only a young mature tree and has grown well within the area most likely due to be out of the area of irrigation which would allow for better aerobic activity in the root system. This tree did not have any capsules to identify the tree but by all other characteristics the tree does look like a SA Blue gum. The tree does have some areas of deadwood and has one large deadwood approximately 2 metres from ground level on the limb that is overhanging to one side. That would be the only limb and I would recommend removing, there is also a hanger which should also be removed while that limb is being removed also.

Remove the dead limb on one side and remove the hanger in the canopy.

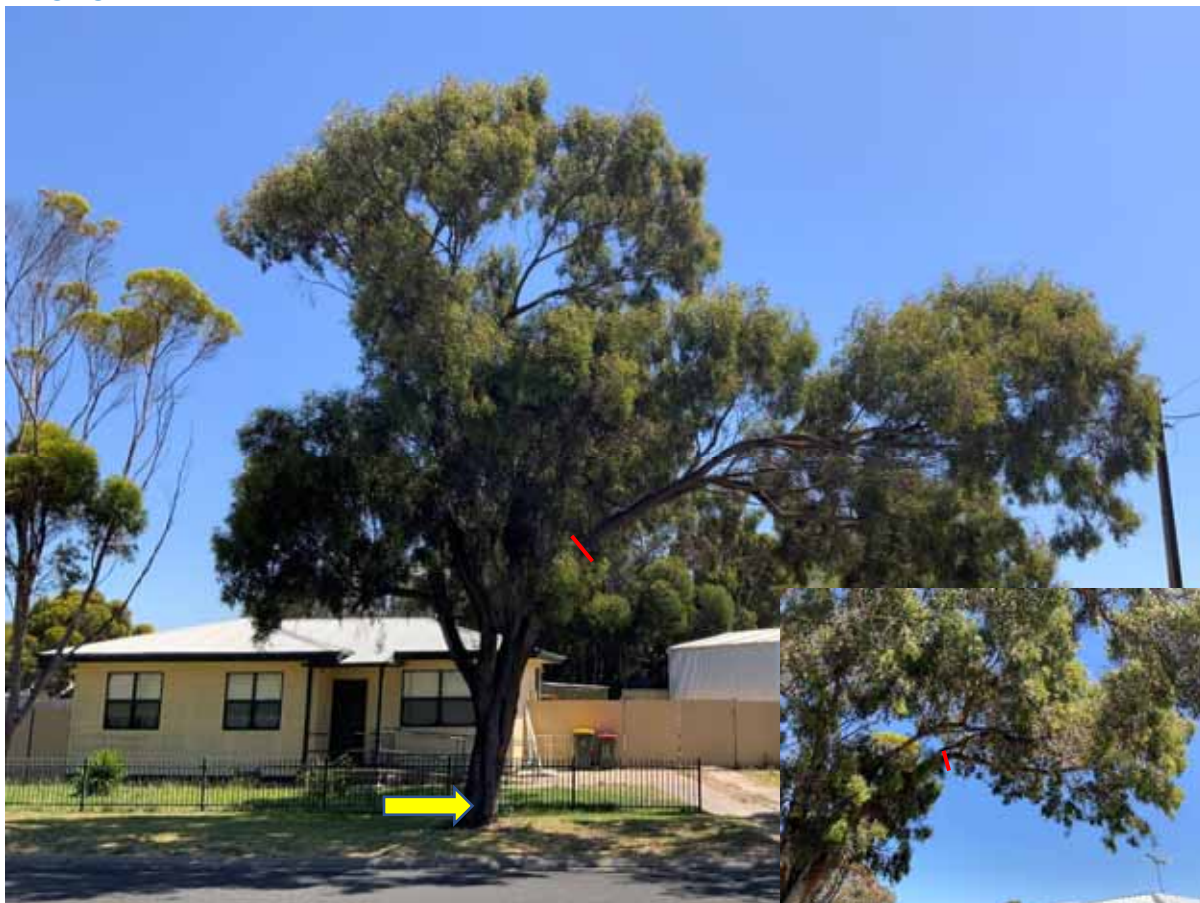
# 1. *Eucalyptus microcarpa*

MEDIUM RISK

This Grey Box has areas of past failures with most on the house side with some being quite large. There is one limb that is overhanging the house which is at the size of where past failure has occurred this large limb which is in the lower part will need to be removed to reduce the weight on the limb itself. This removal will need to take place approximately 1.5 m from the last failed limb to reduce approximately half a ton weight of the limb overhanging the house. The limb overhanging the driveway will need to be pruned off to reduce the weight within the tree as this site has had areas of removal which could've also been areas of failure in the past. These large limbs seem to be the main breaking points within the tree and it's better to remove them now than to wait until they do fail and cause injury or damage to people or structures or damage the tree to a point where the tree will require removal.
