# Open Space Services

## MENINGIE PARK & STREET TREES

Tree Inspection – February 2020

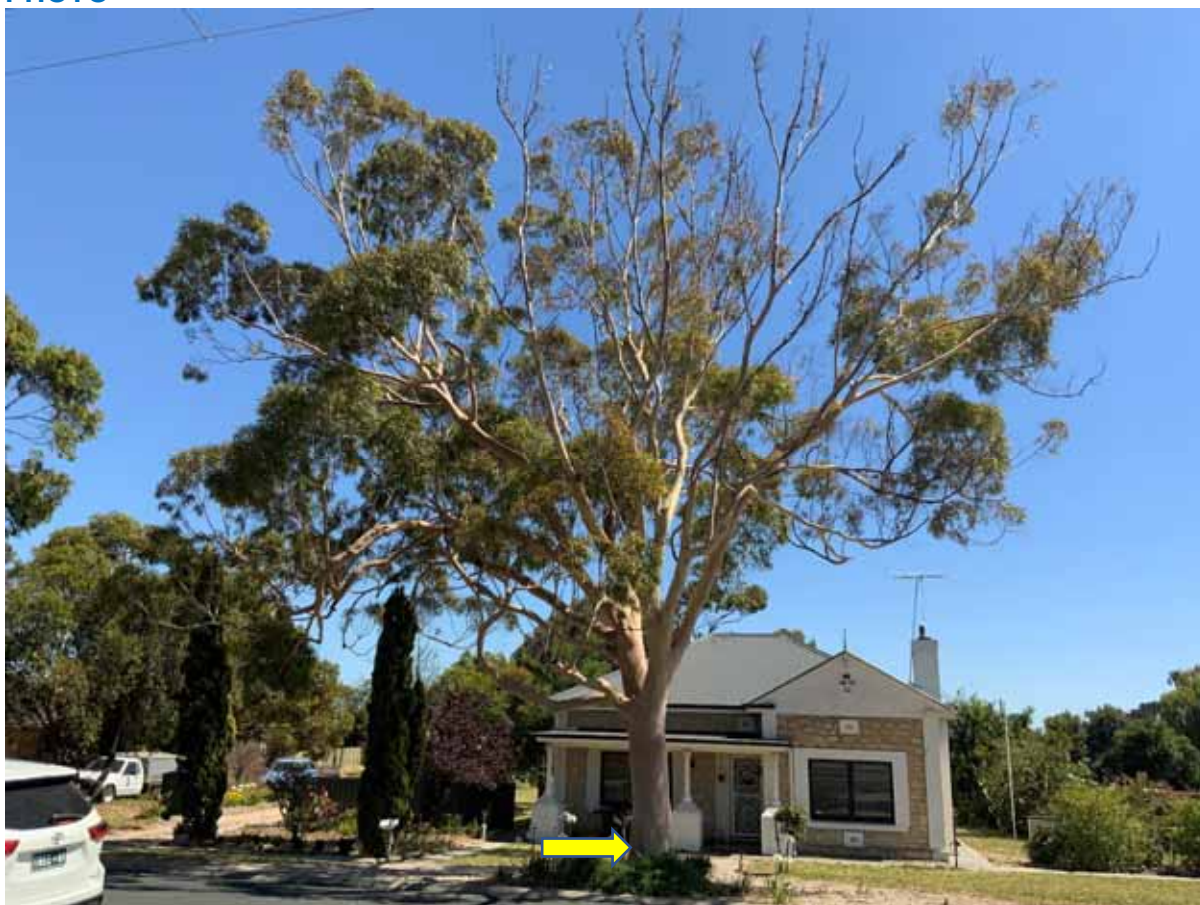
# 1. *Corymbia citriodora*

MEDIUM RISK

This Lemon Scented gum has suffered premature dieback within the top canopy branches, however some of those top canopy branches are starting to regenerate with new foliage, and this can be quite common with the species especially after a drought period or period of long dry weather, the dry periods may also raise the high mineral water table that encompass the town on one side. Within this tree there are several branches which will need to be removed, the limbs over the driveway will need to be pruned of crook branches and branches that droop down, any large deadwood will need to be removed which will include the stag horning limbs in the terminal canopy. The limb growing into the pencil pine and just above the Pencil Pine will require pruning.

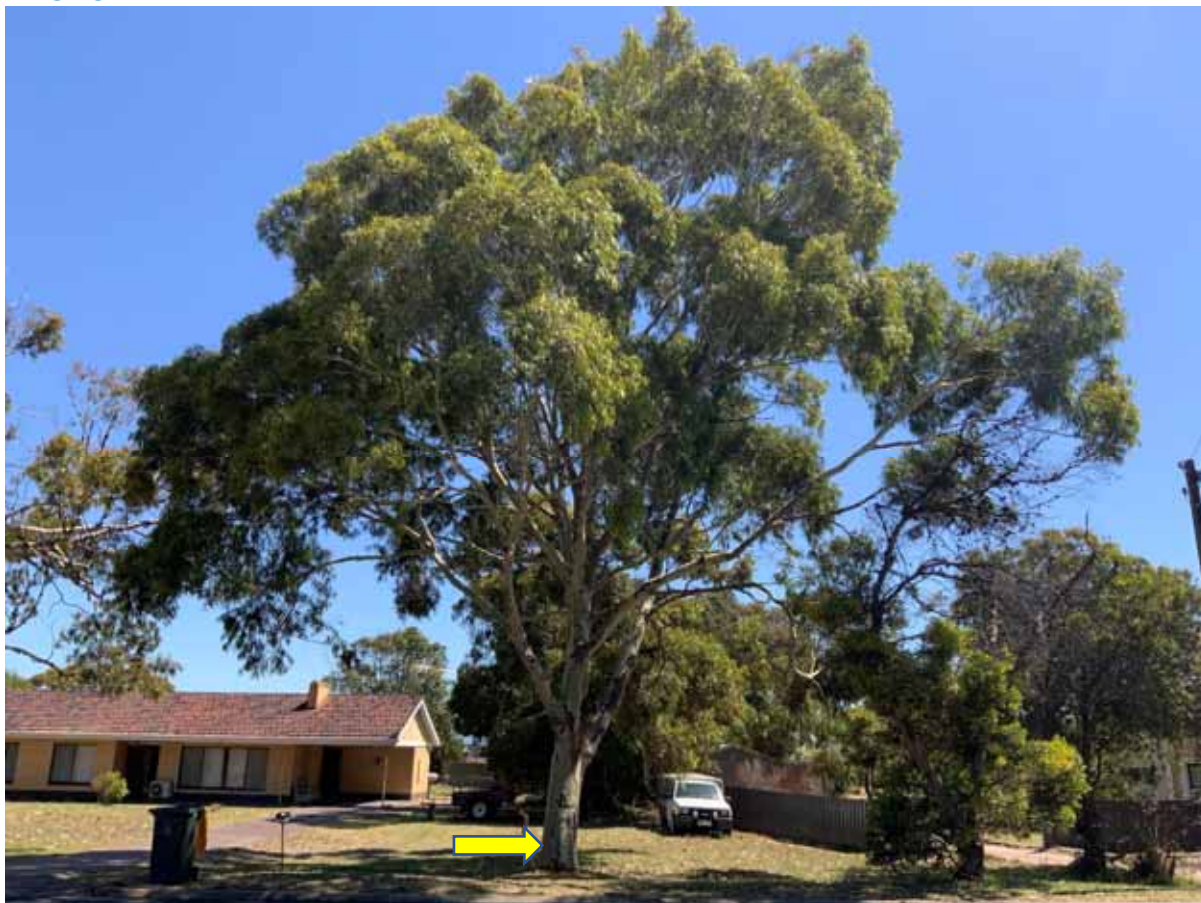
This tree has grown quite large and is also causing problems with the *Eucalyptus lehmannii* next to it, I would recommend removing the *Eucalyptus lehmannii* as it will not grow to a good specimen tree while the Lemon Scented gum remains. The Lemon Scented gum does have a few lower limbs which are crooked and growing down towards the ground, these limbs will need to be removed as they will not dissipate energy from the canopy back through to the trunk system and will usually break off as one has already done on the right-hand side. All the limbs back up through the main scaffold branch system I'm quite sound and clean with no areas of defects. The tree is in good condition and has no areas of defects.

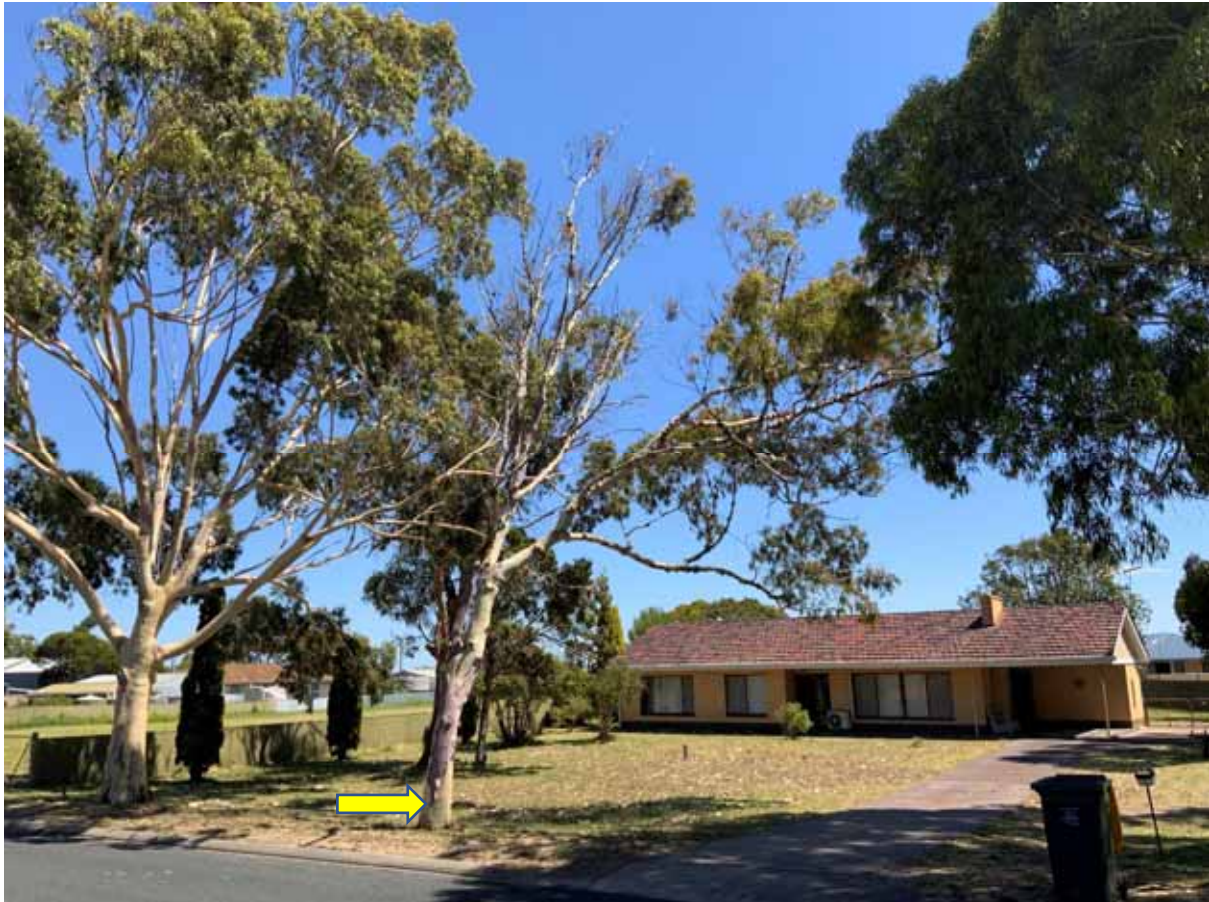
This tree has died all on one side and does have only a few areas of regeneration within the centre of the tree, there is one limb that he's growing down which is towards the driveway of the house this limb has hyperextended to allow the foliage to access the greater light. I'm recommending removing this tree as it will not grow to the specimen that it should and its in a location that is overcrowding. I would not recommend replacing the tree.

Removal is recommended.

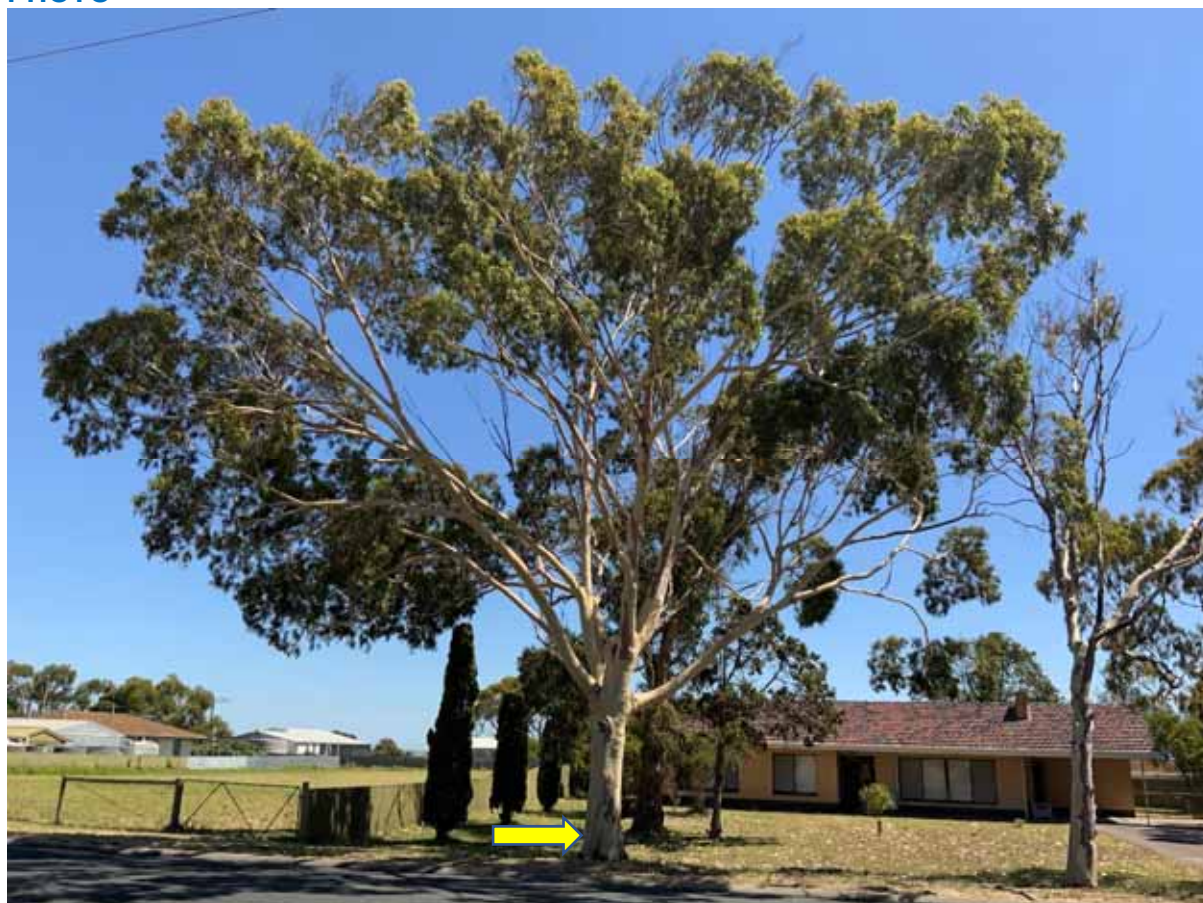
This tree is in good condition with a good overall canopy that is broad domed and has areas of new growth within the terminal canopy. This tree does have some large deadwood inside the main canopy and will need to be removed as it is of large size. There are two limbs that need to be pruned off, both of these are within the area of the private property both are hanging low and will become a problem as they grow. Also prune the foliage away from the Pencil Pine by removing some of the lower branches on the limb growing out over the top of it. The tree is in good condition and does not have any areas of included bark or defects that would cause the tree to become a problem in the future
