21 June 2022

Project No. WGA220616

COORONG COUNCIL CARRIAGE CONDITION ASSESSMENT INSPECTION OF RAILWAY CARRIAGES, TAILEM BEND ON 25 MAY 2022

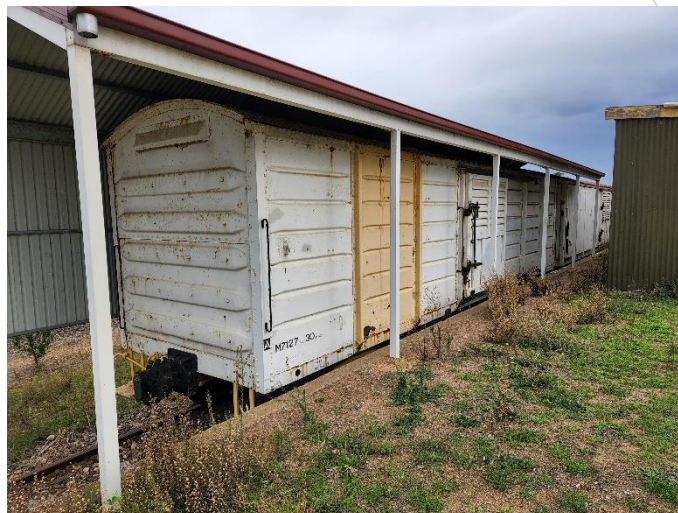
No 1: M7127 Enclosed Carriage. 11.1m long nett. Contains miscellaneous loose slings and rigging gear

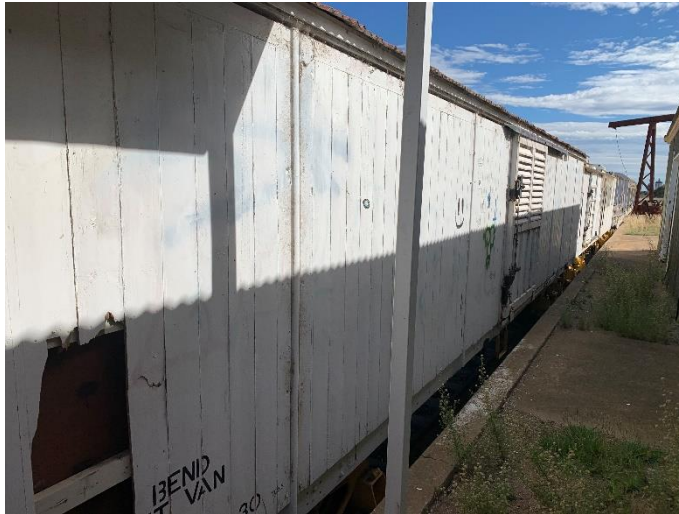
No 2: Timber sided Accident Van No 1, M8213. 13.5m long nett. Contains tools and recovery gear

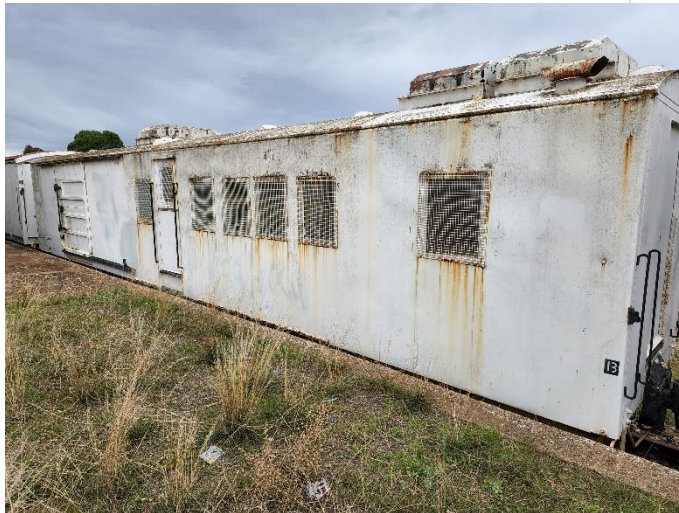
No 3: White enclosed Accident Caboose. 15m long nett. Rec/work area, bathroom, kitchen, store

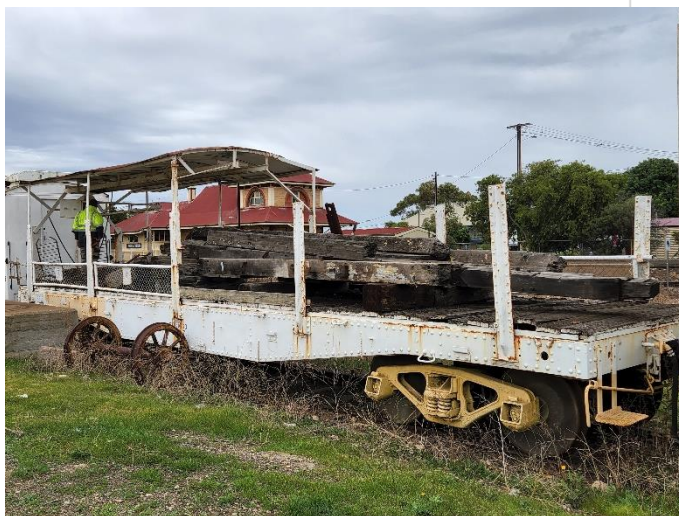
No 4: Older style open-sided goods wagon. 13.5m long nett

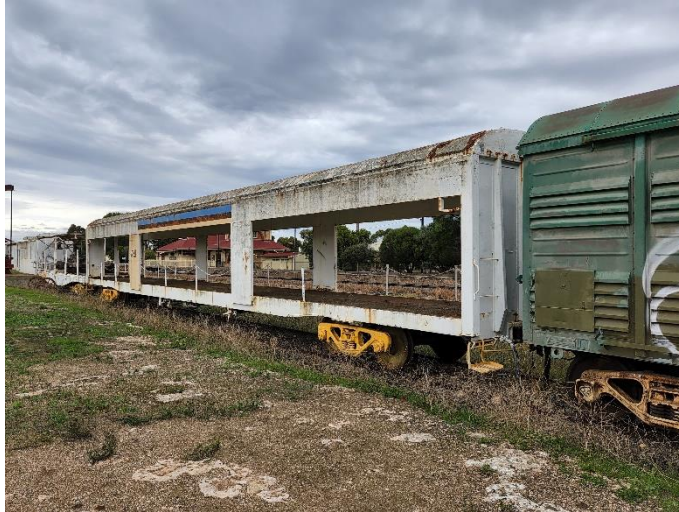
No 5: Very long white open-sided covered goods wagon. 23m long nett

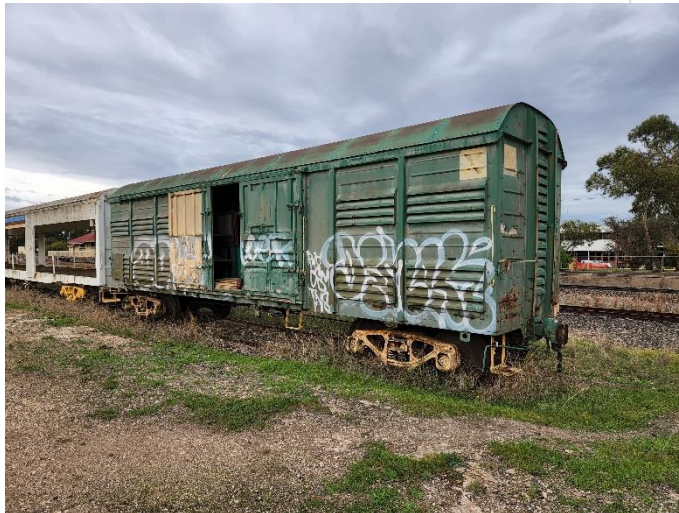
No 6: Green metal clad enclosed carriage, 12.5m long nett

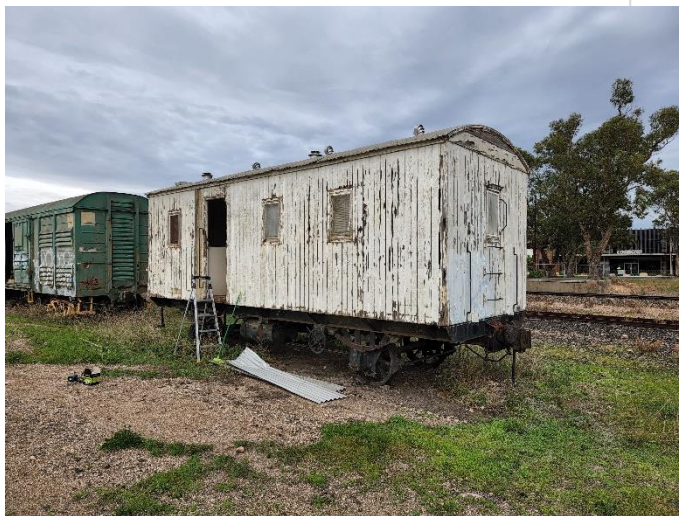
No 7: White timber sided enclosed accommodation carriage. 8m long nett

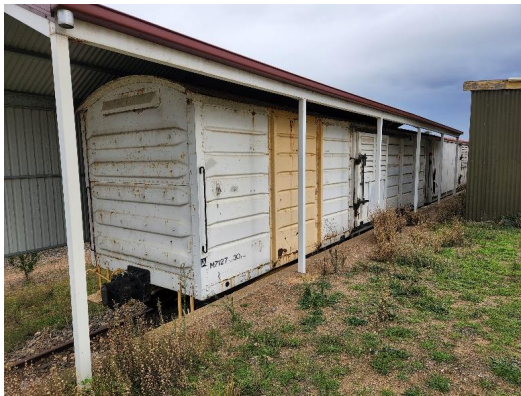
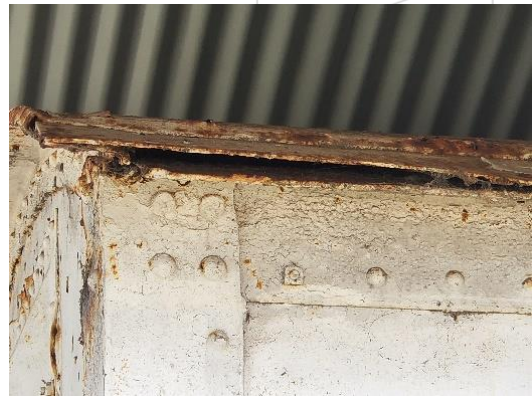
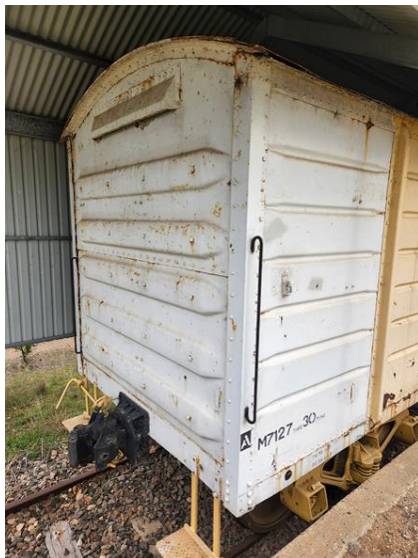
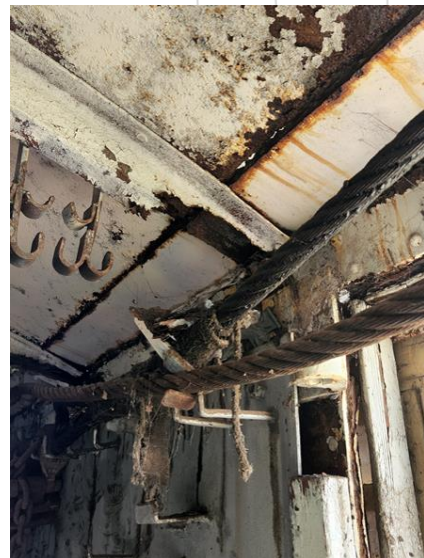
No 1: Enclosed Carriage M7127

Walls: Metal panels bolted (or riveted) together. Some significant rust in places near base. Also, at roof-wall joint.

Roof: sheet metal. Barrel form. Some significant rust.

Floor: Timber planks. Badly worn but generally sound. A bit springy at one end.

Chassis: sound but showing some sign of age. Surface rust but no significant loss of section.

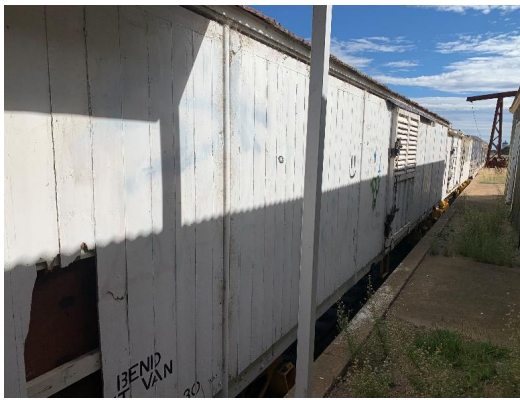
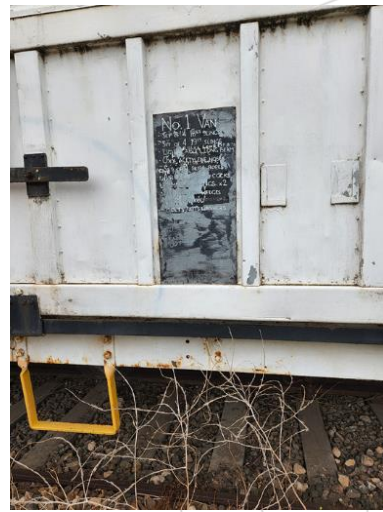
No 2: Accident Van No 1 M8213

Chassis sound but showing some signs of age. Some surface rust but no significant loss of section.

Walls: Timber boards. Painted white. Some graffiti. Some damage at one corner.

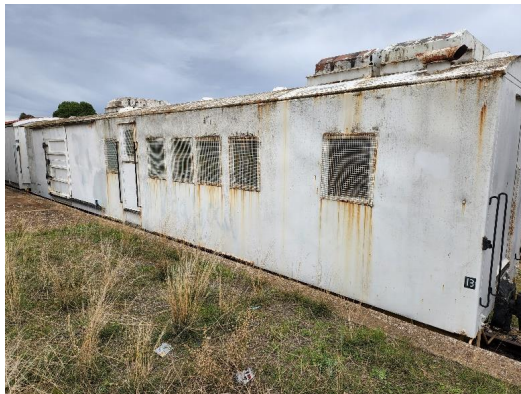
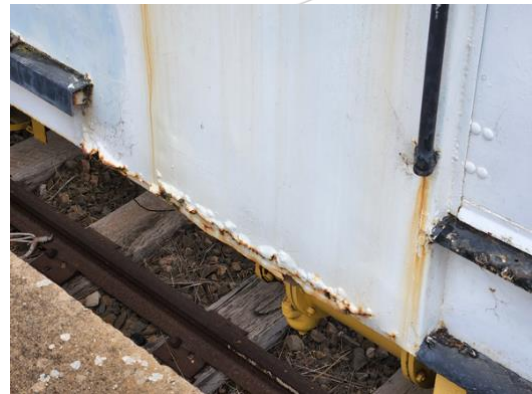
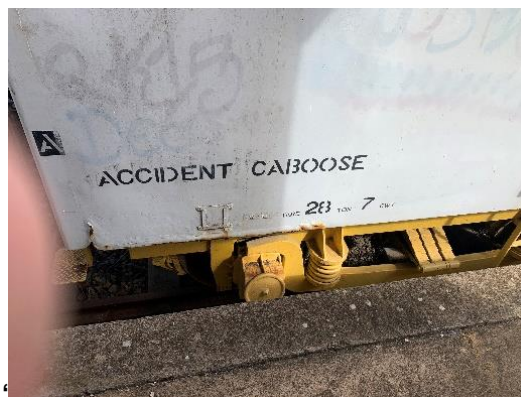
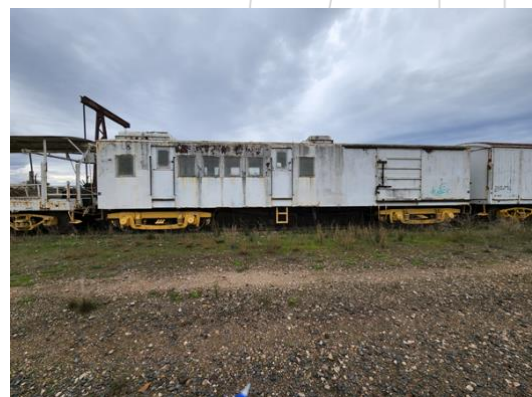
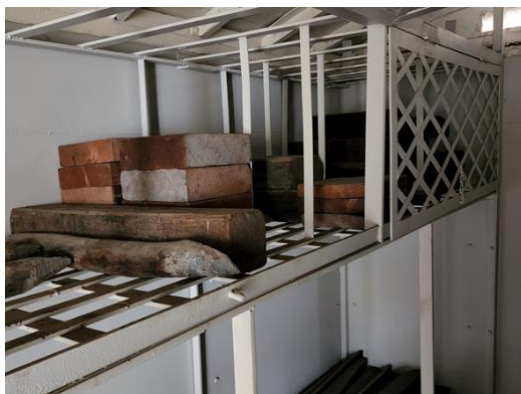
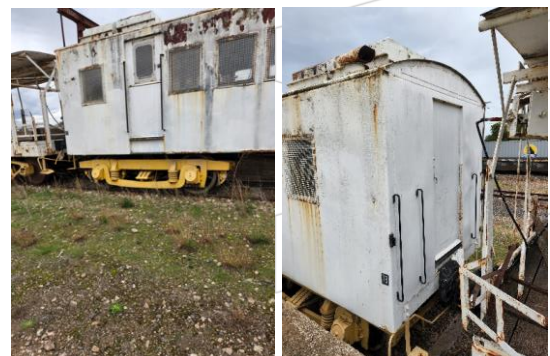
No 3: White Accident Caboose

Walls: metal clad. Some rust at base of walls, otherwise sound. Windows with mesh protection.

Chassis: sound but showing some sign of age. Some rust but no significant loss of section.

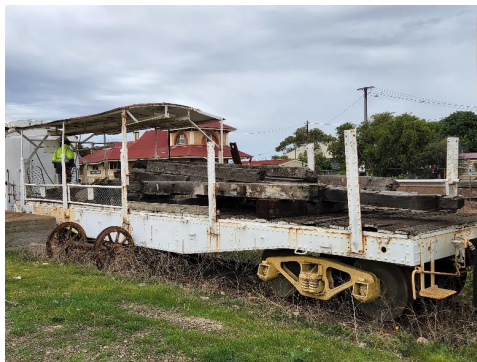
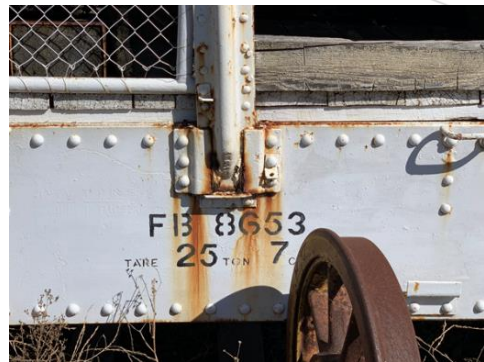
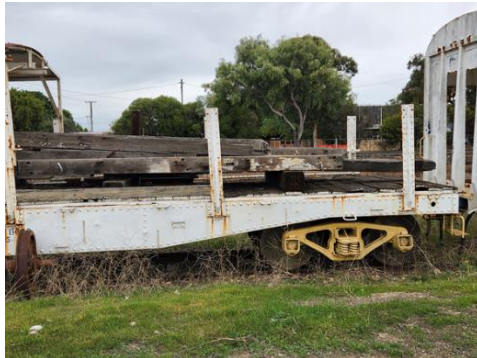
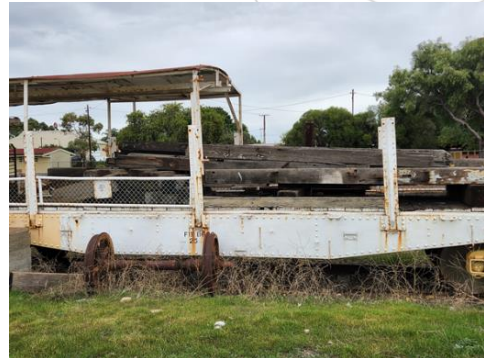
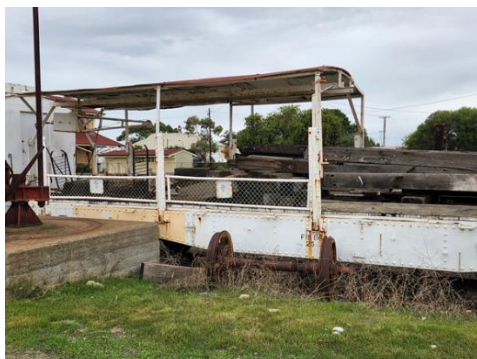
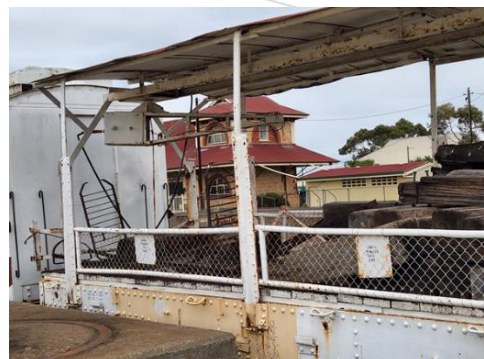
No 4: Older Style Goods Wagon

Timber planked floor. Poor conditions particularly where not sheltered by a roof.

A crude underslung travelling hoist with a slewing jib has been installed beneath the roof structure. It was originally powered by compressed air. Not suitable for use.

Chassis showing signs of age. Sound with some surface rust. No significant loss.

Remove, or secure for transport.

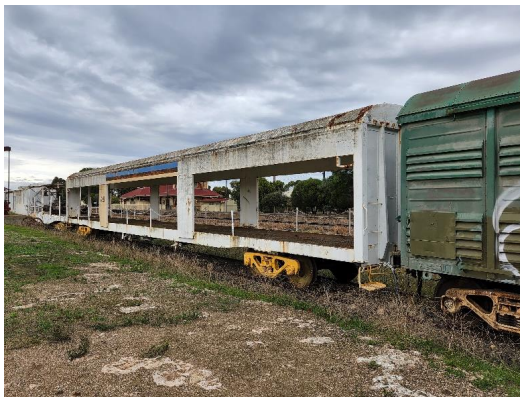
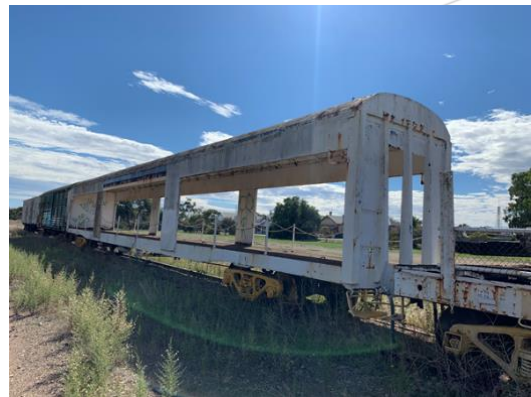
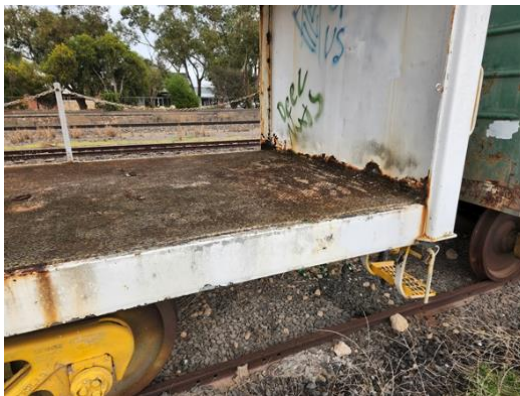
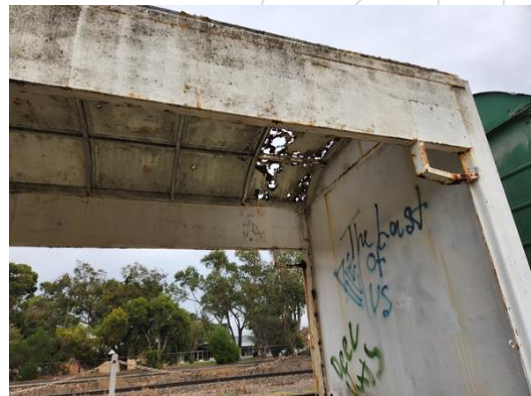
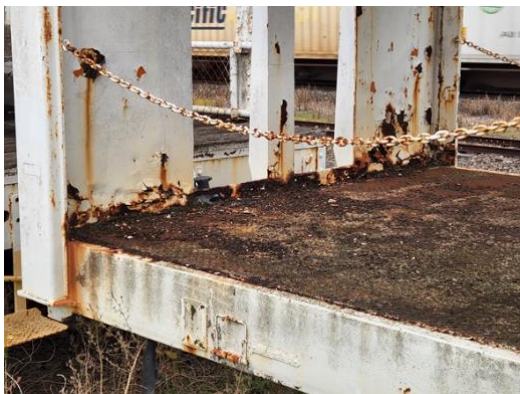
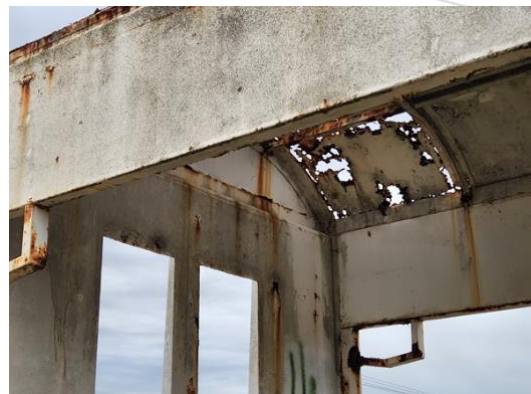
No 5: Long White Open-Sided Covered Wagon

Roof: Metal clad. Very poor. Condition poor, particularly near each end where there is little left.

Not safe for transport. The substructure is ok.

Chassis: sound but showing signs of aging. Surface rust but no significant loss of section.

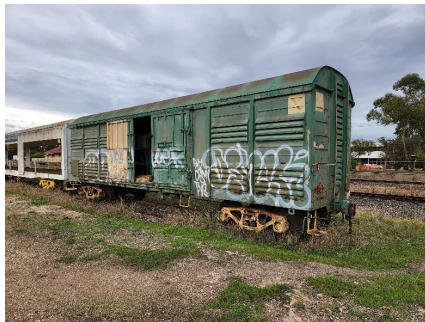
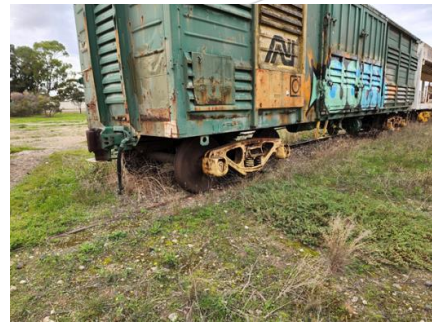
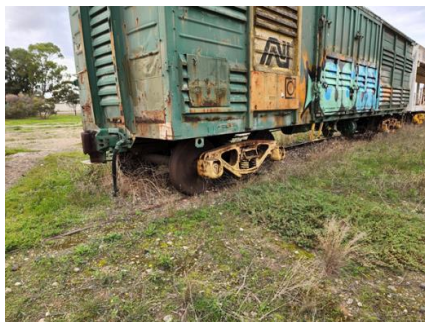
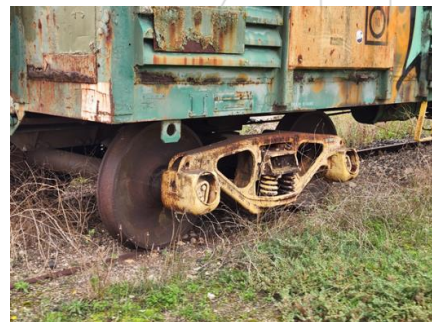
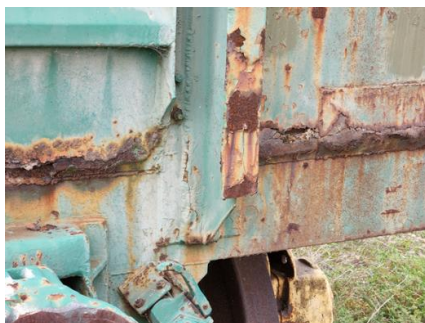
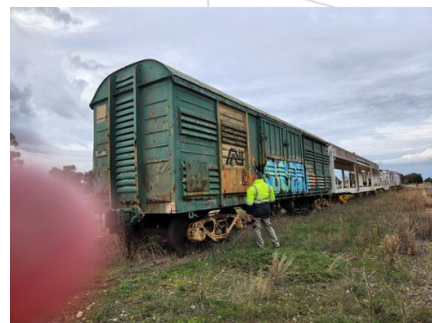
No 6: Green Metal Clad Enclosed Carriage

Chassis is sound but showing some signs of age. Rust is present but no significant loss of section.

Floor, walls and roof metal work are all generally sound but showing local areas of significant rust.

Full of miscellaneous materials. Check. Review before transport.

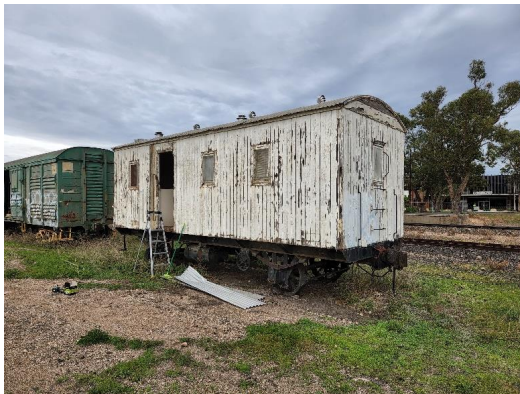
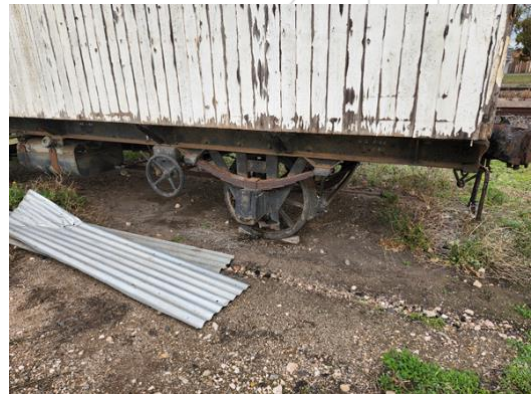
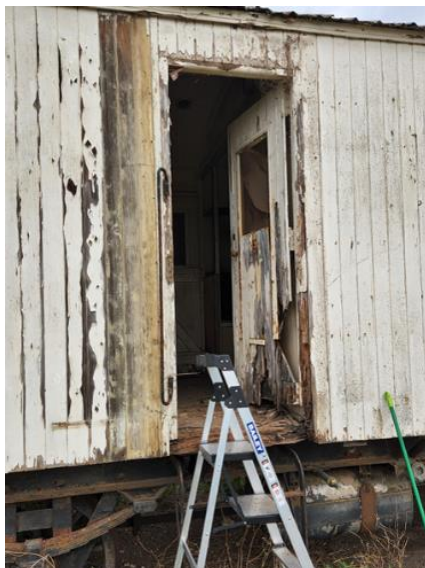
No 7: White Timber Clad Carriage Fitted Out for Accommodation, Consisting of Three Sections: Bunks, Bathroom, Kitchen

Some rot in the wall timbers. One door damaged.

Roof in poor condition but generally sound. Not extensive rust.

Chassis and bogies have surface rust but little overall loss of section.
