# TINTINARA TOWN PARK & STREET TREES

Tree Inspection – March 2021

**Tintinara Town**

**Arborist**

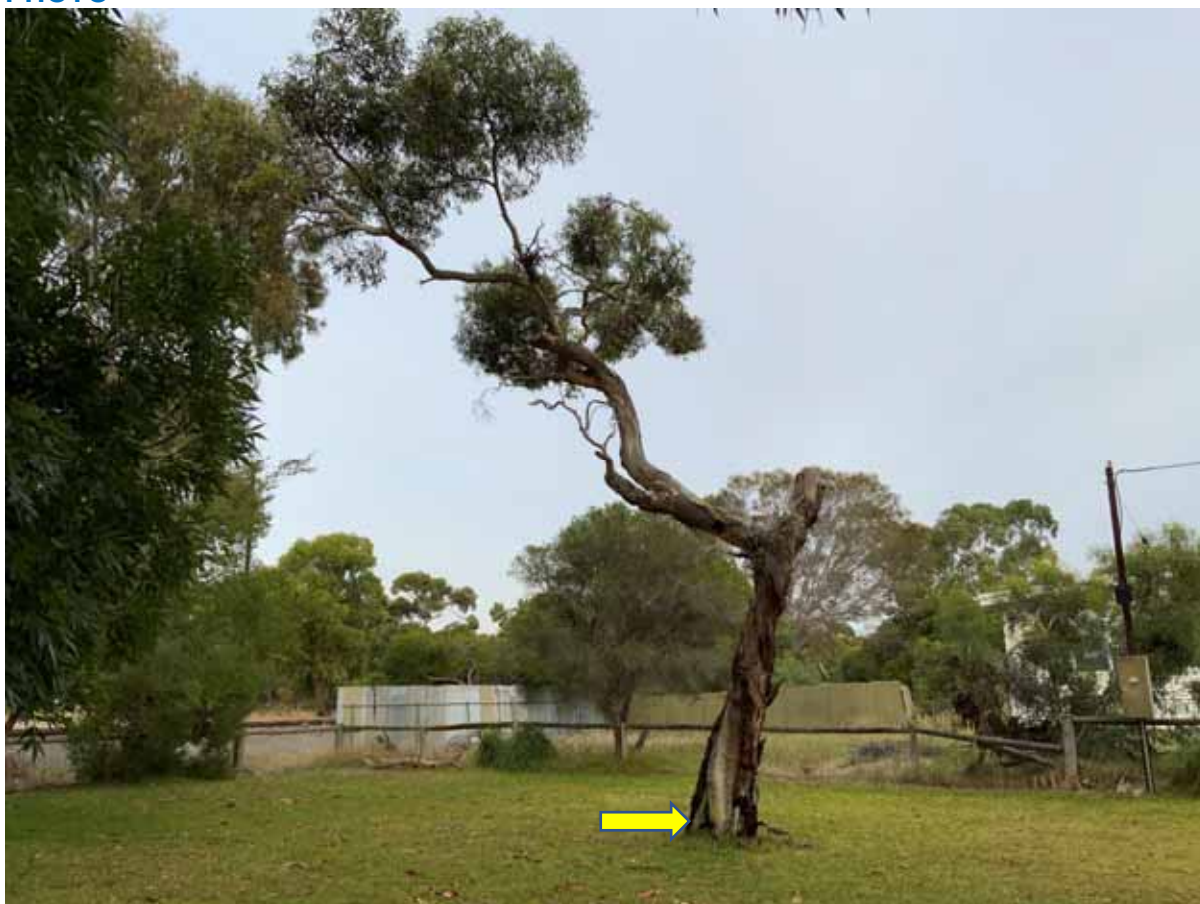
# 1. Eucalyptus leucoxylon

This SA Blue gum has had its main leader broken off, it is also has a large area of exposed deadwood on one side this area is of removed tension and compression wood and is currently decaying close to the base. The ribbing around the area of deadwood is not sufficient enough to sustain the tree in its structural capacity. Having a water meter below it also will be a problem if the it does fail as it would damage the water meter. I'm recommending removal of the tree.

Removal is recommended.

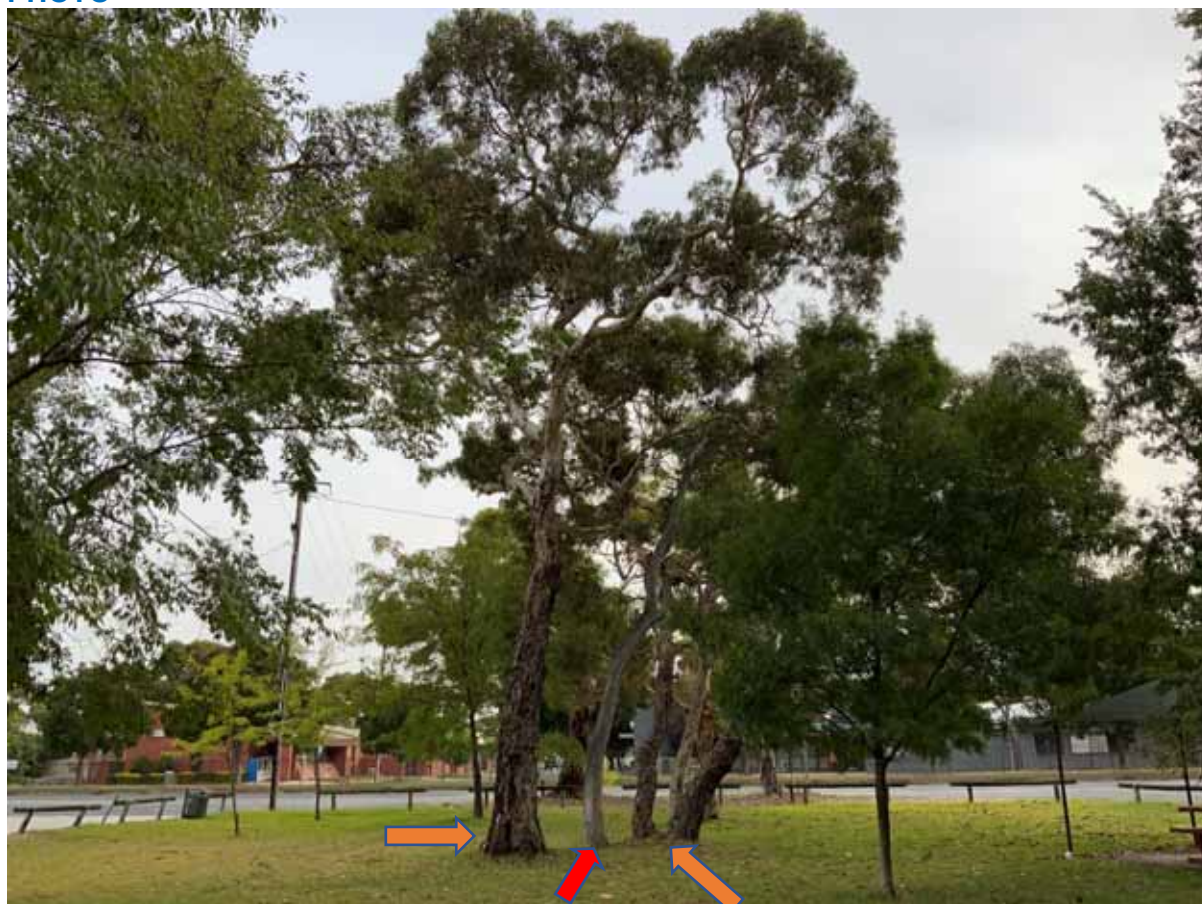
This tree is growing in a row of three, two are alive and one middle one is dead. The trees are very close to each other and would have intermingling roots as well as some being grafted to each other. There is one dead tree in the middle, this tree has been dead for quite some time and the area below ground would have decayed like it would naturally the tree does not have areas of habitat that would be significant the only habitat that this tree would sustain is in the way of insects. The other two trees are in good recovering condition with one that has had a large limb failure which is most likely due to sudden limb drop as the breakpoint is away from the attachment point which is a trait of sudden limb drop. There are areas of deadwood within the live trees, which will need to be removed as it is close to the area where the shade structure and tables and seats are located. I am recommending the dead tree be removed as the amount of decay underground would be at a stage where the dead tree may fail at any time.

Removal of the dead tree is recommended, prune out the large deadwood.

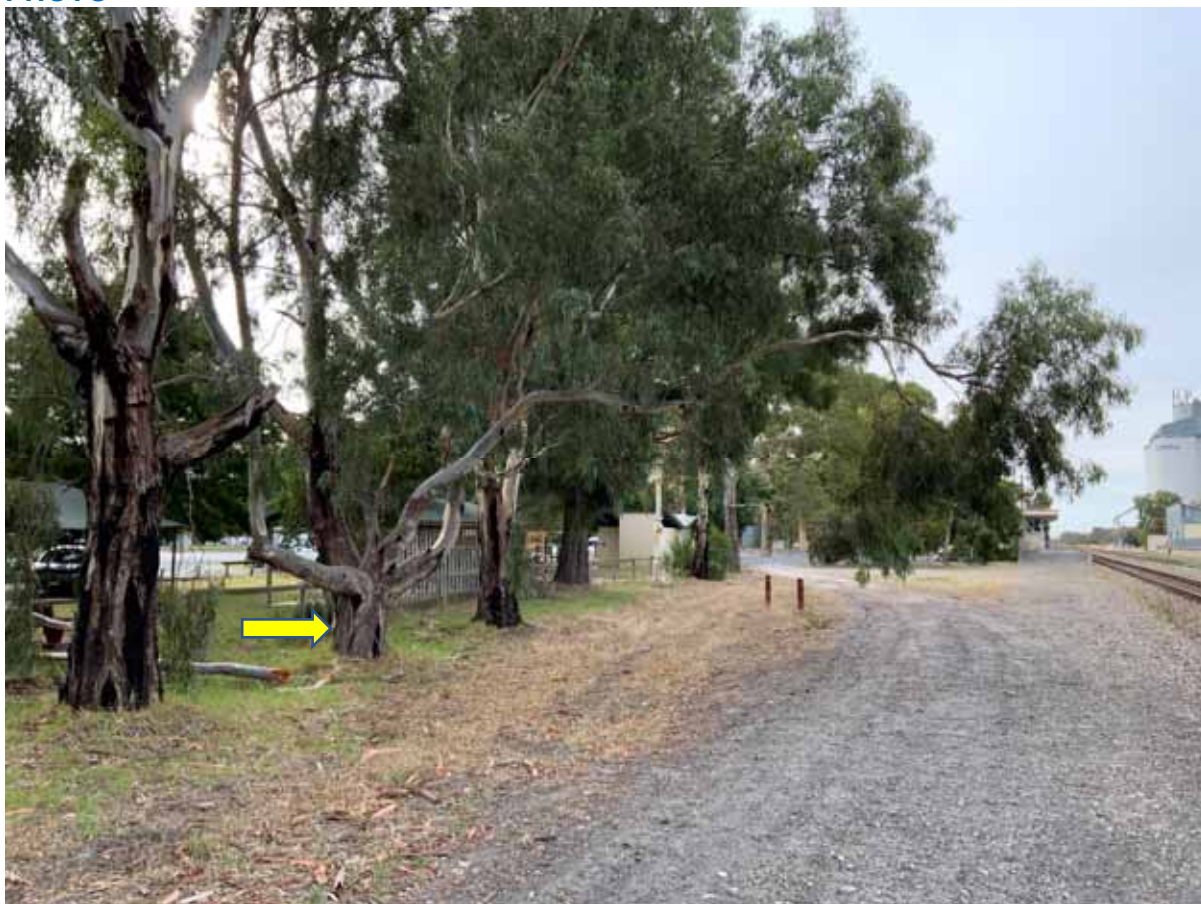
This river gum has only recently lost a large limb and caused damage to the fence however the damage is not significant and the pine rail needs to be reinstated and the fence lifted back up to complete the secure section of the fence. The tree does have areas of canker fungus however, the limb looks to be a clean break and a break that is due to sudden limb drop as there is no defects within the limb itself that would cause it to fail. In the upper canopy there are areas of canker along with some of the attachment points approximately 4 metres from ground level, the trunk also does have areas of canker. The only work needed on this tree is the cleanup the fallen limb, the tree looks to be of sound placement within this area of growth. There is one limb that overhangs the access road next to the rail line which is droopy quite significantly and is hyper extended, I would recommend removing this back to the upright attachment point.

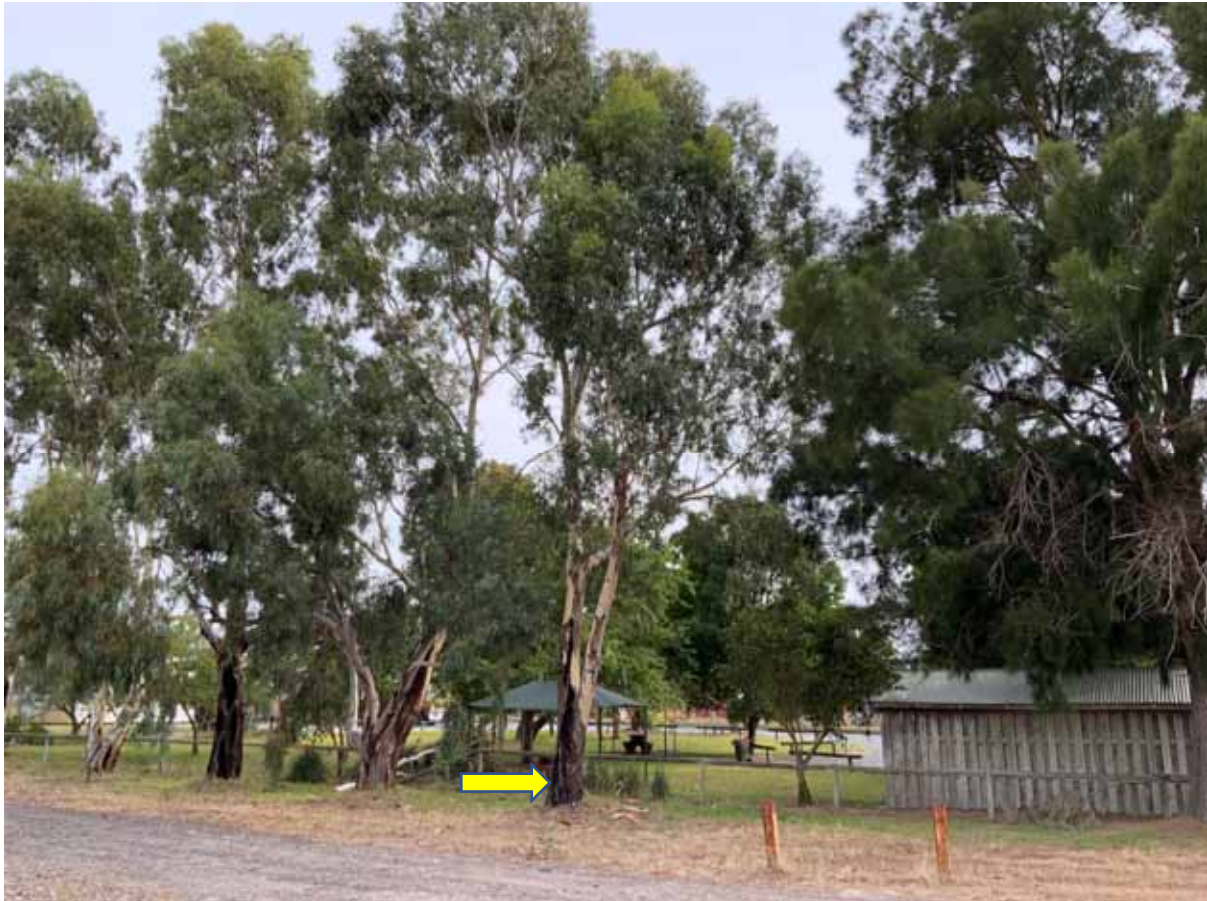
This tree located at the rear of the park also has areas of canker within the lower trunk area of the tree, although the tree does have one limb that is growing over the park and is the only limb that would be any kind of a risk to this area the attachment point looks to be sound, they are areas of canker fungus however this has not reduced any of the structural capacity of the attachment point. With these River Red gums within this area they are prone to suddenly limb drop like we have seen with one next to it, I would recommend removal of this limb as it is hyperextended out into the parking area which is a higher risk as its next to the barbecue and seating places within this park, this is also been the case with Coonalpyn where hyperextended limbs from river red gums do tend to fail so as a matter of sequence I would recommend removing this large limb overgrown into the parking area just to mitigate the circumstances of failure from this tree

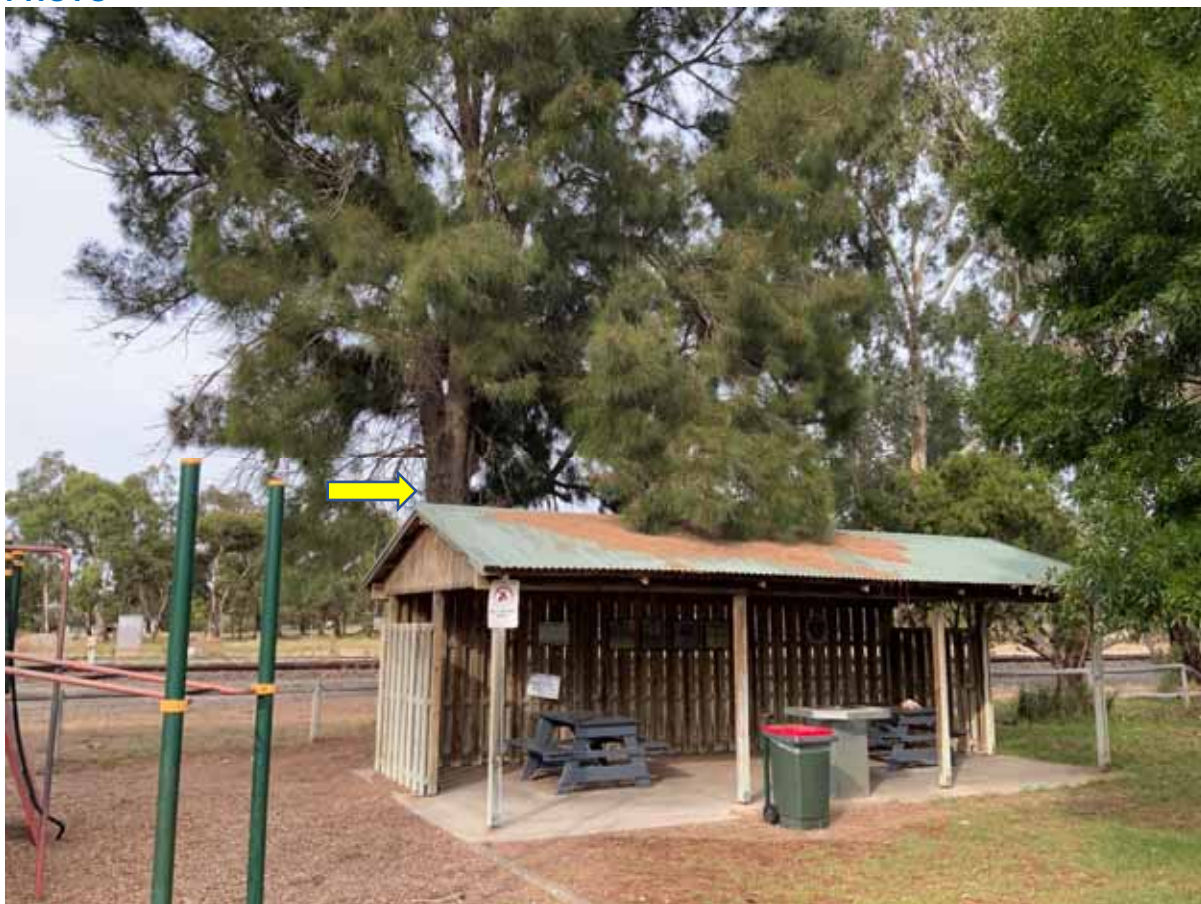
This very large *Casuarina* is in good condition but like most trees in the area have suffered in the past with sacrificial dieback due to the lack of sufficient water, the deadwood is throughout the canopy and most are thin lightweight sticks which main targets consist of the rail corridor and the shelter roof, both are not of high use and the deadwood throughout can be left. There are branches that are hitting the roof of the shelter, this has also caused the roof to retain the fallen debris from the canopy, the foliage will require pruning approximately 1.5 metres from the roof to clear the shed roof and to allow for future growth. to stop any future growth coming into contact with the shade structure itself.

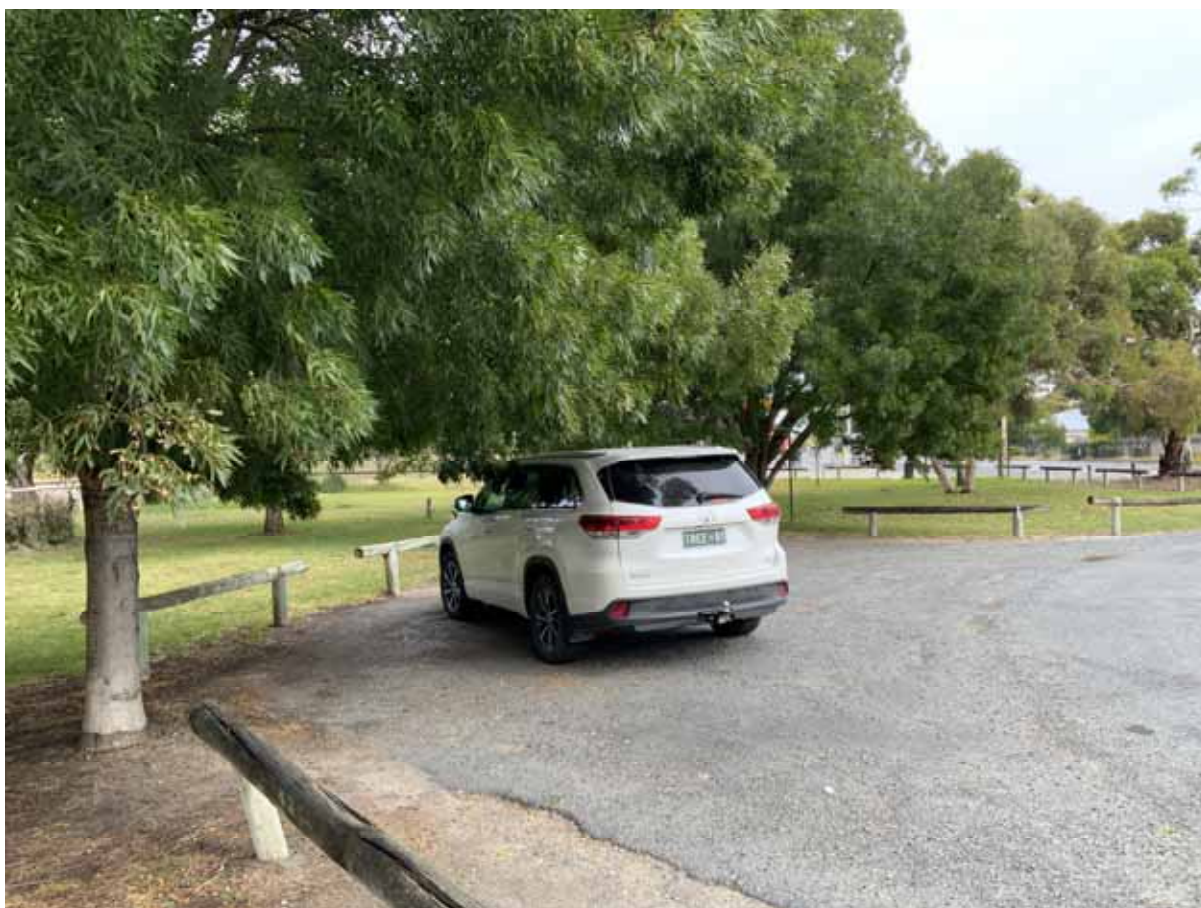
The *Fraxinus angustifolia* next to the toilets will require pruning away from the building itself, also the Ash trees throughout this area of lawn will require lifting so it does not come in to contact with people as they walk through the grounds. Some of the Ash trees are starting to show signs of mineral due to the past irrigation being high in mineral. The Chinese Elm trees within the park are also showing signs that mineral build-up is causing deterioration within the foliage. This will be reversed as the aquifer replenished and the soil is flushed and the minerals become depleted. The foliage near the playground will require lifting also as it is getting quite close to the flying fox and should be at least 1.5 metres away from the equipment. The car park area within the first site will require lifting as it is now touching normal height vehicles when they park within this area, both of the Ash trees in the turnaround car park area will require lifting as they are getting to the stage where they will damage the roofs of cars as a park close by. All access areas that require lifting of the canopy should be approximately 2.1 metres and any access area near structures needs to be 1.5 metres away.

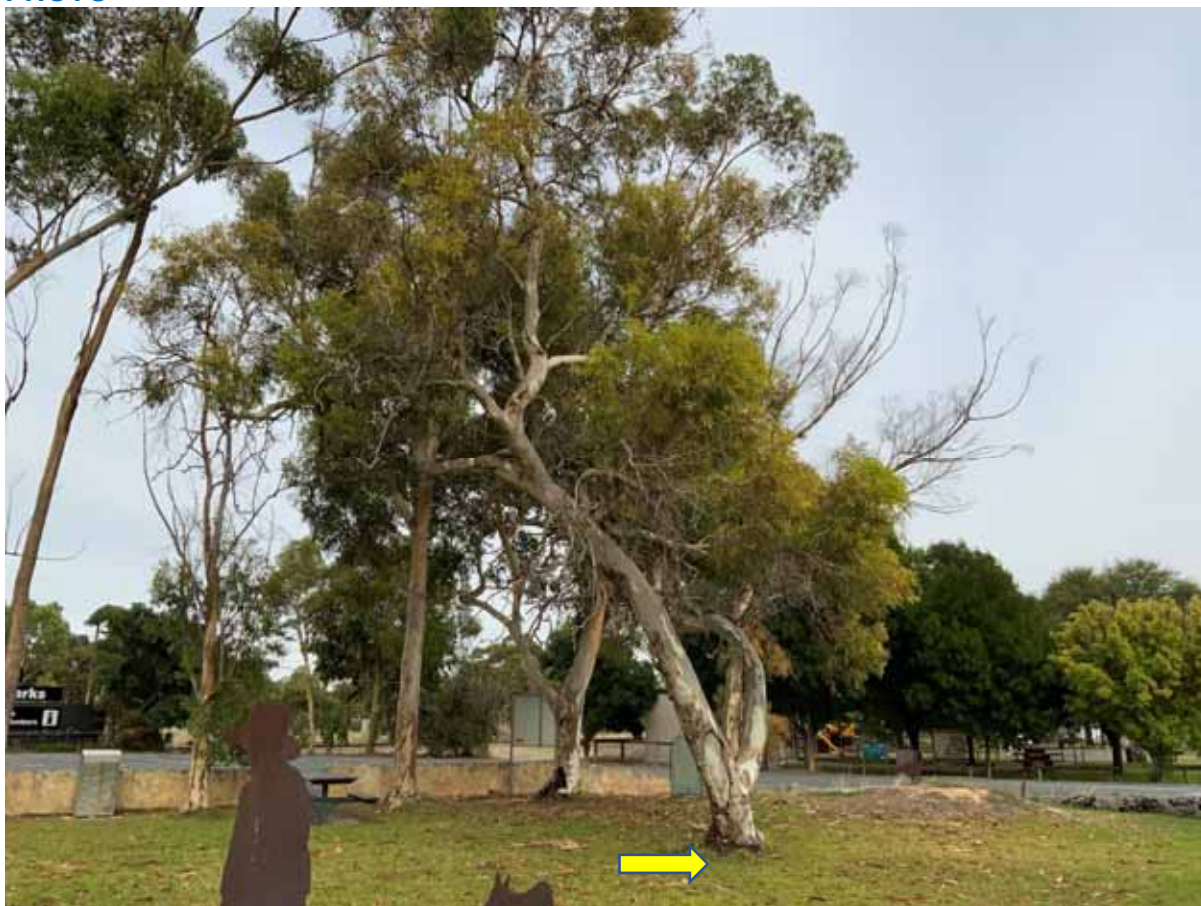
## 1. Eucalyptus leucoxylon

This SA Blue gum has many areas of deadwood throughout the canopy a lot of the areas are from old mistletoe attachment points, some are original dieback, however the amount of deadwood within the tree does require removal as this area is a tourist area and is of medium to high use. The tree does have injury within the trunk, this is slowly becoming engulfed by the wound wood. The tree does have yellowing in the foliage that is mostly due to altered mineral balance, this happens through constant use of bore water, however the tree does have multiple areas of new growth occurring throughout the canopy and may return to its former full canopy due to sufficient ground water ground water Being reinstated by the rains.

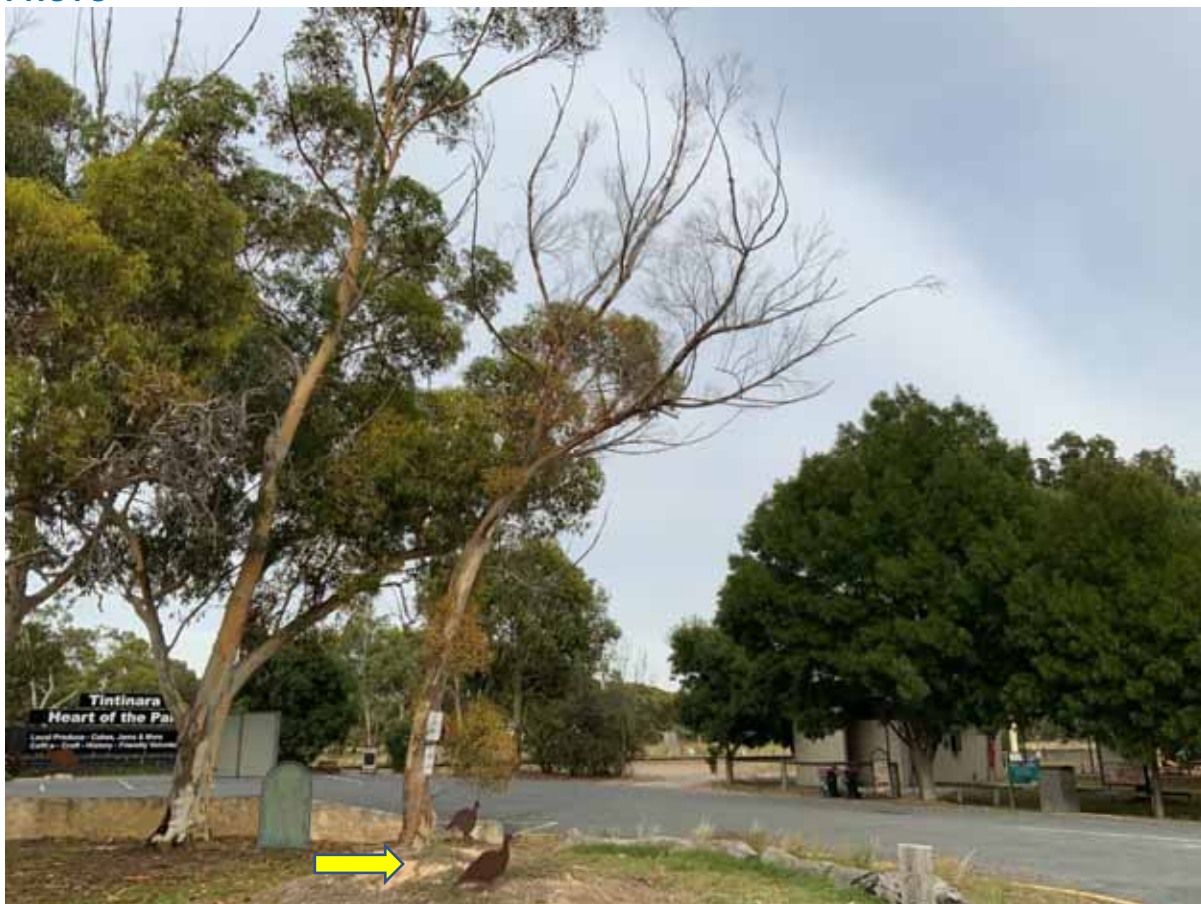
This SA Blue gum is almost dead, the remaining foliage has turned yellow and most of the upper canopy has gone. A combination of mineral build up from the bore water, having one side of its roots in a bitumen hard stand and the domination from the tree next to it has accelerated the declining condition of the tree. The removal of this tree is recommended as it is very unlikely that he can return to his former growth.

Removal is recommended.

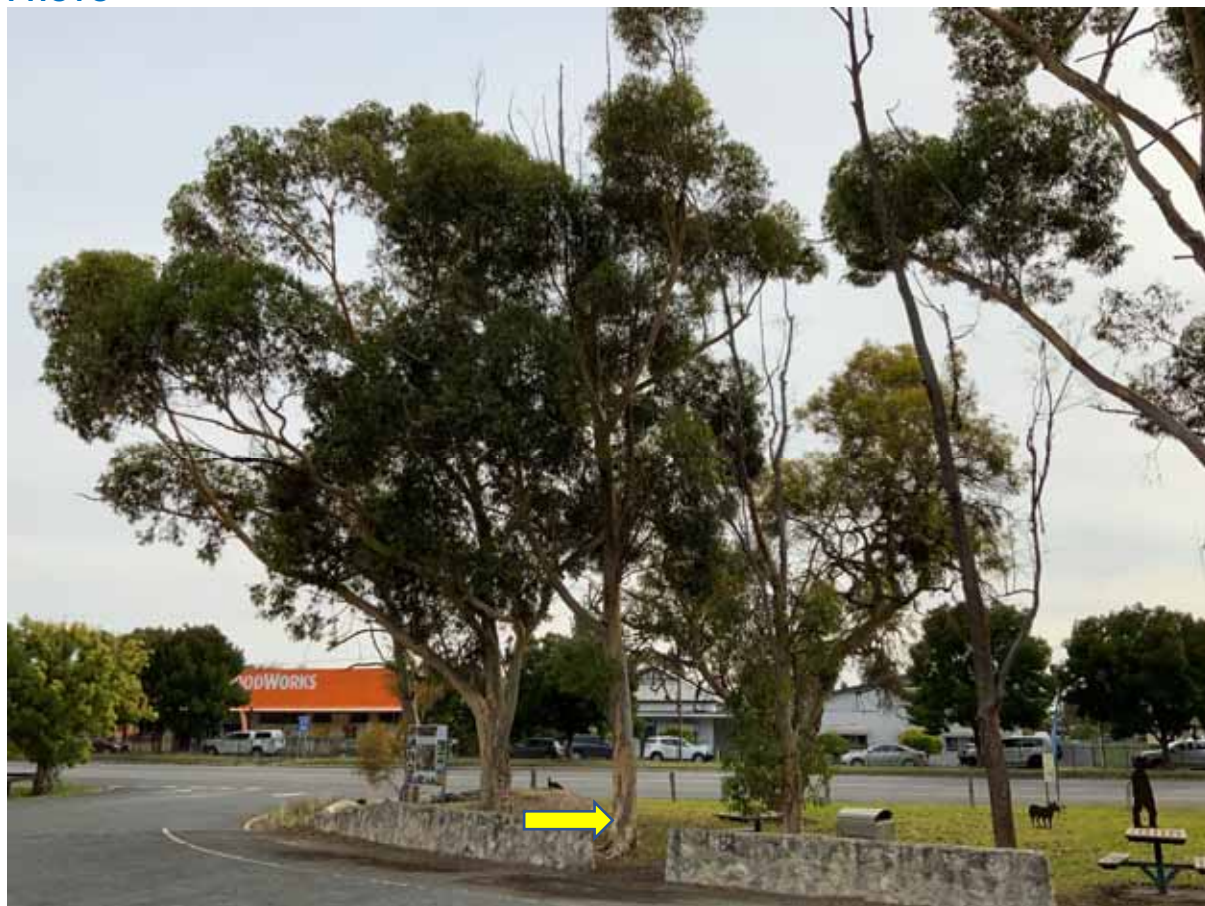
This upright Sugar gum is still in good condition and has also been affected by the mineral buildup but will require dead wooding throughout the canopy as it is just above an area of seating. The attachment points are still quite sound with the areas of solid attachment that they do not require any works.

Removal of only the large deadwood within the tree is recommended.

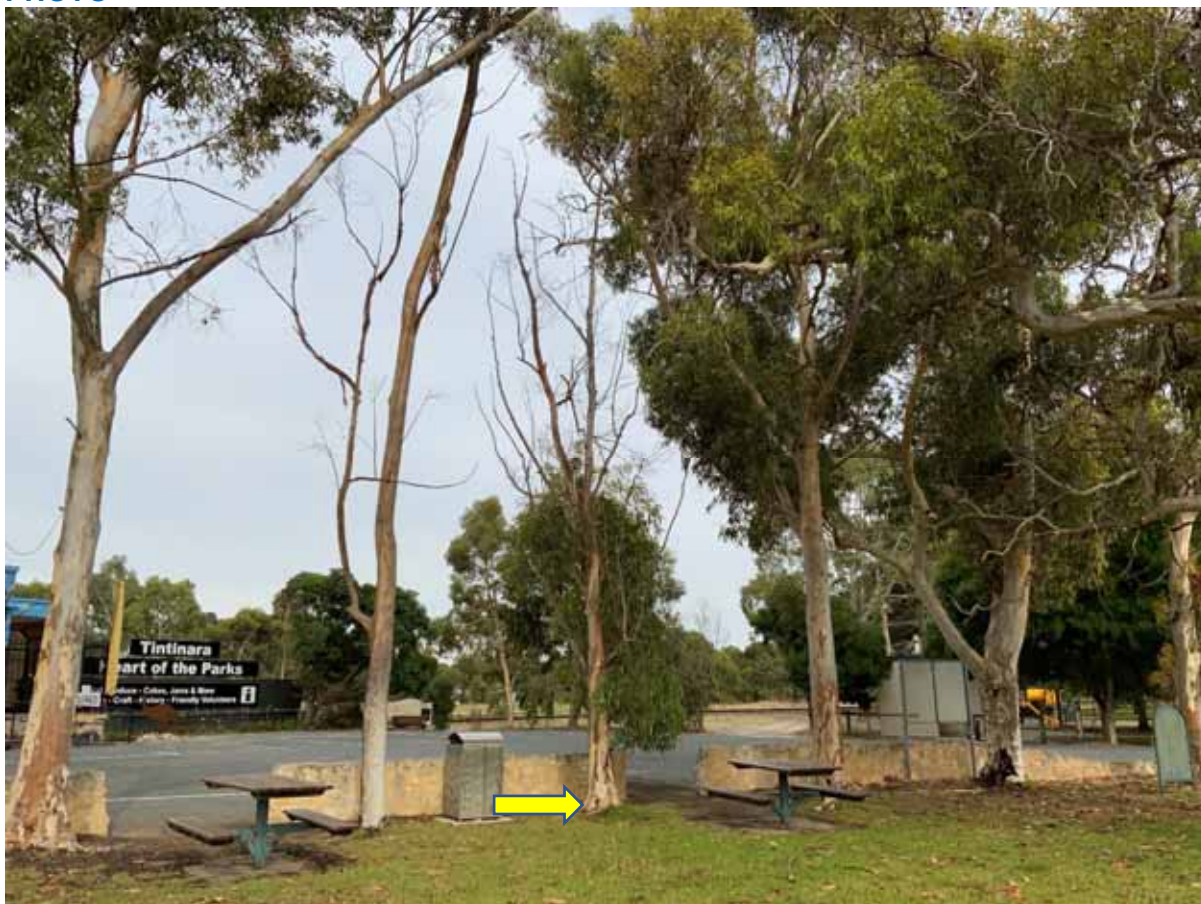
The small tree has not coped too well with the high mineral content and has died right back from the top the only foliage on the tree is epicormic growth from blind buds that have been activated by the high sap content in the lower trunk system. Removal of this tree is recommended as it is close to areas of high use.

Removal recommended.

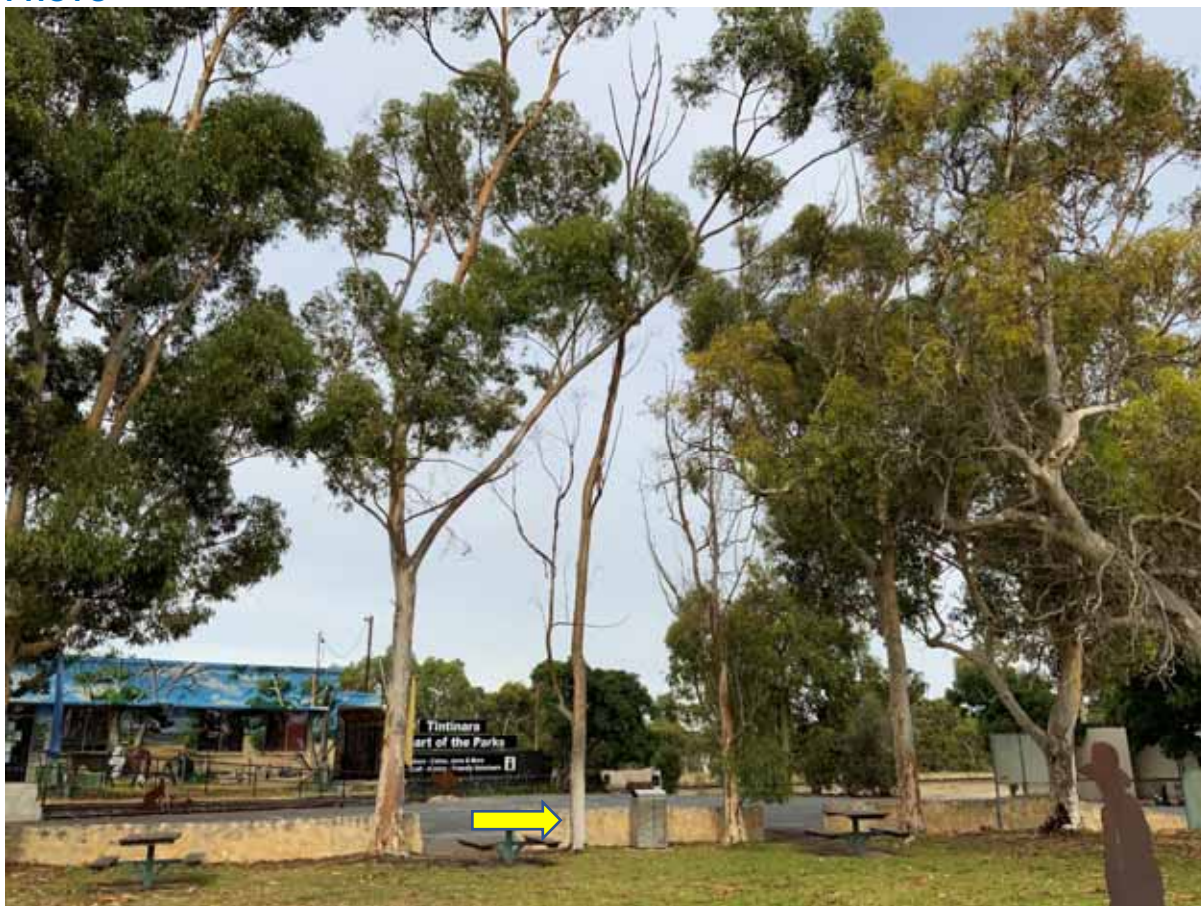
This tree has died it is a slim upright form tree that has no area of habitat and will become a high risk the longer that it is remaining in its current position, naturally the tree will decay and breakdown over time and this is what will happen with this tree.

Removal is recommended.

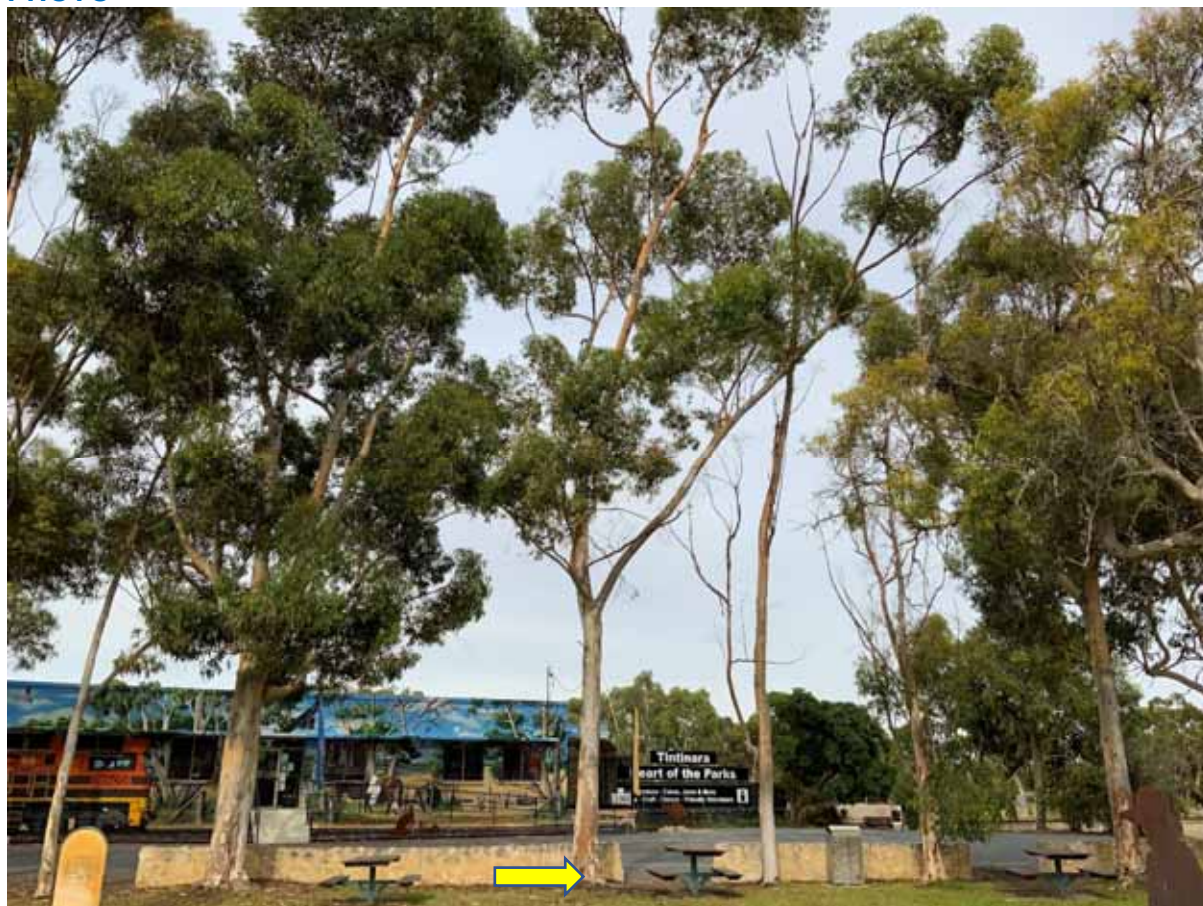
This tree is a tall upright form with one branch out over the area where the dead tree is now, the tree is in fair to good condition and will only need dead wooding due to it being above the seating area. The attachment point is sound and the of branches from the main central trunk are not radical or hyperextended that they would be susceptible to breakage within storms.

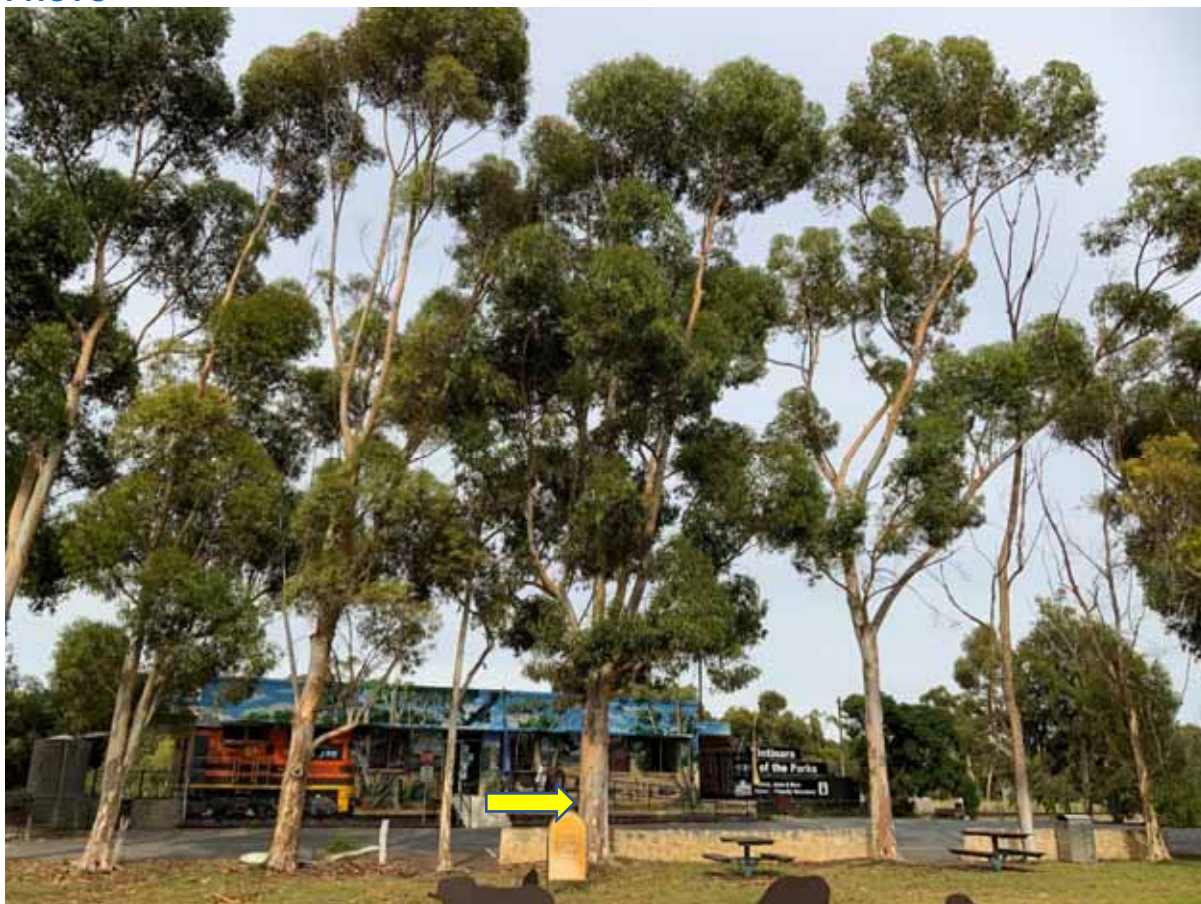
The sugar gum is in very good condition and would have populated the area not just around the lawn but would have had populated roots under the bitumen out to the area which does not get irrigated. The tree does have a good branch structure up through the scaffold branching system, all of it is mainly upright with no dripping limbs that may fail in the future and a defect which can be seen.

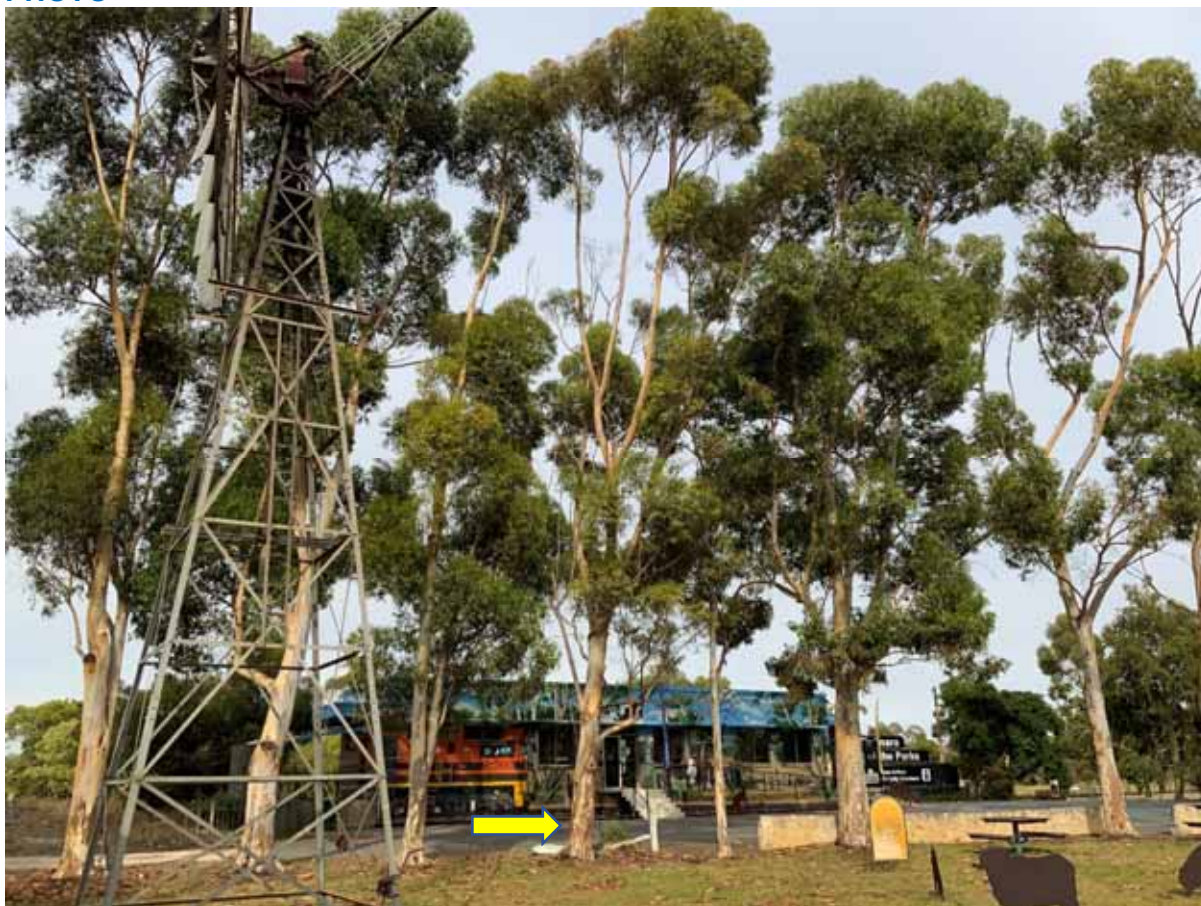
This upright form Sugar gum is also in good condition but does have some areas of dieback due to mineral concentration within the root system. Dead wooding will be required as it is in the access area but the rest of the tree does not require any works and should continue to grow well.

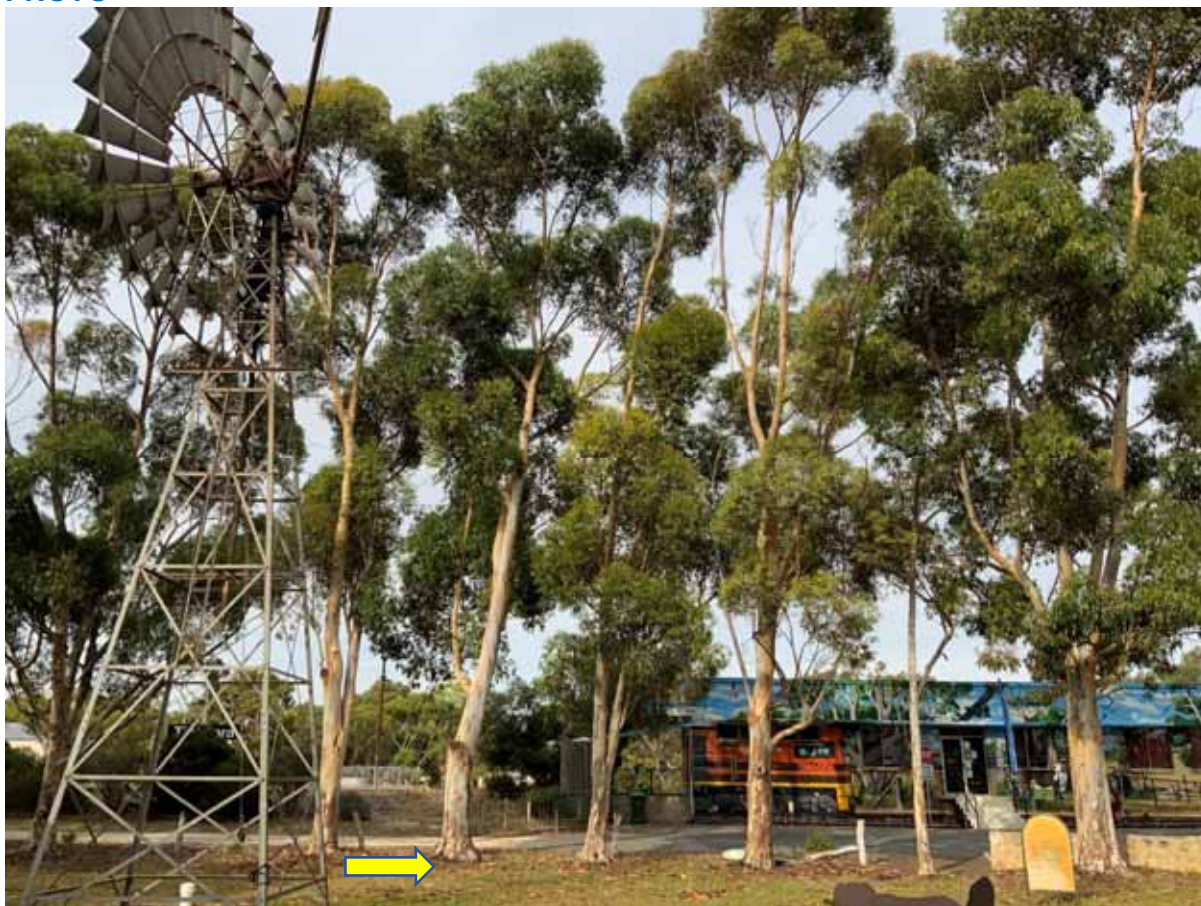
This Sugar gum also would have populated roots outside the irrigated area it is a forest form tree that has grown to the confines of the surrounding trees along this line of plantation. The attachment points approximately 2 metres from ground level is still sound but, in the future, it may develop included bark but for now it is quite sound and it does not pose a problem.

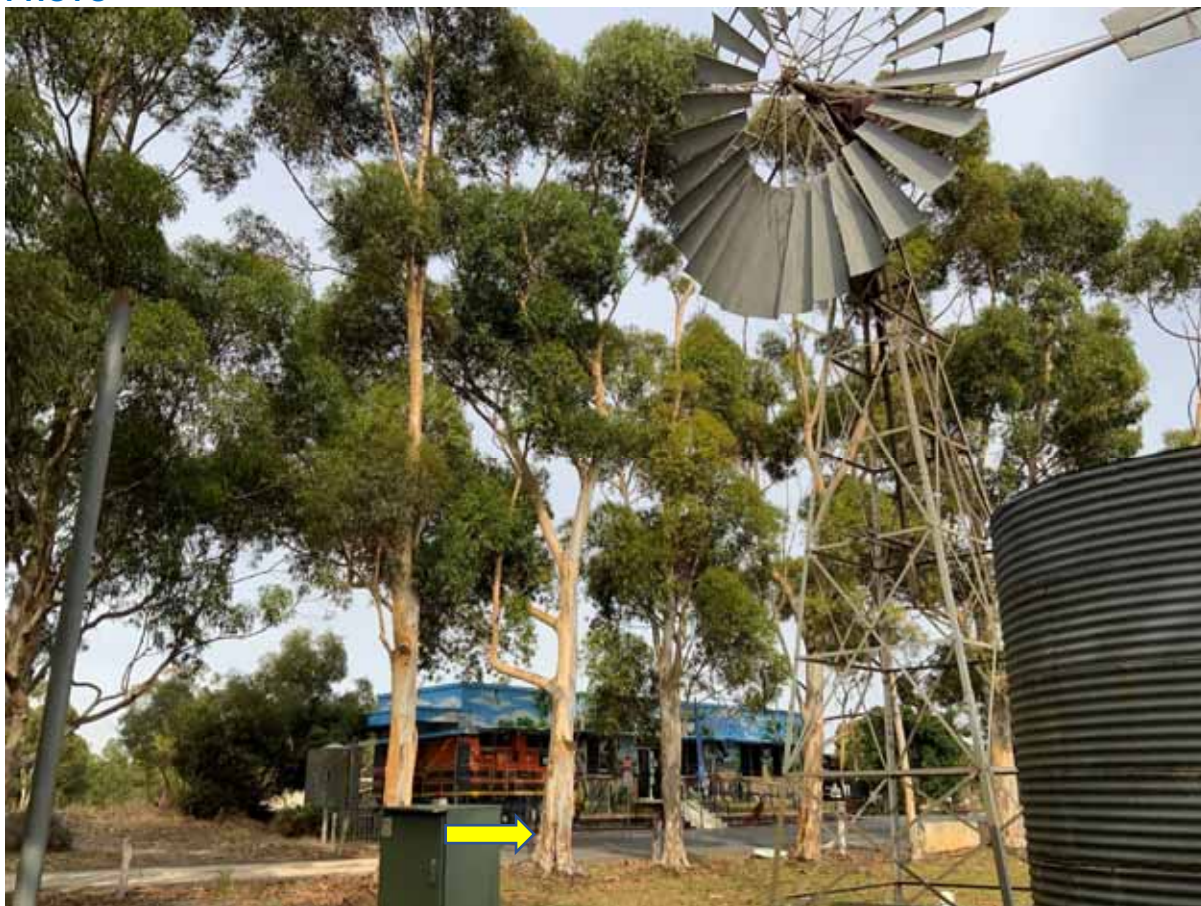
The sugar gum has lost 1 limb in the past; however, it has not affected the tree to extent where it is compromised in its structural capacity. The tree's root system has access to non-irrigated areas and the buildup of minerals is not as high in these trees. The attachments in the upper canopy does have a bulbous area to them however it is through growth and not through included bark, all other attachment points did not have any areas the defects and the tree is sound and does not require any works.

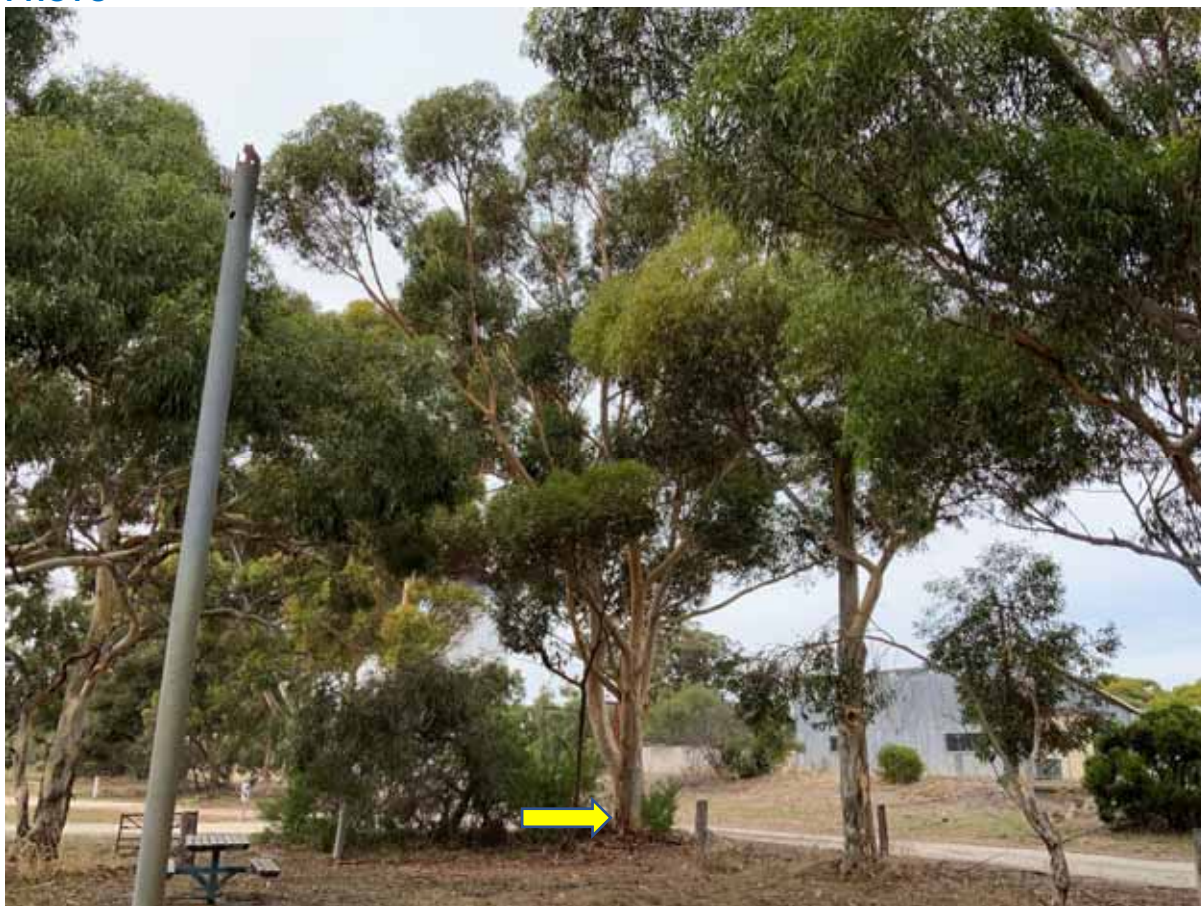
This tree is on the corner and has very little area of irrigation covering the root system. This tree is in very good condition and its upper scaffold branch system is sound with no areas of defects, there is very few areas of deadwood, being in this area they do not require any works at this time this tree is an example of what the other trees would look like if they were not watered by the irrigation..

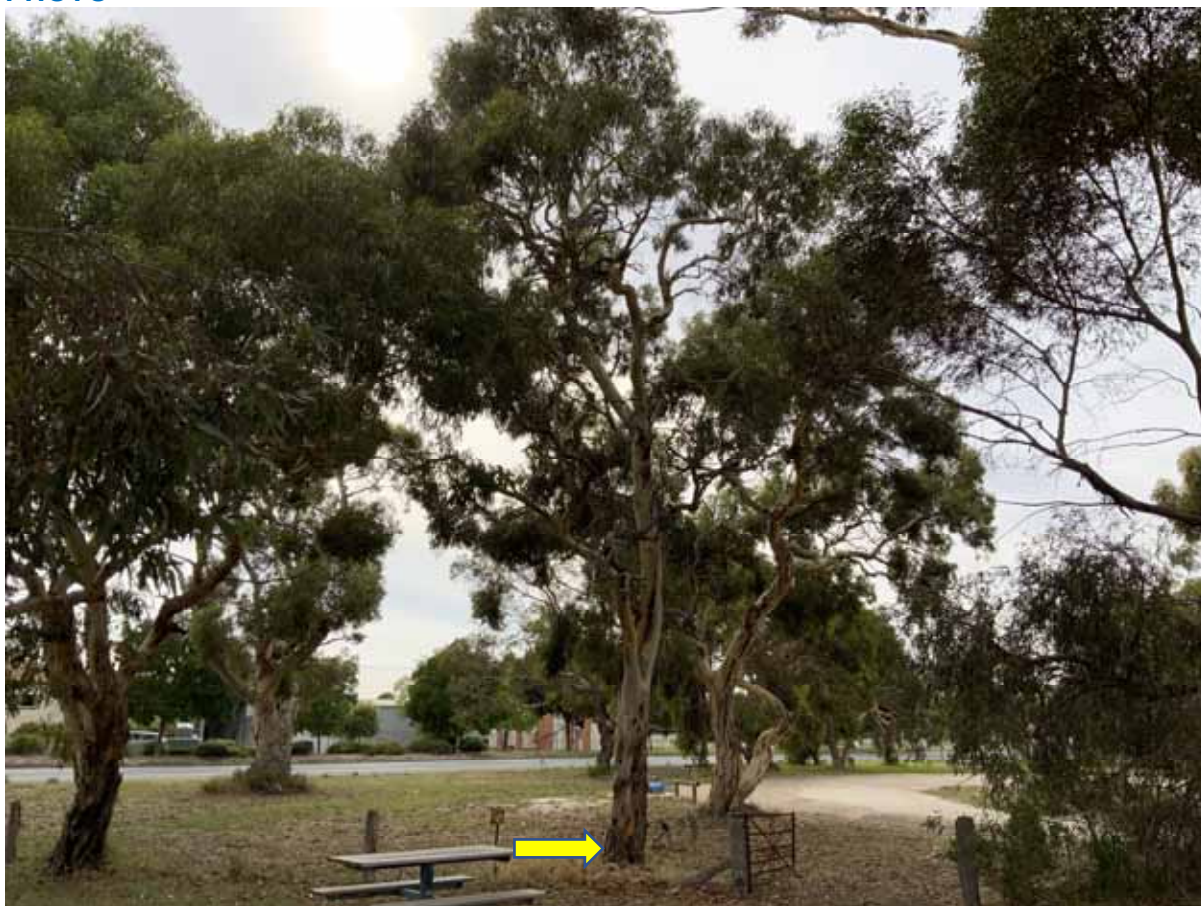
This tree has a root system that is bound on one side by the largest sugar gum that restricts the roots out to some of the area of irrigation, which is why this tree does have dieback throughout the canopy. The tree is in a position which is close to a seat and park bench, with deadwood hanging over this area that will need to be removed. All of the deadwood within this area will need to be removed and it is mainly confined to the lower canopy and on the lower side of the top terminal canopy. I'm also recommending that the small branch growing out of the lower trunk approximately half a metre from ground level be removed altogether as it is causing damage to the upper trunk and will not help the specimen mature.
