# TINTINARA TOWN PARK & STREET TREES

Tree Inspection – March 2021

**Tintinara Town**

**Arborist**

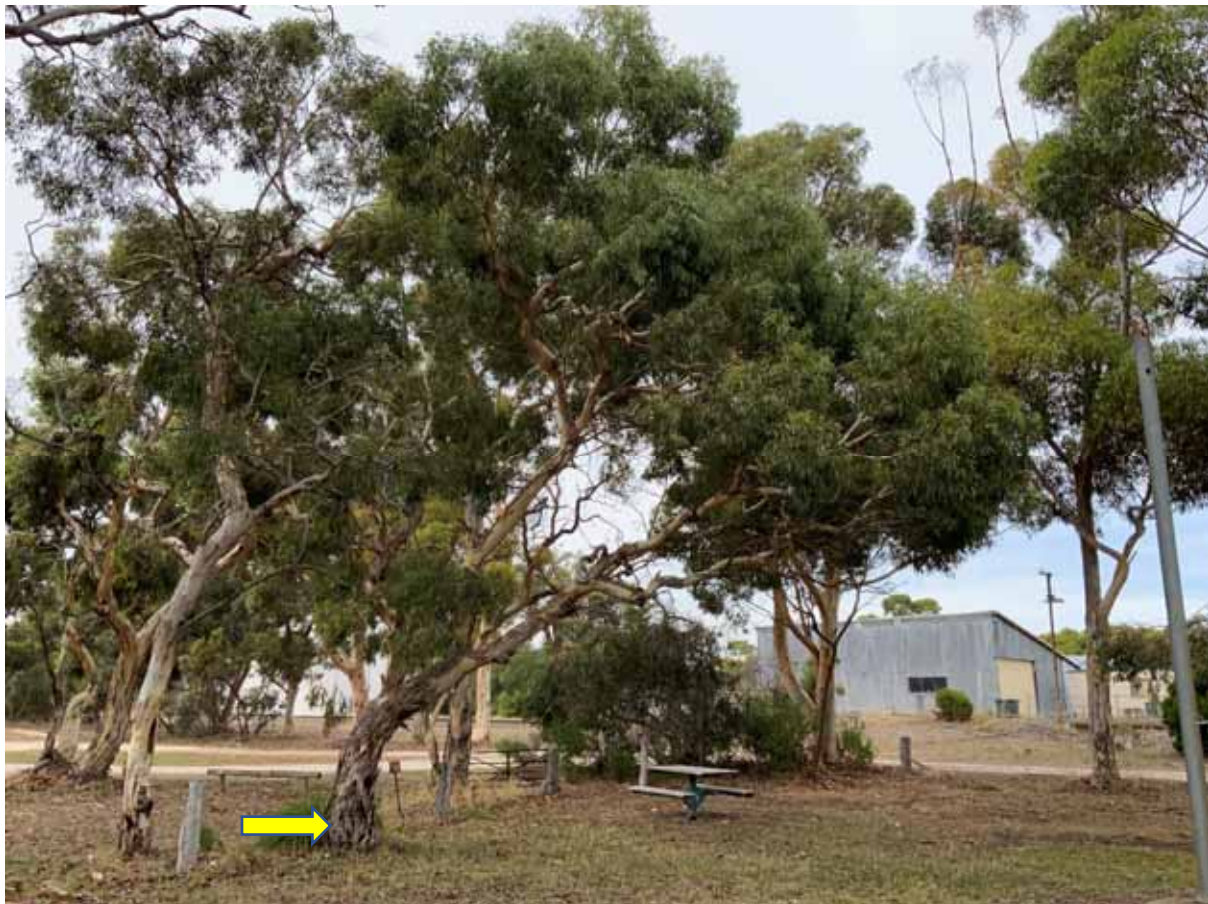
This tree also has its root system within irrigated area and has also suffered from dieback due to the buildup of minerals. History still in fairly good condition but will require dead Wooding throughout the canopy as it is an area of use for seating and tables.

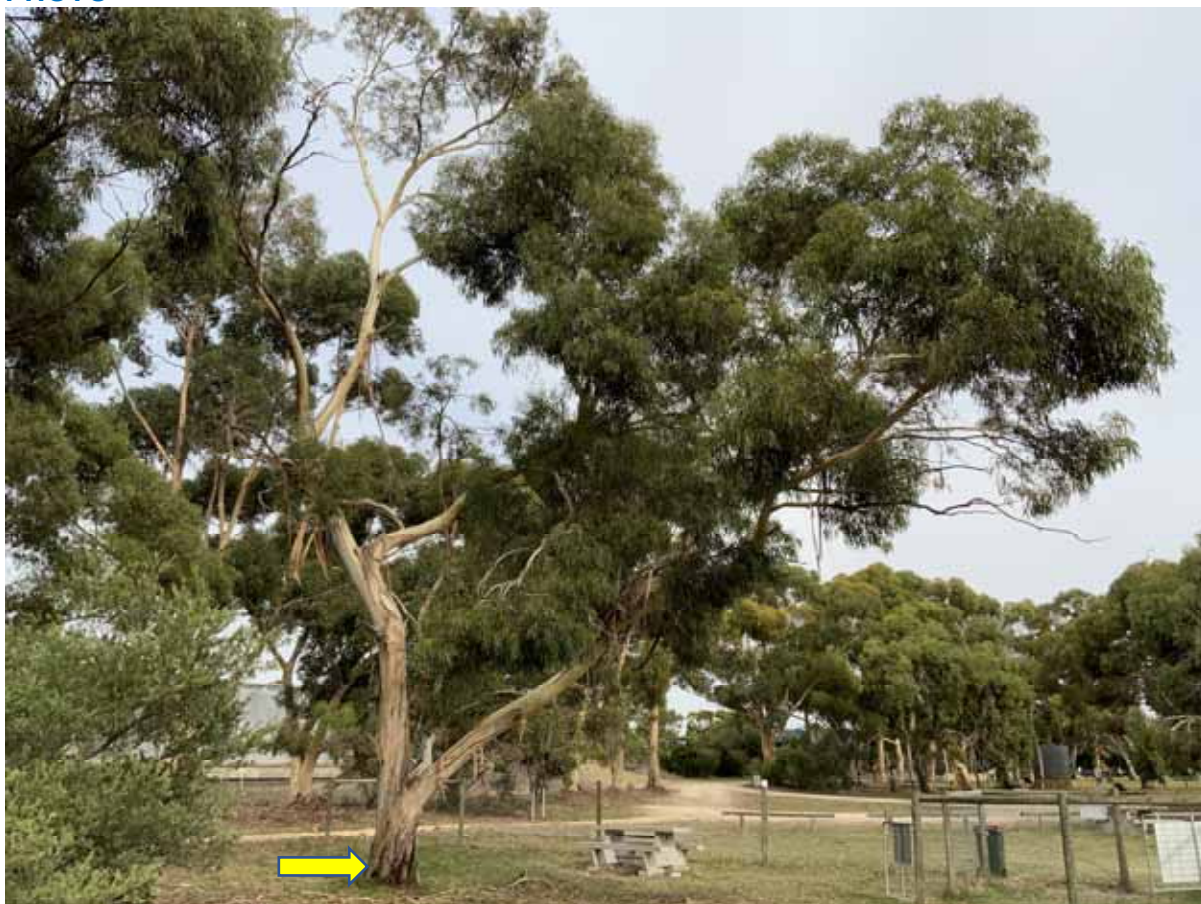
## 1. *Eucalyptus leucoxylon*

This SA Blue gum is in good condition and is growing quite well. There are several areas of large deadwood that will need to be removed as this is a combined high use area with seating under the canopy itself. The tree overall is in good condition with numerous new growths throughout the canopy, the removal of deadwood is the only works that are required for this tree.

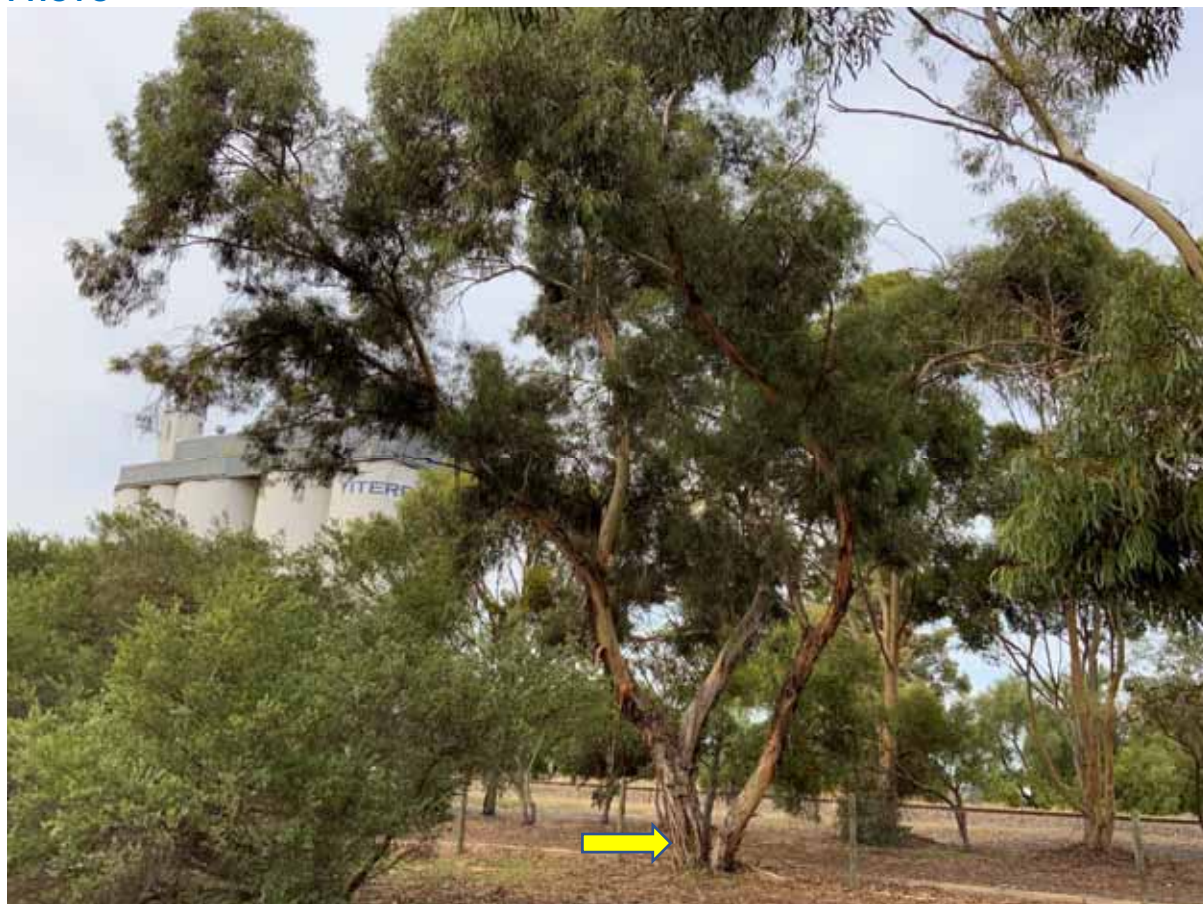
This SA Blue gum is also in good condition it has a twin leader one being smaller than the other at the base of the tree which is of attachment and no areas of defects. The upper canopy has fewer areas of deadwood with only a few large dead branches close to the other Blue gum that can be removed when the deadwood of the first Blue gum is removed, this is only minor works.

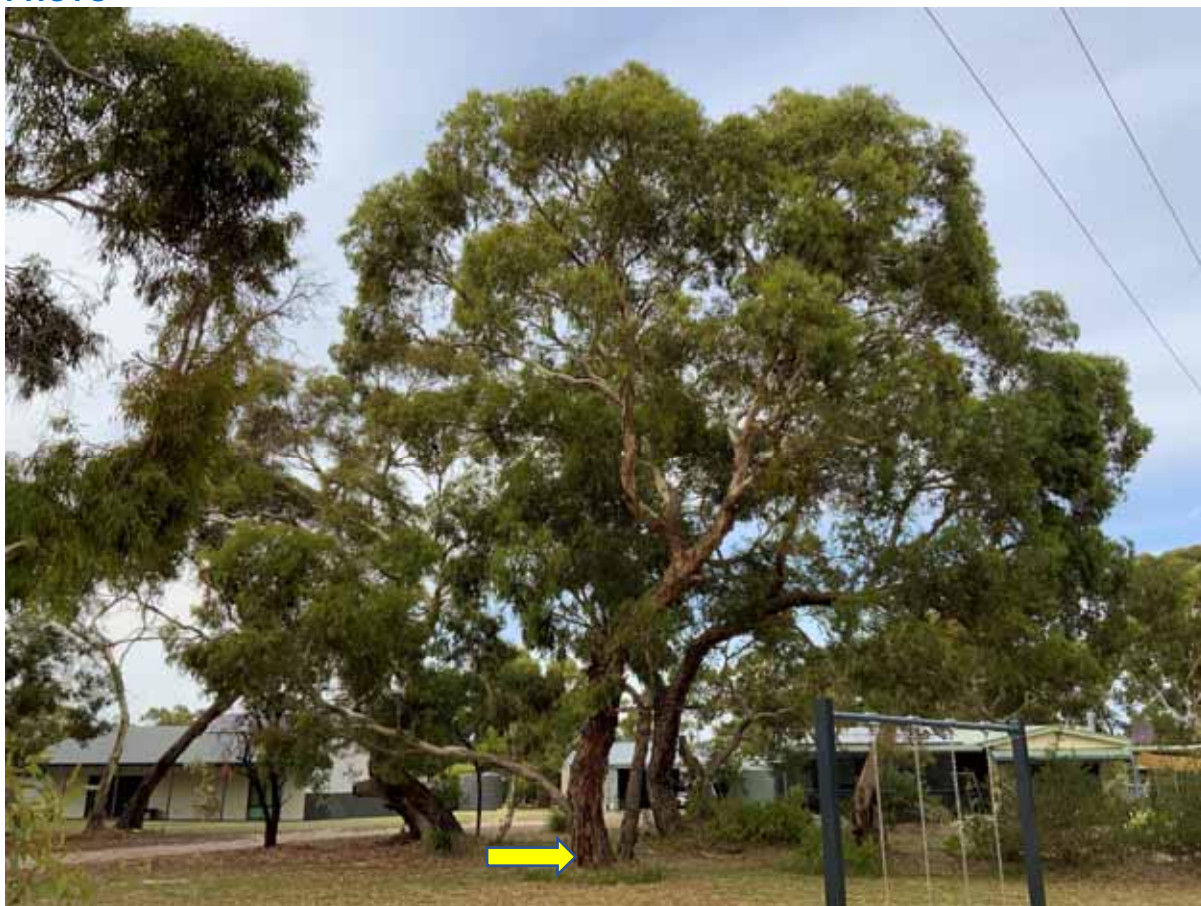
## 1. Eucalyptus leucoxylon

This large specimen has multiple areas of mistletoe however the mistletoe is only of small size and is not affecting the tree in any way. Even as a mistletoe becomes a lot heavier the area below is not of high use and if it does fail. The tree does have a good trunk base with two smaller leaders arising from the same trunk flare, the limbs are much smaller but they are still structurally sound. The amount of deadwood on this tree does not warrant removal this time as many of the trees around here do you have deadwood in them and is not classed as a high or medium risk as it is a low use area and the chances of it falling on someone are very low.

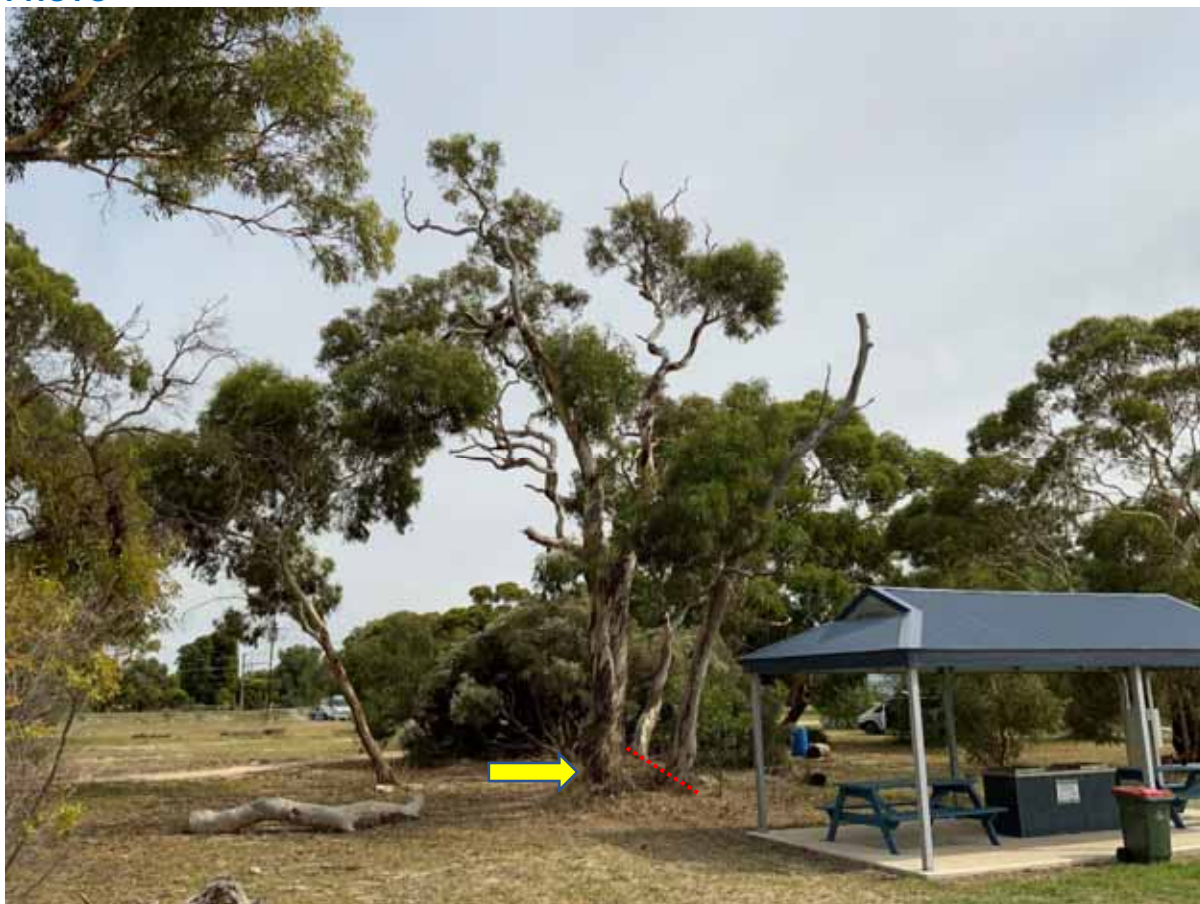
## 1. *Eucalyptus leucoxylon*

This SA Blue gum is a result of the original tree been removed and epicormic growth now be the leaders that make up the whole of the tree above ground. Mature epicormic growth grows in an upright manner with very little scaffold branch system that is only seen on old mature regrowth. The leader with a small amount of greenwood that is leaning over the shade structure will need to be removed as the greenwood is starting to become dislodged from the deadwood and will eventually fail as it separates. The second leader next to it which is the smaller of all the leaders does have a lot of deadwood throughout and I am recommending that the limb also be removed, this will allow for the two remaining limbs to grow, the two remaining leaders will require the large dead wood to be removed as it is close to the shelter and the barbecue.

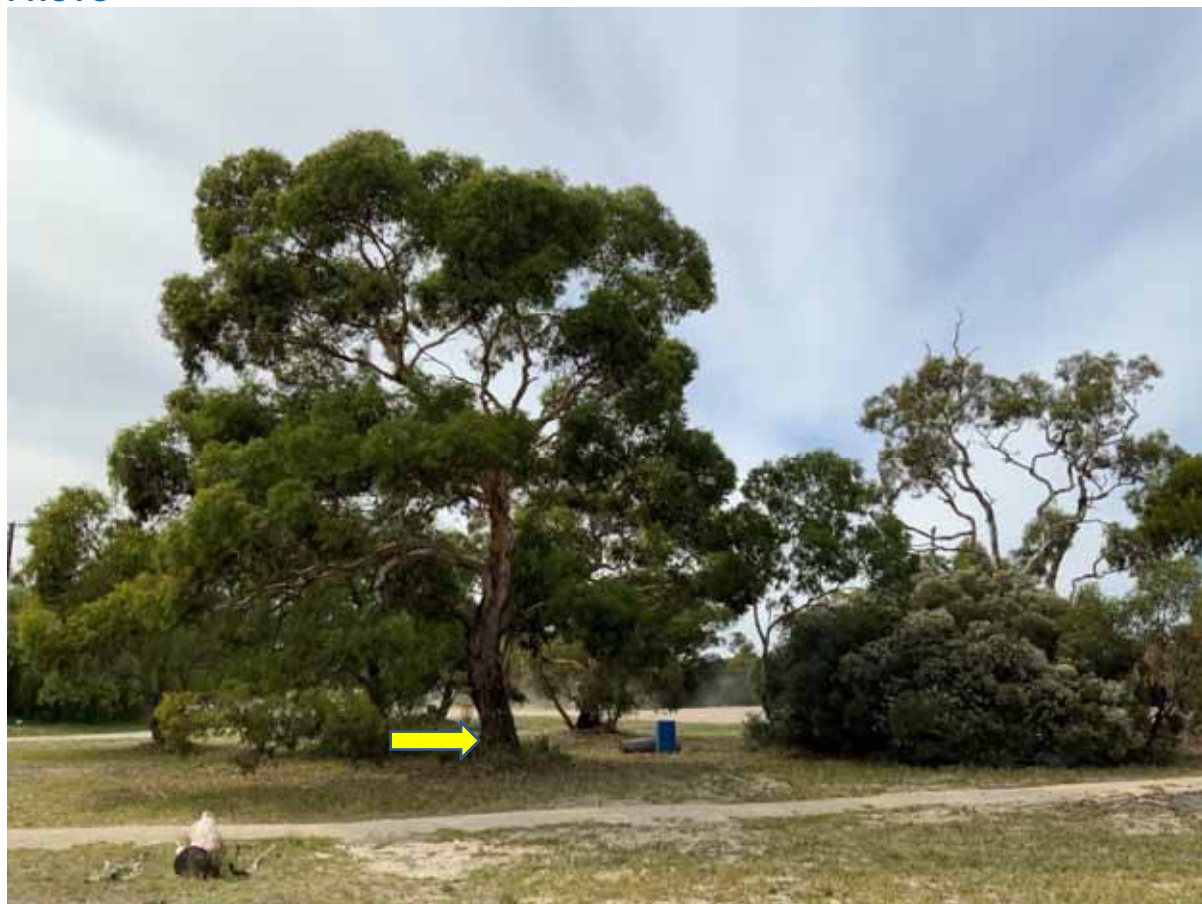
This large SA Blue gum does have areas of Canker fungus within the lower portions of the main trunk system, some of it is on the decline with most of the fungus now being inactive and not causing a problem. The tree's overall structure is uniform and does have a good taper up through into the scaffold branching system. The amount of deadwood is minimal and would not require removal. I am recommending that the lower branch near the path be pruned off and lifted this will allow for easy access for RVs within this area. Being an SA Blue gum the chances of limb loss is minimal compared to the river red gums.

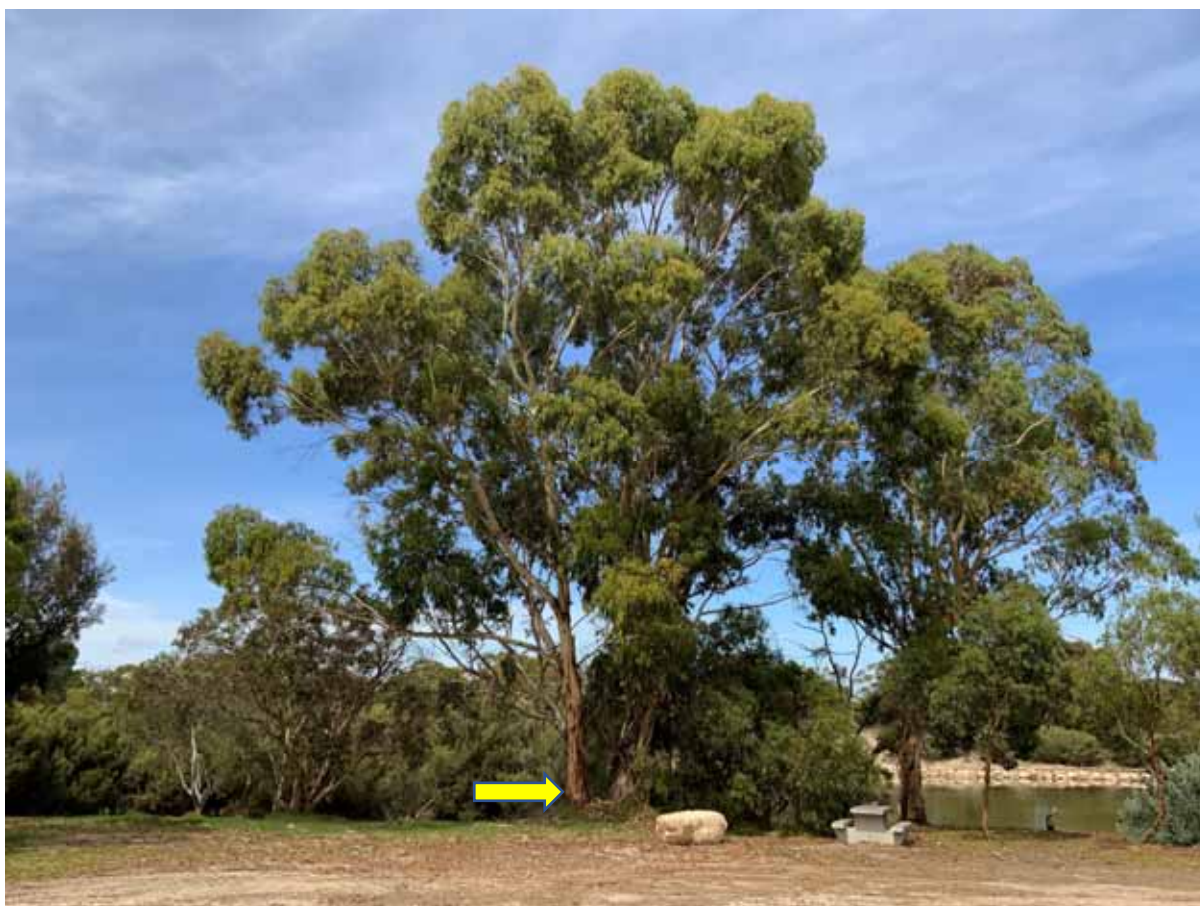
## 1. Eucalyptus leucoxylon

This SA Blue gum has 2 leaders arising from one roof flare below ground. The tree has lost one major limb in the past at least a few years ago due to included bark failure. The scar is ribbing through scar tissue build up and starting the scar over. The tree is still in good condition the amount of deadwood is minimal and there are no areas of decay throughout the main trunk where the breakpoint is. There are several Borer exits holes which is not which is common in large trees and does not cause too much damage to the tree. There is minimal deadwood and due to the area and the use of the area I am not recommending any work on this tree.

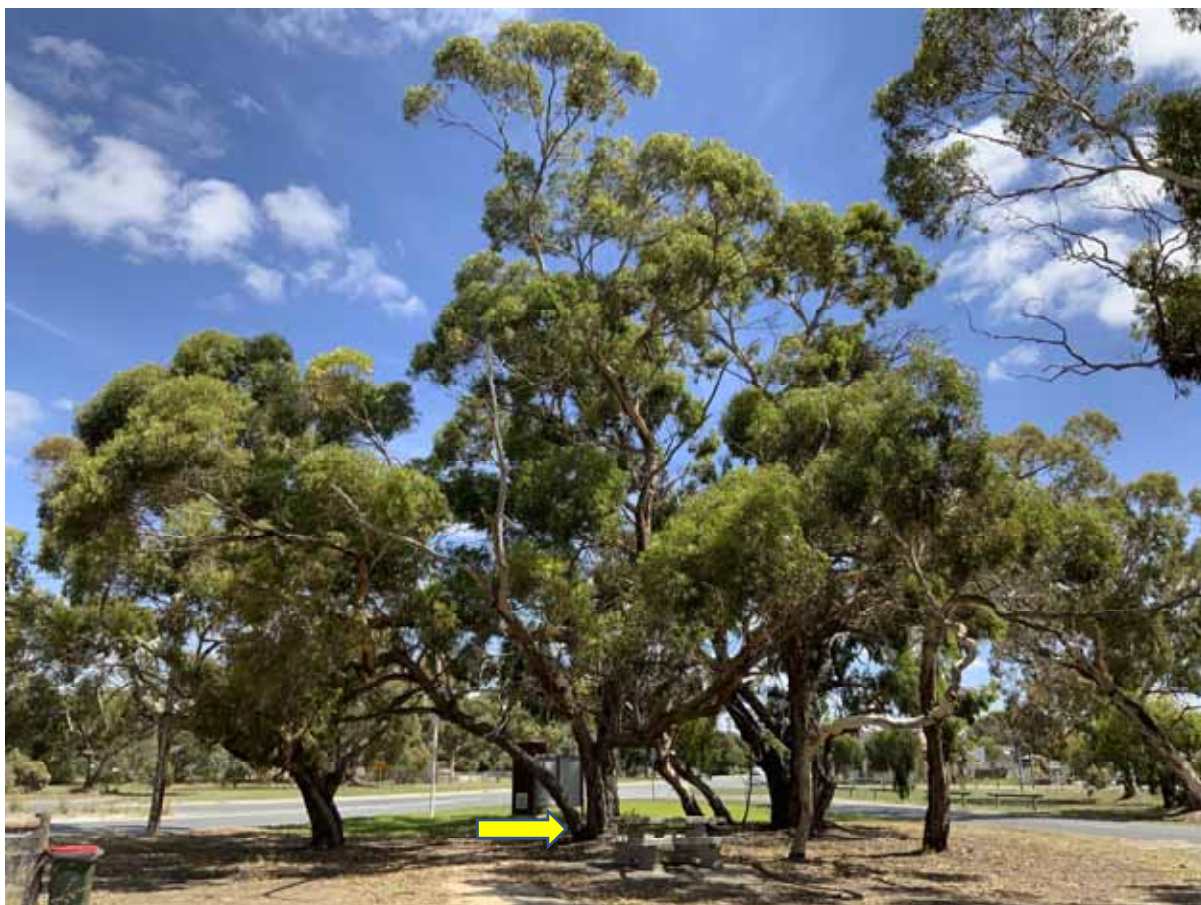
## 1. *Eucalyptus leucoxylon*

This large specimen does have areas of deadwood throughout and being located over the park bench and table I would recommend removing the large deadwood from the tree, I am also recommending removal of the large branch that is dead and bringing that back to the attachment point, the other branch at that attachment point will need to be pruned of deadwood.

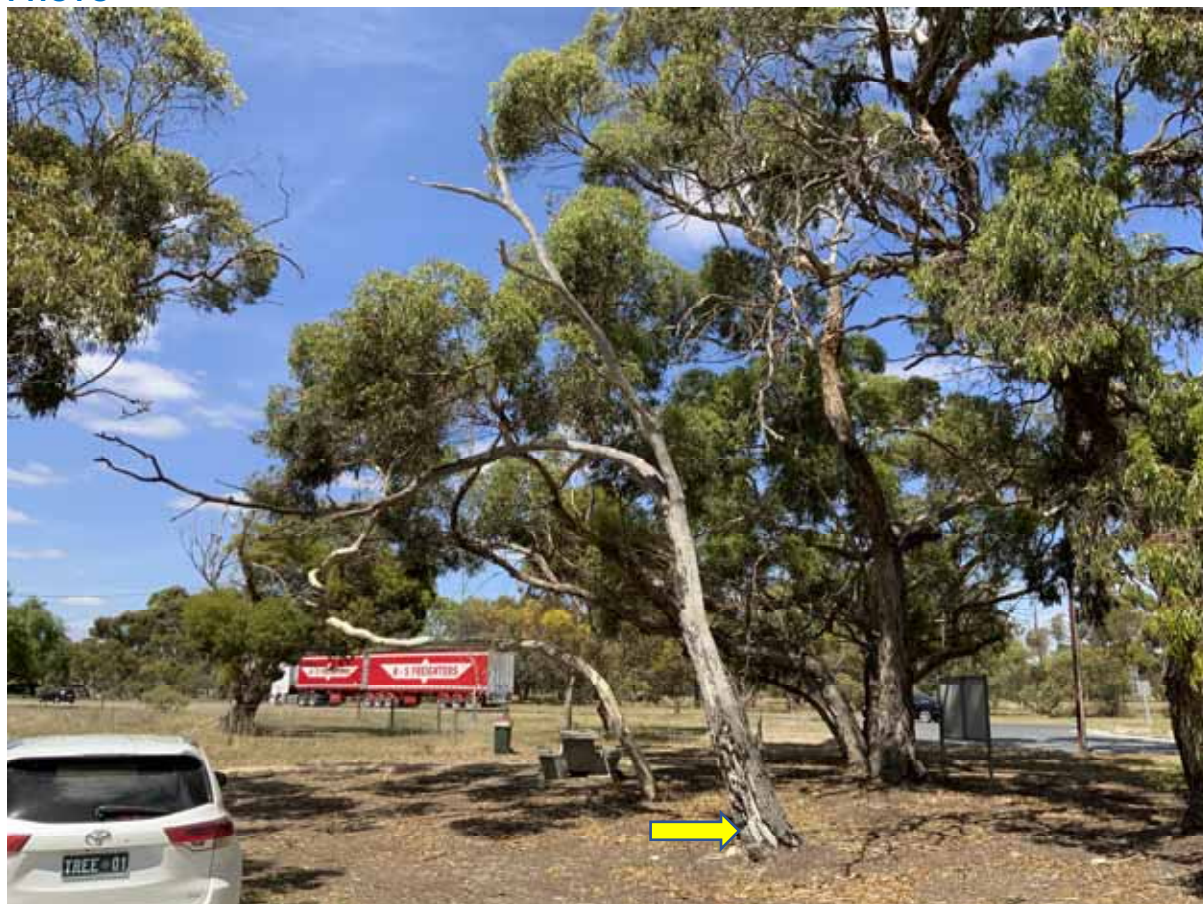
This dead tree currently is stable but will fail as the area below ground decays out, the lean on the tree will facilitate its failure. The decay of the previous scar at the base will accelerate the failure of the tree. There is no habitat value in this tree as there are no habitat hollows or cracks large enough the house micro bats or birds.

Removal is recommended.

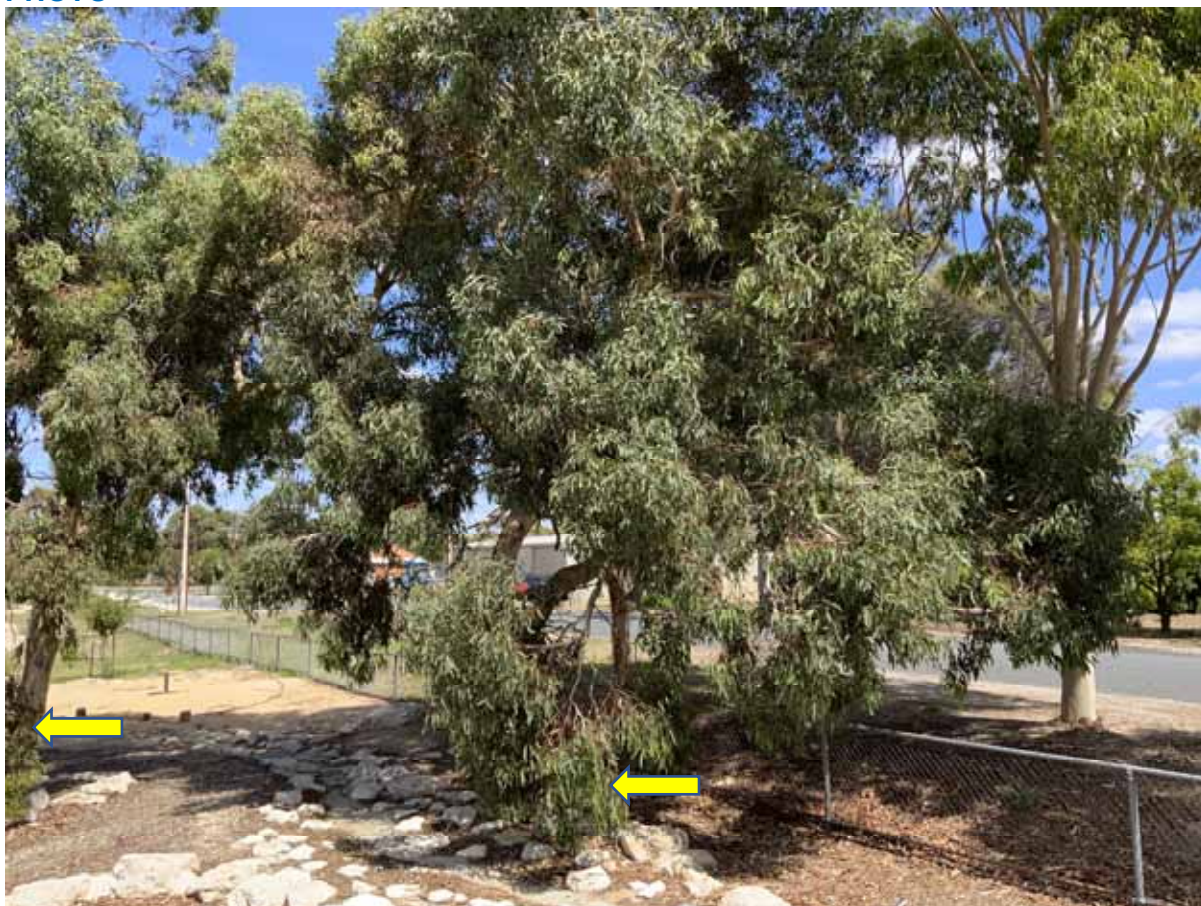
## 1. Eucalyptus leucoxylon

This SA Blue gum near the fence on the playground has grown intertwined with a smaller SA Blue gum the other side of the fence however the small SA Blue gum may be a branched offshoot of the original SA Blue gum as they are not repelling each other and they are growing quite well inbetween one another. Lifting the canopy to allow access to water play area is required, this will allow visual access for children playing in this area. No other work is needed throughout the tree.

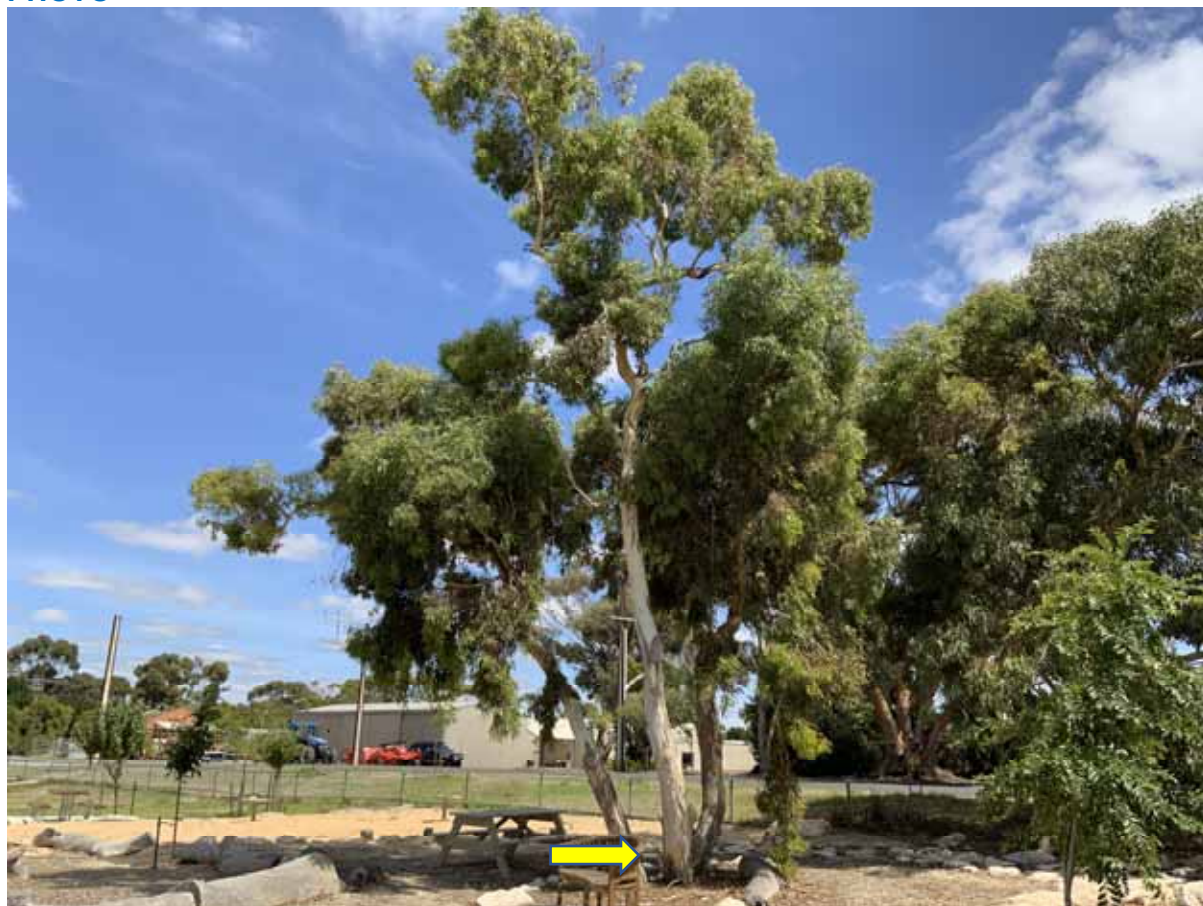
This multitrunked SA Blue gum is one tree; they are all growing from the one root system which could have been the result of epicormic growth. The stems are sound in the attachment and are the remaining of the growth points from the original tree which have now developed their own structural capacity below ground level with in the trunk flare. The tree does not require any works at this time.

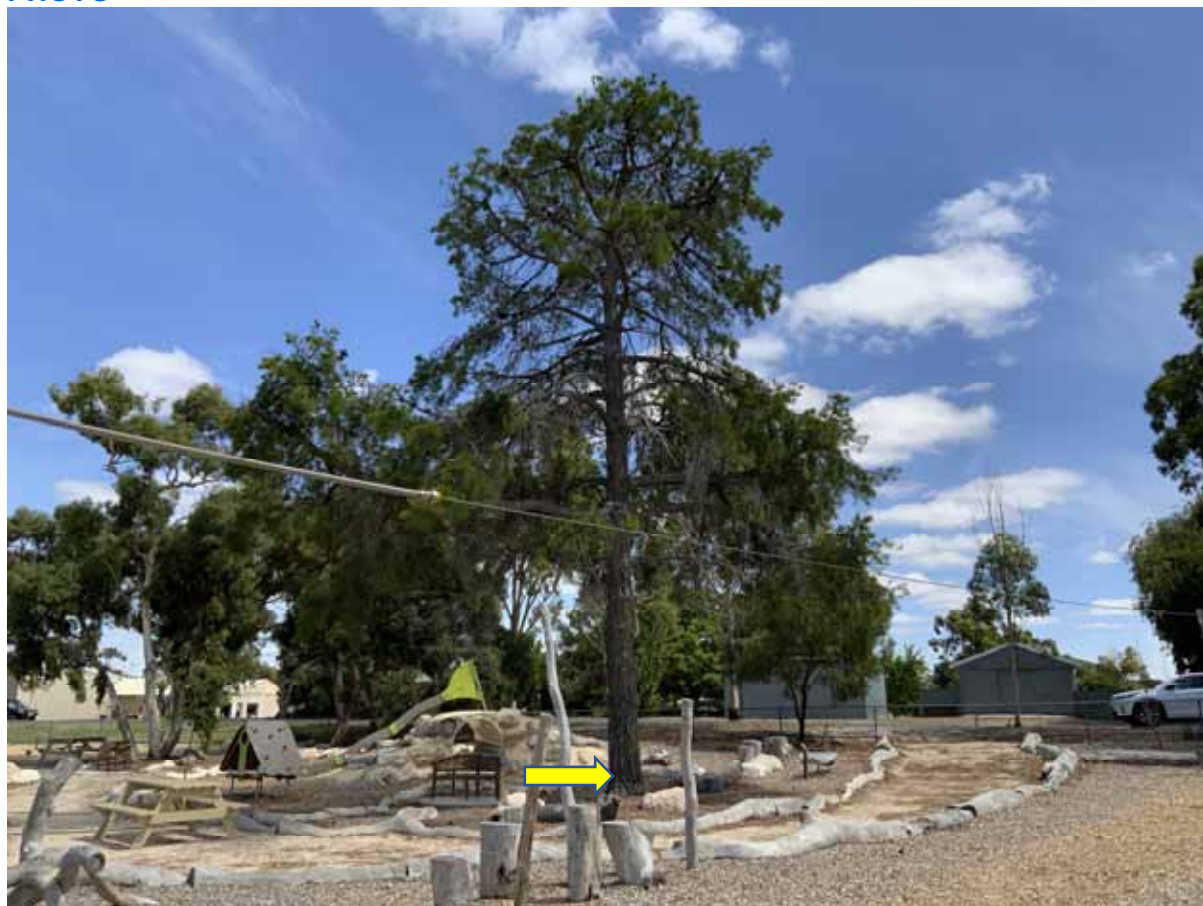
This Radiata pine is in decline and the further it declines the quicker it dies off; the areas of dead foliage will not regenerate as they do not have growth buds as back up. The current green growth has to sustain the growth of the tree which it does not have the capacity to do so at this stage and will only decline further until the tree dies completely. I am recommending that this tree be removed and recommend that three or four deciduous trees be planted to shade the area.

Removal is recommended.

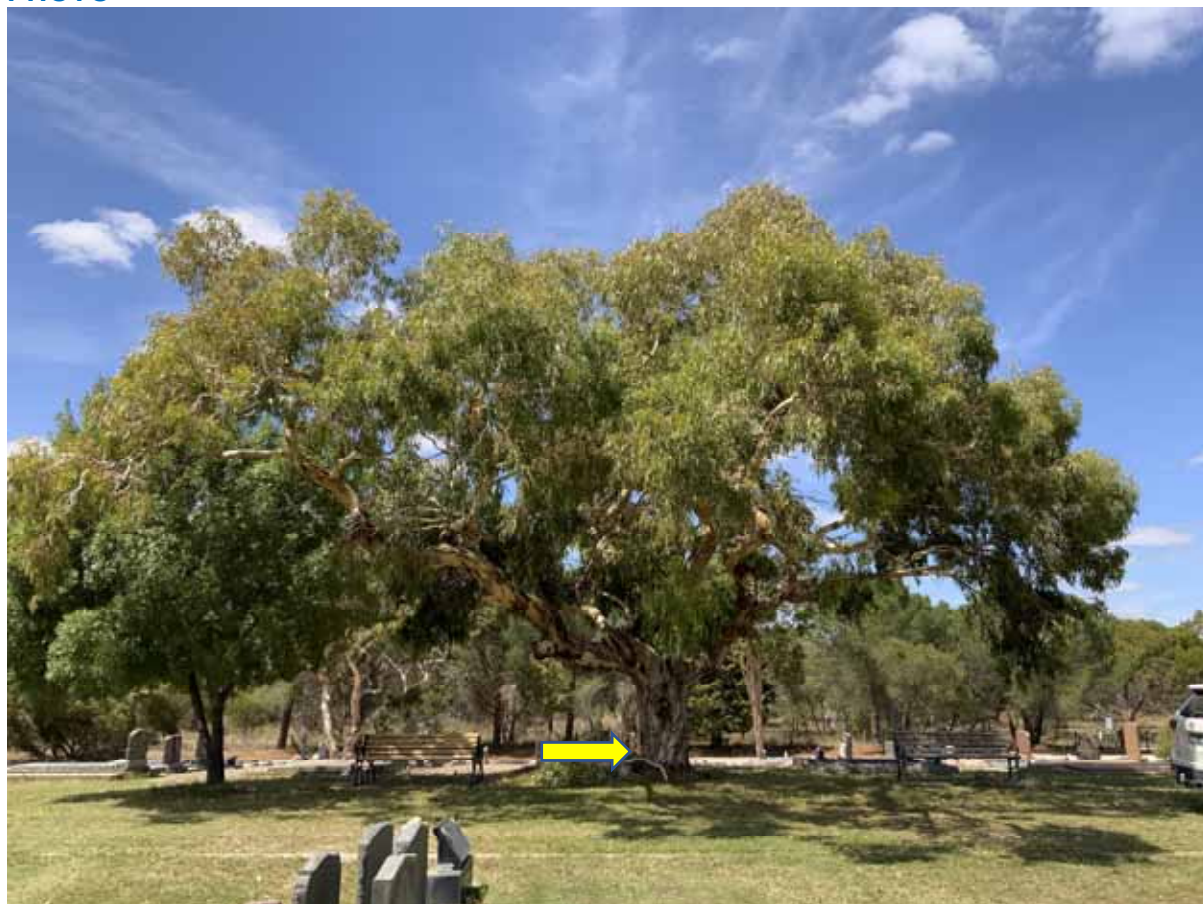
## 1. Eucalyptus leucoxylon

This SA Blue gum is healthy but does have a Canker fungus throughout the whole of the tree. Being exposed on a ridge like this the contorted limbs do break from time to time, The reduction of weighted limbs on both sides as the limbs that are breaking is coming from the hyper extended limbs that have grown on both sides. On one side over the seat is a large limb, which has been pruned before, I would recommend removing this limb back to the attachment point which will also remove the limb overhanging the seat. On the other side where the other two seats are located, I would recommend removing the limb back to the furthest upright approximately in the middle of the seats straight up above there is a top sprout which will continue to grow and form a canopy that shades the seats, It will also remove the branch system in the Ash tree which will allow the Ash tree to grow unhindered and eventually replace this eucalypt in the future. On the back area overhanging the graves I would not remove anything from there as it is a low use area whereas the bench seats park seats are a higher use.

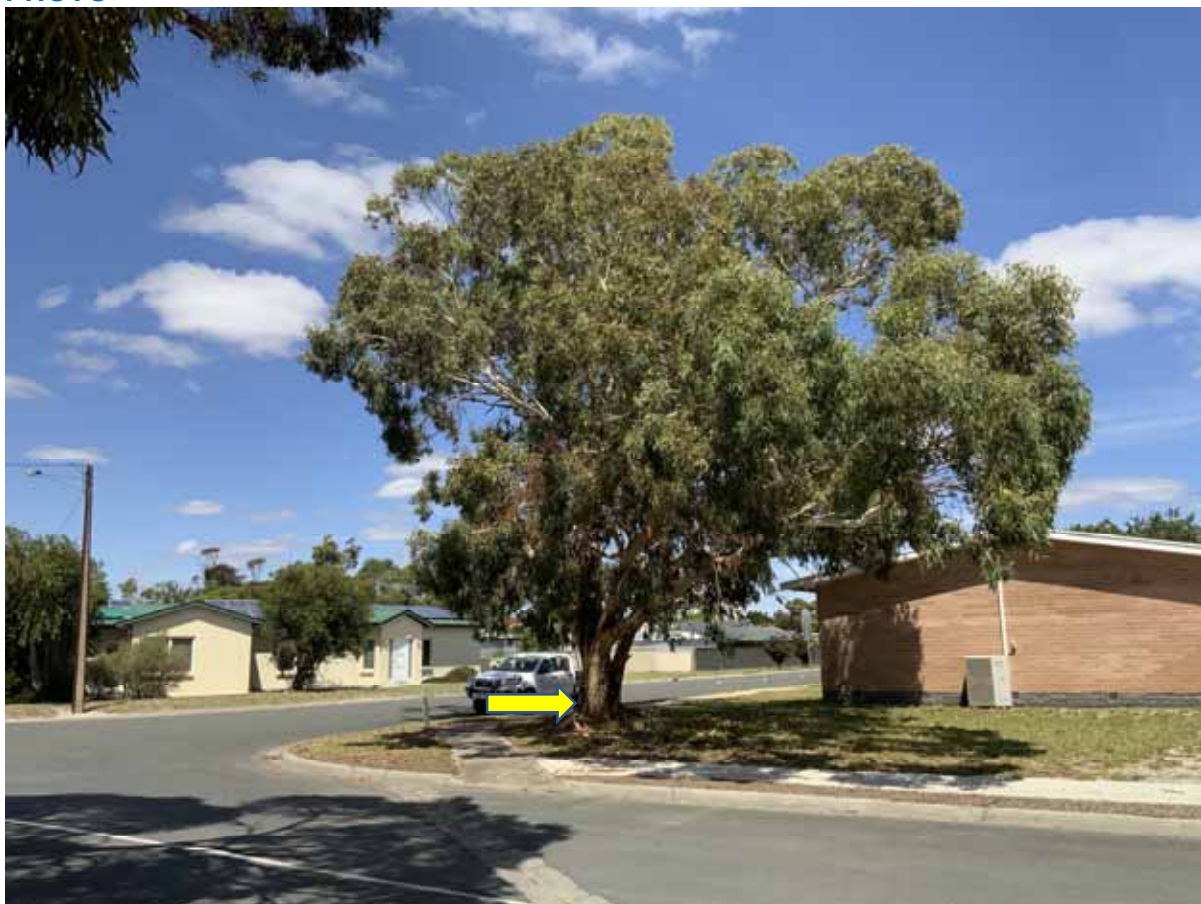
## 1. Eucalyptus leucoxylon

This SA Blue gum is a large specimen, there are several areas of branches that need to be removed from this tree one to reduce any damage on the building and to mitigate any chance of failure through hyperextended limbs that are potential failure points in the future. There are two limbs growing over towards the building, both limbs should be taken back to the attachment point, the second lower limb should be taken back to the nearest attachment point approximately 6 metres from ground level and this will remove a lot of the foliage and future growth points close to the building.

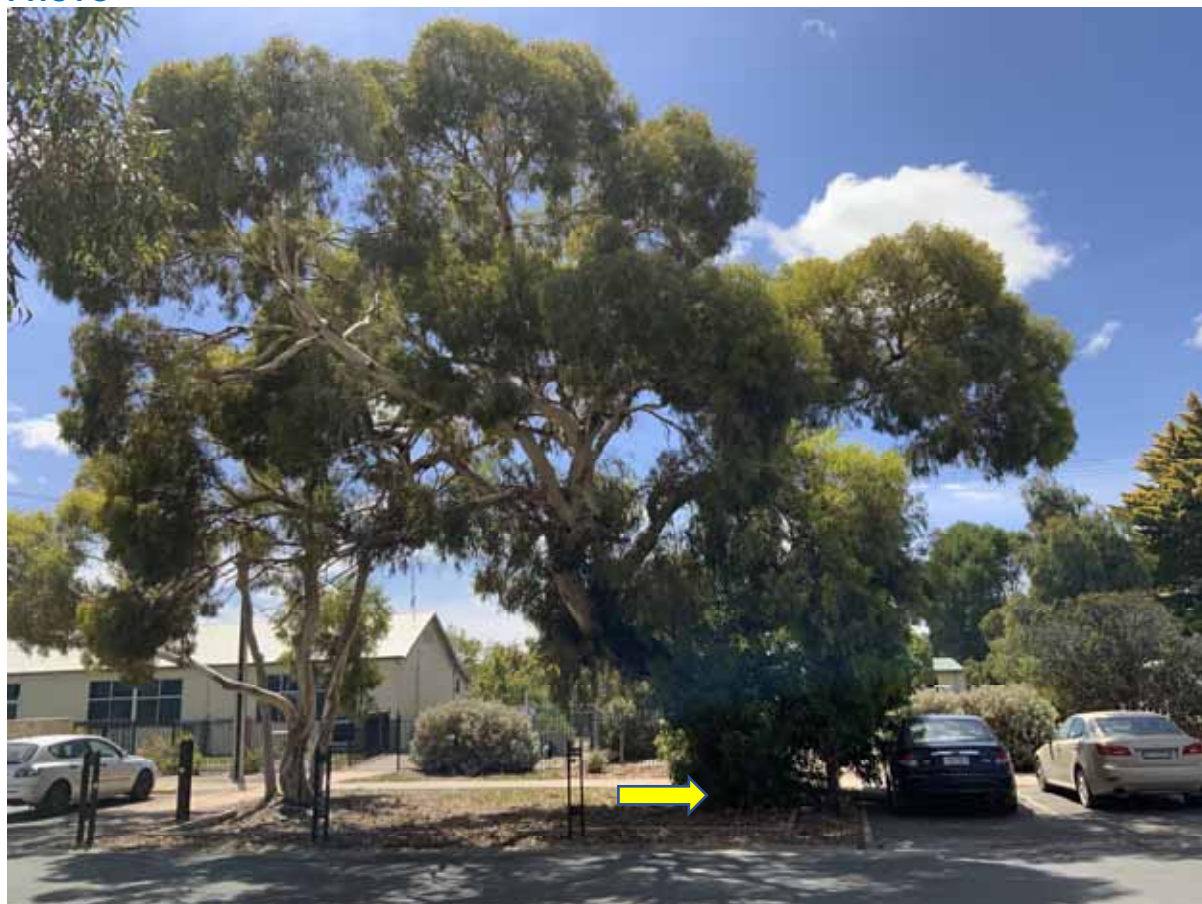
This SA Blue gum has grown to a good height, it has been pruned in the past with several areas of large limbs been removed. The base of the tree there is a and Acacia melanoxylon and also growth at the base of the trunk itself. As a car park is close, I would recommend removing the Acacia as this will become a problem in the future for carpark. I'm also recommending removing the growth on the lower 6 metres of trunk to allow for better upper terminal growth in the future. The tree has minor amounts of deadwood that don't require removal at this time, but I would recommend removing the stubs back to the branch collar that have been left from previous pruning's, this will remove the likelihood of future growth sprouting in these areas.

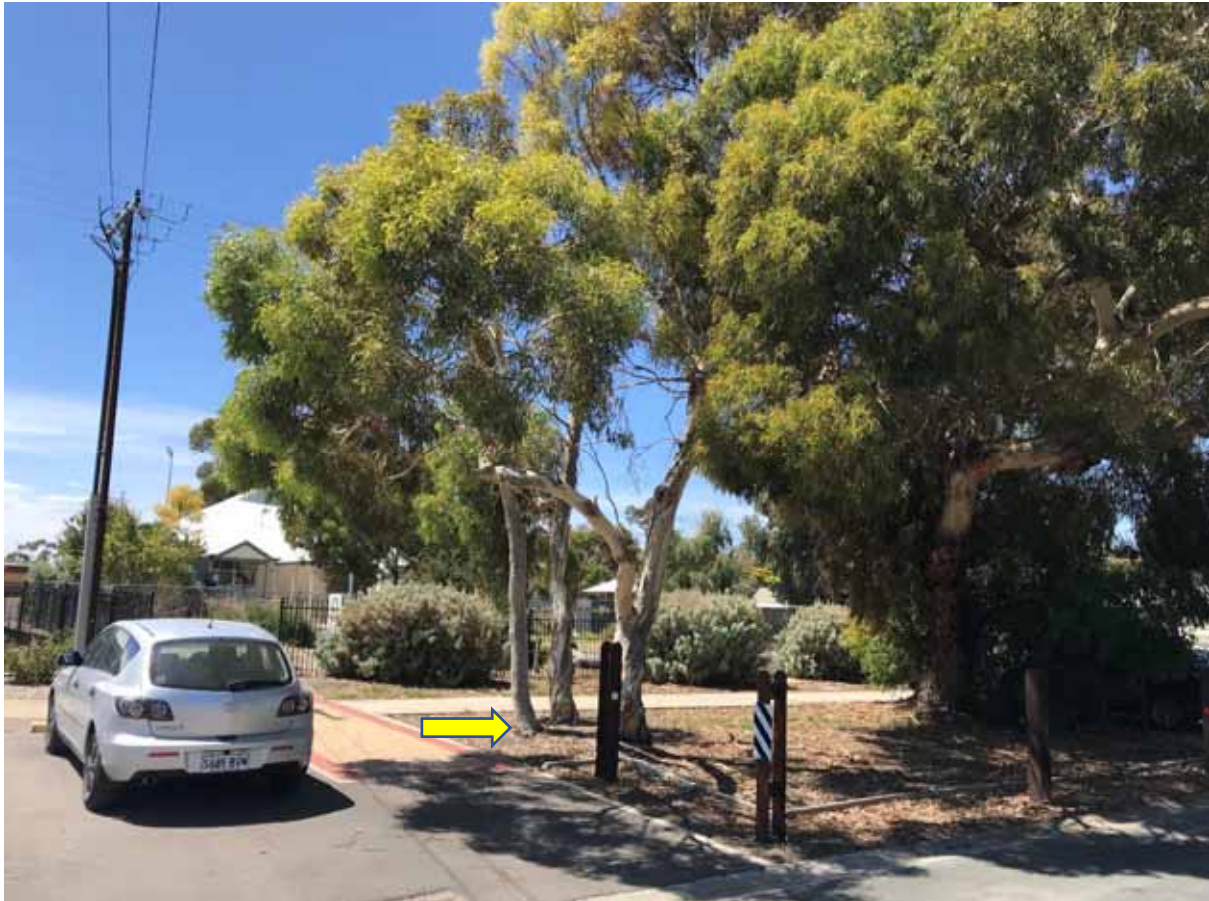
This tree was most likely a singular tree to begin with and now is three areas of mature epicormic growth. It probably would've had more however failure and removal have left the left the three remaining on their own. This tree will never become the tree it should be as the three uprights will never develop into a specimen tree that would be worthy of amenity status. The health and condition of the growth along with the lean out of heavy end weight is a risk close to the car park, it is highly likely that the tree will die back as it is of inferior growth and should be removed to mitigate any further problems in the future.

Removal is recommended.

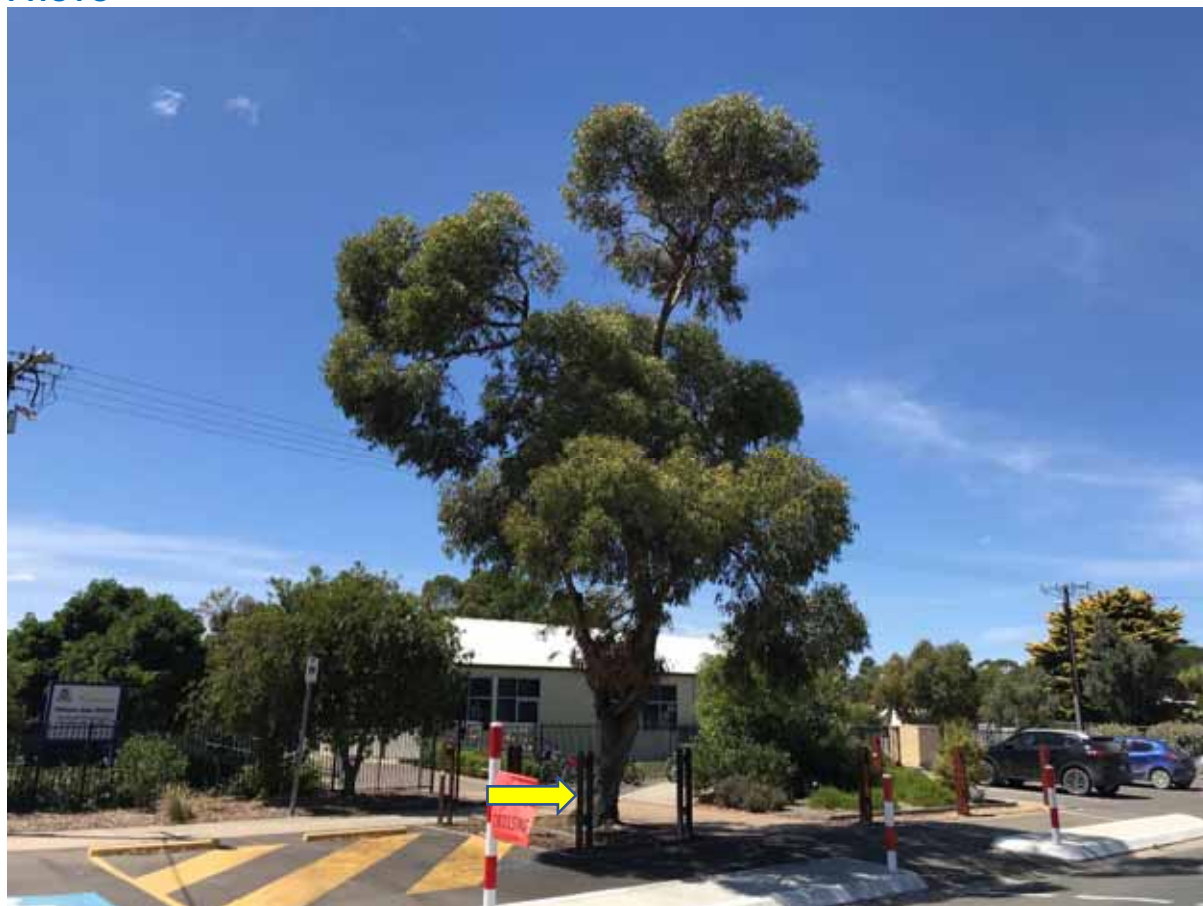
This upright specimen is an SA Blue gum is an upright specimen does have one limb hanging over the footpath, it also has one drooping limb over the area near the crossing which will need to be removed. On the opposite backside there is one stub that has been left which is now producing epicormic growth that needs to be removed due to it being weak growth. The rest of the tree is in quite good health with no areas of defects around the base of the tree, the tree does have the start of canker fungus in some of the bark of the main trunk system which should have little impact on the tree.

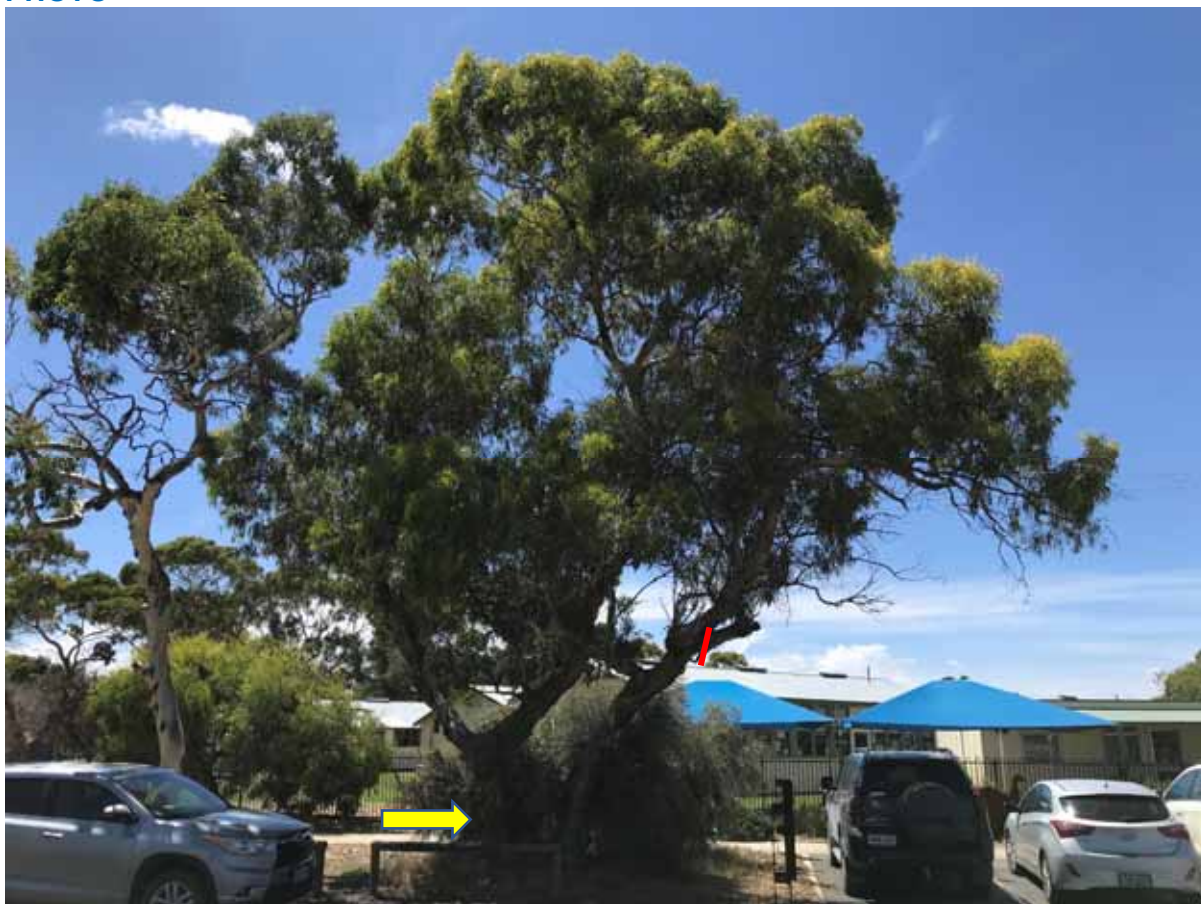
This SA Blue gum has grown to the environment with a spreading canopy along the footpath line, the canopy is full but does have some small areas of deadwood in the lower canopy at self. The attachment points at the base I sound with no areas of defects throughout the tree that can be seen. I am recommending that the deadwood be removed and the stub be removed back to the collar as it is near the car park.

Prune off deadwood and remove the broken stub back to the collar.
