# TINTINARA TOWN PARK & STREET TREES

Tree Inspection – March 2021

**Tintinara Town**

**Arborist**

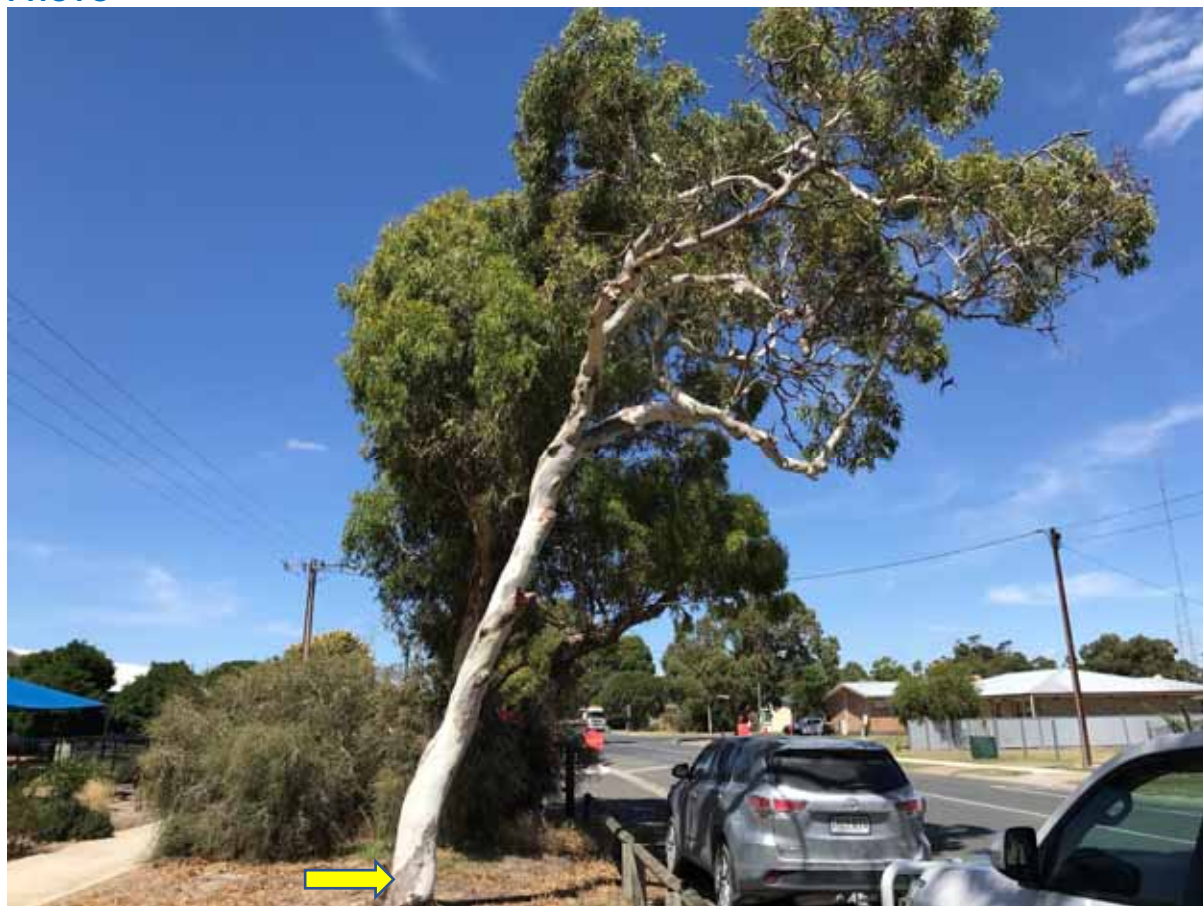
This Pink gum has lost several limbs in the past and at the base the area of exposed deadwood is starting to rot out. The trees on the lean and as the other tree next to it becomes more mature and larger, this tree will become even more end heavy over towards the road. The area of decay at the base of the tree and expose deadwood will make this tree unstable and failure will occur.

Removal is recommended.

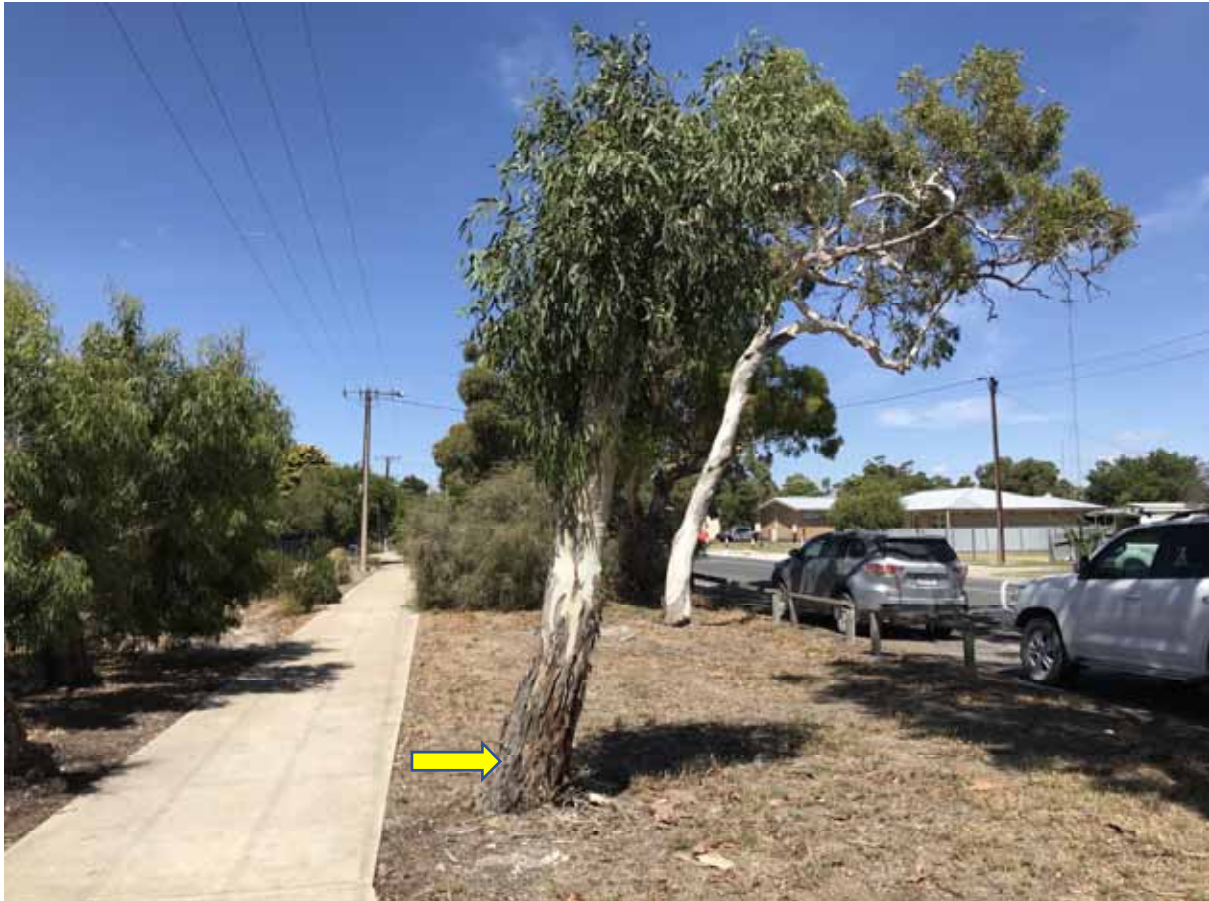
This Pink gum has been lopped or broken off and the new growth near the break point is epicormic growth which is of weak attachment and will become a problem as it matures. Being close to a school and car parking area, I am recommending that the tree be removed to mitigate future failures of the growth.

Removal is recommended.

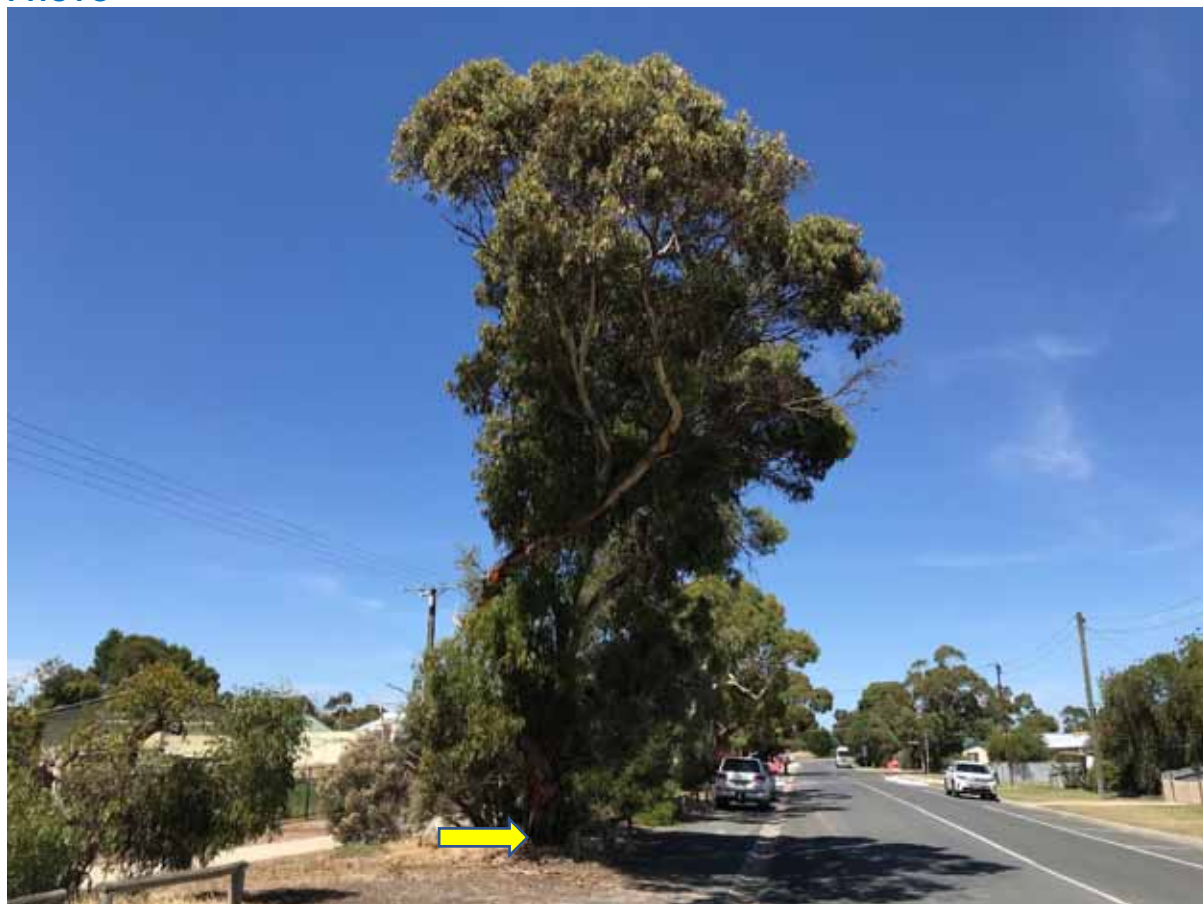
This SA Blue gum, has lost one large limb off to the side however the rest of the tree has grown quite well, the limb was most likely hyperextended that grew underneath the shade of the above canopy. I'm recommending that the large stub that has been left from the breakpoint be removed this will also remove the epicormic growth which is starting to grow. The tree does have a few areas of large deadwood visible that will need to be removed due to the area below being for parking.

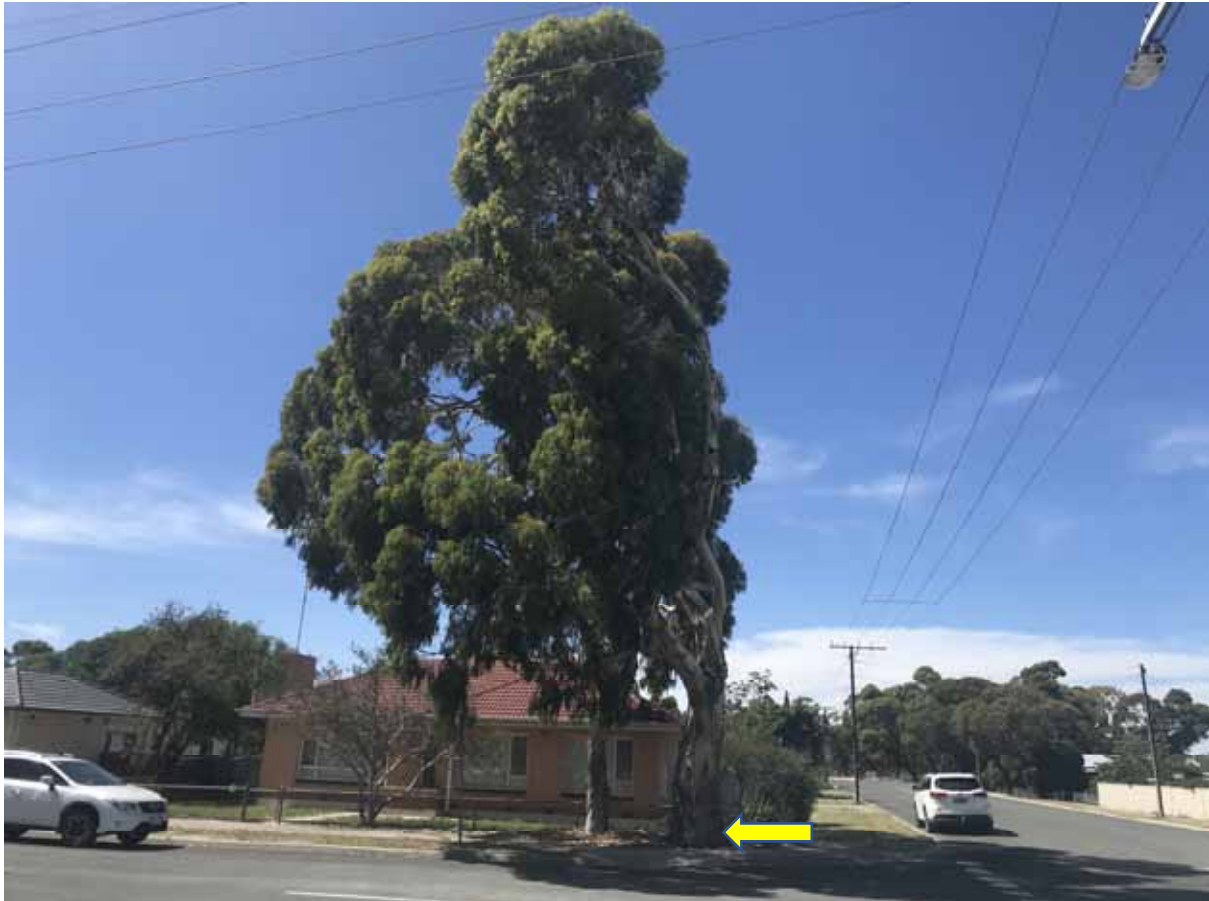
## 1. *Eucalyptus camaldulensis*

This large SA Blue gum has been pruned away from the utility lines which has removed approximately half the canopy. The tree next to it also looks to be from the same tree although I doubt very much that it is. The tree next to it is dead and does need to be removed, its causing damage to the upper trunk of the large tree with a defined area of disease Canker at that point of encroachment on the other tree. I would also recommend pruning foliage away from the house that is close by and lift the lower foliage to a height that is the same around to the give way sign, this will be only a minor weight reduction but will be a purpose lift for clearance.

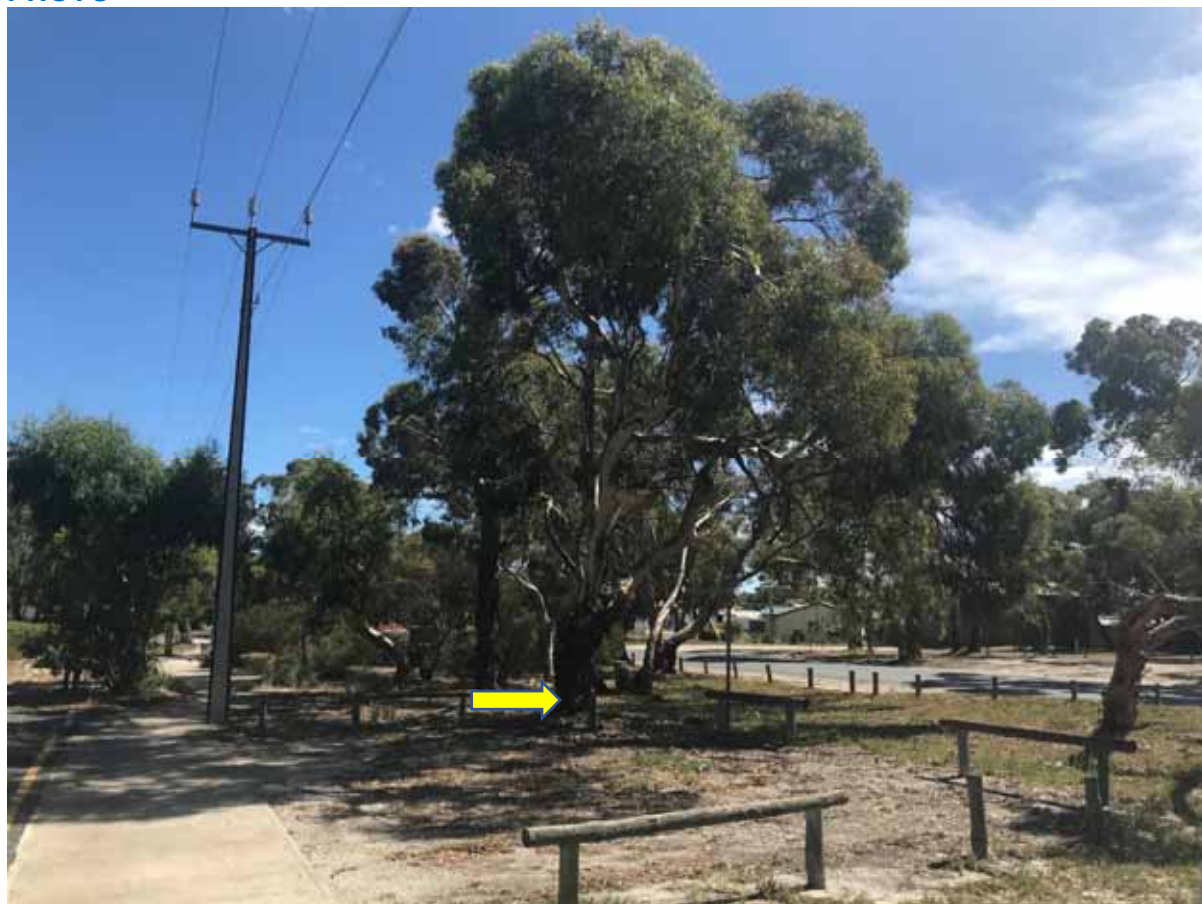
## 1. Eucalyptus leucoxylon

This large SA Blue gum has had areas of multiple failures in the past, the tree has also been pruned which leads me to think there was also many other failure points that were either mitigated or pruned after the fact. This tree will need to have some cleanup pruning undertaken, removal of the deadwood throughout the tree is required, some of this is quite large and is in the area of the staff car park. There are two limbs growing out into the garden bed area, these limbs need to be pruned back to the attachment point as both are rubbing together and have created a weak point where they have been rubbing. The weighted and dripping limb over the car park will also need to be removed which will leave the form of the tree in an upright tight form and hopefully reducing the risk of limb failure in the car park area.

Prune off limbs that are rubbing into the garden area, remove limbs extended in the car park to reduce limb failure over the car park.

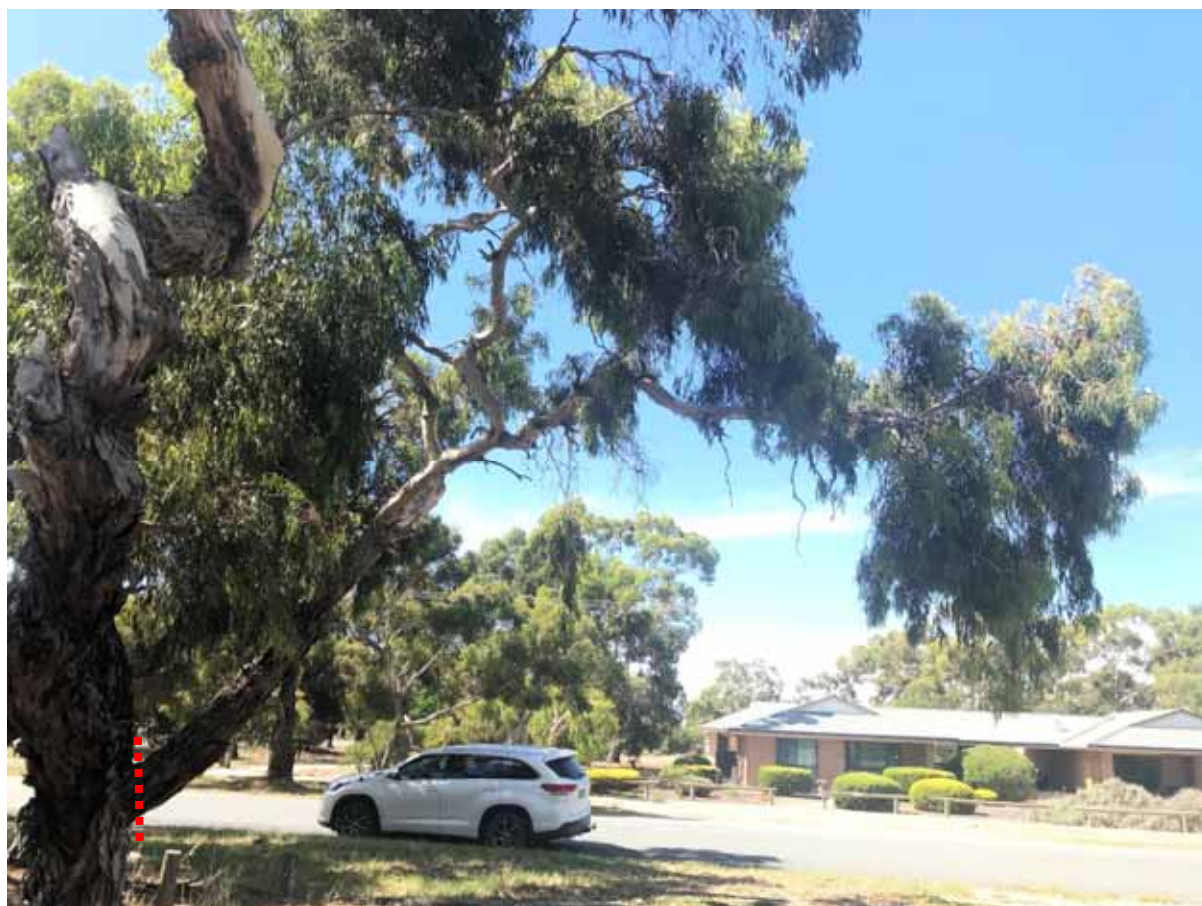
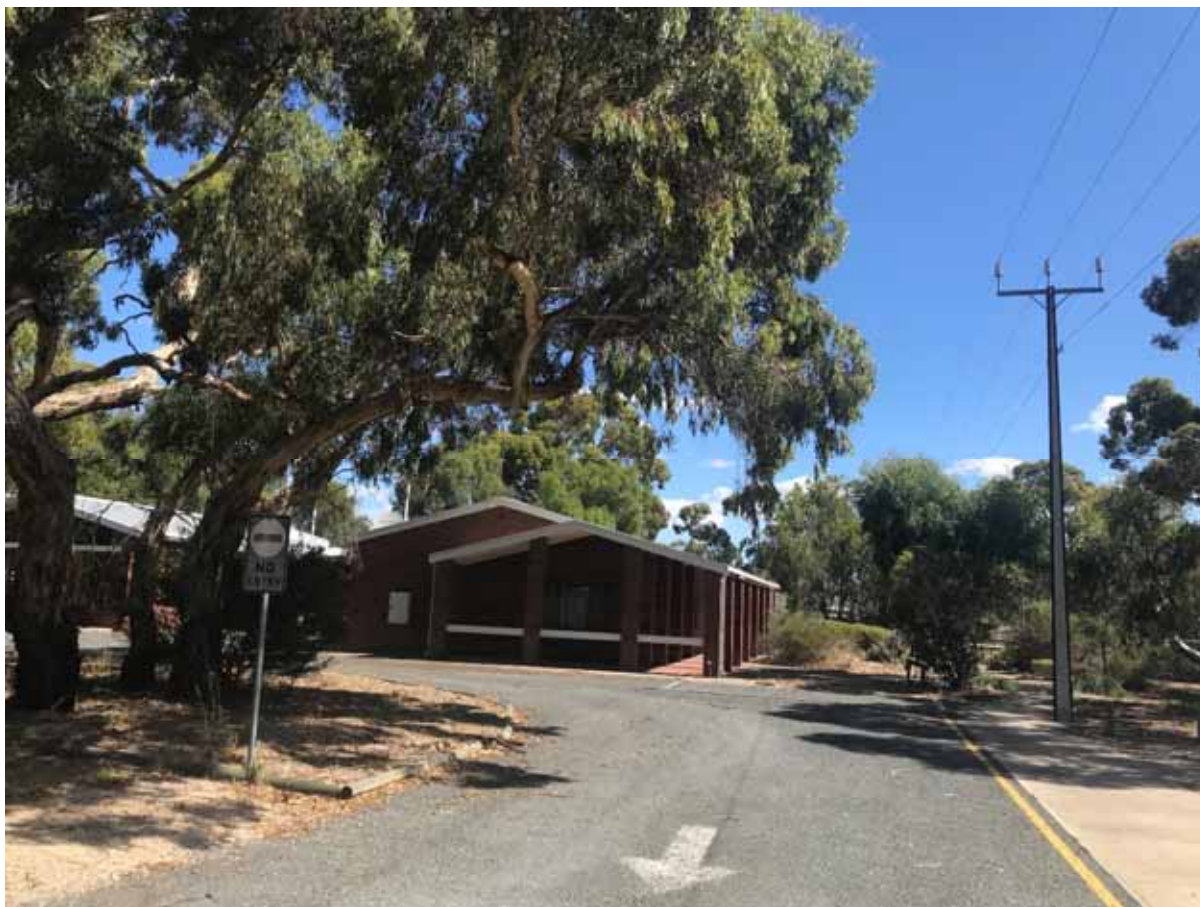
This area in the garden bed, I'm referring to as one because all these trees all rely on each other. Because they rely on each other, when trees are removed, they will impact the remaining trees protection systems and then that can lead to limb failures. The trees have grown with the protection of the other trees and the trees' reaction wood is only tuned to the areas that are not protected, when removing a tree from on area, the trees that have relied on that tree's protection does not have the wood strength to cope with the pressures that are now placed on it, this is why we try and keep the dynamic inclusive structure of the tree groupings as much as we can.

an inconvenience for not having shade but it will mitigate any risk that the limb breaking and falling onto two cars.

Most of the other trees are quite well structured, with the only requirements being the drooping limbs that are hanging low on the car park exit, this will need to be at least 3 metres of clearance to allow for any Firefighting devices into this area in case there is a fire. No other work is required for this group of trees.

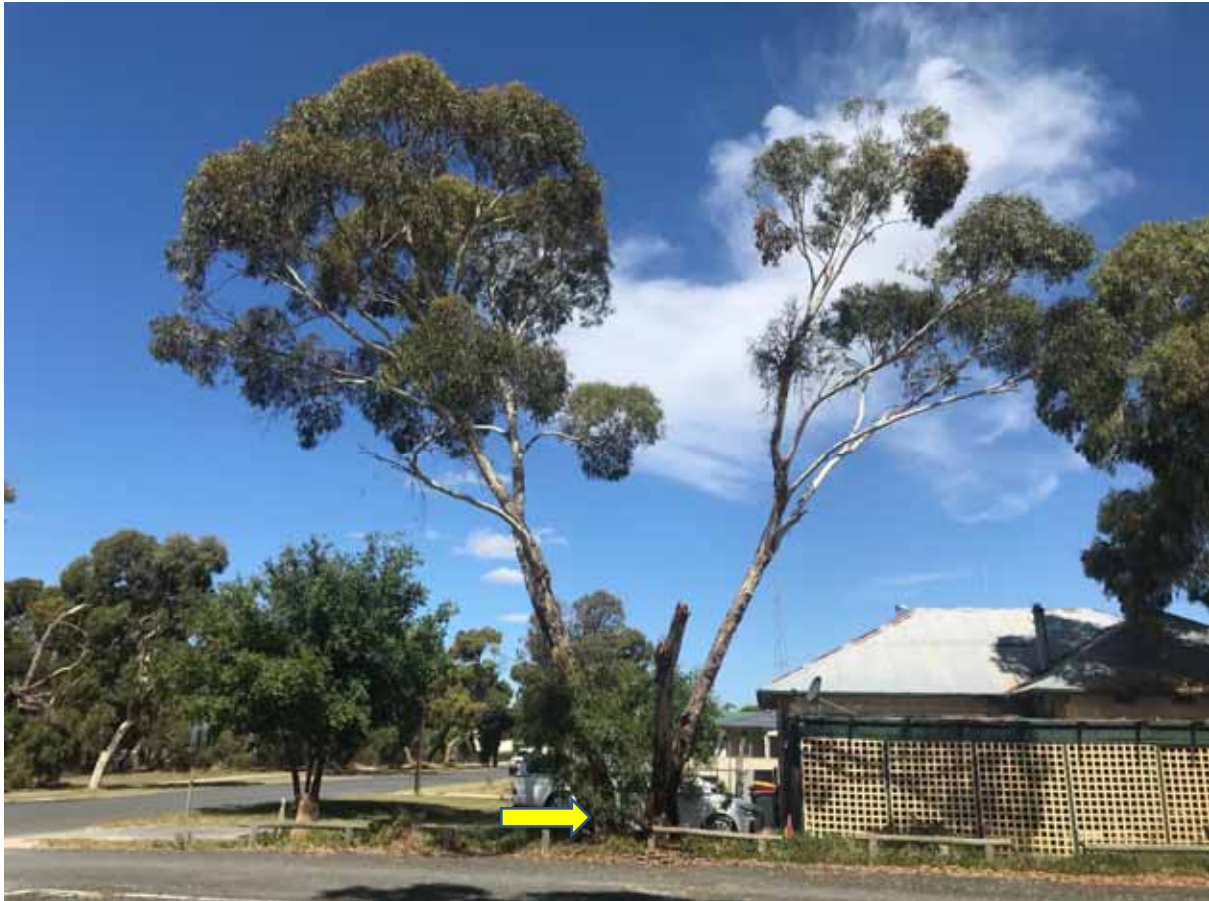
This tree was not marked however this tree does have a problem as it is hyper extended with both trunks being end heavy areas of canopy one area of terminal canopy has broken away on the second leader. This will also diminishing a lot of the protection that the other leader had. Having two leaders from the same root base usually indicate that the tree was removed before and this resulting generated regrowth is from epicormic buds in reaction to the original tree being removed, the upright extended multiple limbs are also a trait of mature regrowth. I would recommend removal of this tree altogether as the breakage is an indication of what will most likely happen to the other two leaders.

Removal is recommended.

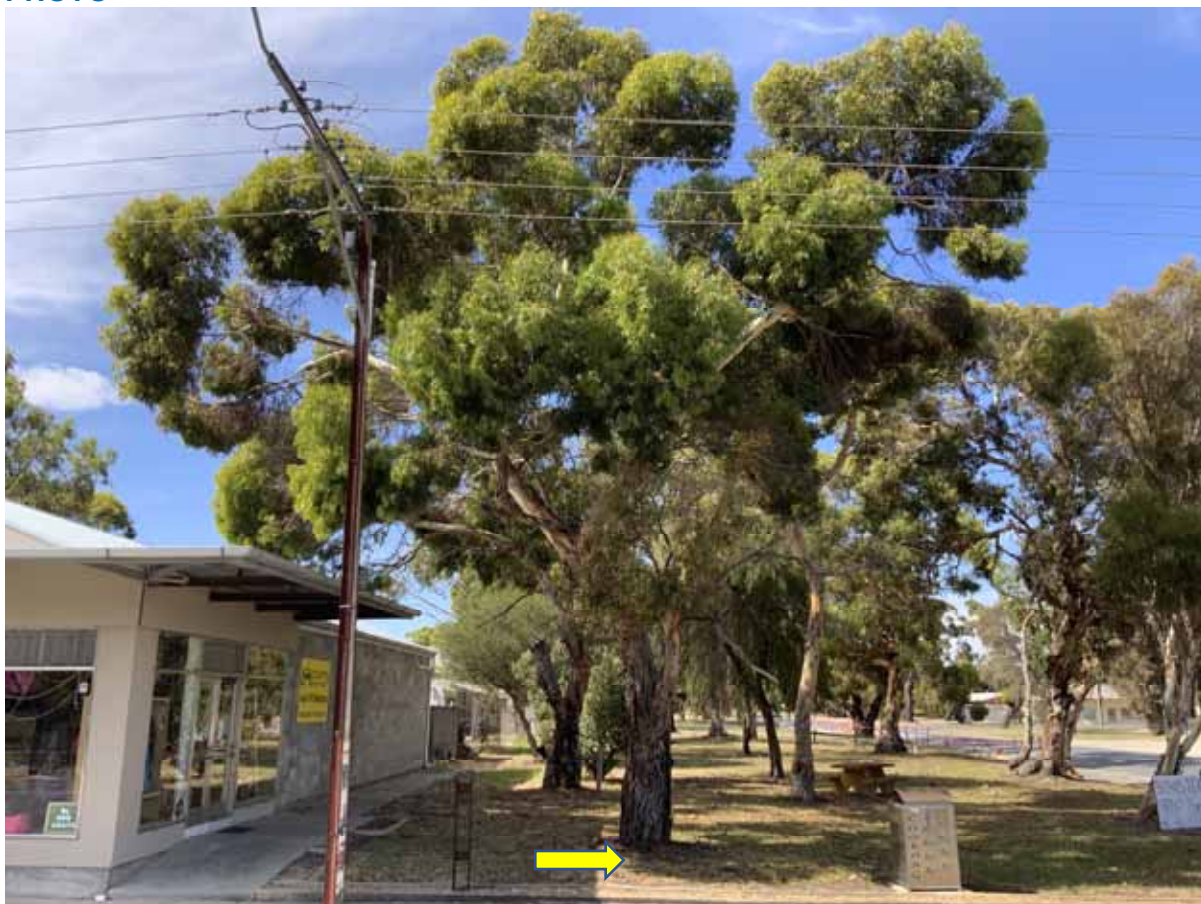
## 1. Eucalyptus leucoxylon

This SA Blue gum is in good condition and is currently in a good growth cycle, the canopy does have deadwood throughout the canopy. Being close to a shop and walkway the deadwood will need to be removed which is mainly in the lower canopy, also clearance of foliage from the building to 1.5 metres.
