COONALPYN TOWN PARK & STREET TREES

Tree Inspection – November 2020

Coonalpyn Town

TREE AUDIT

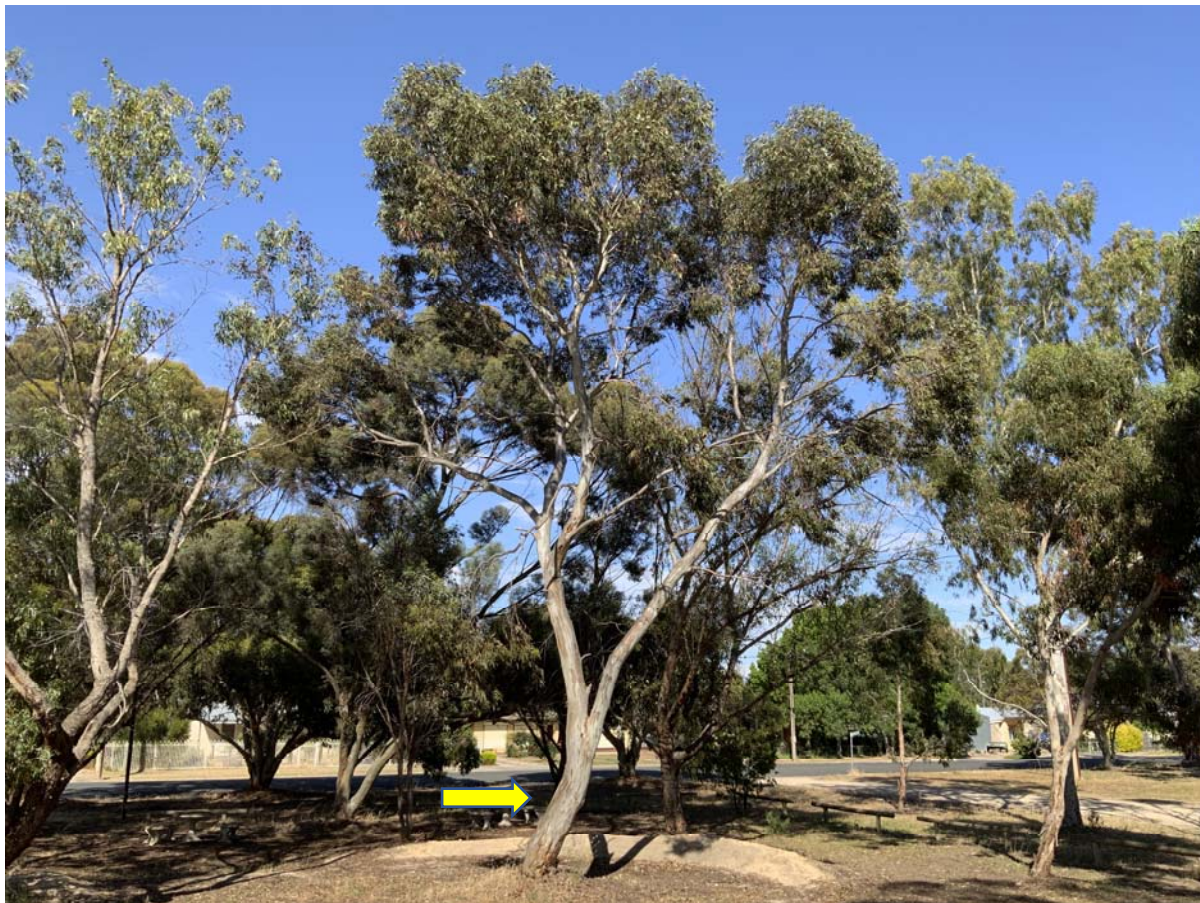
1. Eucalyptus leucoxylon

This young mature specimen bifurcates approximately three metres from ground level, there are minor amounts of deadwood throughout the canopy and the taper from the trunk to the terminal canopy is fast which indicates a stable growth pattern throughout the tree's life.

There are six areas of large deadwood that could be removed but with the amount of deadwood on the other trees this would seem to be impractical for this tree however I will be putting it down as a recommendation. The tree does have some discoloring in the upper secondary prosecution attachment point however the discoloration does not lead to any fires within the branch it's the Campion layer which has been injured but is not critical for a structural capacity.

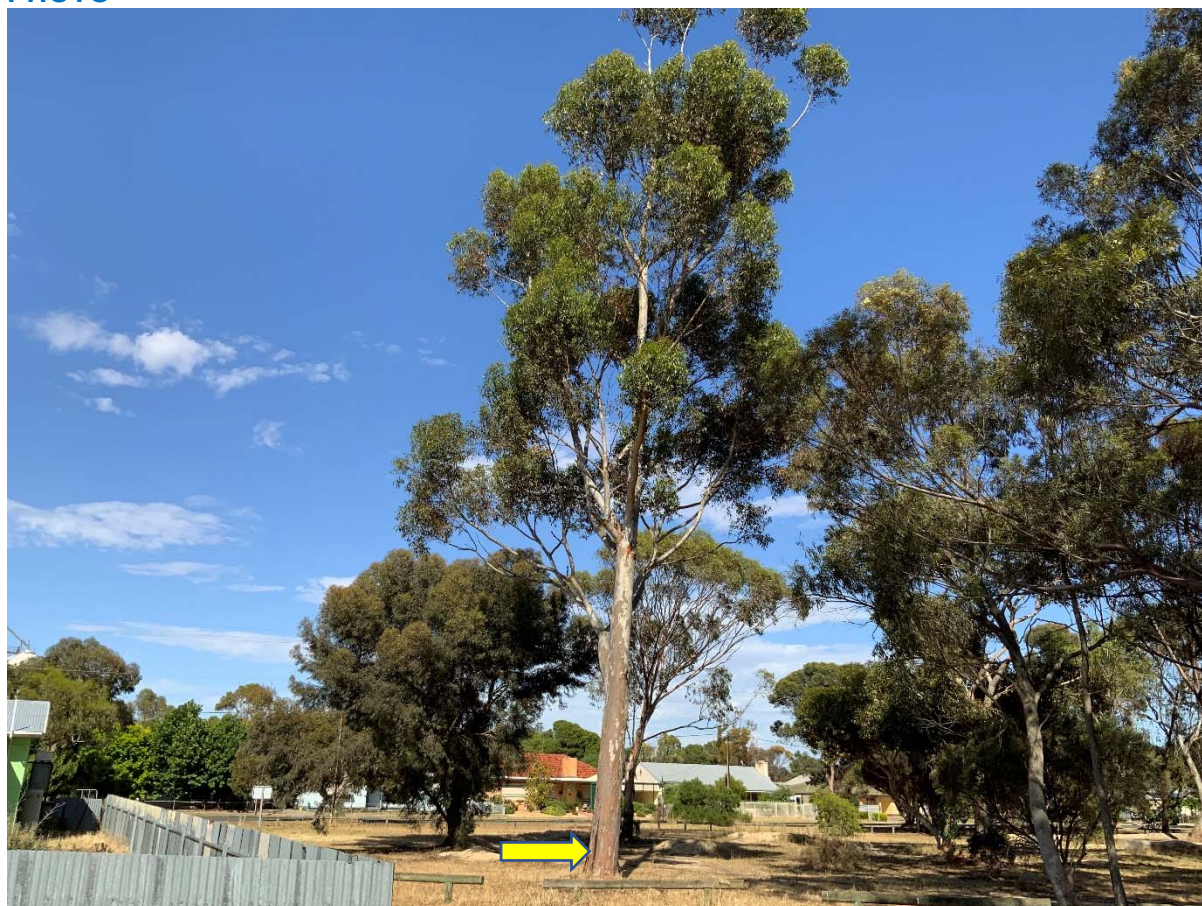
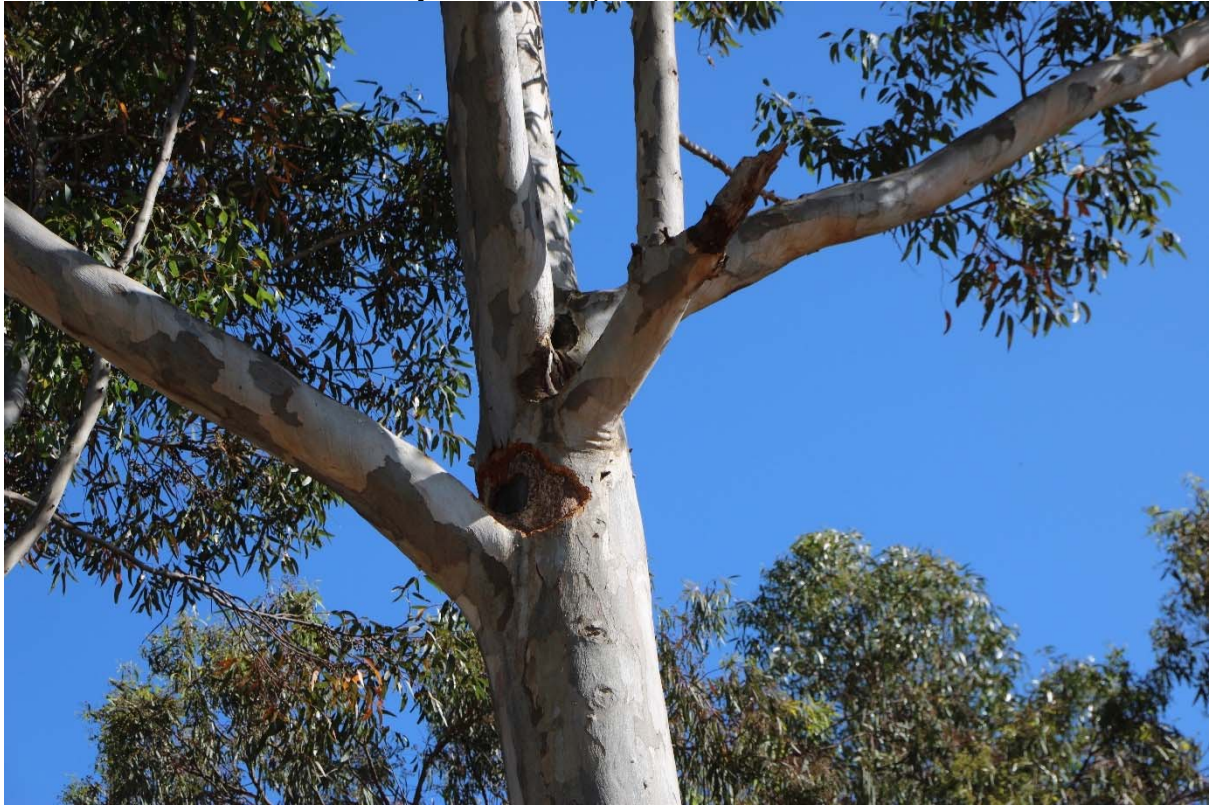
This Sugar gum is a single trunk upright form tree, the Corellas have damaged this tree and have eaten out areas around the attachment points. The secondary attachment point where the scaffold branch system of scaffold branch takes off has areas of multiple bird damage at least three times the birds have caused damage and have removed the cambium layer to the heart wood, the heart wood is now forming a hollow within this area of attachment.

This could cause the limb to fail as the decay becomes greater as it populates itself inside the hardwood. On the opposite side there are two failures in large branches both of these branches have failed most likely because of storms as it is the only area that is exposed to the extreme. The areas of attachment above that have also been damaged by the birds and have started to decay within the hardwood also. Being the weak point at the halfway mark of the tree and in a defined area of attachment points it is recommended that this tree be

removed as it will not recover from the decay that has now started to encroach within the hardwood. There is no other way of remedial prune that will remove this risk.

Removal is recommended.

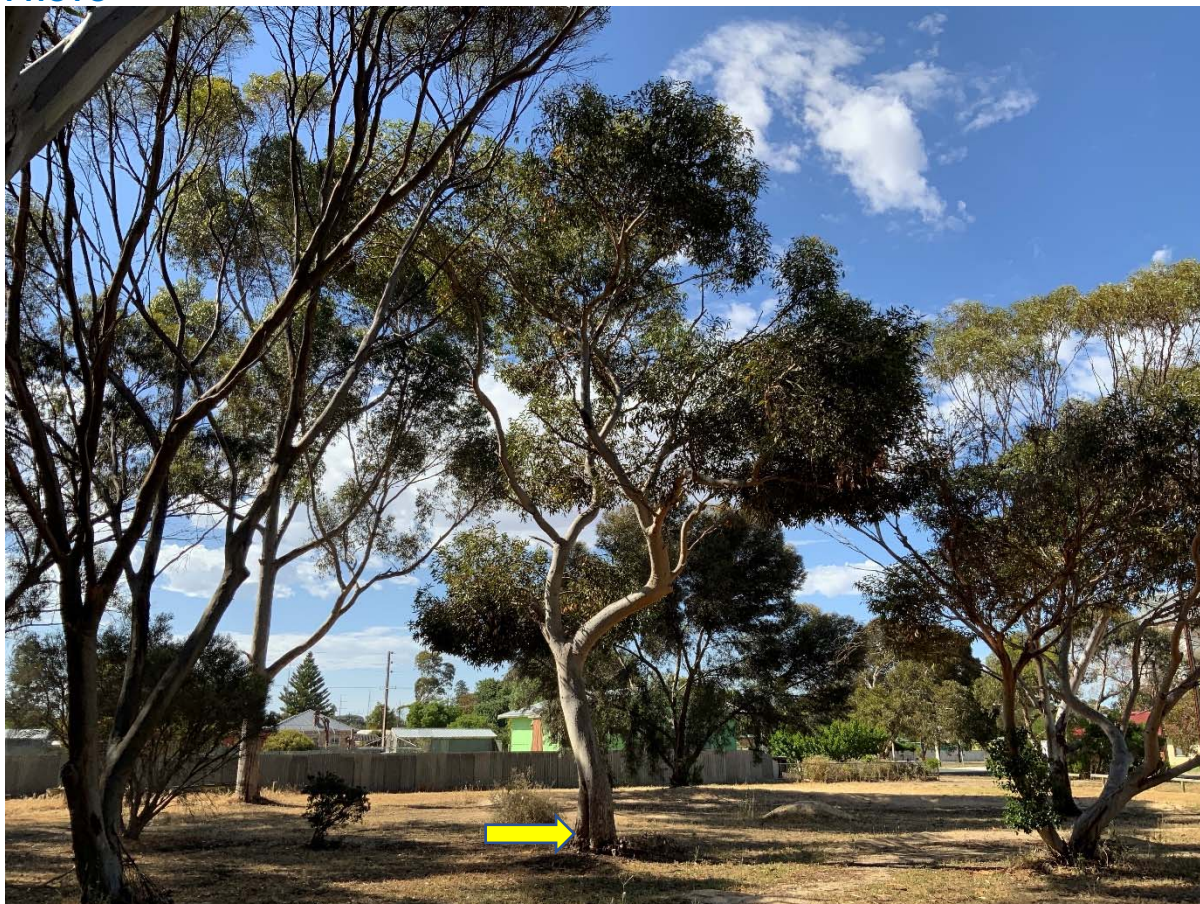
This Sugar gum has had injury at the base but has ribbed within the area of wound allowing the tree to stabilise its structural capacity. The upper branches show areas of dieback which is all under canopy which indicates that this is happened due to accelerator growth within the terminal canopy blocking out the available sunlight for the lower areas causing them to die back similar to what they do with in a drought when there is not enough moisture around.

The size of the dieback is small which indicates that it is from natural occurrence. There are no areas of large failures apart from one of the lower ones which is the area of the crown union. The tree is otherwise healthy and has many areas of new growth throughout all of the terminal canopy, and the scaffold branch system is a good make up and distribution throughout the canopy.

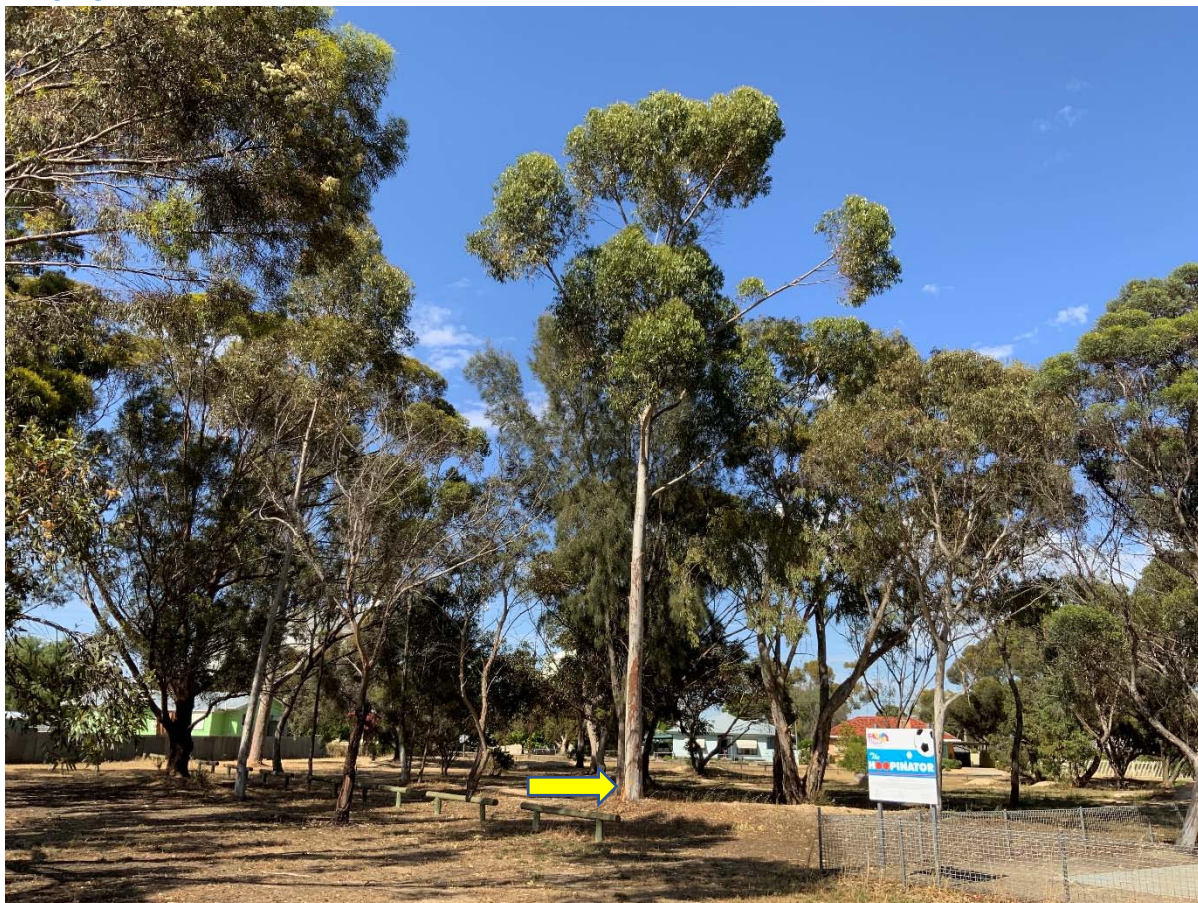
The Sugar gum is a tall upright specimen which is also known as a forest form tree, this tree has had a canopy development where it has grown up through the existing trees and once it has come across to the greater light source its canopy has developed out from the lower middle area canopy and grown out into the lions tail forms which has allowed for greater light use however this is also caused breakages in one of the limbs it is also caused the upper canopy to have a small cluster of terminal branches some of which have broken off.

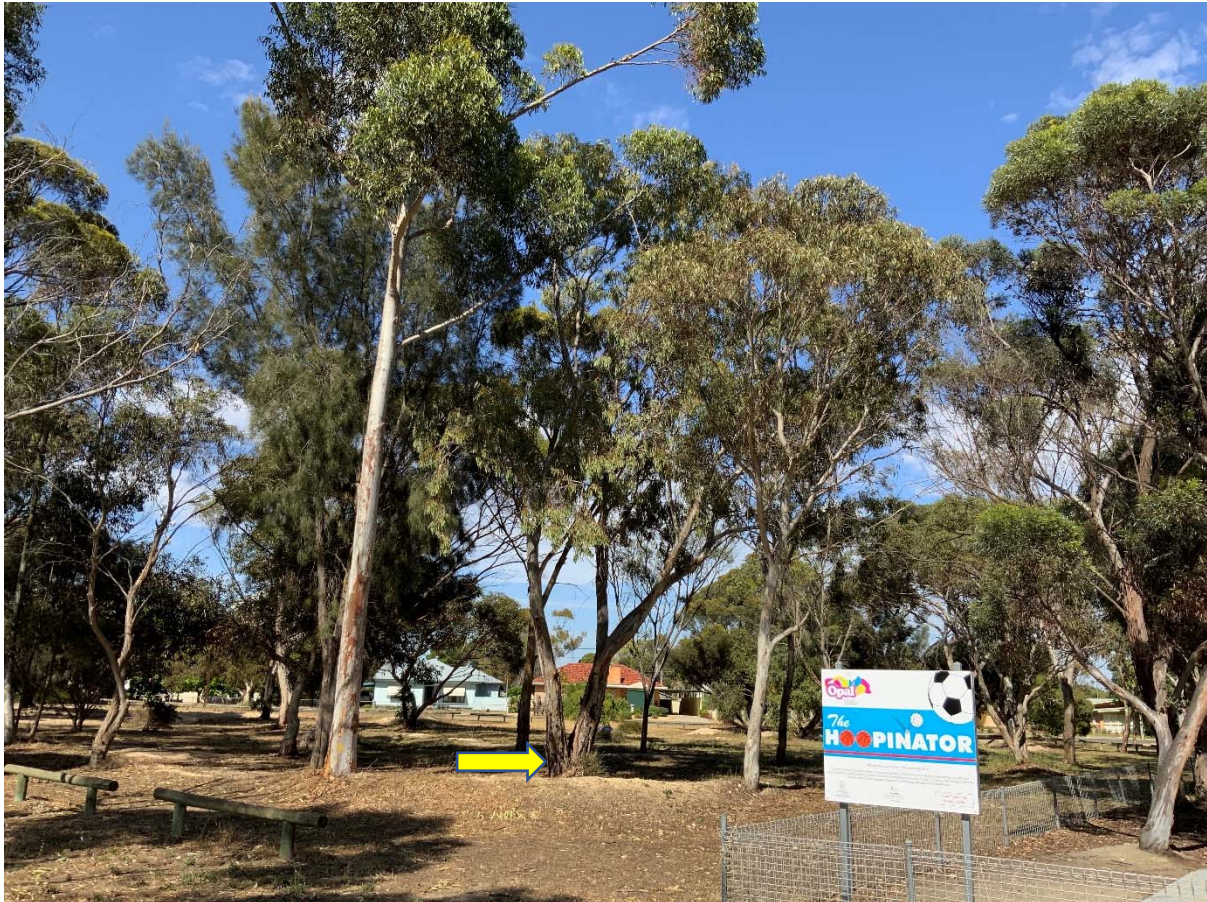
This River Red gum is a twin trunk tree which bifurcates at ground level and the union surpasses the ground level by approximately 40 cm. This tree has Canker and is currently active within the lower trunk and within the splits, this can be seen all around the tree itself. The Canker dissipates when he gets into the upper scaffold branch system from there on it is quite clean throughout. The other scaffold branches do have deadwood within them which is quite normal most of the deadwood is a result of upper canopy production reducing the production value of the lower canopy to a point where the tree rejects the non-productive foliage and concentrates its flow within the upper canopy foliage that is producing a lot more of the energy for the tree. I would recommend removing the large deadwood from the tree

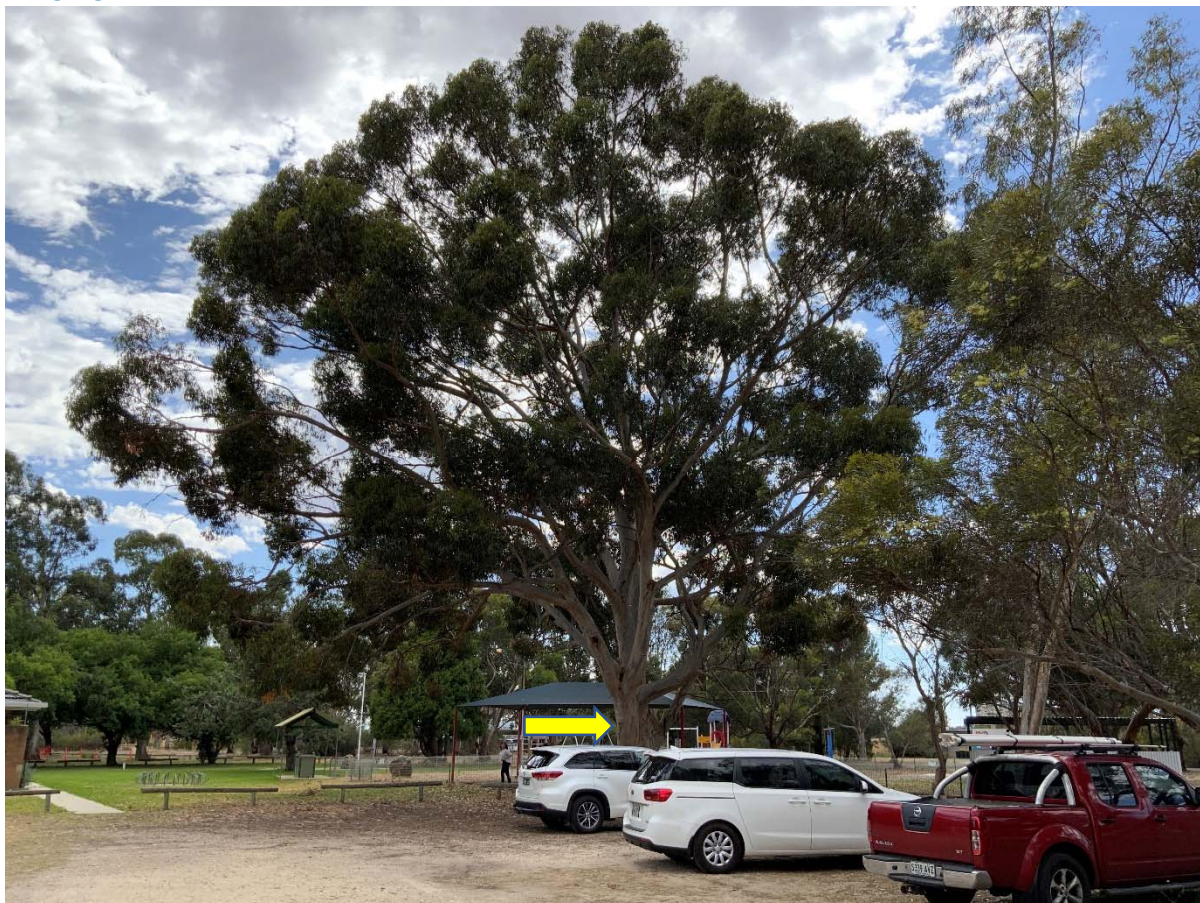
This large mature Sugar gum has very good scaffold branch system throughout the whole of the canopy. The tree does not have the amount of bird damage which would be expected from this tree especially being a larger tree available for scouting by the Corellas or the Cockies within this area. With this tree I'm recommending that the large deadwood be removed and also the lower drooping branches especially on the side of the swimming pool be removed there are three on the lawn and car park side, is there is one over the playground the lowest of the branches should all be removed as these branches will become end heavy as they extend out underneath the canopy and have been known to break in other trees from experience.

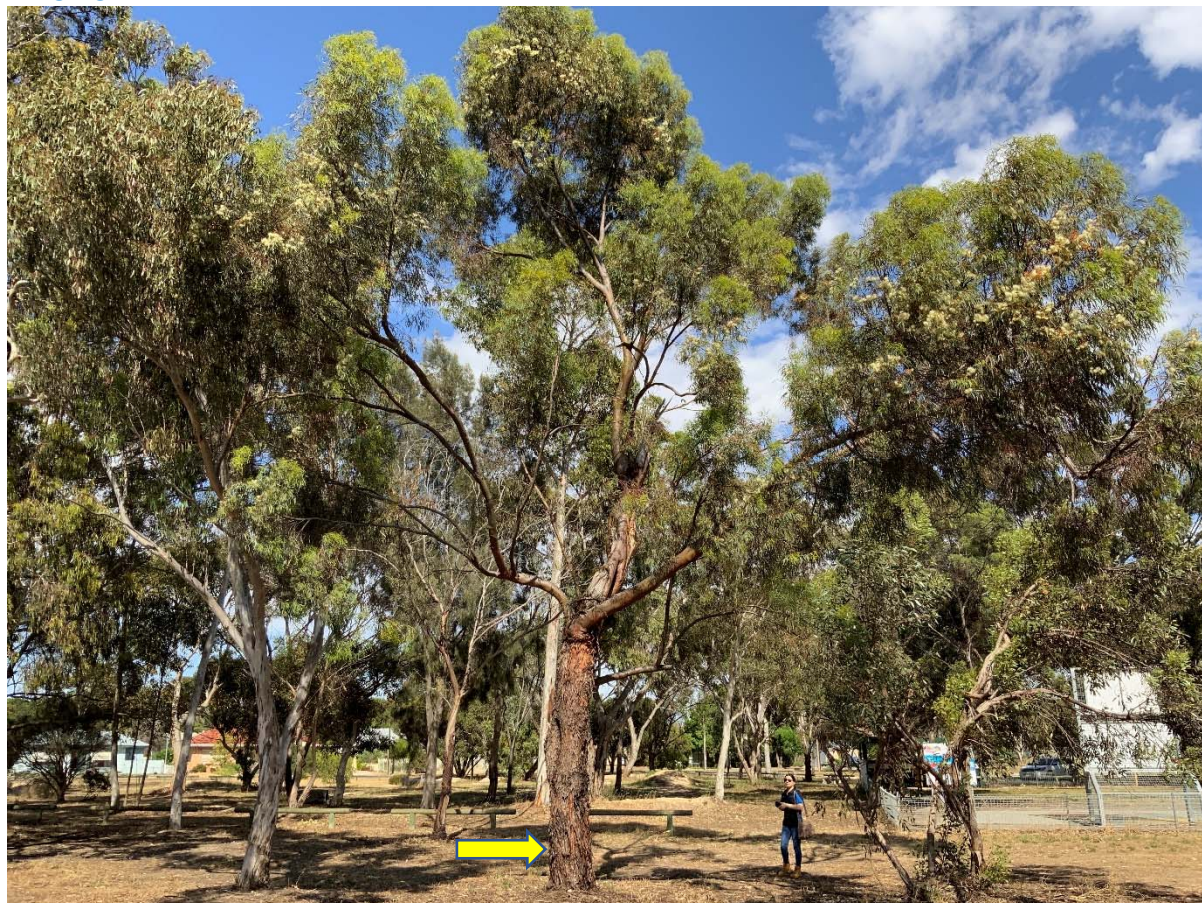
7. *Eucalyptus spathulata*

This Swamp Mallet has had many failures both within the trunk and above the crown union with large amounts of visible deadwood and encroaching wound wood that is trying to rib the area to stabilise the breakout points. The tree shows traits of being a tree that drops limbs which is usually genetic and will continue to drop limbs over the time of its life. Having the lower limb hyperextended indicates that the limbs could fail at any time due to the pressure that is placed upon the area of deadwood and injured wood and I would recommend removing the whole tree as remedial pruning will not remove the risk of failure in this case.

Removal is recommended.

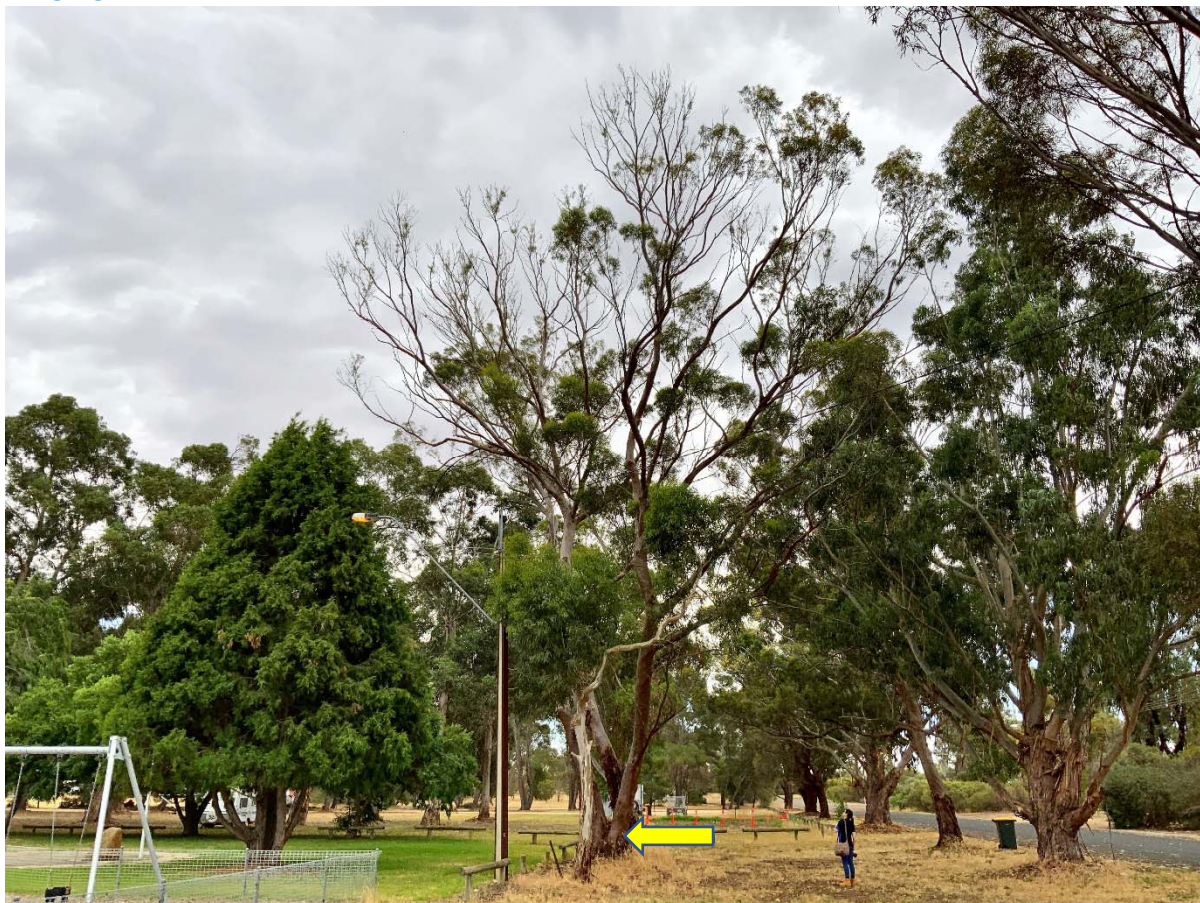
This Swamp Mallet has multiple areas of deadwood throughout the canopy, there are new sprouts in the area of what looks to be deadwood in the terminal canopy area which has regenerated most likely from shock through prolonged periods of little to no moisture both from the atmosphere and from the soil. While the tree is in a rebound from shock situation, I would leave the tree to grow on, if it does die in the years to come it can then be removed.

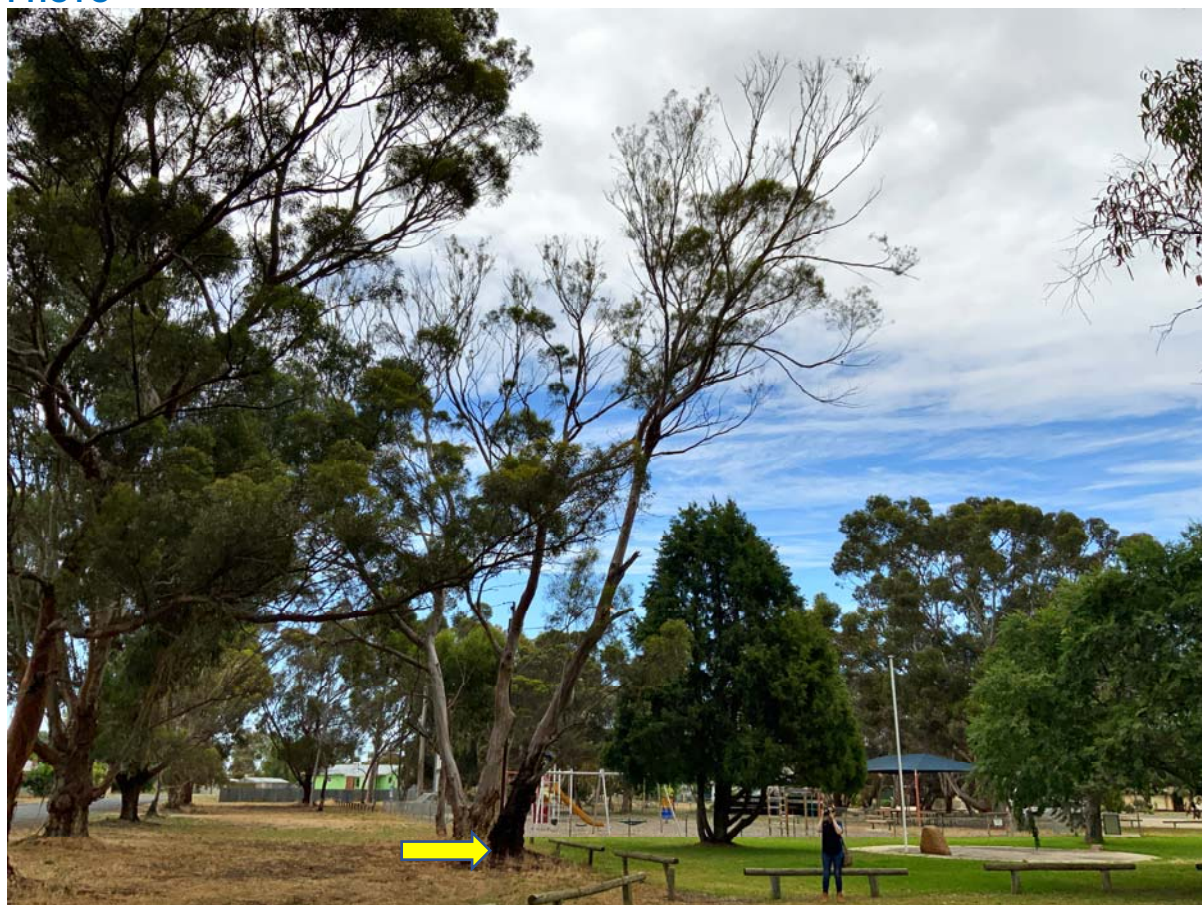
This tree is a single trunk specimen, it has grown on a lean away from the neighbouring tree due to phototropism. The tree has canker on the tension wood side which also has a lot of sap wood missing causing the tension wood to be non-existent on this tree. Having the tension wood removed from the tree has severely weakened the tree to a stage where failure can happen while there is no flexibility within the lower trunk system. The tree is hyperextended leaving it vulnerable to environmental forces.

Removal is recommended.

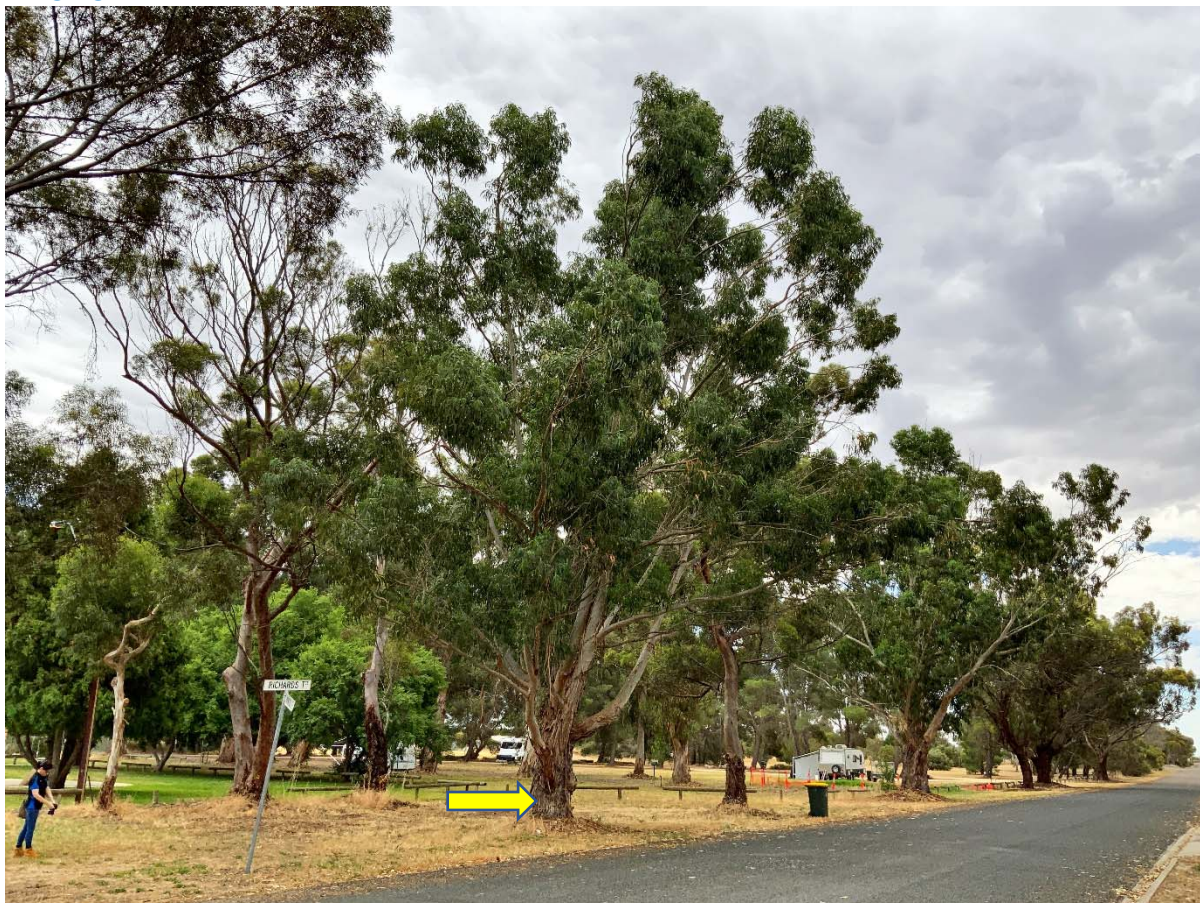
This Tasmanian Blue gum is of a form that is usual to the Adelaide hills area where a lot of them have the lower branches come out within the first 2 to 3 metres of the trunk further towards the Southeast you go the more upright they seem to be which is attributed to the higher rainfall area and they respond in a manner where they grow up rather than out. This tree is in good condition it does have some areas of larger deadwood however being a roadway tree is not as big a risk as it is within the caravan park and with this tree I would not assign any works to this at this time. The side branches are in proportion to the tree itself and in an overall manner they are not hyperextended.

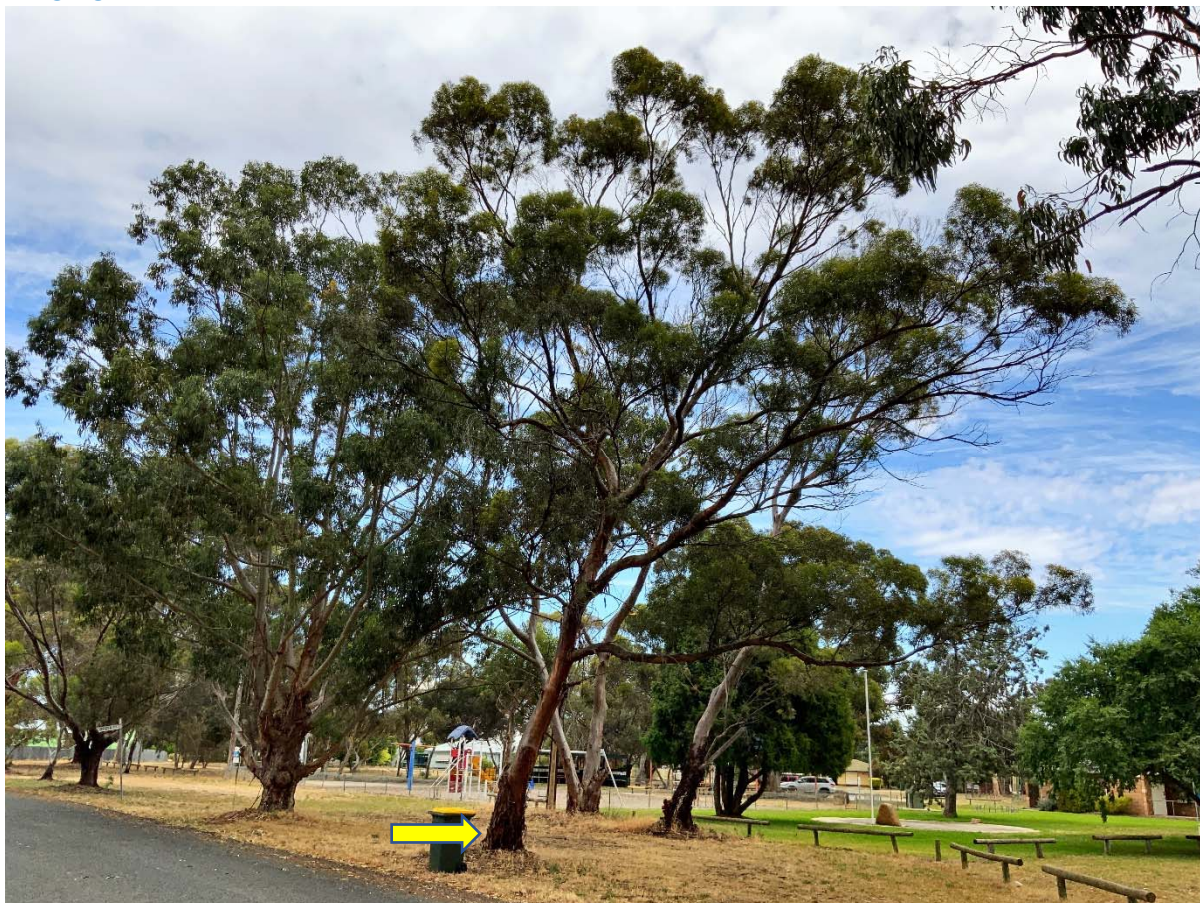
This Swamp Mallet is a single trunk upright form specimen that is growing a lot better than most of the Swamp Mallet's in this area. The tree is healthy with a good spread of foliage throughout the canopy, enough to sustain the growth of the tree. There are areas of deadwood within the tree but are not of size that would be of risk for this area.

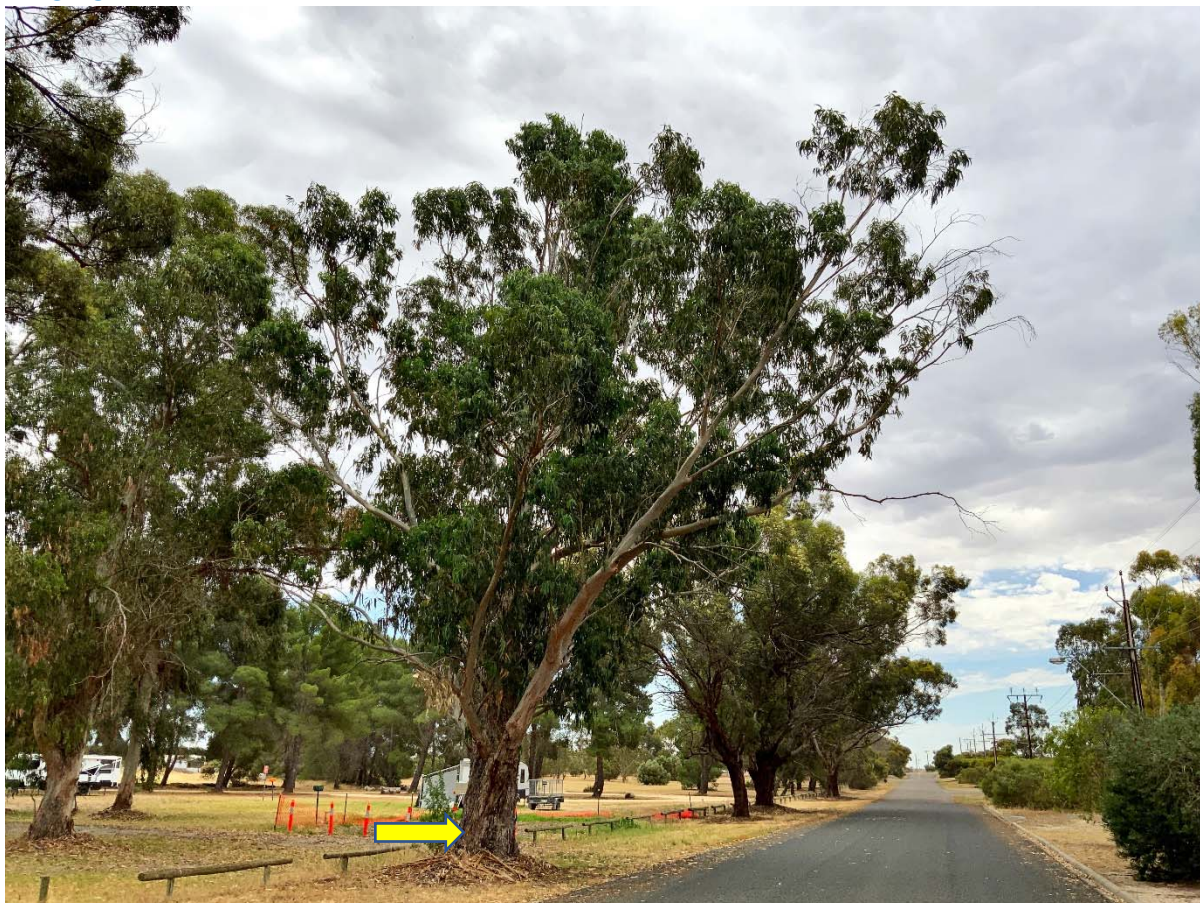
This Tasmanian Blue gum has good branch attachment to the trunk and no areas of decay, included bark or defects that would render the tree unsafe. Being close to the caravan parking area I would recommend removing the large deadwood also the large deadwood on the opposite side near the road should also be removed. As the road goes past this tree and may even be used as a place to park due to the good shade cast, the dead wood should be removed.

I am recommending that all the large deadwood be removed from the tree that would cause injury or damage. The upper canopy does not have a lot of deadwood, it is mainly the lower and mid canopy that does.

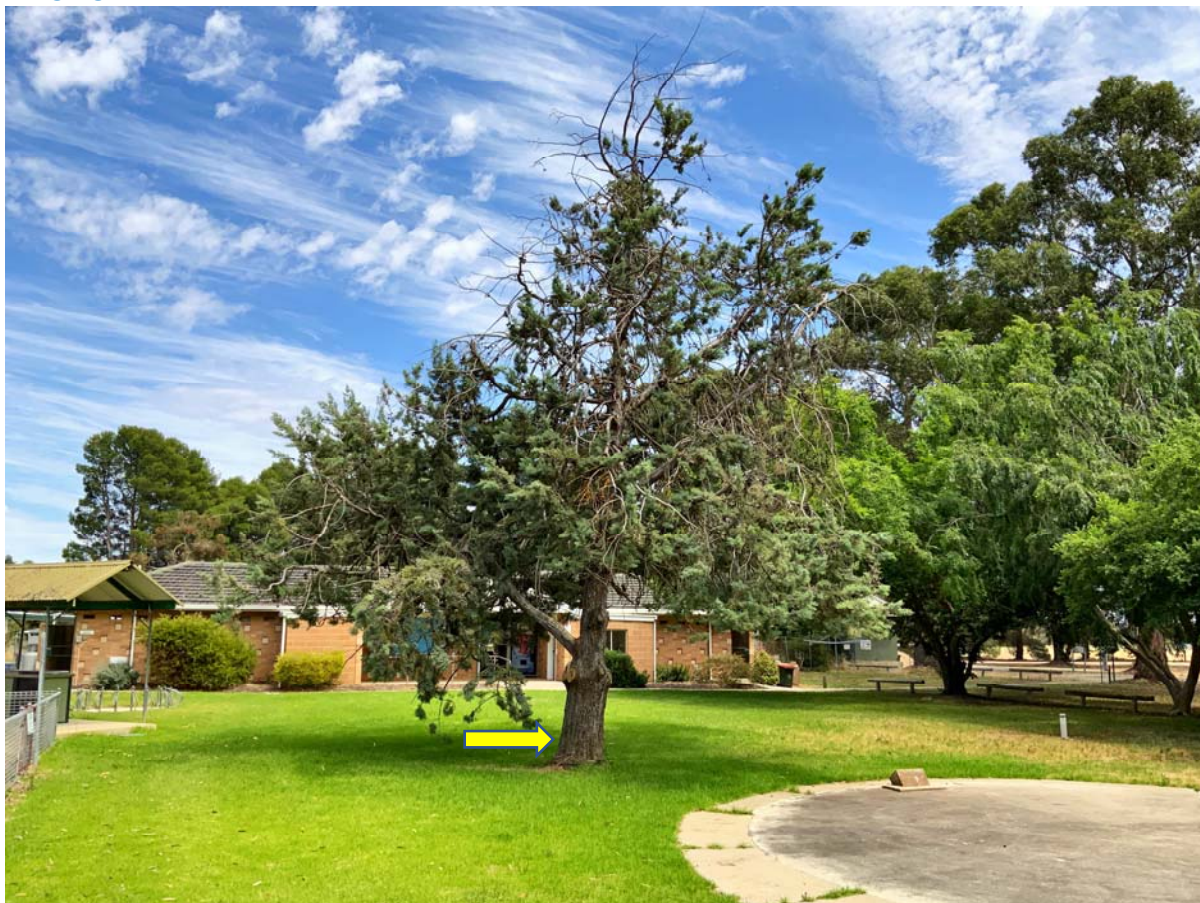
13. *Cupressus macrocarpa*

This Pine tree has lost a lot of its foliage due to dieback, a number of the lower branches which have been removed most likely were also dying. The tree does show signs of Cypress Canker which is present within the tree which causes a lot of the sap to extrude from the tree as it blocks the circulation of the SAP causing it to burst from the cells and is what you can see on the outside of the tree. The lower limbs which remain do have areas of exposed deadwood which reduces the amount of cambium which also reduces the amount of sap flow that makes it out to the foliage. On all Coniferous trees there are no blind buds where the tree can regenerate once those areas of foliage are removed, they will never regenerate again this is why care needs to be taken with pruning.

Removal is recommended as the tree is in serious decline and will most likely slowly die in the near future.

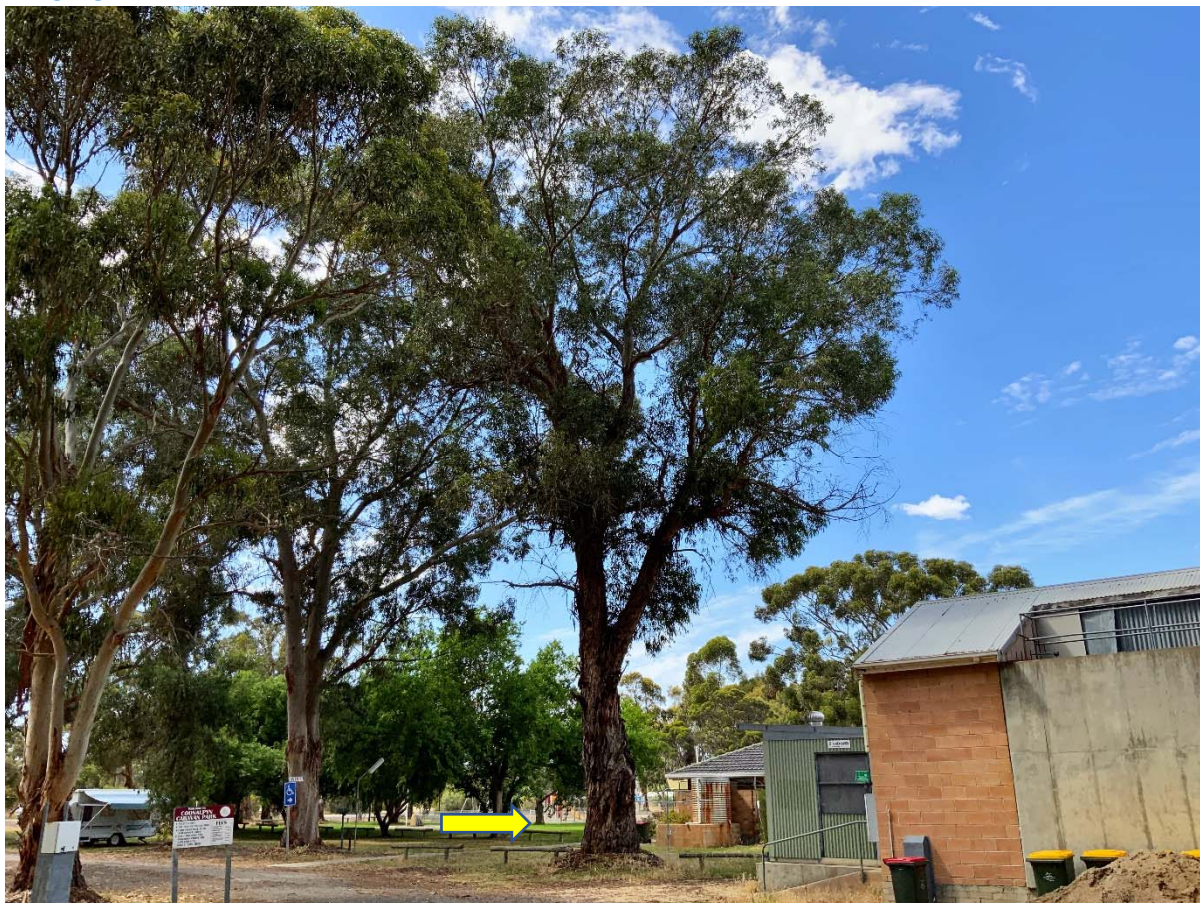
14. Eucalyptus globulus

This Tasmanian Blue gum is a large mature specimen, it does have Canker fungus up to approximately 10 metres, the lower branch also has signs of Canker within areas of the cambium liar, this extends up to approximately 6 metres but the upper canopy is void of Canker. The tree is healthy like most and the increase in available moisture this time of year allows for new growth in the terminal canopy.

The tree will require the deadwood to be removed above the chemical shed as it is quite a large branch and it is drooping which is an area which is prone to failure, I would also recommend removing the large deadwood off the other side which is closer to the lawn and the path area and this only needs to be done within the lower canopy range of this tree..

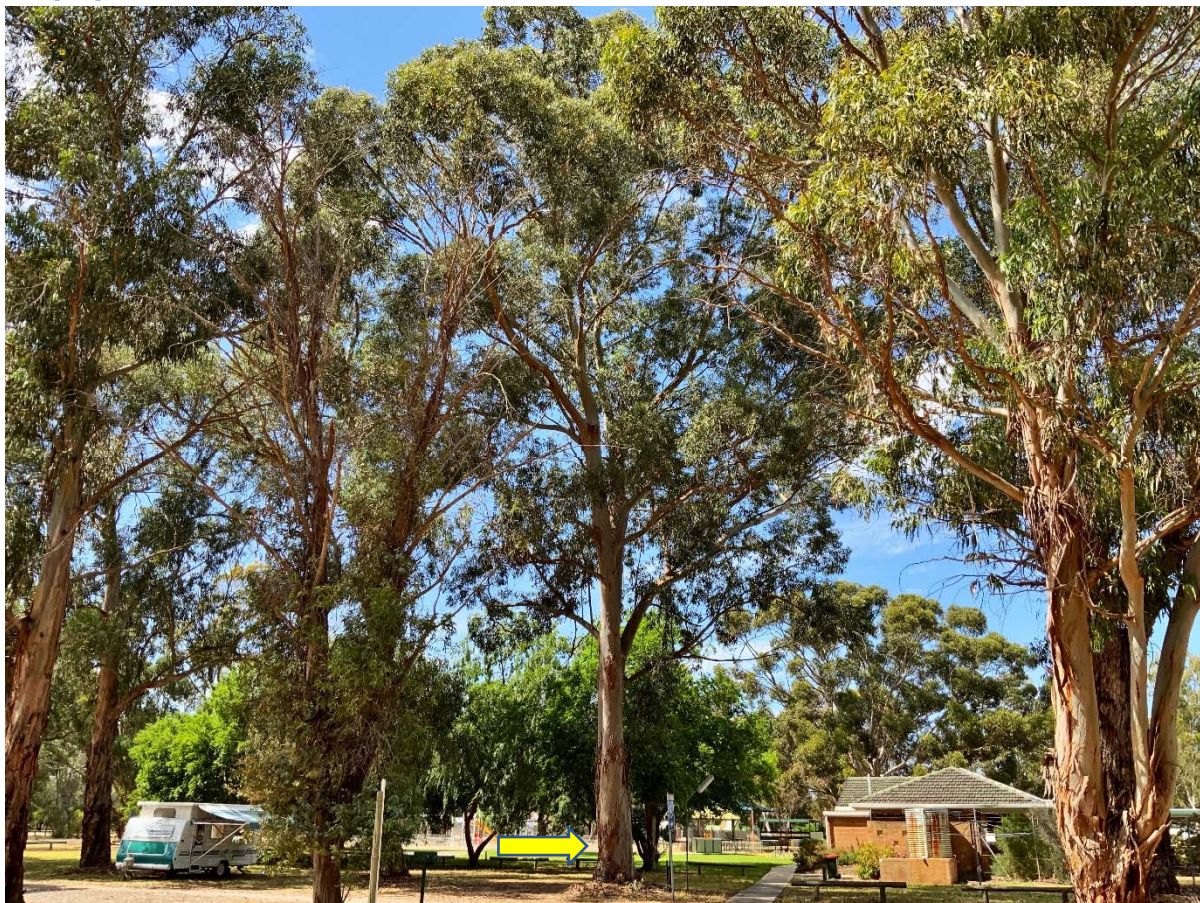
This Tasmanian Blue gum bifurcates approximately 3 metres above ground level the attachment point is sound with no areas of inclusion or defects that would render the tree a risk. The twin leaders from that point of attachment are basically mirror images and both have the same caliper and height of each other. There is areas of large deadwood in the lower to Mid canopy which will require removal, not too much above that that needs to be removed.

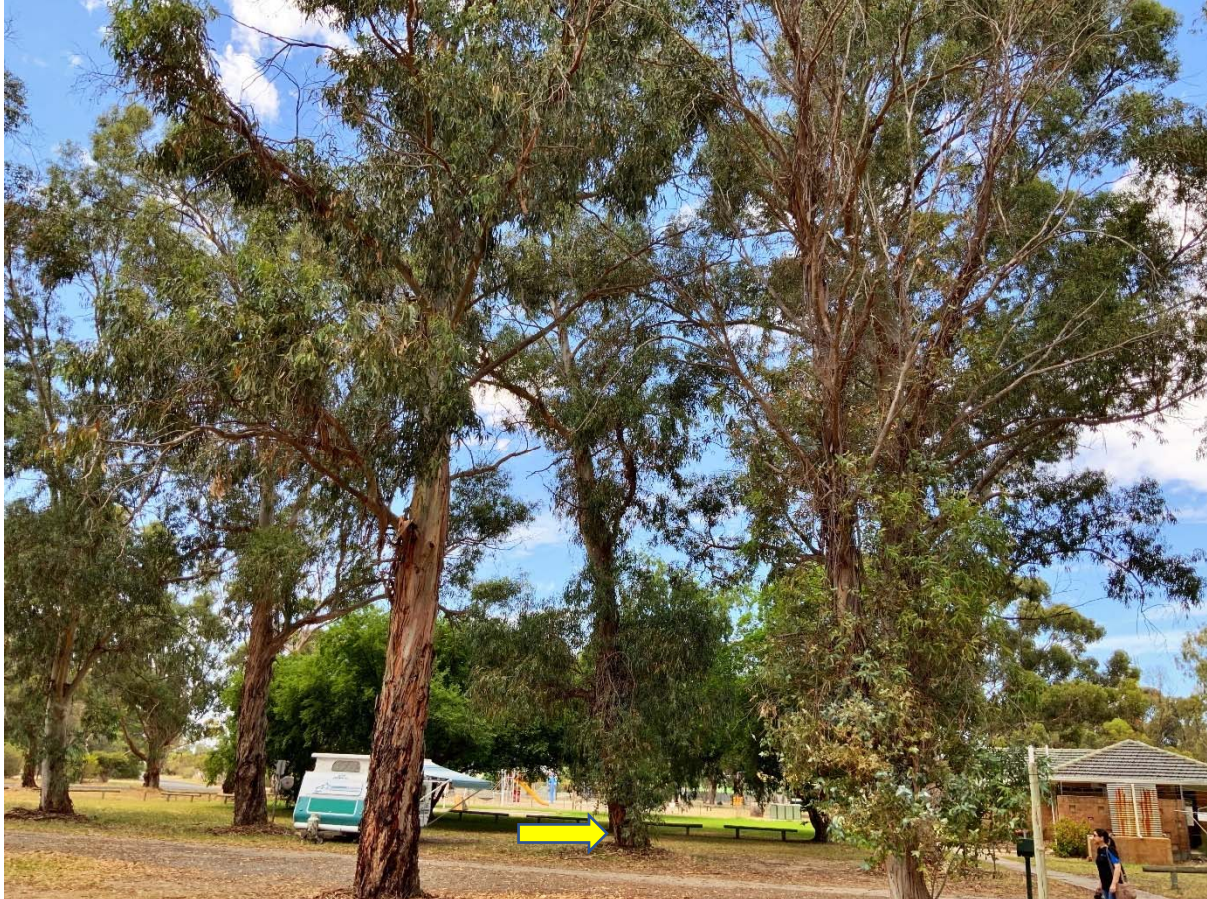
This Tasmanian Blue gum has spotted areas of Canker within the lower 3 metres of trunk system the Canker has not covered the whole area it is only showing up in minor areas which could also be areas of Borer exit holes. The trunk has epicormic growth and now that the upper canopy has regenerated it's foliage this area of approximately 6 metres from ground level will need to be removed.

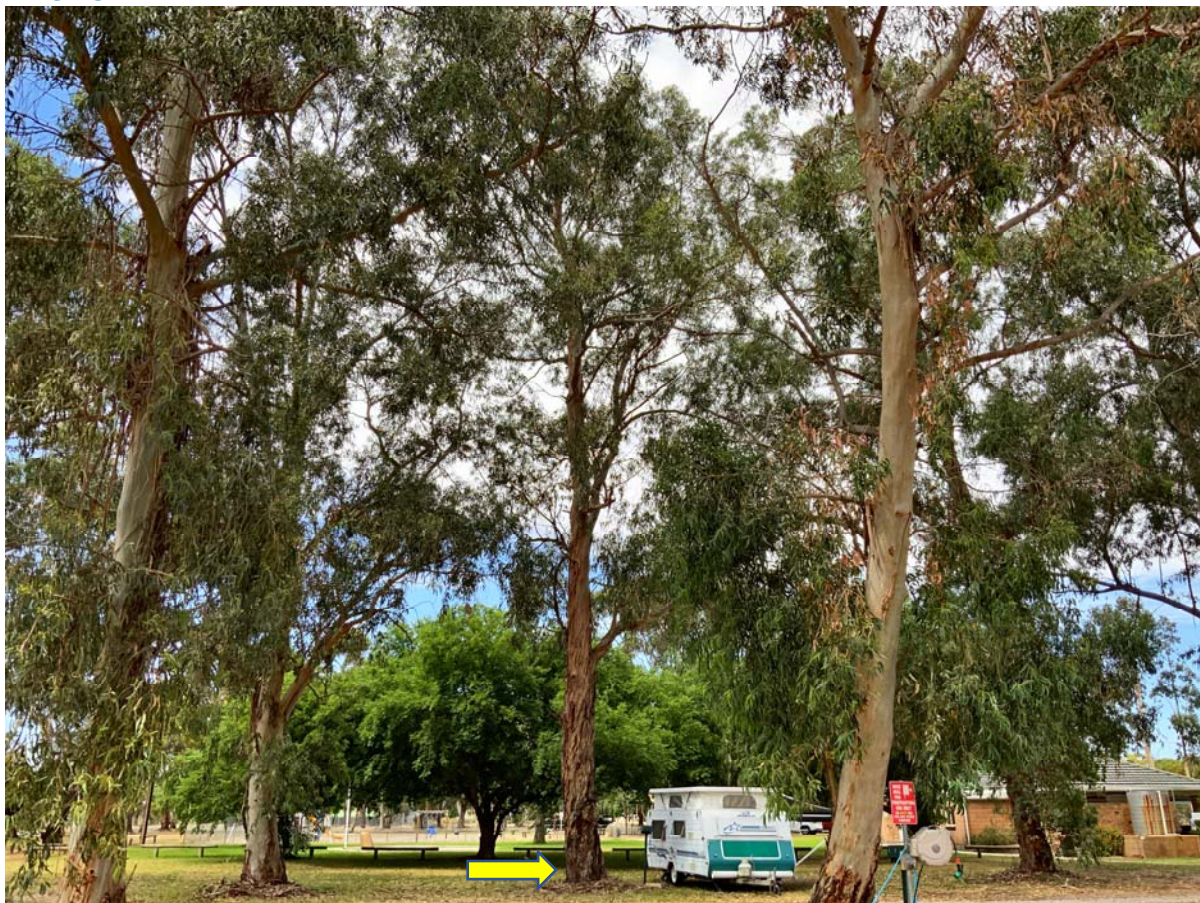
This Tasmanian Blue gum is a good upright form tree that has not suffered shock or stress in that capacity, the tree does have spotted areas of canker in the lower trunk to approximately 3 metres above ground level, there are no areas of epicormic growth in the base.
