COONALPYN TOWN PARK & STREET TREES

Tree Inspection – November 2020

Coonalpyn Town

TREE AUDIT

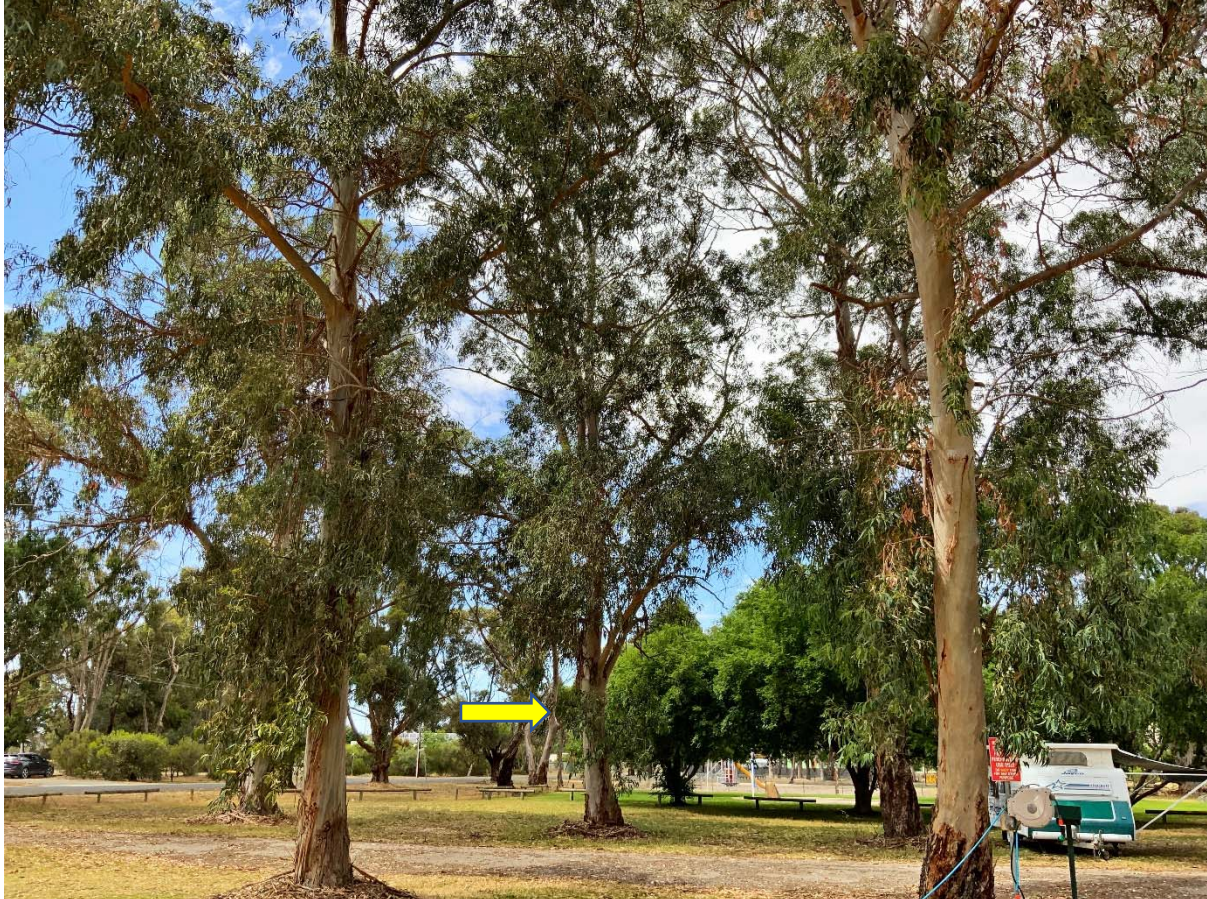
This Tasmanian Blue gum is an upright form also which has grown to the environment within a crowded regimental form along this area of the caravan park. This tree does have areas of large deadwood throughout the lower middle and upper canopy which will require removal. The tree also has a minor amount of epicormic growth in the trunk, everything below the main Crown union will need to be removed to allow the upper canopy to develop.

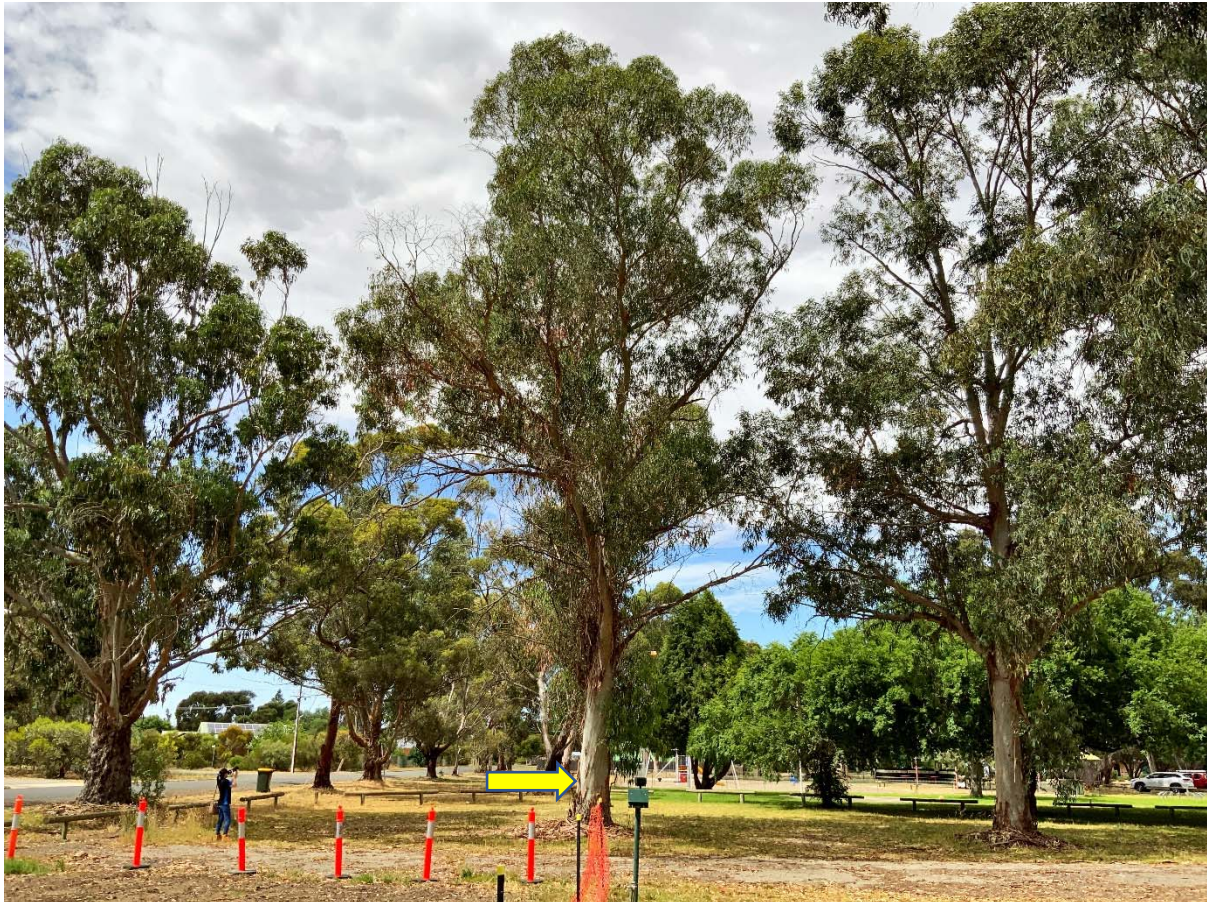
This Tasmanian Blue gum being an end tree even though it is close to the verge blue gum, the canopy has spread a lot further than most of the other trees Avenue. This tree does have larger areas of deadwood within the lower and mid canopy the terminal canopy is mostly clear of large deadwood which seems to be the normal along this area.

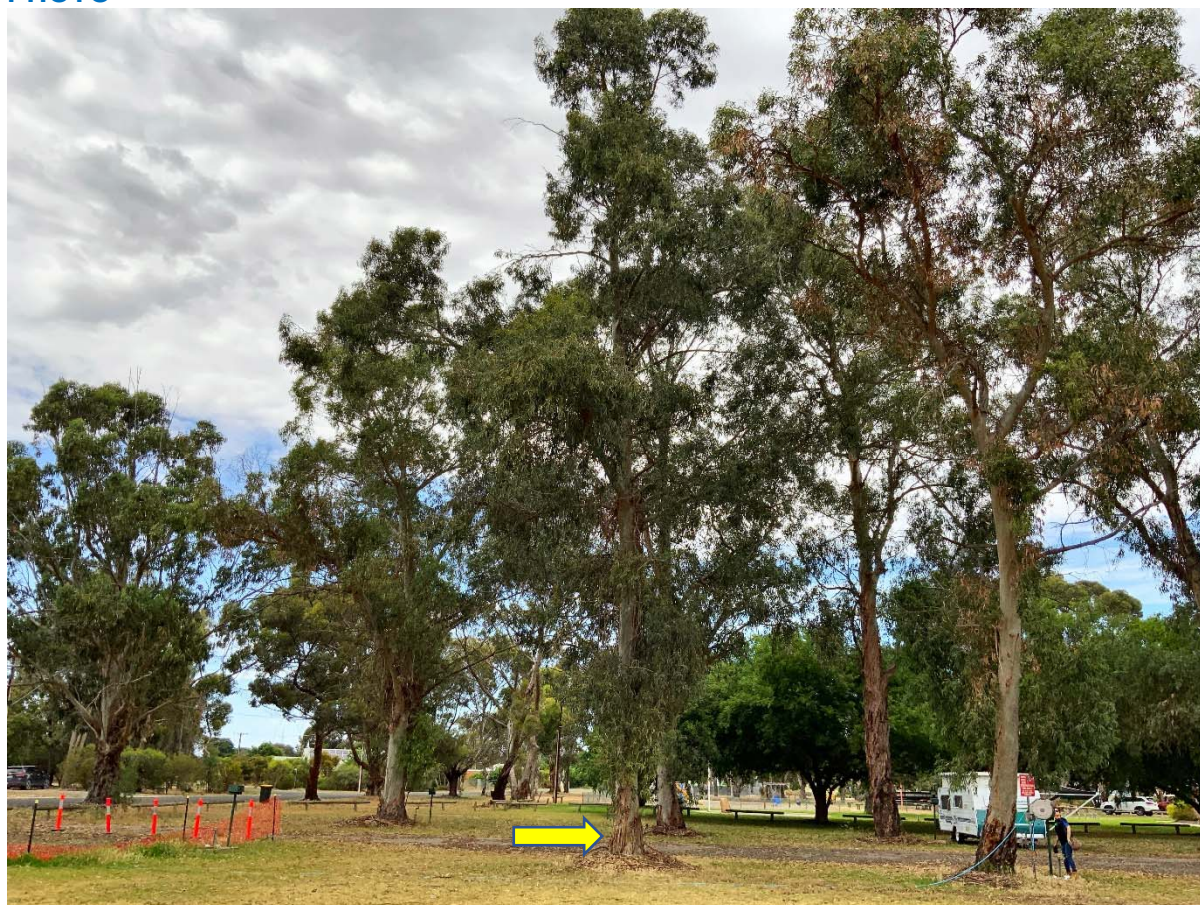
This Tasmanian Blue gum is younger than the trees on the opposite side of the access road and look like they have been planted approximately 5 to 10 years later than the opposite side. This tree has a few areas of large deadwood that will need to be removed also the epicormic growth in the lower 4 metres of the trunk will need removal. The upper canopy is mostly clear of Deadwood with only the lower canopy needing pruning of large deadwood.

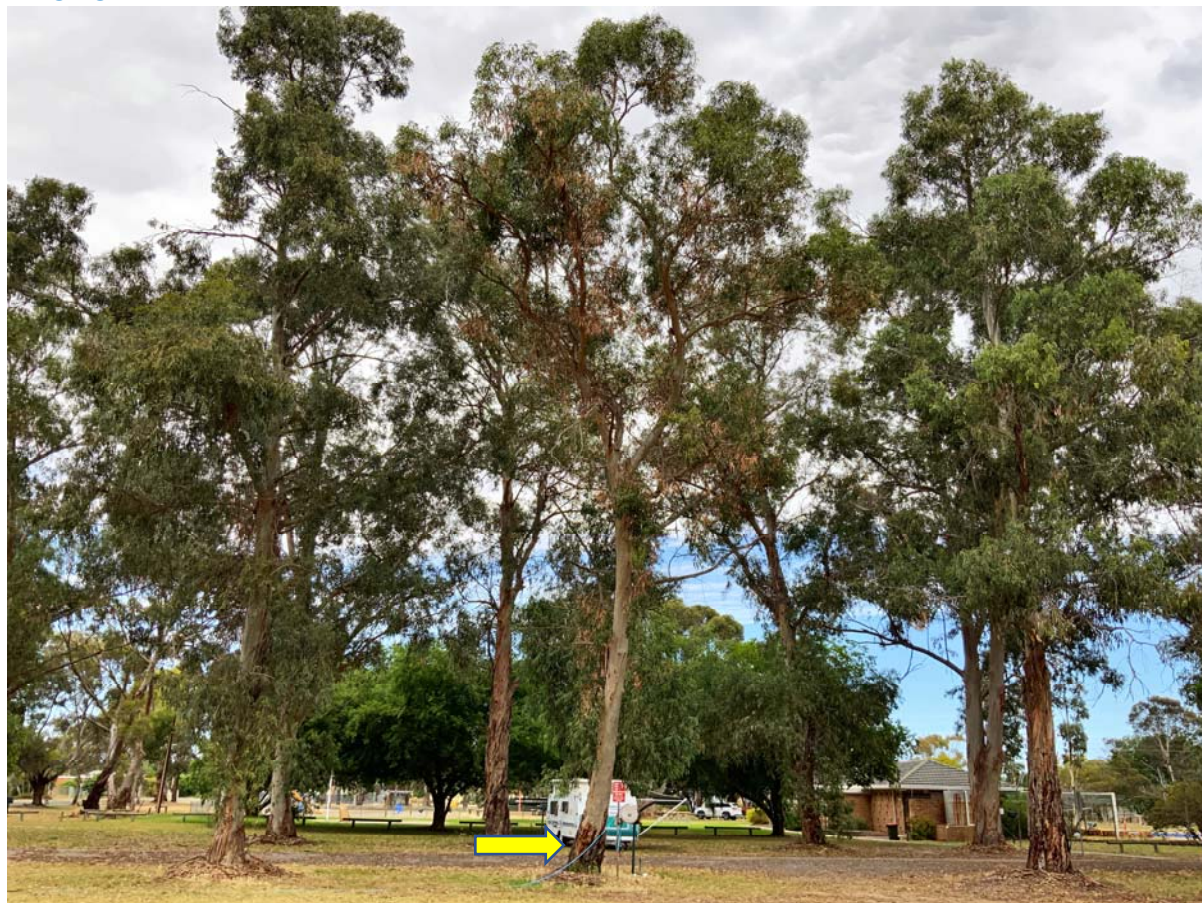
This Tasmanian Blue gum has areas of dead foliage spotted throughout the whole of the tree. This is quite unusual for this species of tree to have dieback spotting throughout the tree and is mainly noticed on pine trees. This tree also has large areas of large deadwood which will require removal. Epicormic growth within the first 6 metres of the trunk from ground level up will need to be removed.

The areas of deadwood are a little bit concerning but the tree does not look to have insects that would cause this problem. The spotting looks as though it has all happened at the same time and can also be attributed to poisoning which can happen when the base of the trunk is sprayed with chemical.

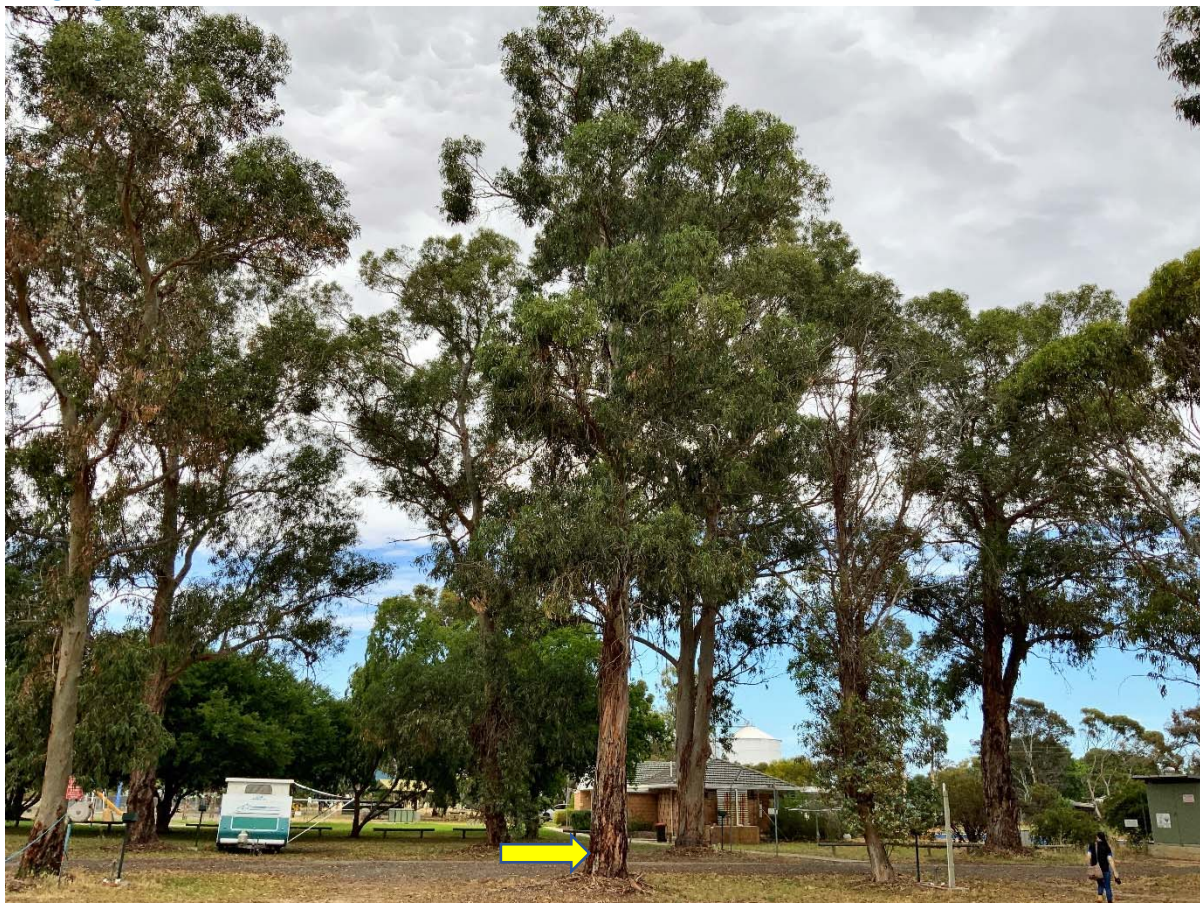
This Tasmanian Blue gum has grown quite well and does have a lot of new generated foliage and new growth throughout that terminal foliage throughout the whole canopy. The lower trunk up to 2 metres has areas of Canker fungus in a semi uniform manner. The tree is also been injured at the base and wound wood has increased upon the injured area causing ribbing around the injured area. The tree does have areas of deadwood in the lower and Mid canopy which will require removal.

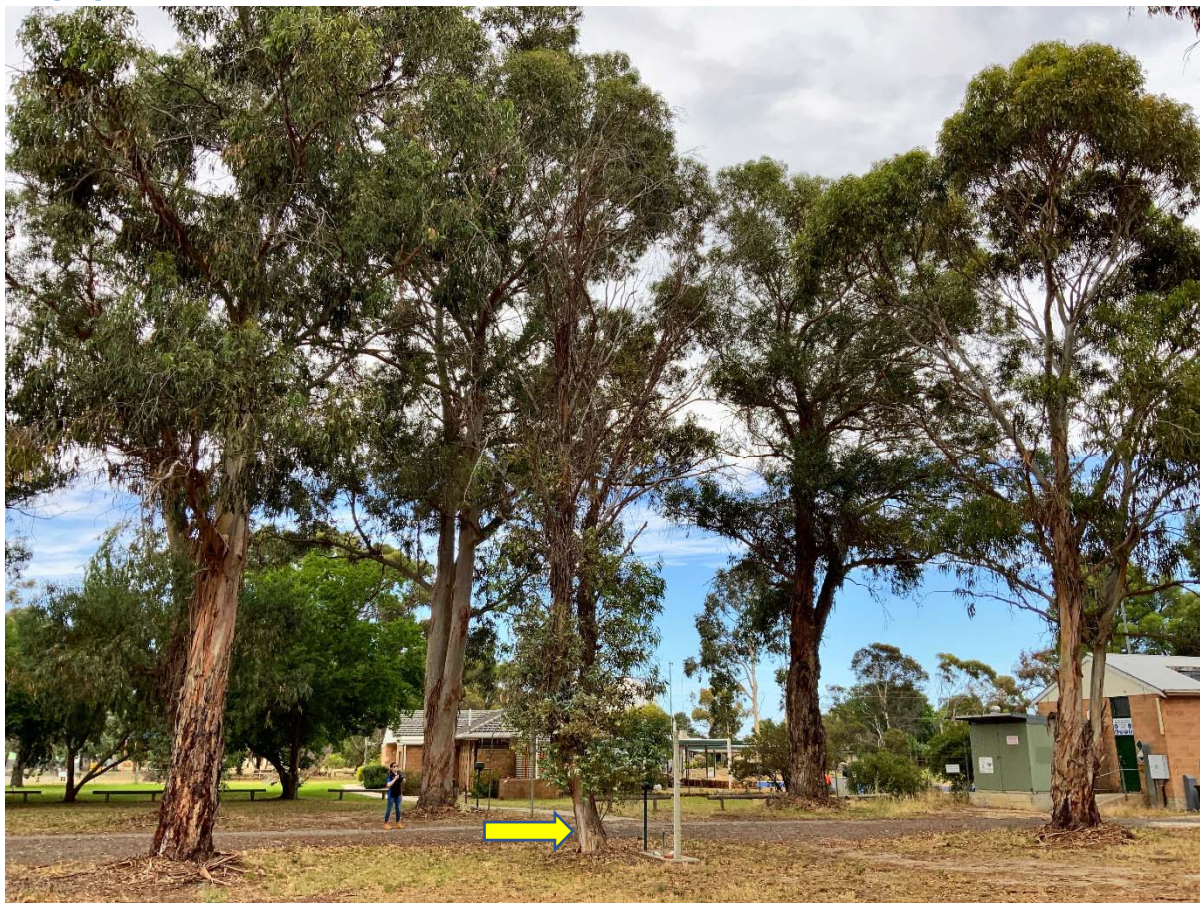
This Tasmanian Blue gum has died within the mid to upper terminal canopy area and as a result the lower portion approximately 6 metres up is all epicormic growth from blind buds which have been triggered by hormones within the pressurized sap flow, this growth will not grow into a specimen tree that would be fit for this area as the growth is weak within the attachment and will fail often only leaving a few areas which are strong enough to carry on the tree.

Removal is recommended, I would also check to make sure no one is using glyphosate or any type of Atrazine specified chemicals near the area where water is available as this could be the problem causing the trees to die if off targets spraying or overflow of poisons is used.

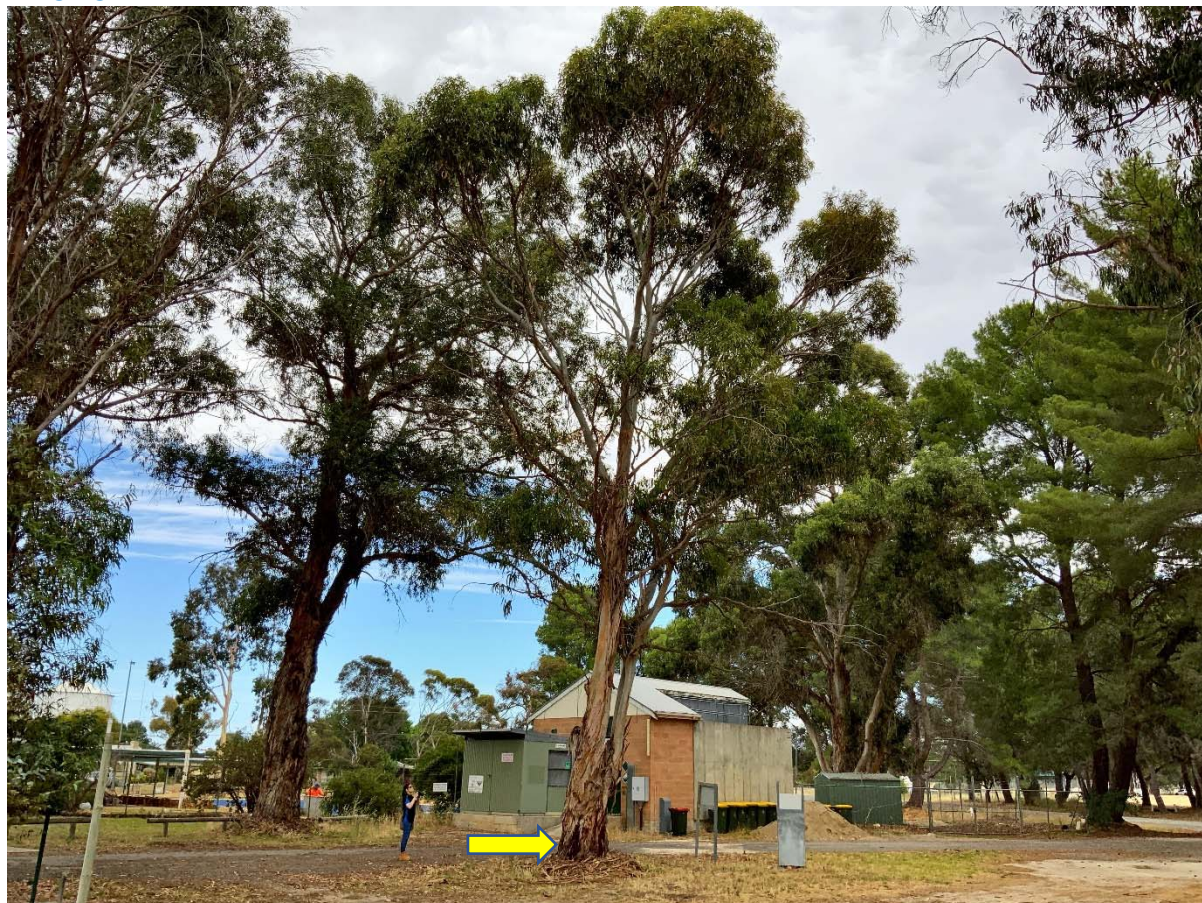
This Tasmanian Blue gum has grown well with a slight lean that is insignificant. The trunk has a secondary growth stem which should have been removed when it first started to grow, the stem will need to be removed to allow the main trunk and terminal canopy to grow without the competition of a growth that will compete against itself. The lower trunk has Canker fungus up to approximately 1.5 metres. There are areas of deadwood which will require removal due to this being a caravan park.

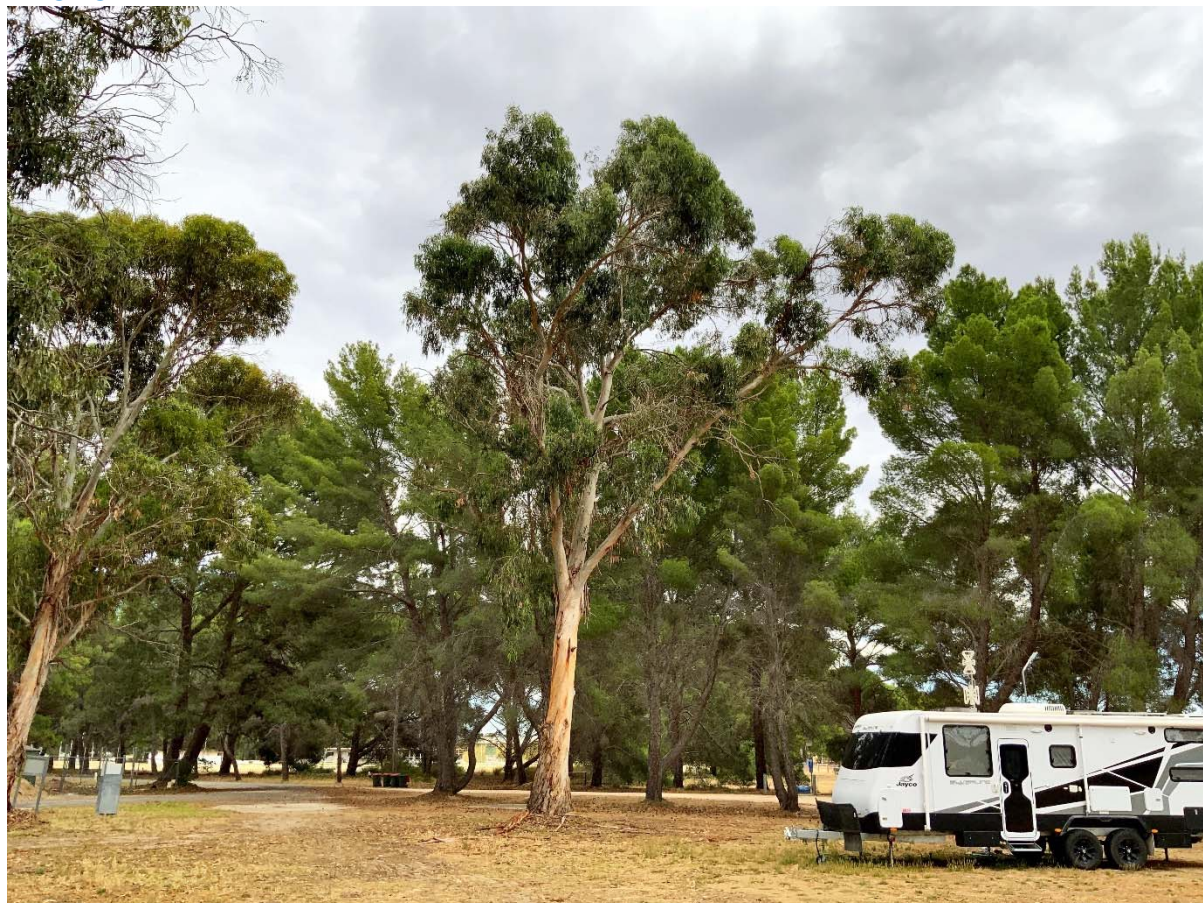
This Tasmanian Blue gum has good crown development with a single trunk form allowing for good canopy development. The scaffold branch system is well distributed and the tree has very few areas of Canker at the base. There are areas of deadwood which will require removal as they are quite large. There also looks to be Borer in the upper trunk approximately 5 metres from ground level this is in two places where lesion-like staining has occurred, there is also the old one or two in within the scaffold Bryant systems which also indicate fungus activity throughout the tree.

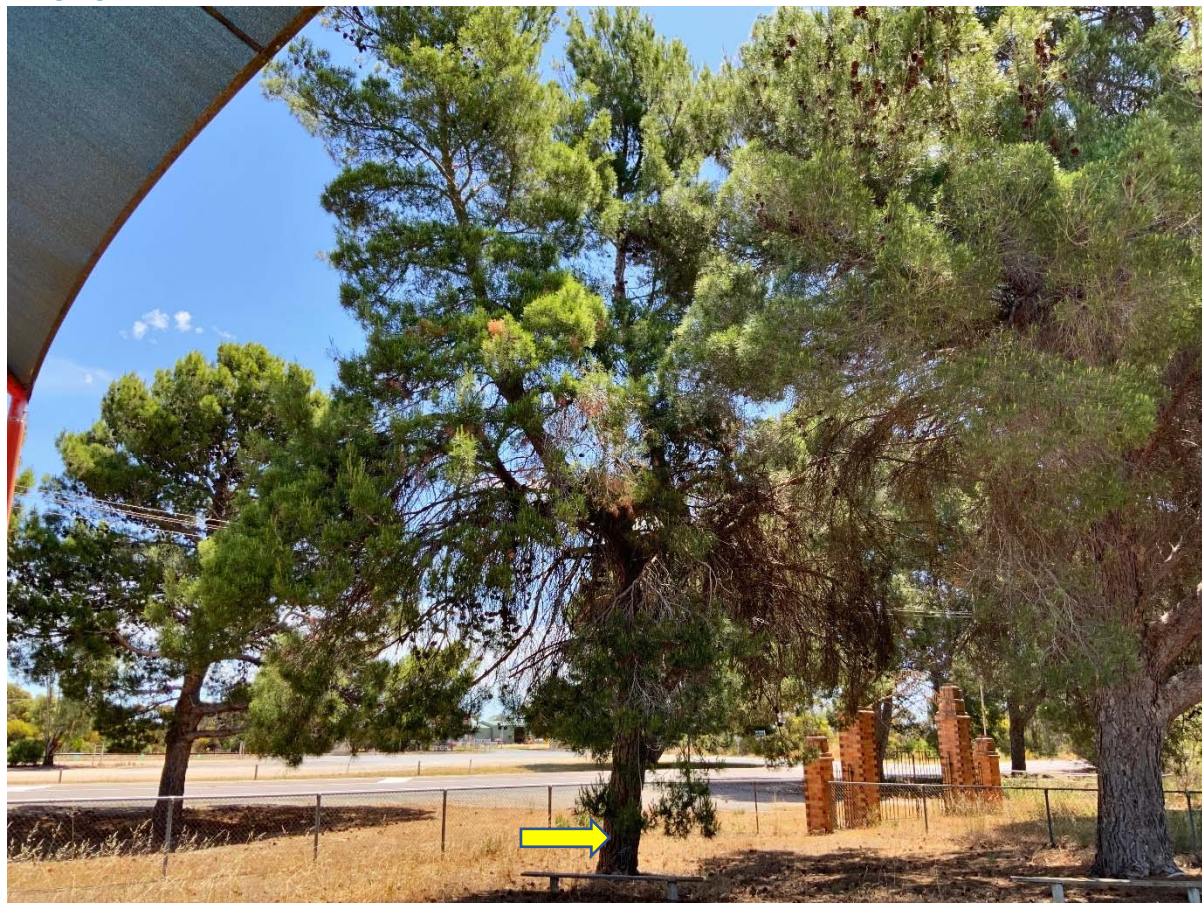
26. *Pinus halepensis*

This Pine is a young specimen that has grown to the conditions of the environment, the tree does have persistent deadwood on the trunk and because they are located above the seats, they will require removal and also lifting of the canopy up to approximately four metres. This will ensure that the lower older deadwood is removed before it does fail and other deadwood above it can remain and most likely in 6 years this can then be removed further as the canopy develops. The upper canopy has areas of crook branches however none of the branches look to be unstable or a risk in this case.

Pruning of the lower canopy and deadwood to a height of four metres above ground level is recommended.

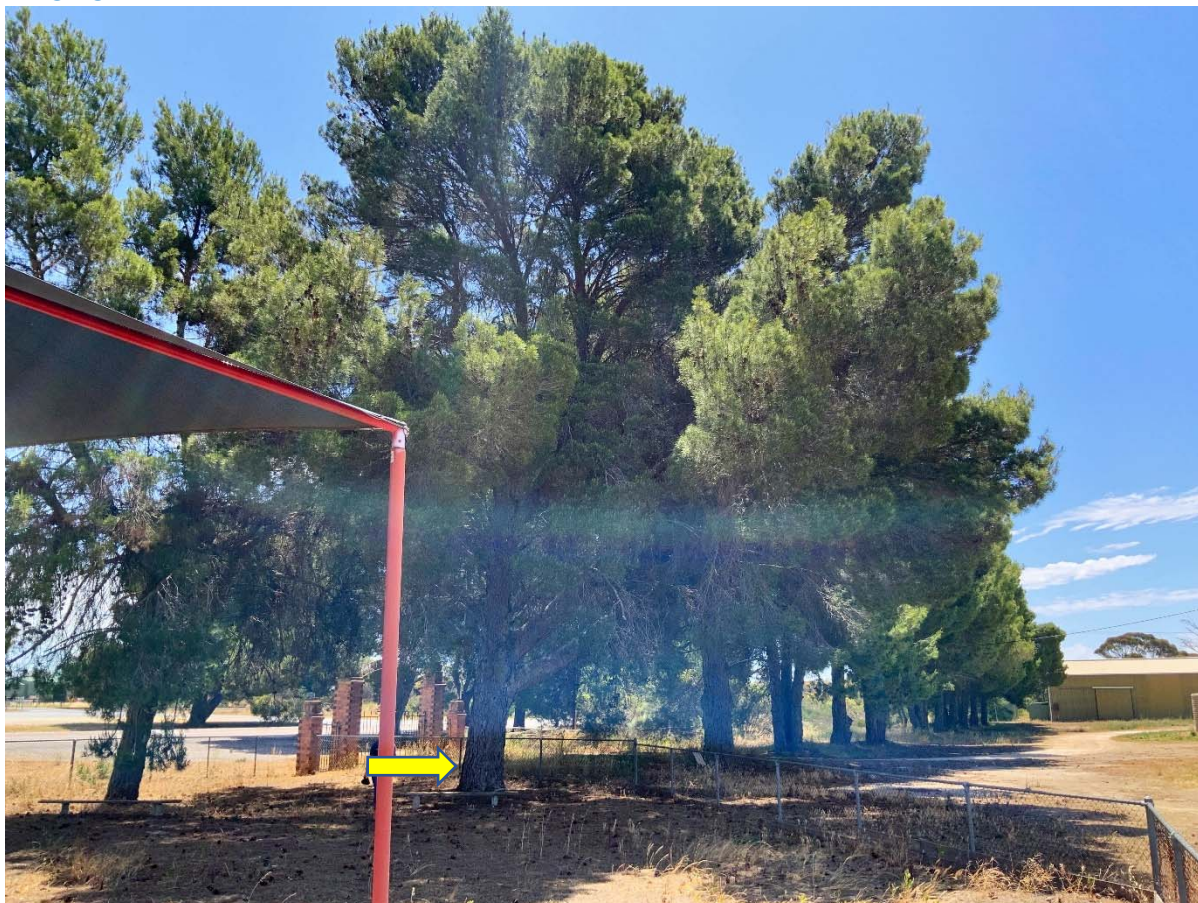
This Pine is a much more upright formal specimen, the under canopy does have areas of persistent deadwood of which can be removed from this tree and is not a great amount. The canopy should be lifted the same as the other tree to keep them at a consistent height where they do not come in contact with anyone that uses this facility. This includes the area outside the gate to balance the tree and allow it to develop naturally in a balanced state to reduce further maintenance.

Pruning of the lower canopy and deadwood to a height of four metres above ground level is recommended.

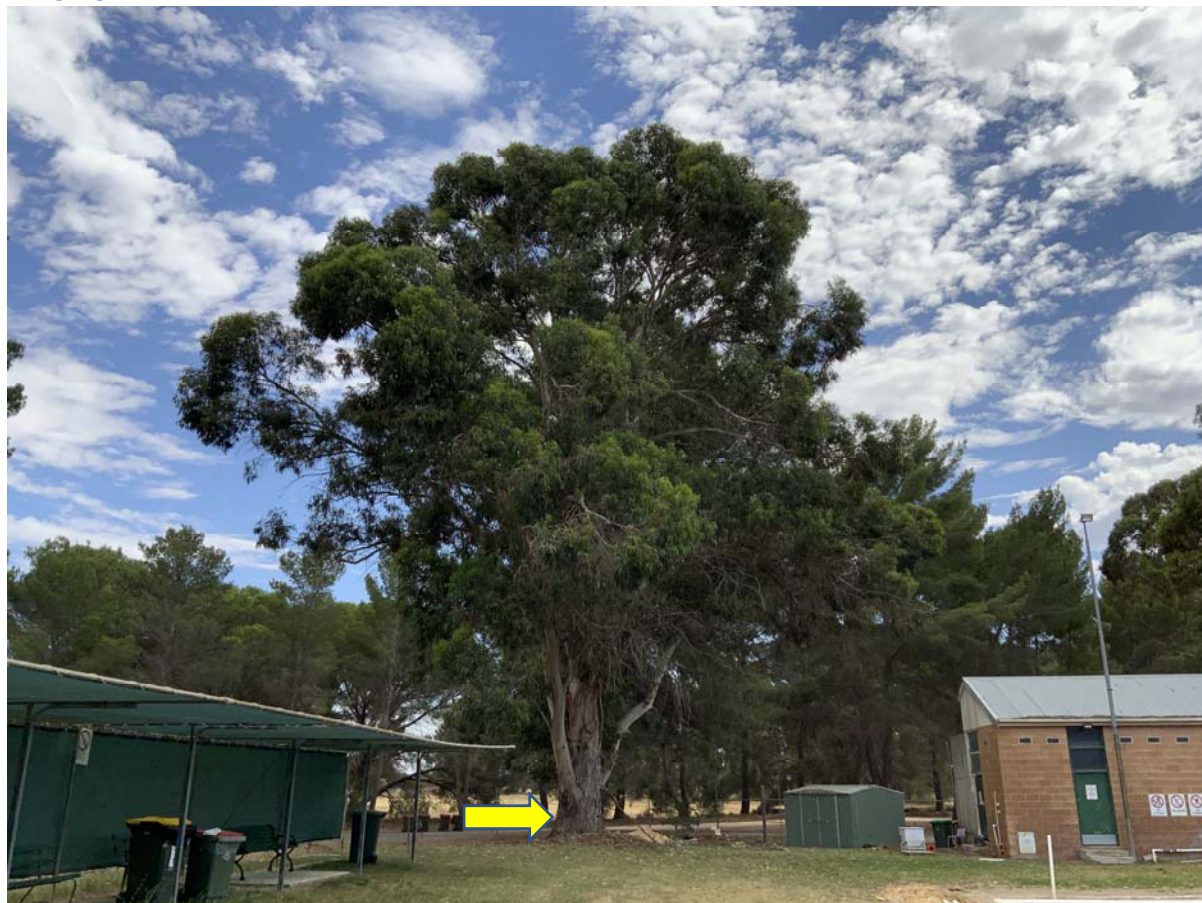
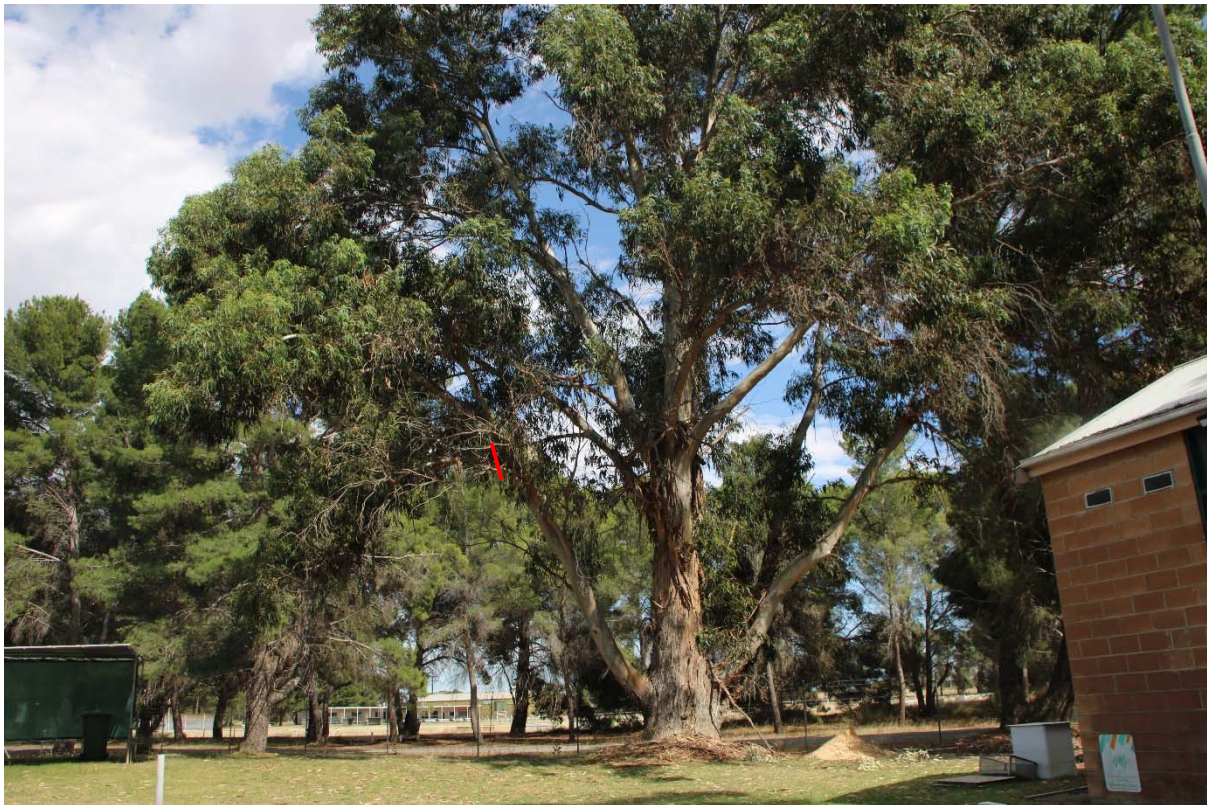
28. Eucalyptus globulus

This large mature Tasmanian Blue Gum has multiple leaders arising from a lower central trunk system with the central original trunk still remaining. The tree does have an extraordinary amount of deadwood throughout the canopy and as this being a swimming pool the deadwood will need to be removed.

There is one branch overhanging near the shade shelters which will require removal as it is drooping too low to be energy dissipating through the trunk. There are no areas or defects that can be seen within the attachment points coming from the main trunk system.

These trees are susceptible to White Ants and they will usually infiltrate the inner hardwood until branches such as big scaffold branches start to break off and expose the area of white and infestation if this occurs the tree will need to be removed as the White Ants would've eaten through the base and up into the central hardwood. I did not find any traces of White Ant activity in any area within 100 metres of the tree.

Deadwood in this tree is the highest risk that the tree poses and will require removal, as there is little to no flex within deadwood, the deadwood can crack when subjected to storm events, any cracking within deadwood has a much higher decay rate than live wood has which intern accelerates the weakened area causing the deadwood to fail which can happen once the threshold of structural integrity has been overcome.

The only limb that I'm recommending for removal is the drooping limb growing down towards the shade structures, this limb will create a pressure point at the point of attachment which is the area where the limb acts independently to the lower leader. At this point the energy dissipation is reduced and weakening or failure can occur.

The deadwood and limb removal is most likely going to take approximately five hours to complete and will require an elevated platform rather than a climber however a climber can be utilised in the upper canopy where the elevated platform may not reach.

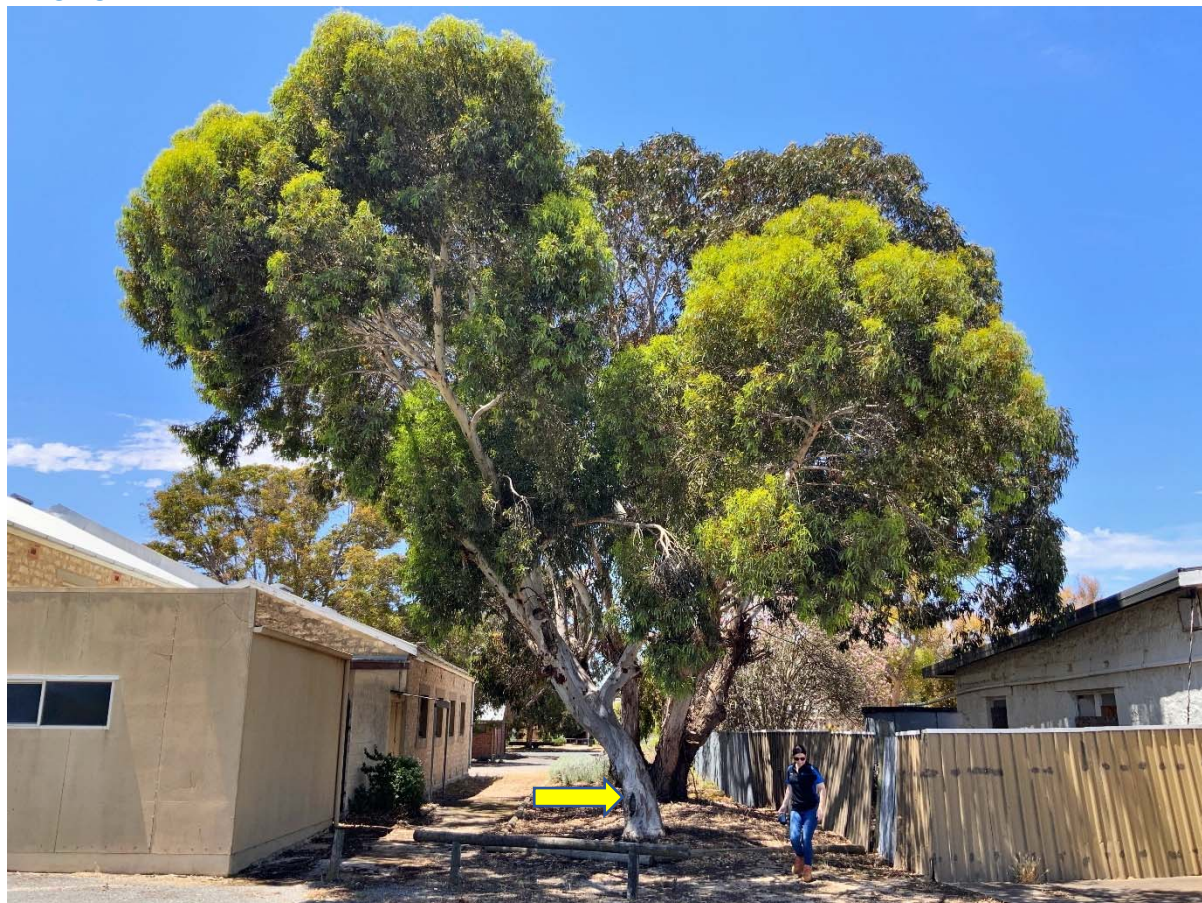
29. Eucalyptus

This Eucalypt is in a good growth cycle with new growth throughout the terminal canopy and is in a very healthy state, the tree looks to be on a lean, but is of normal growth which has had the secondary leader removed most likely because it was overhanging the neighbor's house.

The tree has had areas of failure in the past and most of them have produced ribbing through wound wood that has tried to engulf the areas of injury. At this time the tree is stable and does not require any pruning at this time.

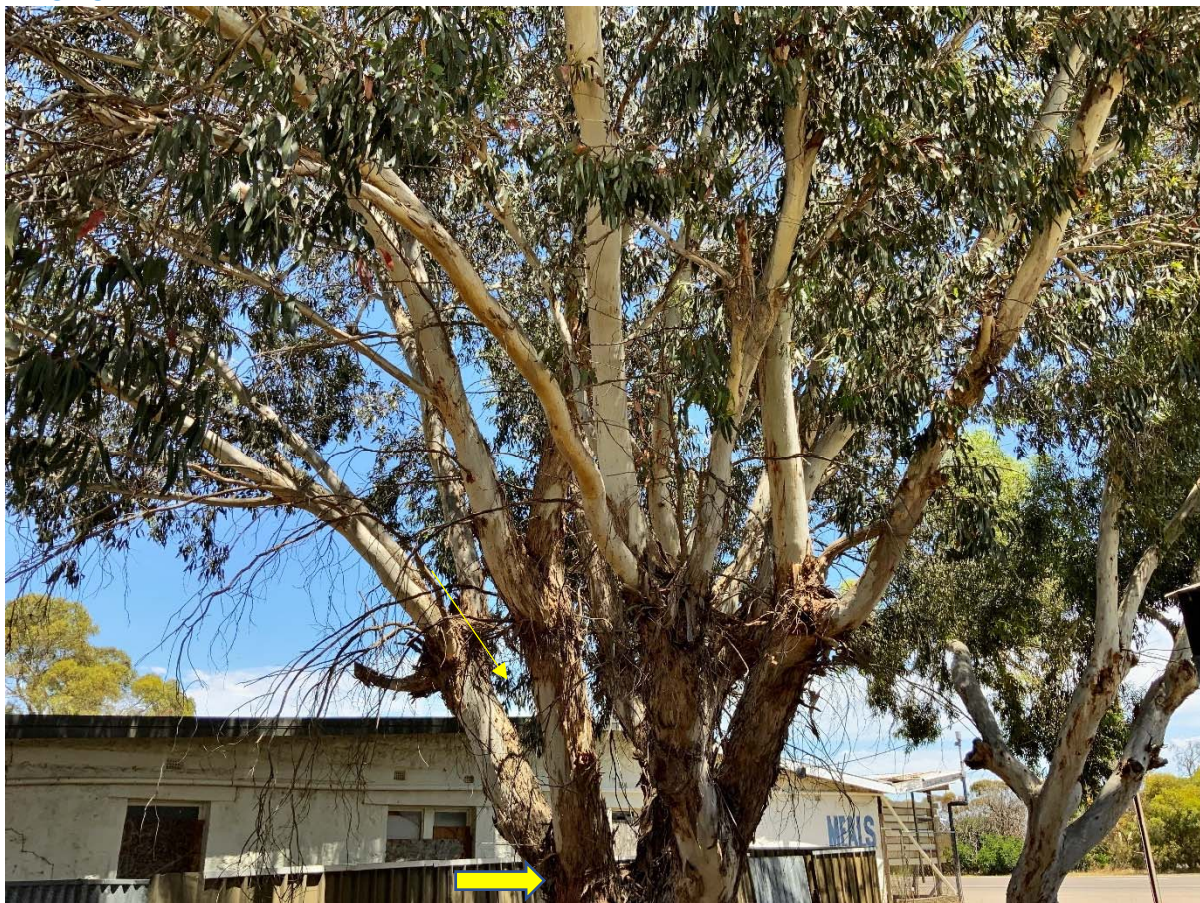
This SA Blue Gum looks to have been lopped at one stage and now has produced a live canopy of growth which is the makeup of the entire canopy at this time. The upright growth is singular and does not develop into a scaffold branch system that is accommodating to a wide domed canopy like it normally would have. As the area is of low use the tree can stay for now however if the growth starts to fail from this tree then it should be looked at to be removed. There are areas of deadwood that can be reached by the pole saw, I would recommend removing the deadwood which shouldn't be too much of a problem with the pole saw, what deadwood that can be seen is epicormic growth which has not made it into the size of the growth that is now on the tree. There are also two limbs (little yellow arrow) that is growing over towards the old service station these limbs should be removed so they do not come in contact with the building.

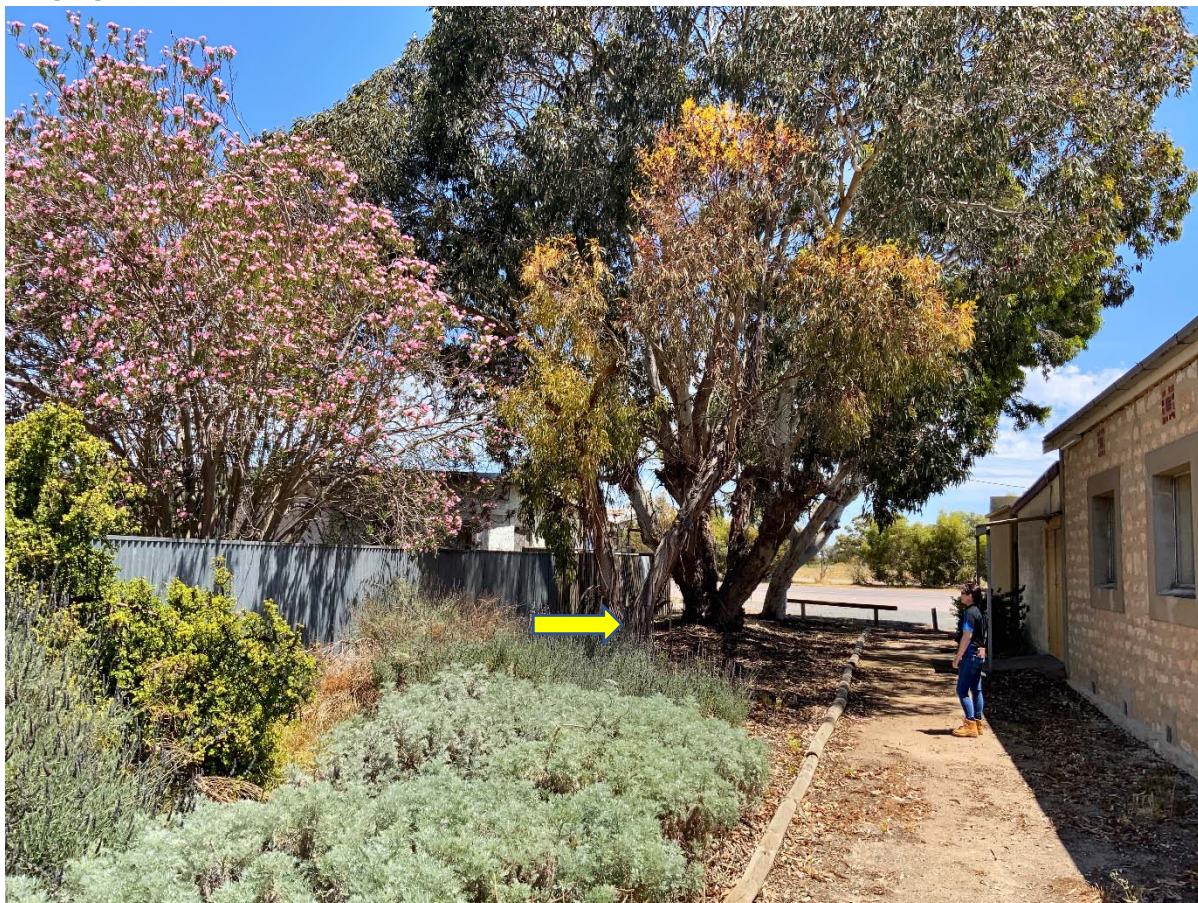
This SA Blue Gum has lost a limb on one side and is now epicormic growth, the other side is not in good condition either and will become a problem in the future as it tries to grow underneath the large tree, this tree is planted too close to the larger tree and will become a greater problem in the future as the tree matures. I'd recommend removing this tree as it will not grow to a form specimen like it should and will become unstable in the future.

Removal is recommended.

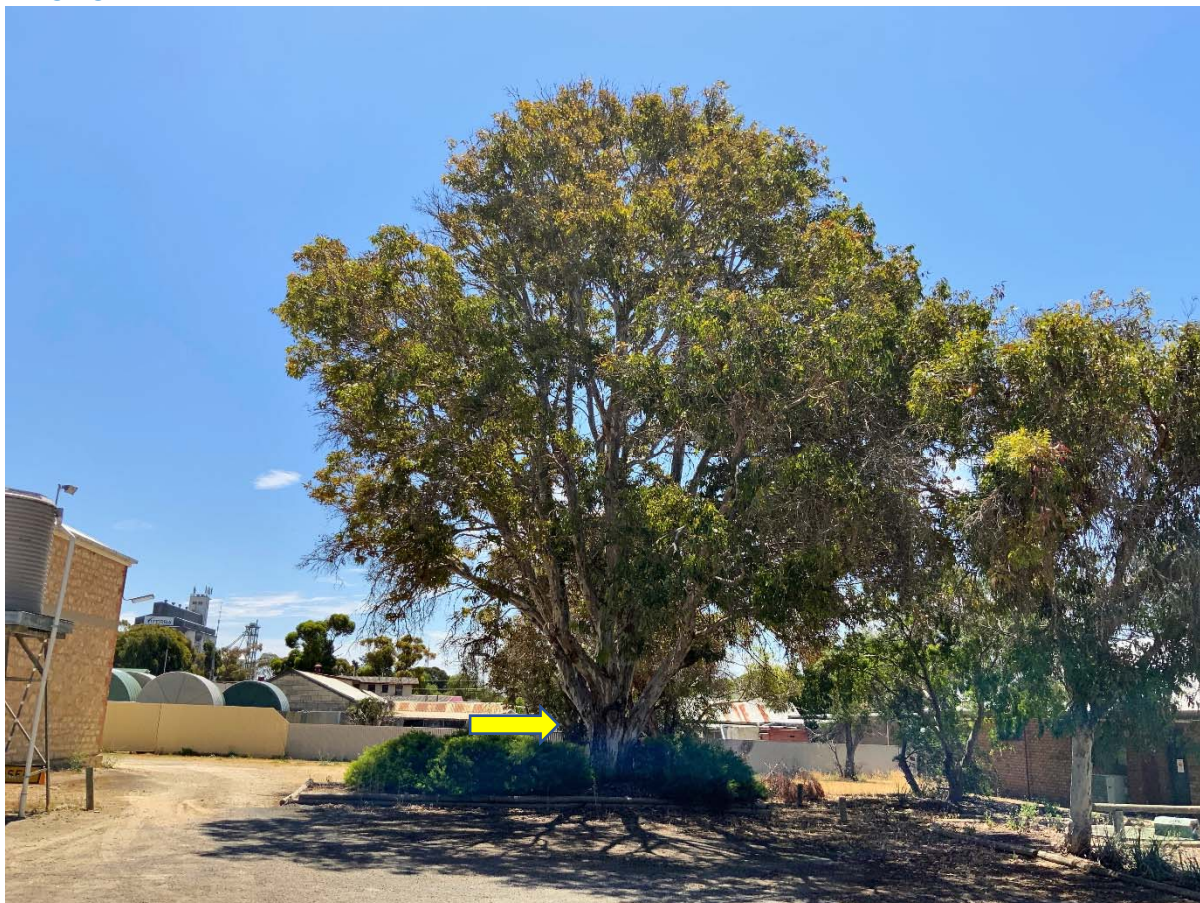
32. Eucalyptus leucoxylon

This tree is a good size and has good canopy spread throughout. The trunk is a stubby trunk with multiple limbs arising from the trunk itself. The tree has suffered in the past through water stress and because of this there has been dieback within the lower branches and not so much within the terminal canopy. I am recommending removing the deadwood from the lower branches and in places lifting the canopy where the canopy is drooping this should allow for reduce limb drop of dead wood drop throughout the canopy where people park beneath. No other pruning is recommended as a tree is coping quite well and will rebound once so moisture is replenished which it is currently underway.

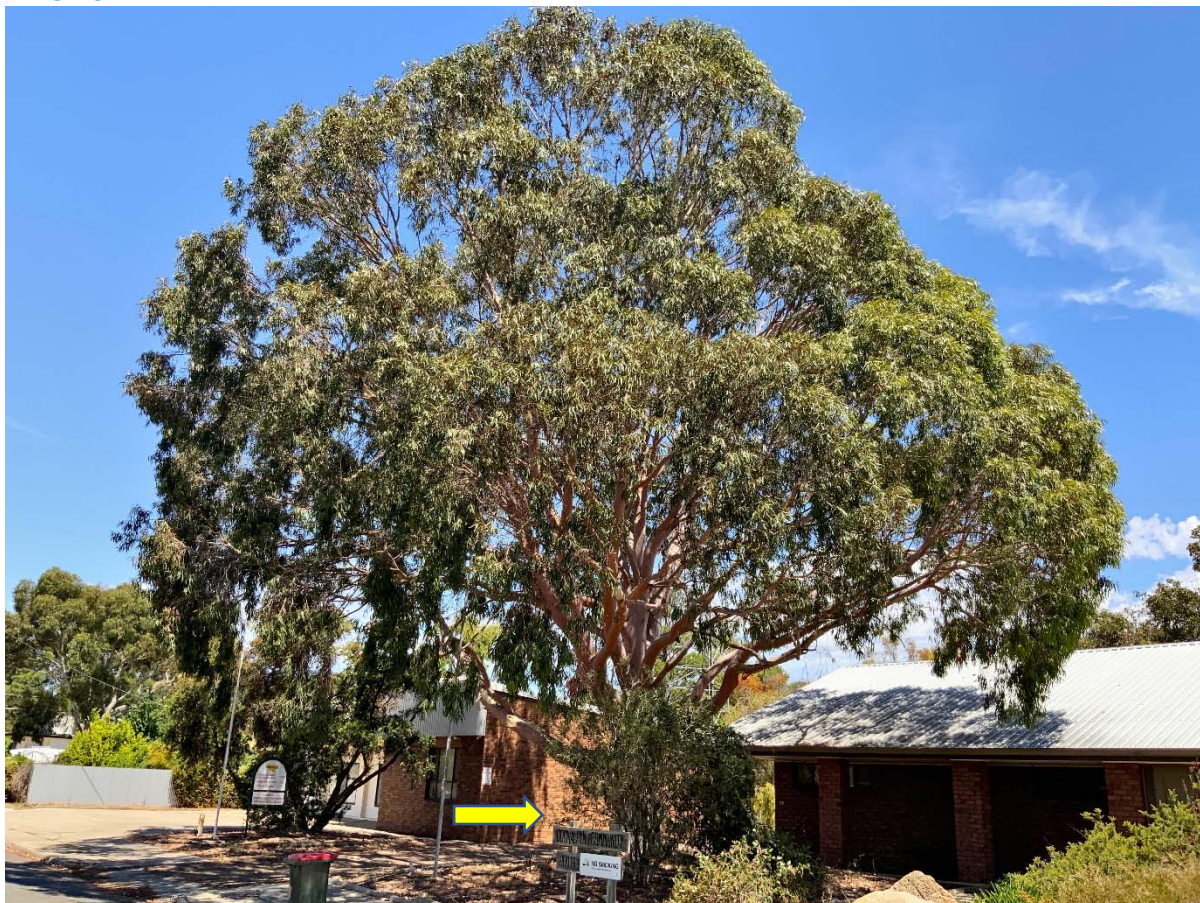
This Lemon Scented Gum has grown very well and does have good trunk and scaffold branch make up into the terminal canopy. The tree has very few areas of deadwood but will require removal of any deadwood that is within the tree as this is a health centre and the tree should not be a potential risk in this area. The tree is a broad domed specimen tree rather than upright open formed narrow tree, there are two different or defined forms for this tree and this is the one is the better tree form for the species as it is more compact within the canopy.

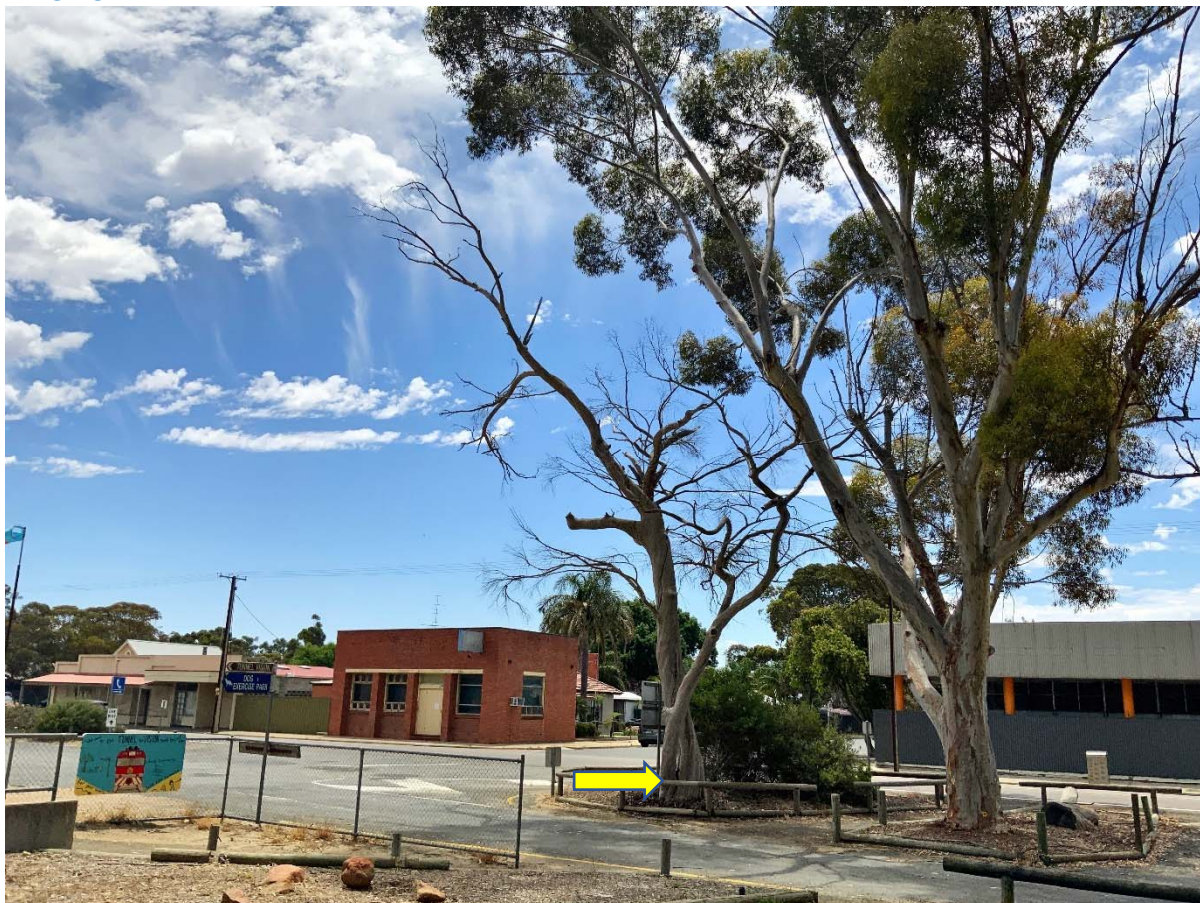
34. *Eucalyptus cladocalyx*

This dead Sugar gum has died and is currently void of bark and no live wood whatsoever the tree continues to dry out and as a result significant cracking is starting to occur within the heavy coil twist of the tree, this will lead to the tree cracking open and failing. The tree does not have large limbs that are a purpose of habitat, the cracking is starting to get to the size where they will become a habitat for micro bats, however it is very unlikely that they would possess this area at this time.

Removal is recommended as it is in within an area of public traffic and a public thoroughfare the rest stop and public toilet indicating that the traffic is of slow movement and of consistent use.
