COONALPYN TOWN PARK & STREET TREES

Tree Inspection – November 2020

Coonalpyn Town

TREE AUDIT

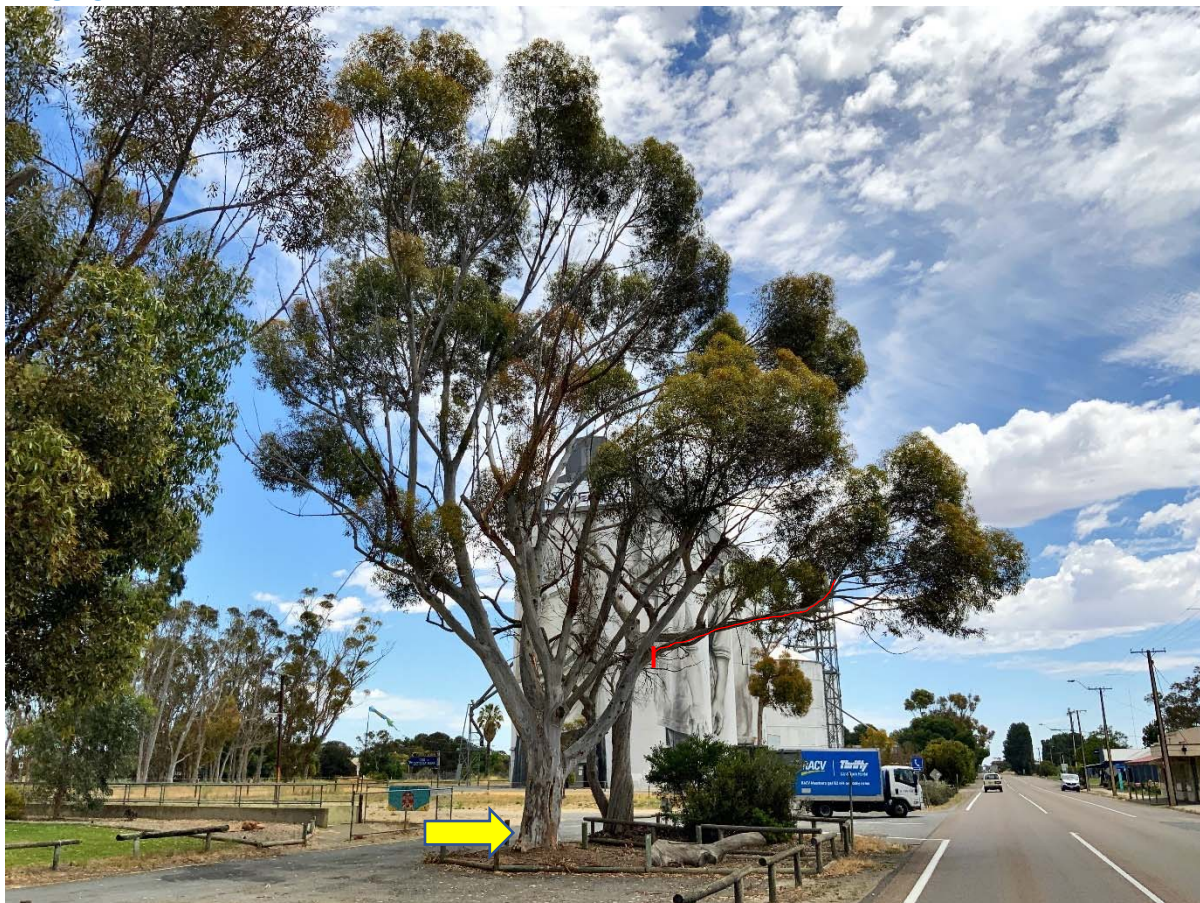
This large sugar gum has multiple areas of deadwood in the lower and mid canopy, the tree is also starting to develop hyperextended branch system due to past pruning that has occurred where new growth has begun or growth that already existed has accelerated in growth since the pruning occurred causing hyper extended growth within that area. There are areas where the dead tree next to it has started to cause damage an injury to the tree trunk, I am also recommending that the limb growing out to the roadway be removed this is quite a large limb and it will sag over time and many of the largest trucks that travel along this road cause major damage to the limb that it is growing on. Also I recommend removing the large deadwood within this area as it is an area where car parking is allowed and the slow moving frequent traffic

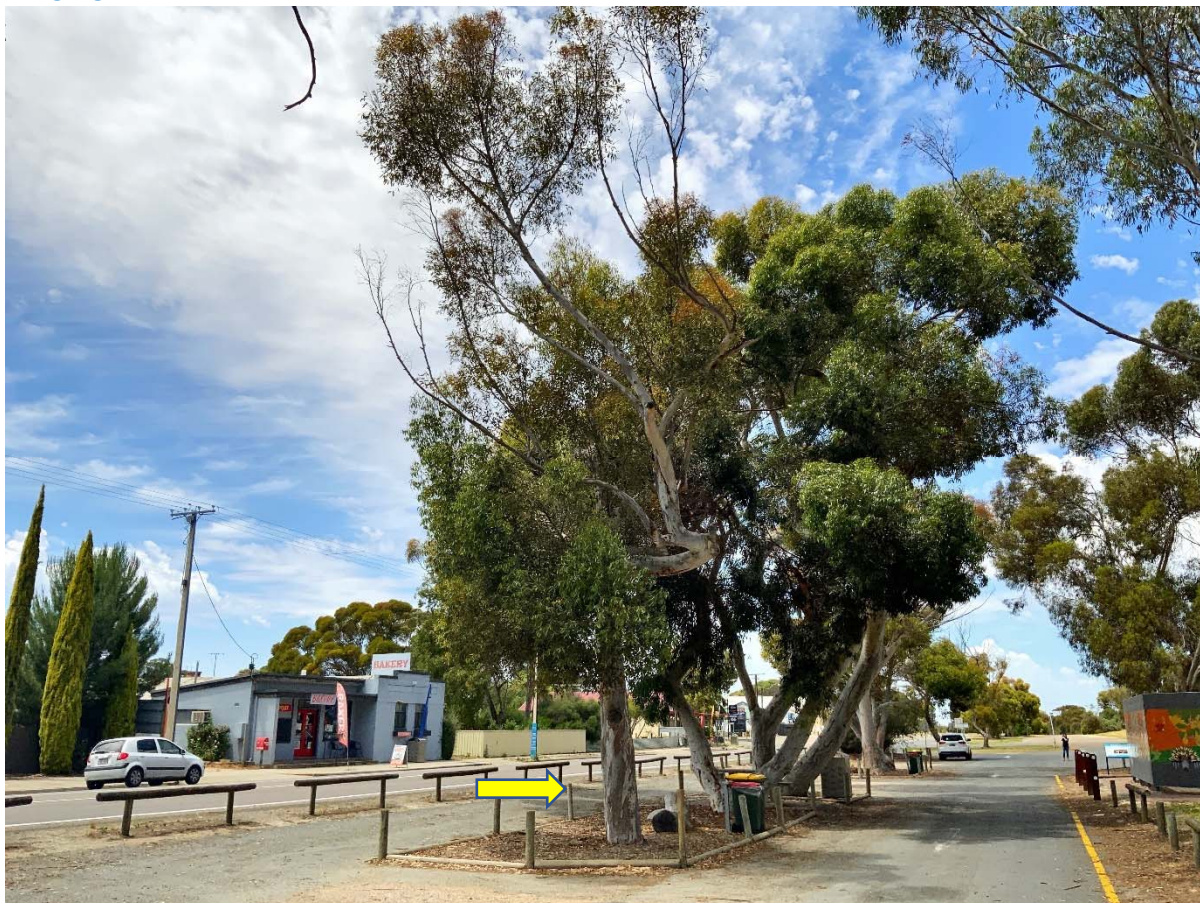
This young mature Sugar Gum has grown in an upright form that does have areas of deadwood but only a few that will need to be removed. The epicormic growth within this tree that is approximately 2.5 metres from ground level has grown significantly and does make a large part of this canopy now. This should not be removed as it will take away a lot of the energy producing foliage that the tree needs to survive. There is a lot of new growth within the old foliage which is a good sign that the tree is functioning enough to sustain itself and grow.

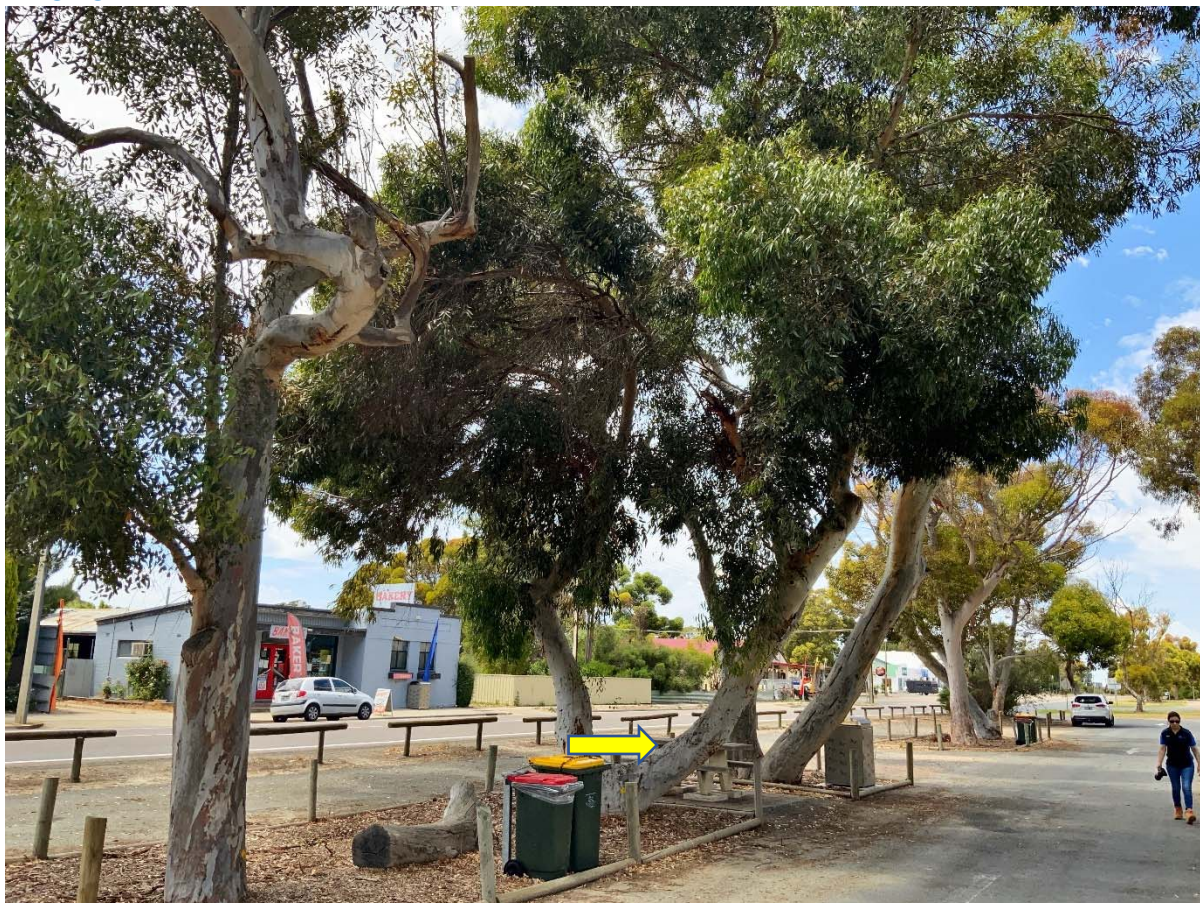
This Sugar Gum bifurcates approximately 800 mm from ground level, the tree is quite stable it has had pruning in the past which has caused secondary and tertiary growth to replace the areas of prune limbs, however many of these limbs are contained within the garden bed area with only one limb that has failed in the past. I'm not recommending any pruning on this tree and it is growing well and has not a lot of deadwood throughout the canopy..

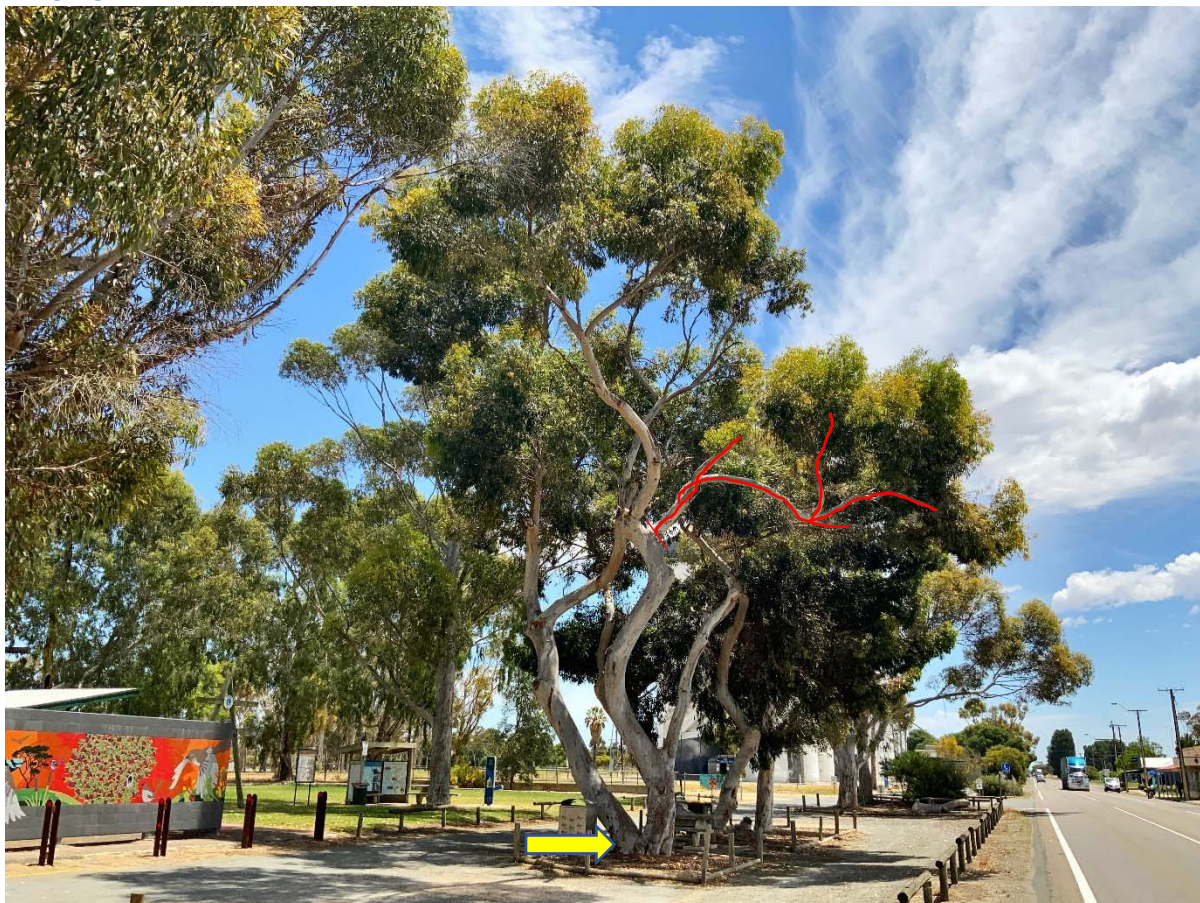
Sugar gum, this tree bifurcates approximately 600 mm from ground level and has twin well-structured leaders that extend up to the scaffold branch system. The leader closest to the main road has a large dead limb which will require removal to allow the branch to callous over and seal its wound naturally. On this tree the birds have caused damage, some of the damage is only recent. The mid canopy has storm damaged stubs that have started to produce epicormic growth, the stubs will require removal due to the weak new growth.

The limb that is growing out over towards the highway will require removal back to the attachment point on the trunk, this will remove any of the canopy growing out onto the highway and reduce any chance of failure or from tracks hitting it as it drips when it becomes a large weight of canopy within that area.

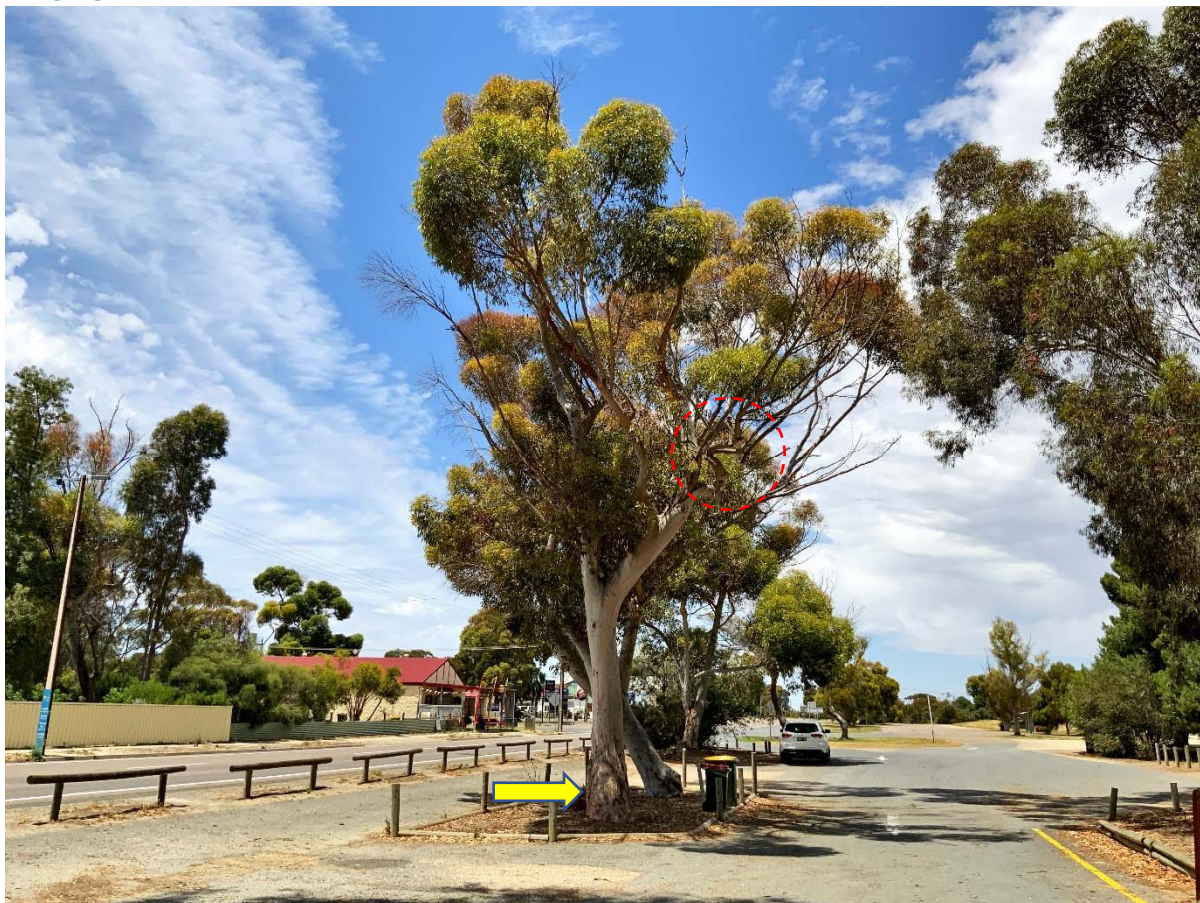
This Sugar gum is one of two within the garden bed across from the toilets, this tree has extensive deadwood of large size throughout the canopy which will require removal. There is one low crooked limb that will need also to be removed as this does not dissipate energy back through into the trunk system and will most likely fail like most like this do. There are large areas of deadwood in the upper canopy which is starting to rot out and will eventually become weak and fail these being such large branches will cause significant damage or injury.

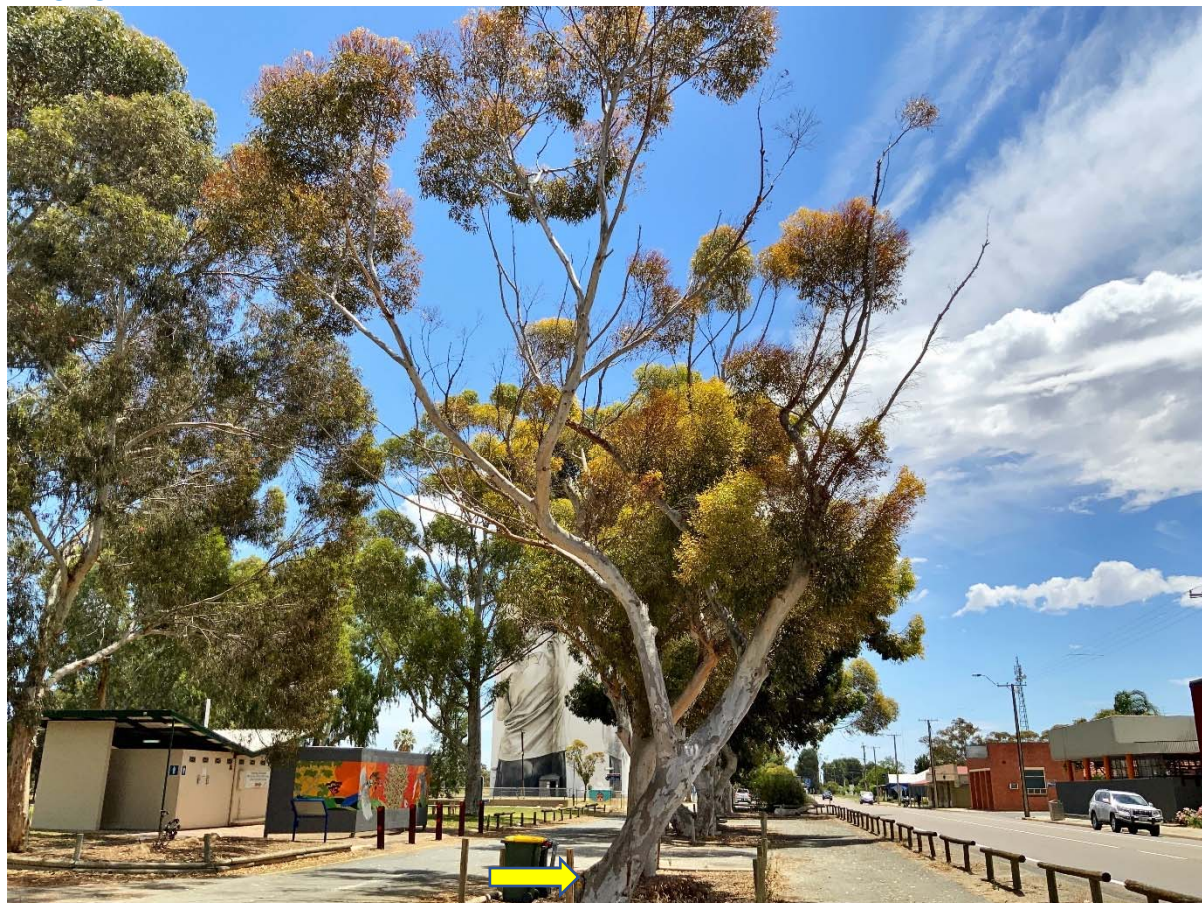
This young mature Sugar gum bifurcates approximately 3 metres from ground level, the upper canopy is of broad opened configuration with areas of deadwood of size and also epicormic growth which is hyperextended out from the areas of the cut points. Both the deadwood and the epicormic growth will need to be removed due to the hyperextended growth from these cut points becoming overwhelmed during storm events and failing either at the base or just up from the base.

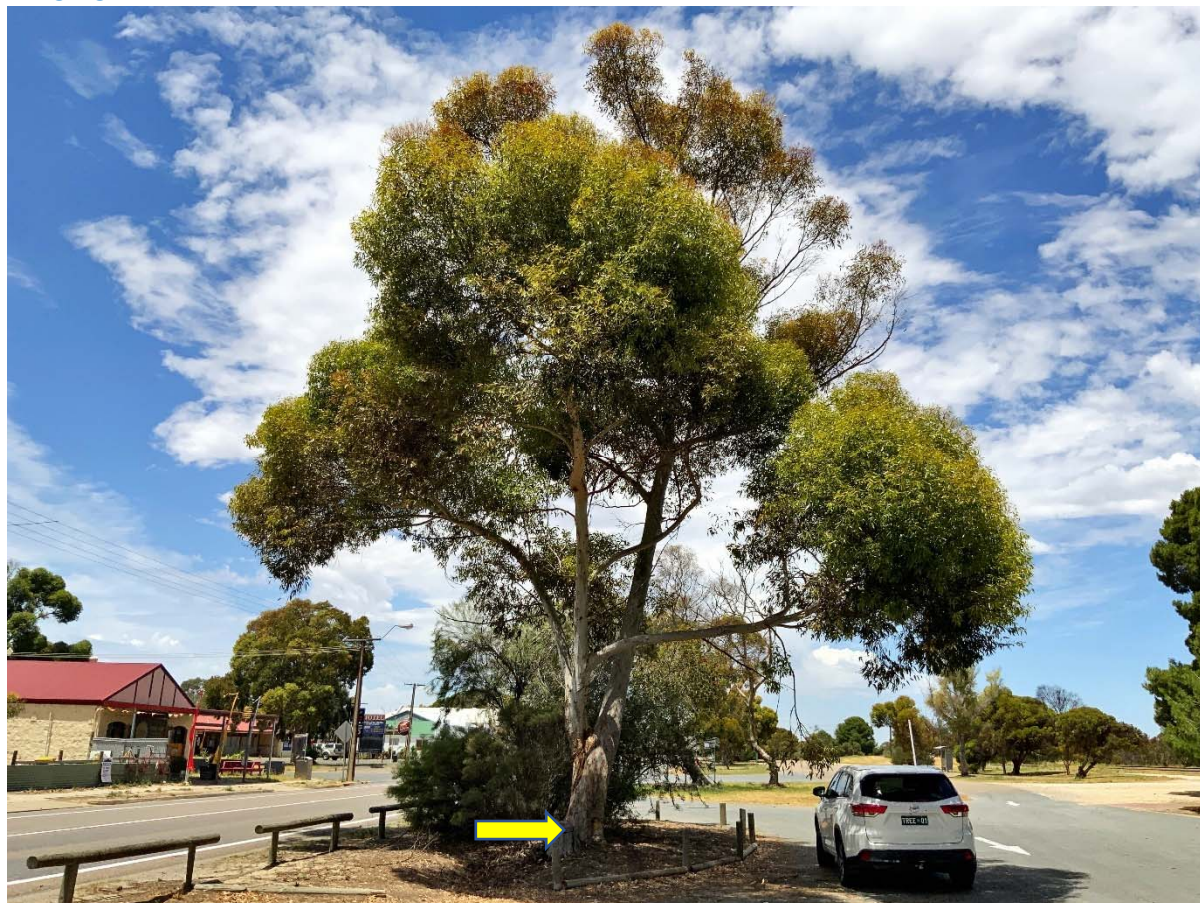
The trees canopy has only a minor amount of deadwood which does not require removing, on the highway side I am recommending that the canopy be lifted by weight reduction of the lower canopy to allow for enough access where trucks do not hit the canopy and cause branches to break off, pruning of the lower canopy will promote upper growth also reducing the amount of future maintenance.

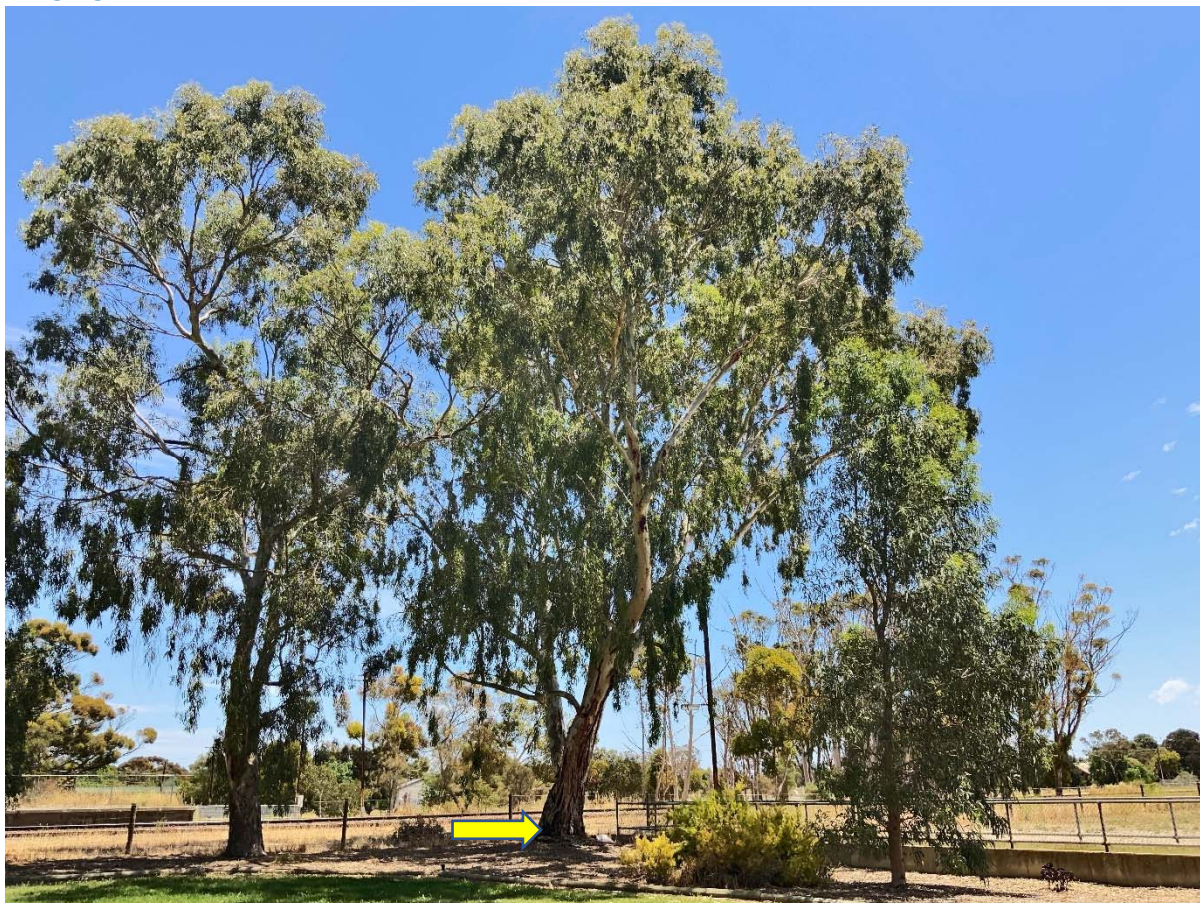
This large tree has double bifurcation at approximately 1.5 metres resulting in triple leaders of good size that have developed into a good even canopy. This tree looks to be suffering from water stress and has suffered from water stress in the past as there are many areas of failed limbs and one recent failure which is from suddenly drop which can be associated with past water stress. Being a River Red gum, they do have extended sinker roots but they will suffer if they do not get the required amount of water they need to survive.

This is one of the trees where the stomata are not fully sealed off to reduce evaporation from the leaves, they will continue to evaporate when they do not or cannot afford to lose moisture. The tree needs to be audited more regularly to determine if the tree is becoming a greater risk of limb failure.
