Open Space Services

WELLINGTON EAST CEMETARY TREES

Tree Inspection – March 2021

Wellington East

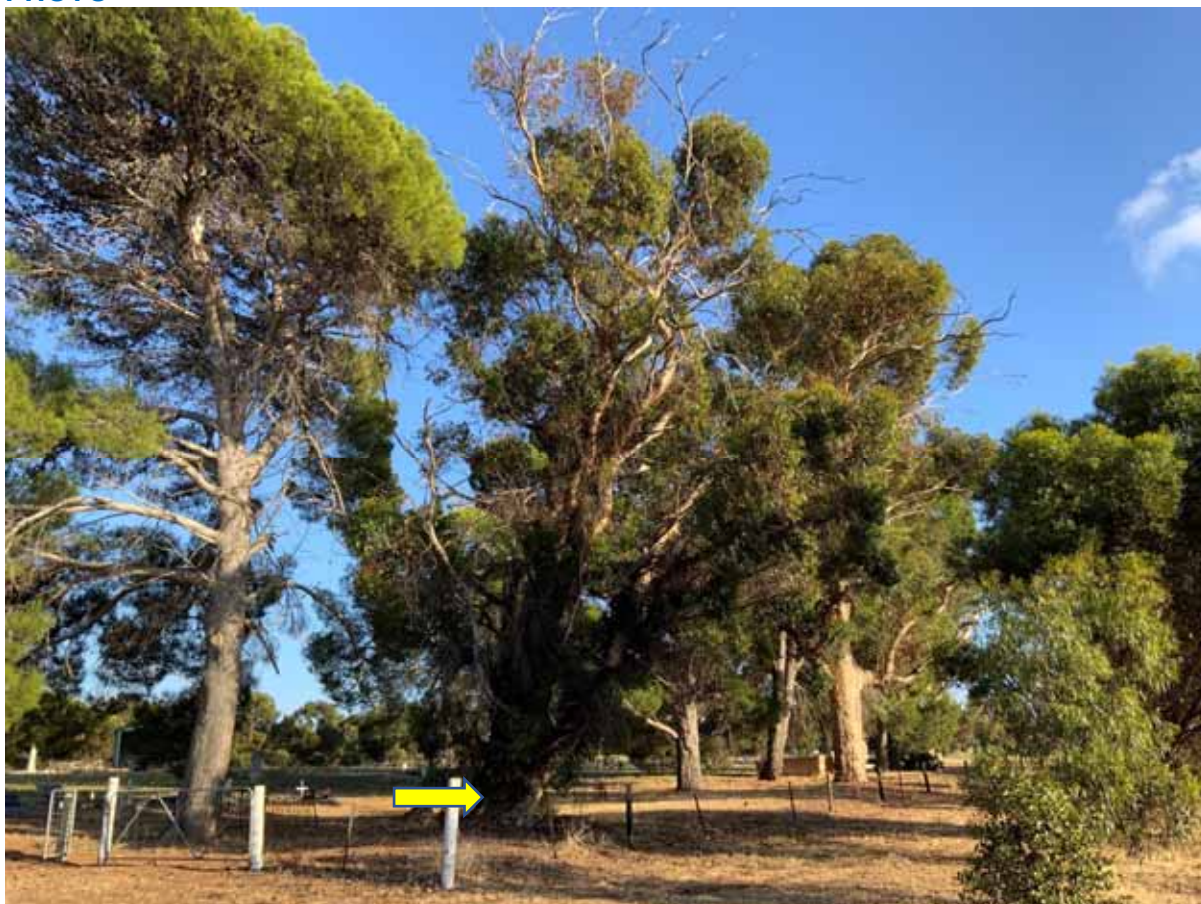
1. Eucalyptus species

MEDIUM RISK

This large eucalypt has suffered in the past from both water stress and from the encroachment of the large Aleppo pine. The tree has grown out on an angle due to phototropism and the confined area of planting that has occurred throughout its growing life. The tree is regenerating which indicates that the passed problems are due to water stress. As the tree is regenerating it should continue to grow back especially over the winter months when the rejuvenation of soil moisture becomes adequate to sustain the tree. The amount of deadwood will need to be removed back to the point where regeneration has occurred. This is due to it being in the entrance way and in a high traffic area for this situation which is not as high as it would be in some other places but still significant. There are some larger Deadwood approximately halfway up which will need to be removed as it is quite large and does not look to have habitat hollows within them.

Prune out the large deadwood.

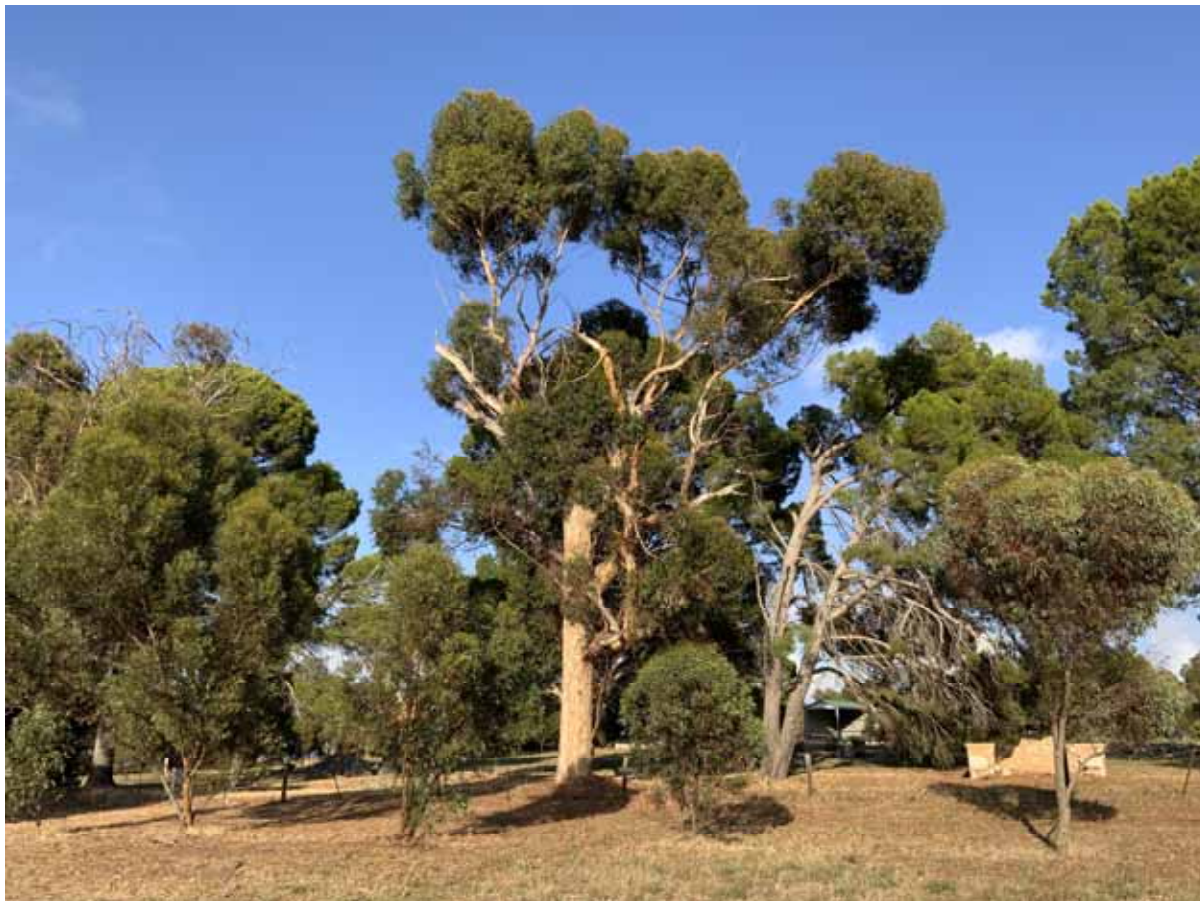
2. Eucalyptus species

MEDIUM RISK

This tree has multiple failures in the past with at least 10 that can easily be seen and are large and some may have been a result of falling limbs further up. The tree has had significant dieback also due to water stress and this tree is going to need deadwood removal including the stubs from previous breaks. If the tree has more failed limbs in the future then the tree may need to be removed, however as the tree is in a low use area I am recommending that the tree stay for now. There is one limb which is growing out over the fence which is on a lean and I am recommending removing this branch back to the attachment point this will also remove the hyperextended branch that looks to be the next area of break on this tree.

Prune out the large deadwood and remove the limb growing out over the fence.

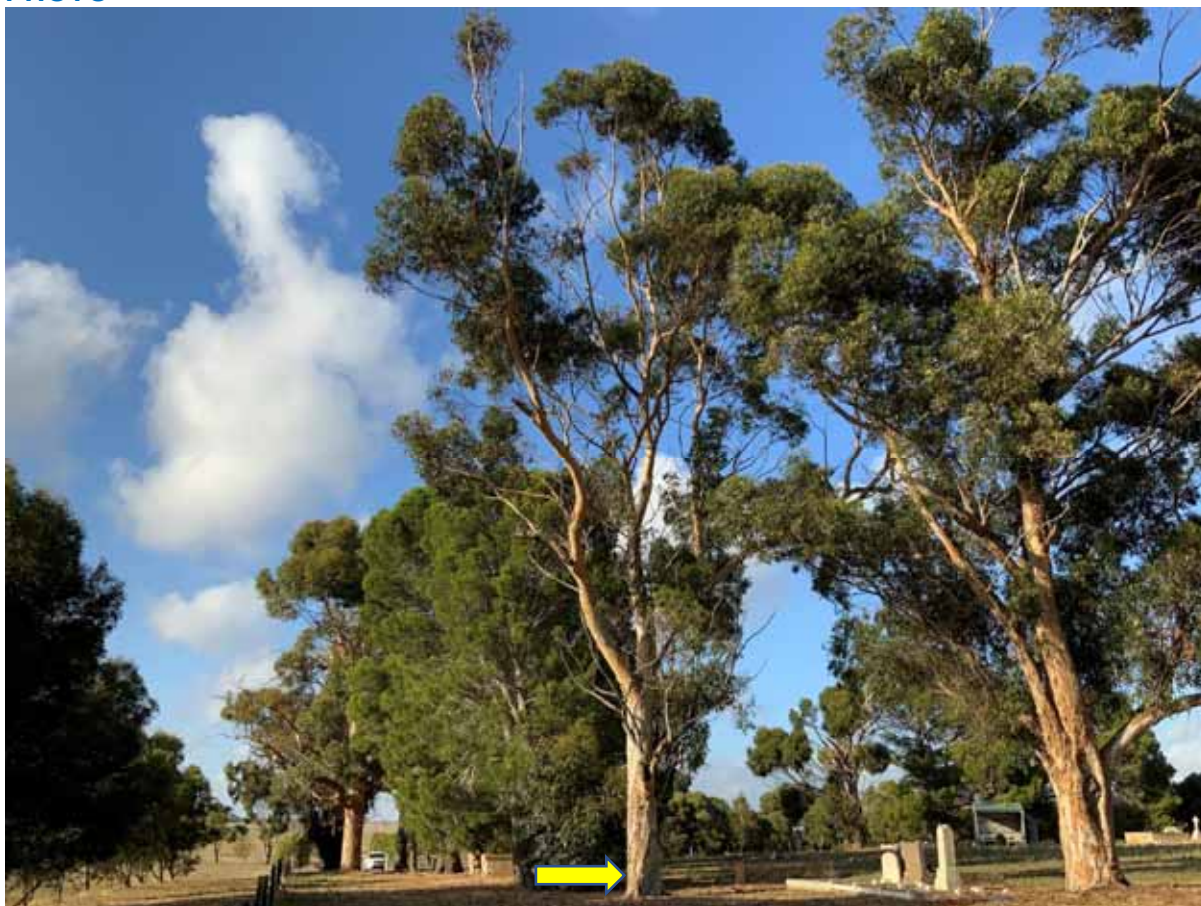
3. *Eucalyptus cladocalyx*

MEDIUM RISK

This tree has suffered from water stress in the past but not as bad as the other two trees have. This tree does have a void in the attachment point approximately 5 metres from ground level this looks to be from Borer damage. The void is only on one side with the remainder being structurally sound. There is one large dead stub over the access way between the fence and the tree which will require removal as this piece of deadwood may fail. The trees in the past have had bird damage throughout the area but most of the damage is being encroached by wound wood. I recommend removing the deadwood and the void should be inspected at least every three years.

Prune off the large deadwood.

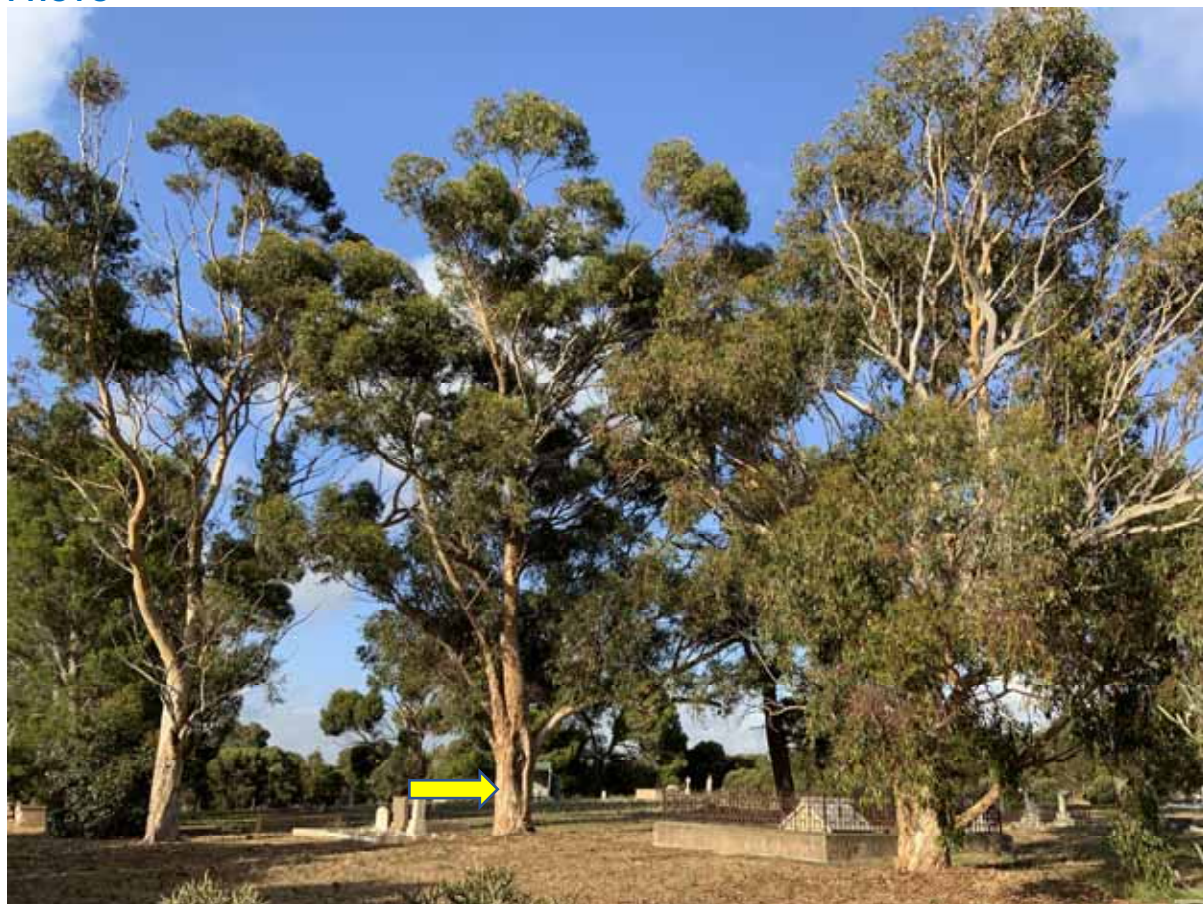
4. *Eucalyptus cladocalyx*

MEDIUM RISK

This is the fourth in the line of trees that will require dead wooding although not as much as the other trees, this tree is more isolated than the other trees and has grown much better because of this. The tree does have an injury on one side of the trunk, there is a hollow habitat within the centre which extends from the central attachment point, however the live wound wood around these areas is quite large which indicates that the tree is still held together in a quite sound manner.

Remove large dead wood throughout the canopy.

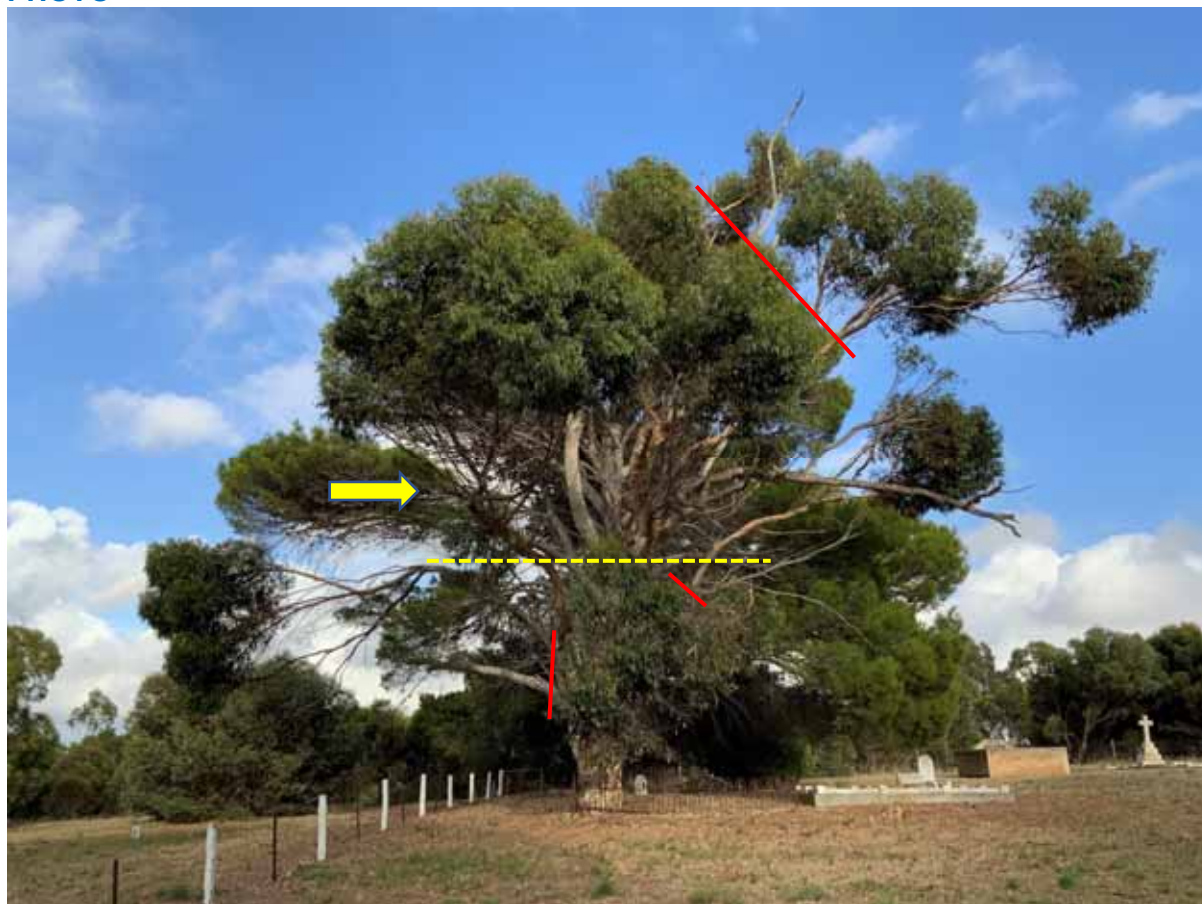
5. *Eucalyptus cladocalyx*

MEDIUM RISK

This tree also has suffered from water stress but is regenerating quite well. This tree will need deadwood removal as well as removal of second tier and low hyper extended live branches. The hyperextended limbs are the limbs that are extended outside the canopy and can easily be broken off when storm events occur. The larger dead wood to be removed is abundant throughout the tree which is due to water stress, foliage below the yellow line will require removal as this will develop faster than the upper foliage which will continue the upper canopy dieback when the area becomes low in moisture.

Prune out the larger deadwood, prune out the hyperextended green wood and remove foliage from below the yellow dotted line.
