21 June 2022

Project No. WGA220616

COORONG COUNCIL CARRIAGE CONDITION ASSESSMENT INSPECTION OF RAILWAY CARRIAGES, TAILEM BEND ON 25 MAY 2022

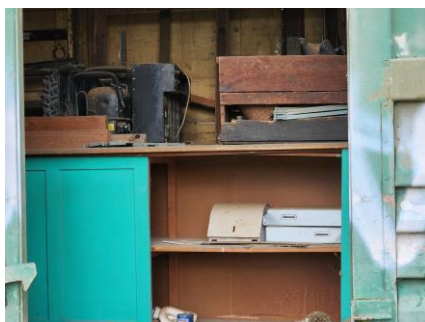
No 7: White Timber Clad Carriage Fitted Out for Accommodation, Consisting of Three Sections: Bunks, Bathroom, Kitchen

Some rot in the wall timbers. One door damaged.

Roof in poor condition but generally sound. Not extensive rust.

Chassis and bogies have surface rust but little overall loss of section.

Plenty of loose items.
