# TINTINARA TOWN PARK & STREET TREES

Tree Inspection – March 2021

**Tintinara Town**

**Arborist**

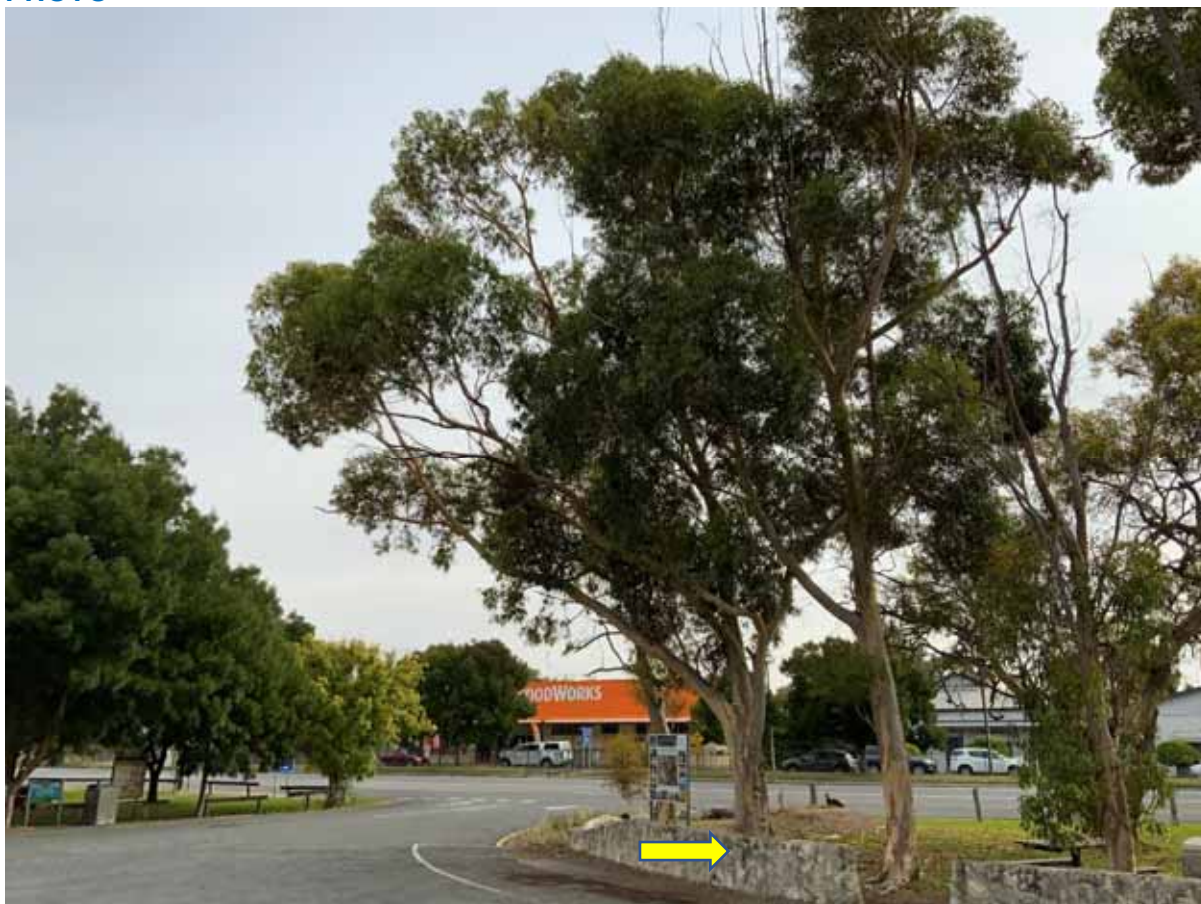
This tree is a lot larger than the one before so the concentrates of minerals within this tree is far less than the small tree. This tree's root population is much larger and it would take more to impact this tree. However, there are areas of dieback as the tree is not immune to the mineral buildup within this area. The larger dead limbs will need to be pruned out of the tree.

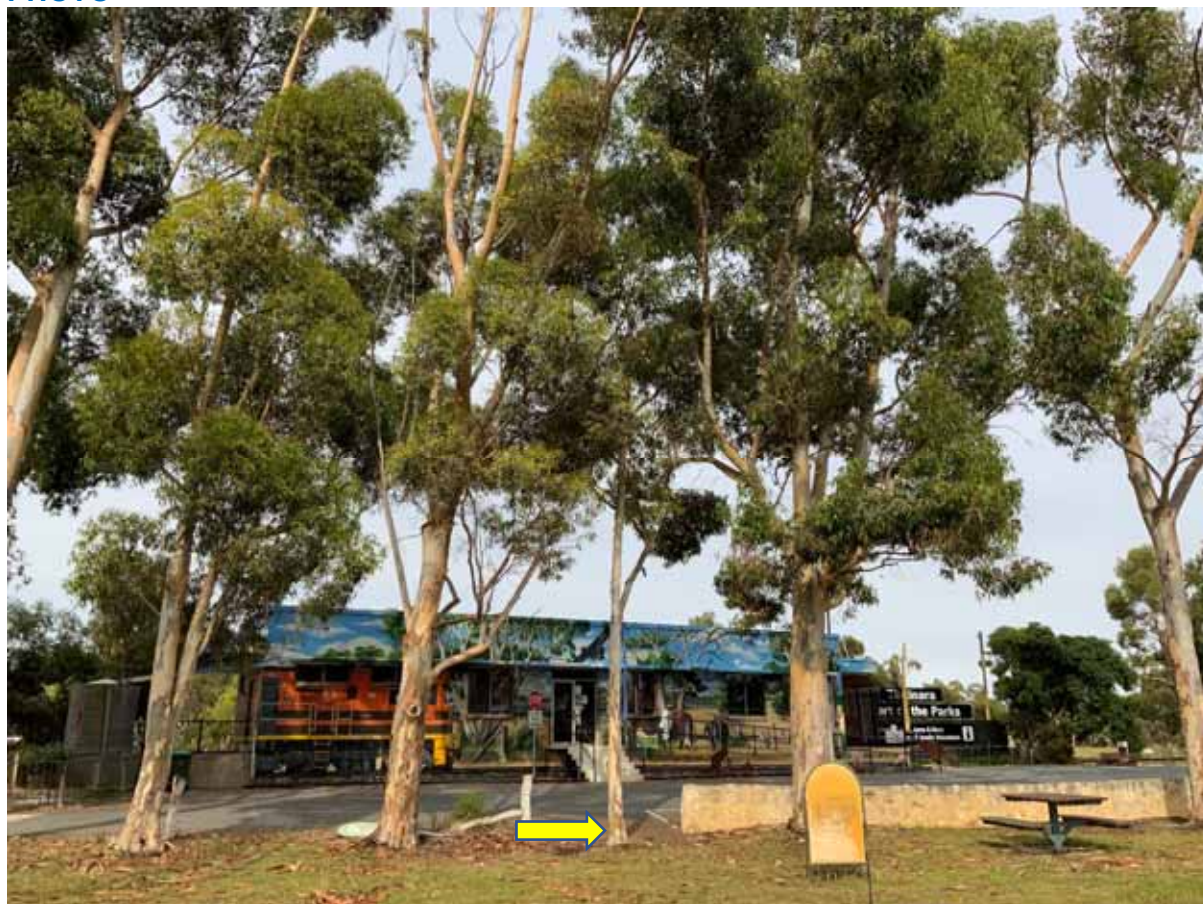
This tree is only a young specimen but is growing well within the confined area of related to gums, the tree will continue to grow as it is close to the terminal canopy where sunlight will allow it to fill out much more than it currently is.

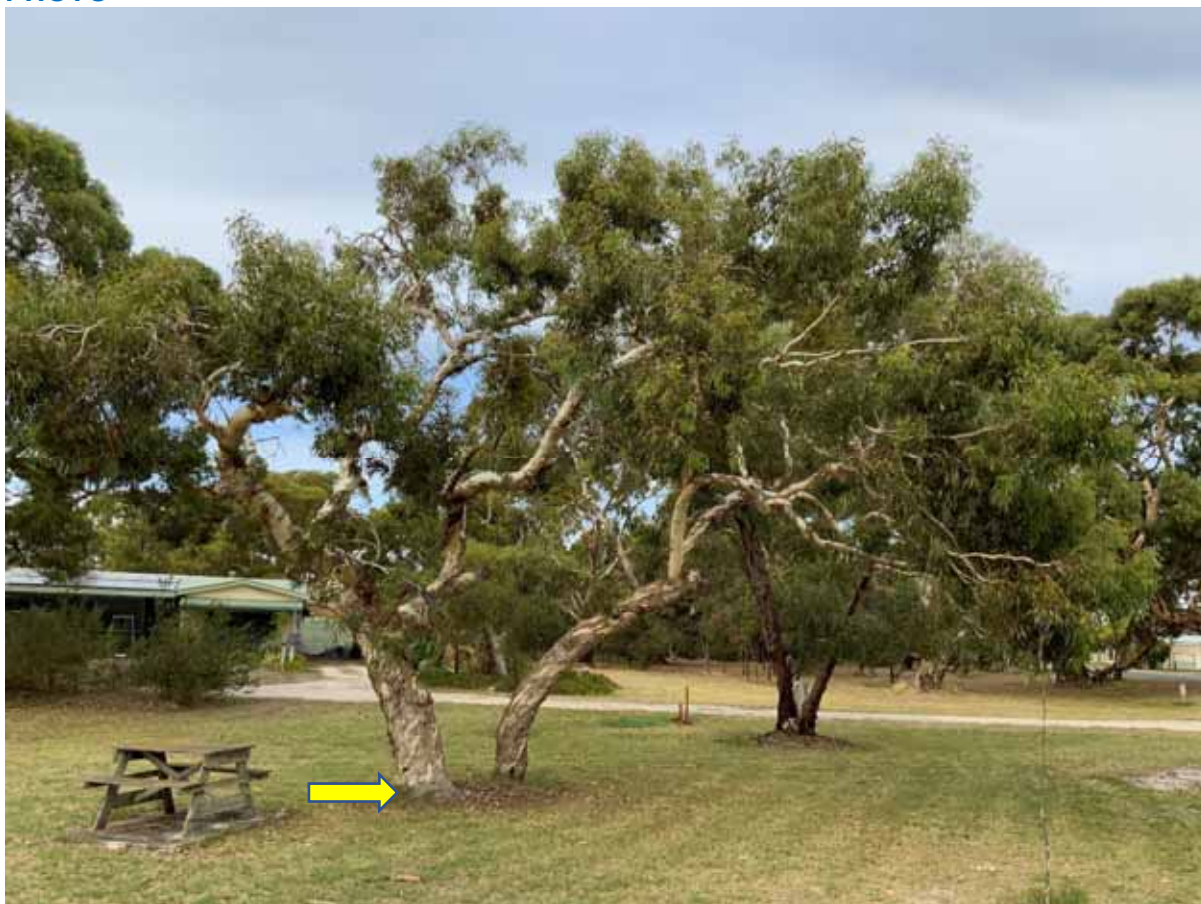
This Pink gum is located close to the swing and also close to the old bench seat and table. A lot of the deadwood has been removed and the tree itself is looking quite healthy with good growth sequence throughout the canopy. The tree does have a torsion twist which is not uncommon, it does not reduce the structural capacity of the tree. In the upper canopy there are deadwood that is rubbing against the live wood this will need to be removed as well as the deadwood that remains within the tree should also be removed.

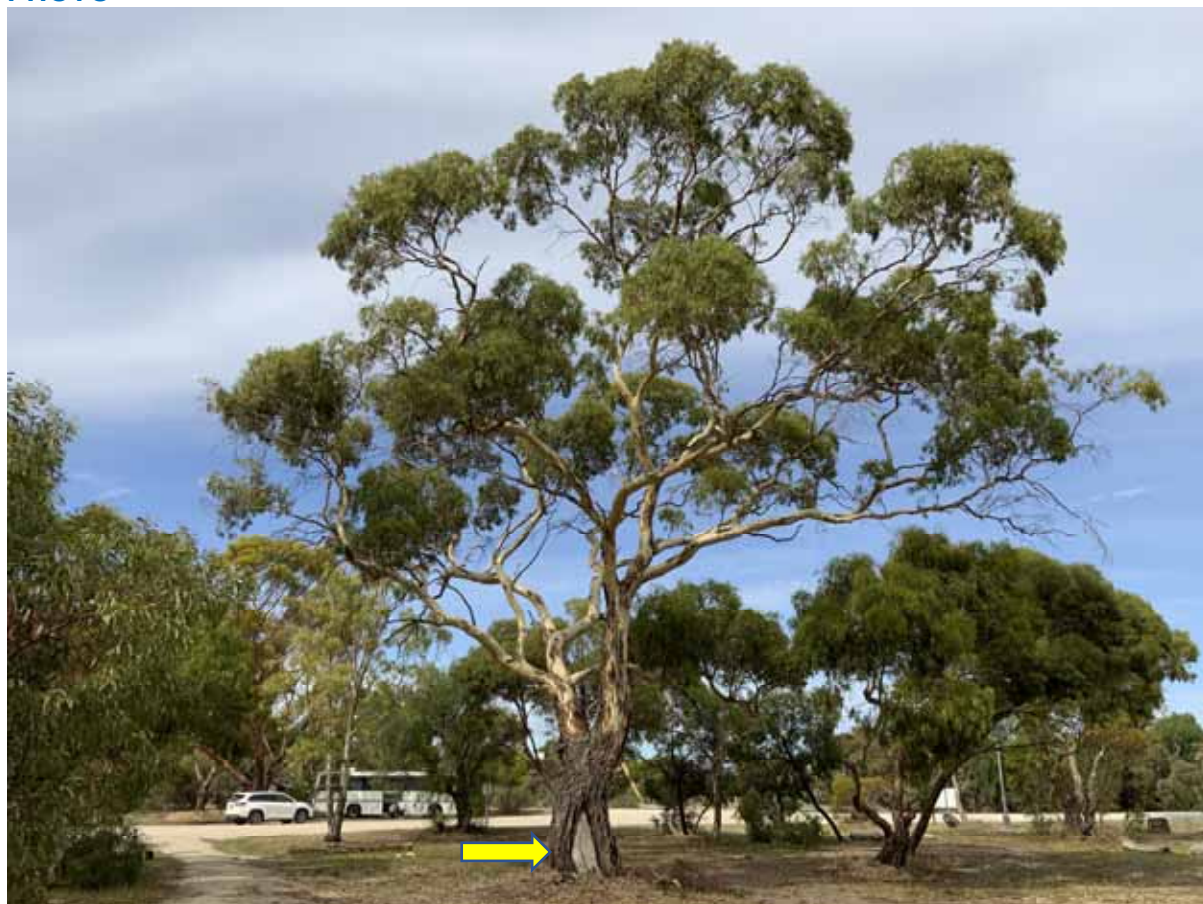
This SA Blue gum does have a good structure and form, it does have a large area of exposed deadwood at the base but this has been ribbed by the tree to strengthen the area of lost structure support. The tree's overall structure is very good the only thing that is a problem here is the deadwood, the amount of large deadwood in this area needs to be removed due to the amount of people that camp in the area.

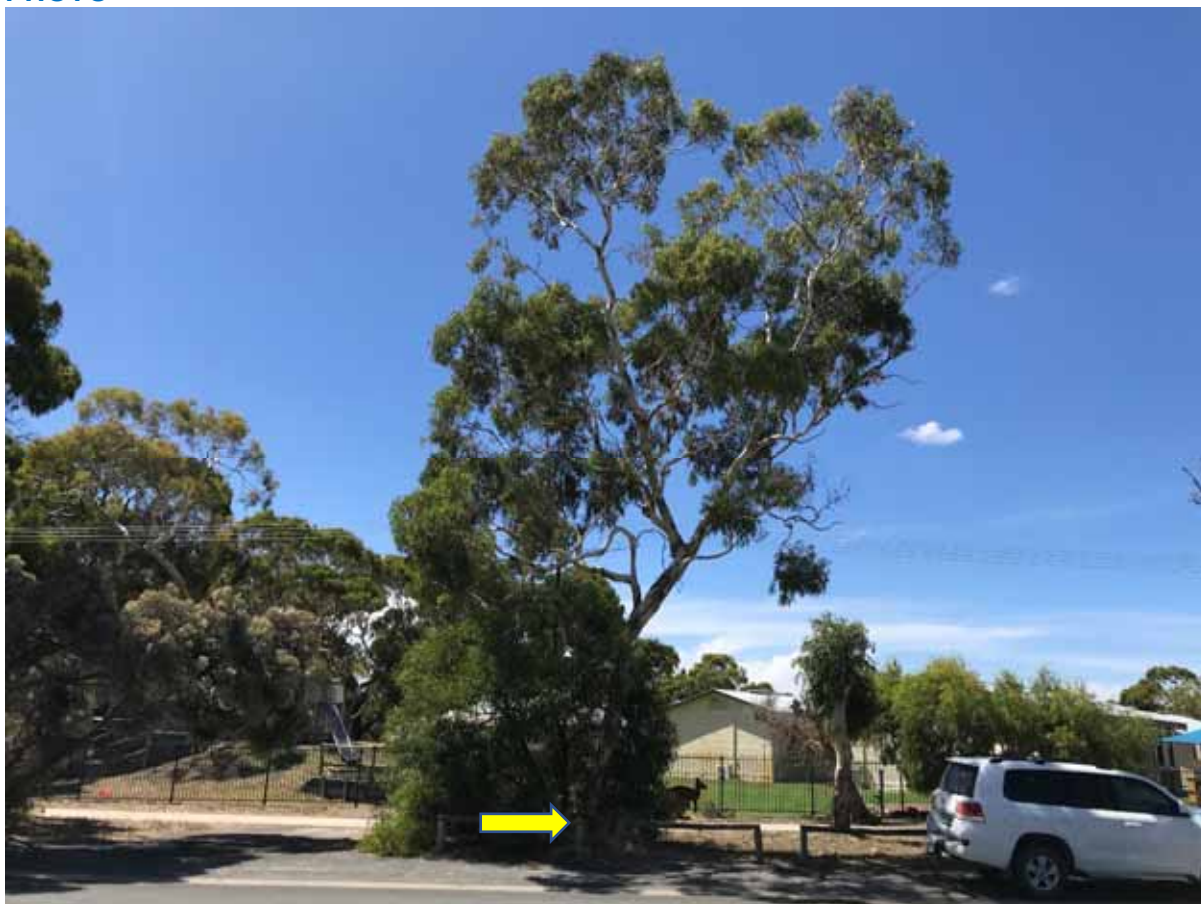
This SA Blue gum has lost one of its leaders in the past due to included bark however the tree has started to envelope the old deadwood and is still growing quite well in an upright stable configuration. The tree has good canopy cover and a domed canopy acceptable to the size of the tree. There are a few minor areas of deadwood however the deadwood is a natural dieback progression of under canopy small wood.

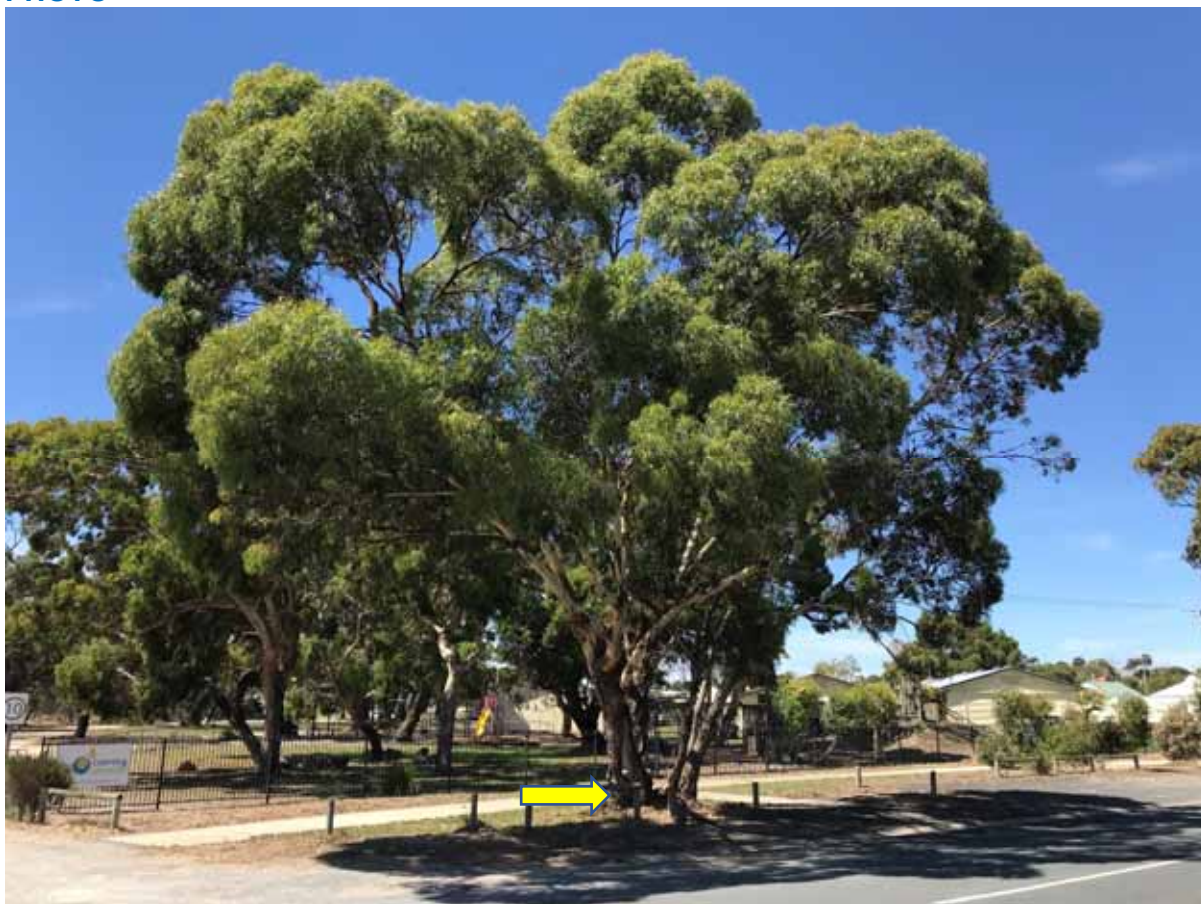
This tree has multiple trunks which indicate that it may be a tree that was removed in the past and the current growth is epicormic regrowth. The tree is still structurally sound even though there is deadwood at the base of the tree the wound wood has expanded through growth to encase the separate leaders. There are some lower deadwoods which will need to be pruned this can be done with a pole saw.

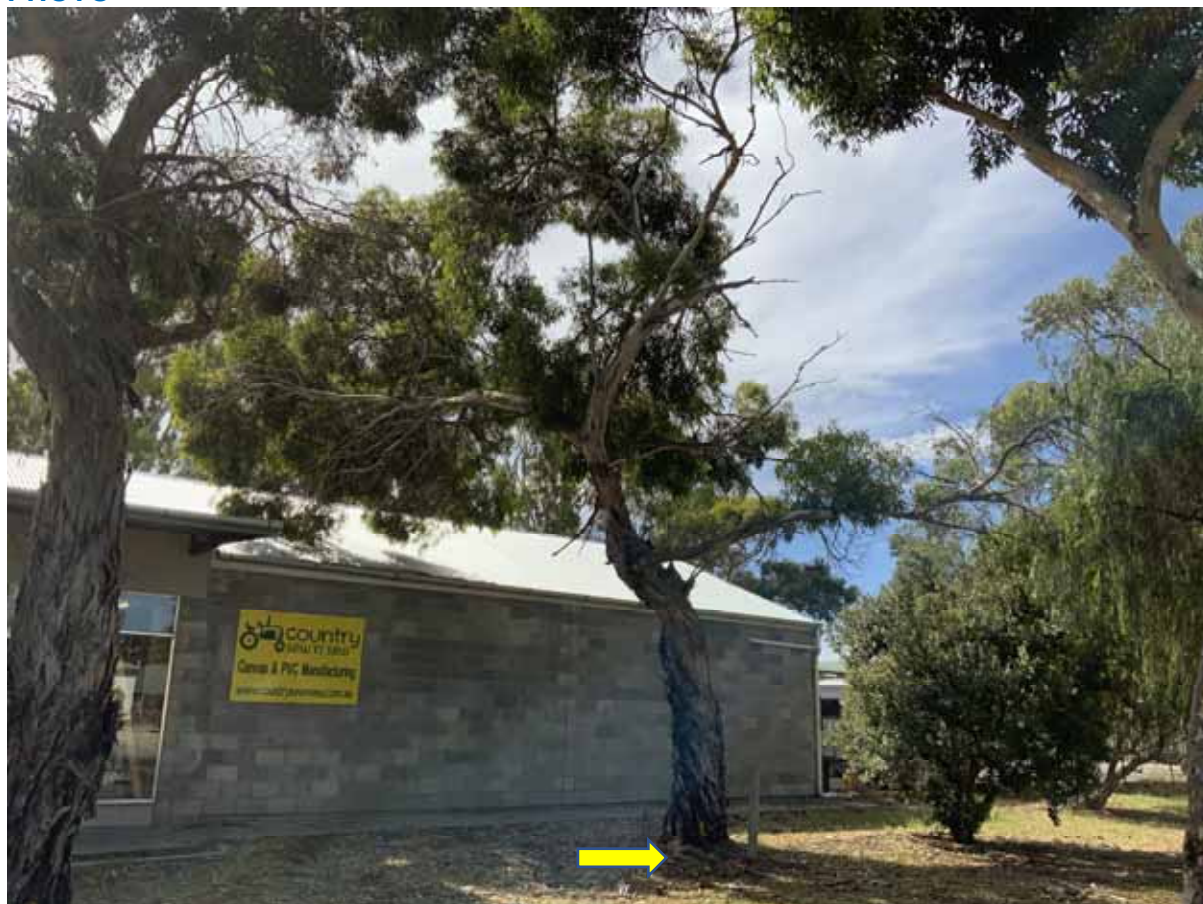
This SA Blue gum is in fair condition and within a good growth cycle that is filling out the canopy. The tree has grown to its environment, the canopy is adjusted to the area of greater light, it does have areas of deadwood and the canopy is touching the roof of the building. Both the deadwood will need to be removed and the foliage pruned back 1.5 metres from the building.

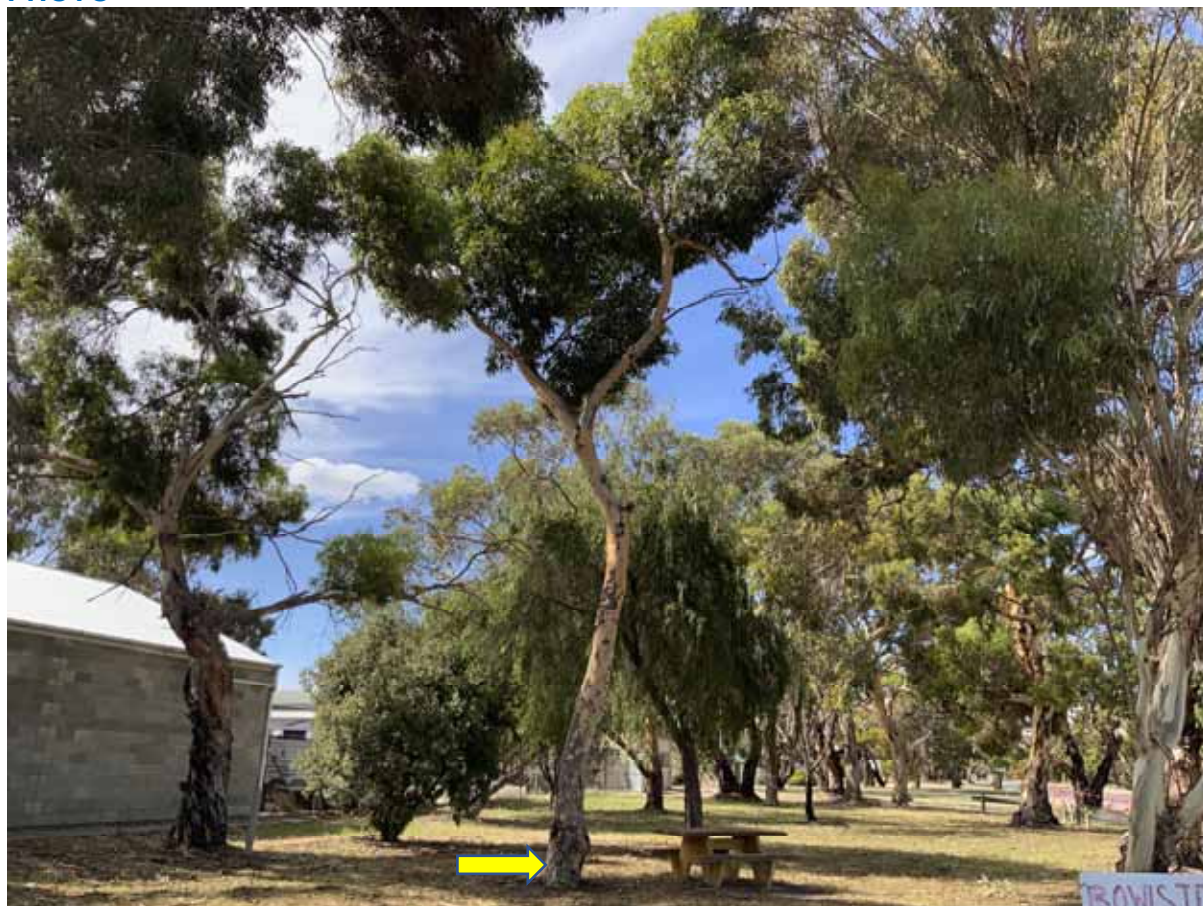
This Sugar Gum has grown in a forest form upright manner, the canopy has a small sail area on top of a well tapered trunk, the area of deadwood is minor and does not require removal this time. This species has grown better than the Blue gums and have a better foliage for energy production.

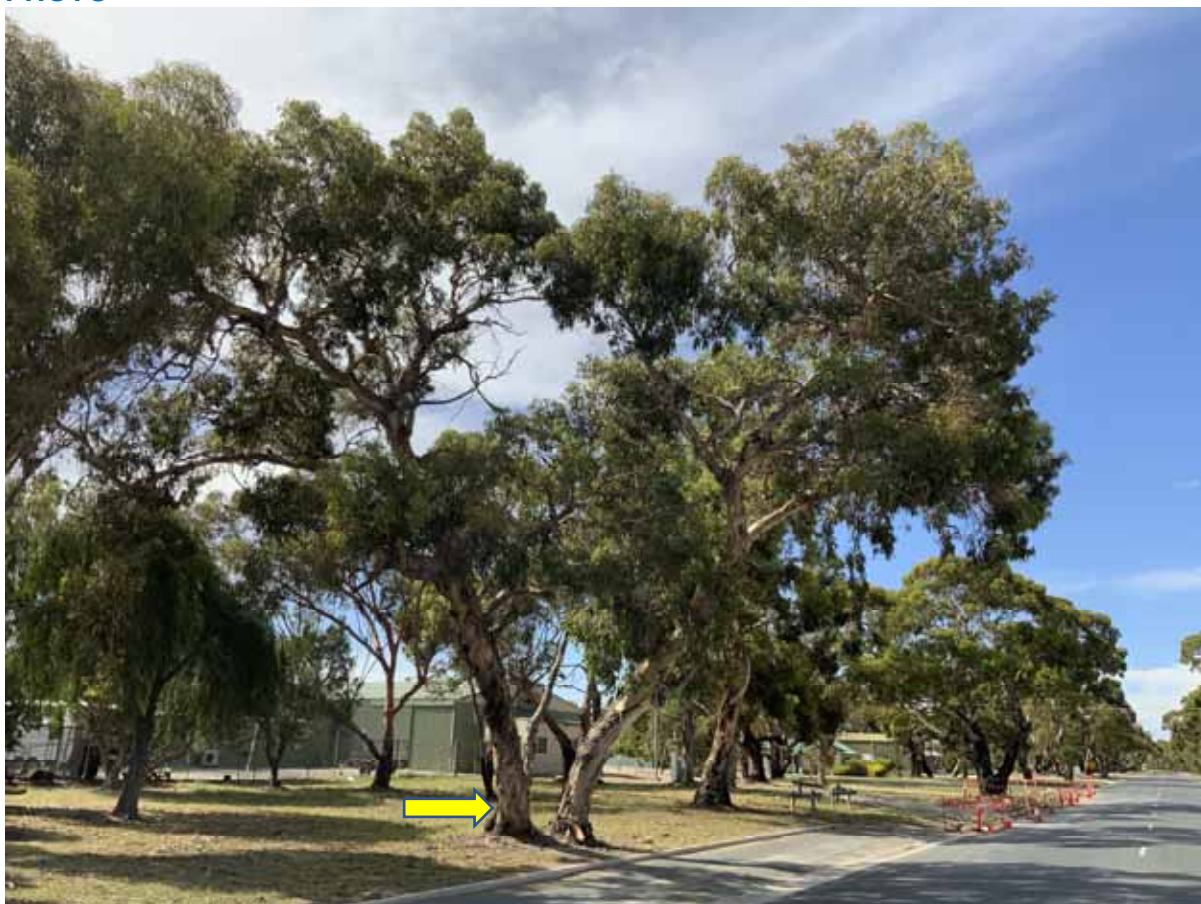
This SA Blue gum is a twin leader tree with one leader that leans out over the road, weight reduction over the road to lessen the weight on the end of the large branch growing out over the road is needed. Weight reduction of the leader on the other side over the table and chairs, remove the bottom limb next to the top limb over arching limb, and remove the larger deadwood from the tree.

Weight reduction pruning of the large limb over the road and pruning of limbs over the seat is recommended, remove the larger deadwood from the whole canopy.

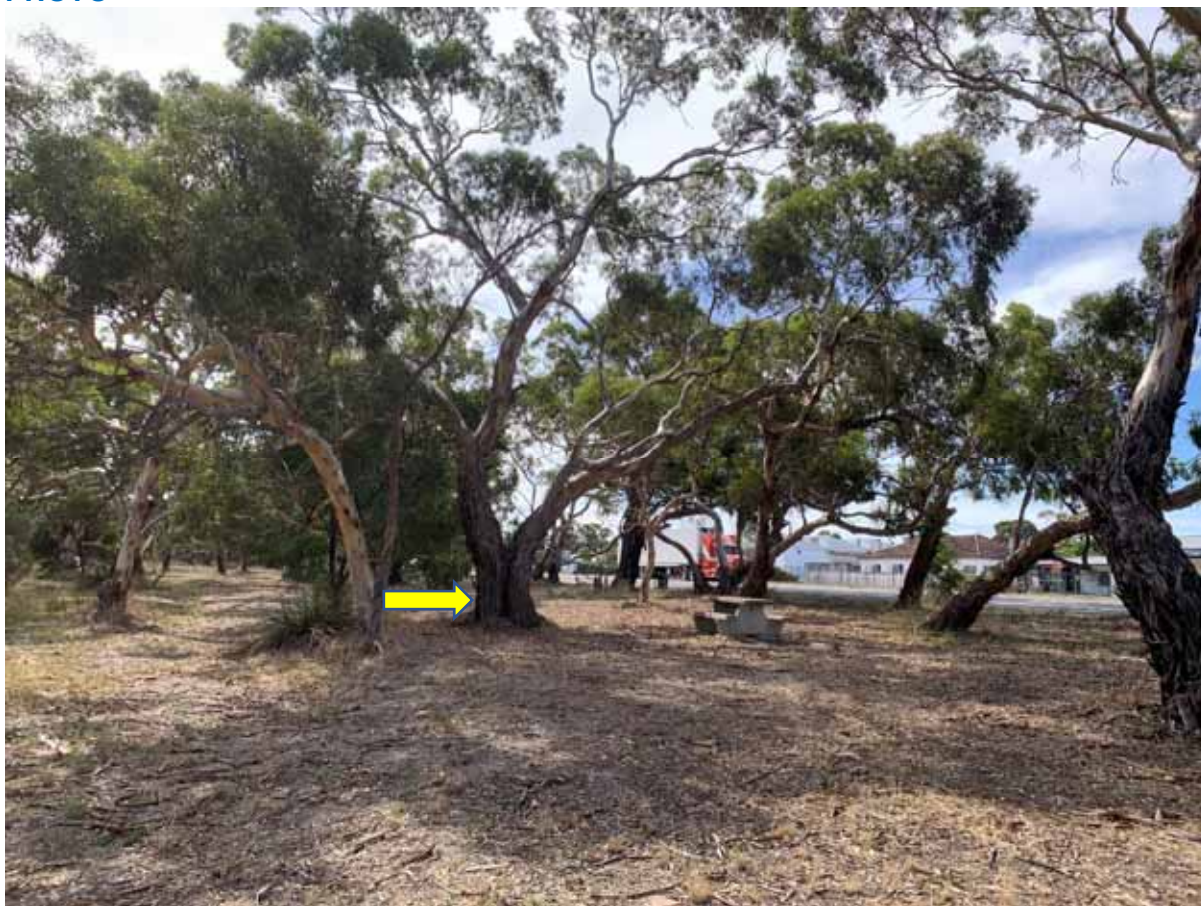
It's SA Blue gum will need to have a large limb that is growing into the next tree removed down to the attachment point. Removing the limb hanging over and resting in the other tree will also reduce the rubbing on both trees. The large deadwood that is above the seating area will also need to be removed, all other deadwood can be left as this area is a natural roadside rest and is only a low use area.

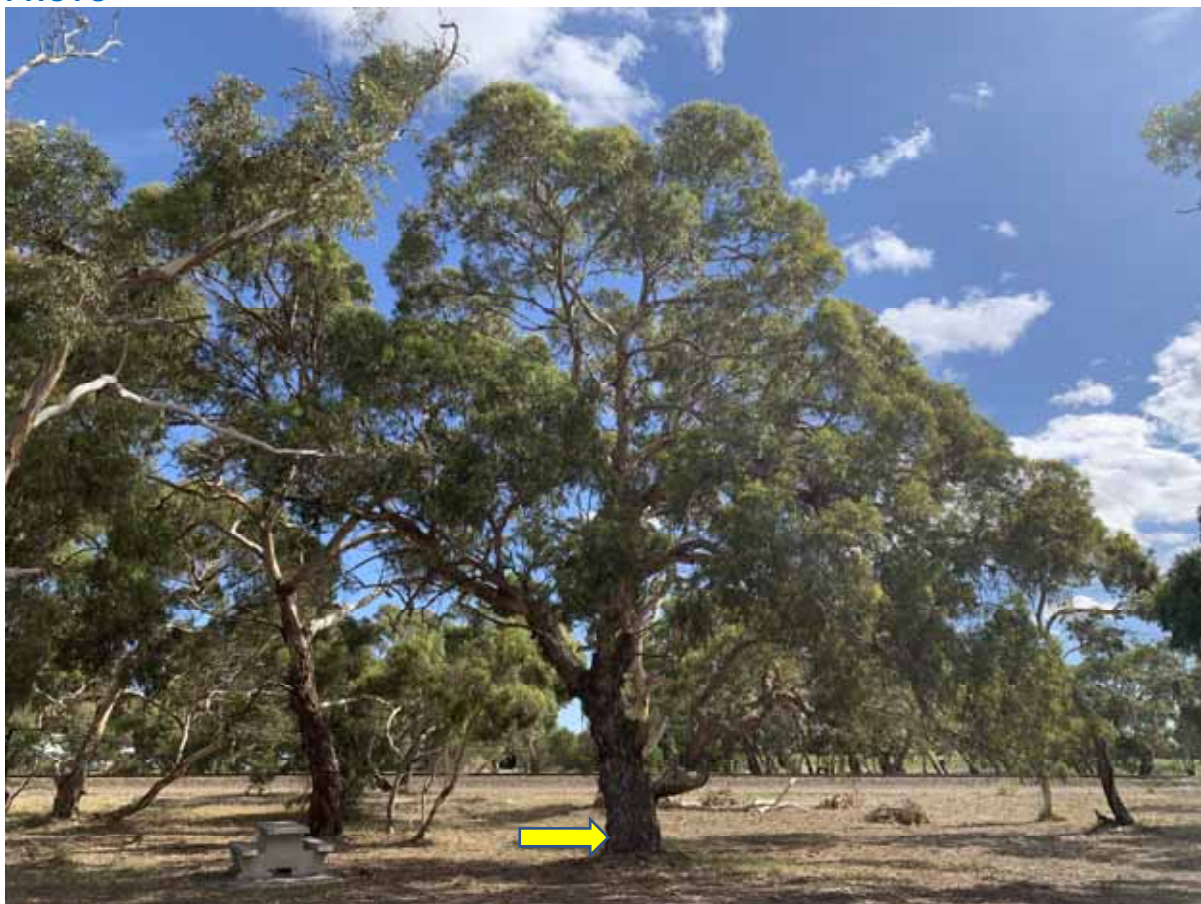
This SA Blue gum is growing near the park bench, the tree is in good condition but has areas of large deadwood that are close to the park bench along with the area of general use, these will need to be removed but only dead branches greater than 20mm in diameter, the trees canopy is of good structure and should most likely grow to be an old mature specimen.

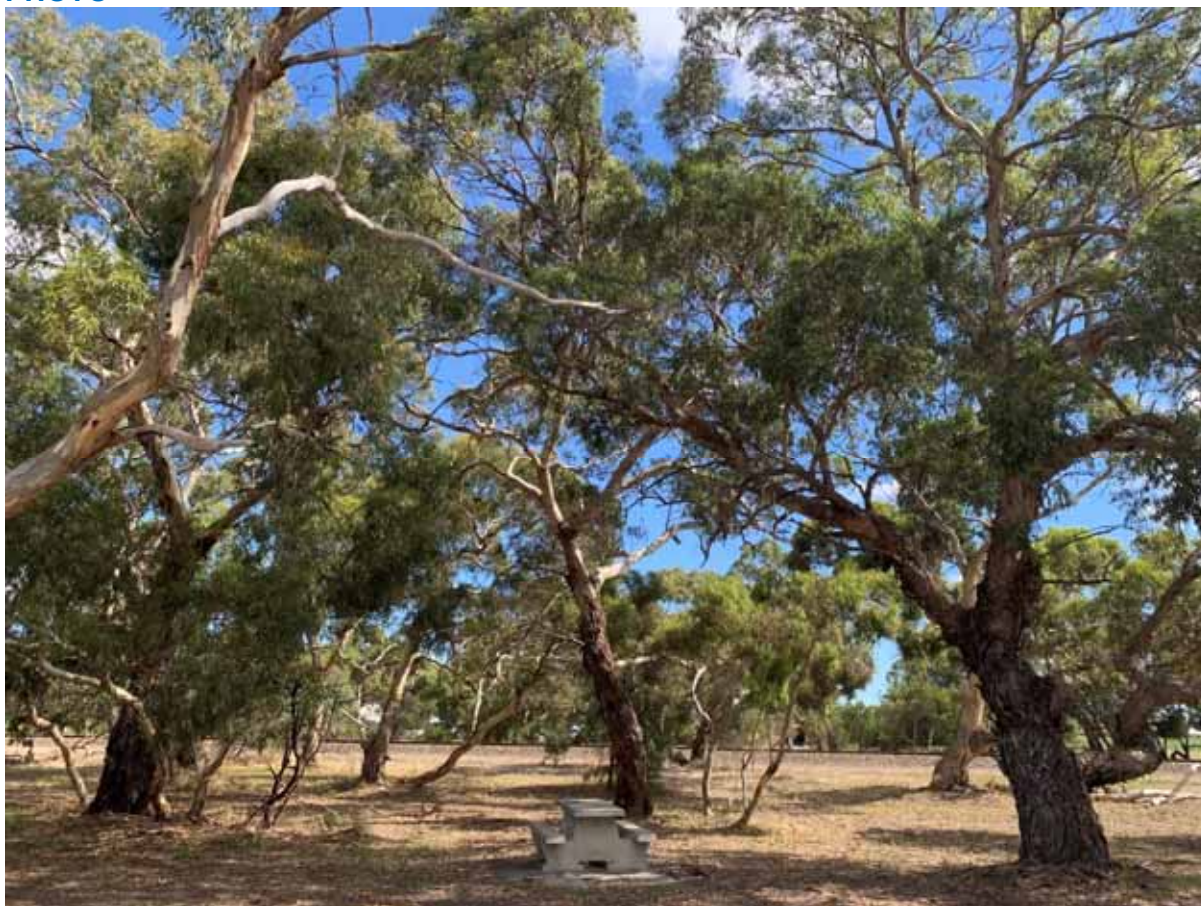
This SA Blue gum is a young specimen compared to most around this area, the canopy does have some large deadwood which will need to be removed from the general use area around the park bench, the tree has enough canopy area to allow it to grow well and become a good mature specimen.

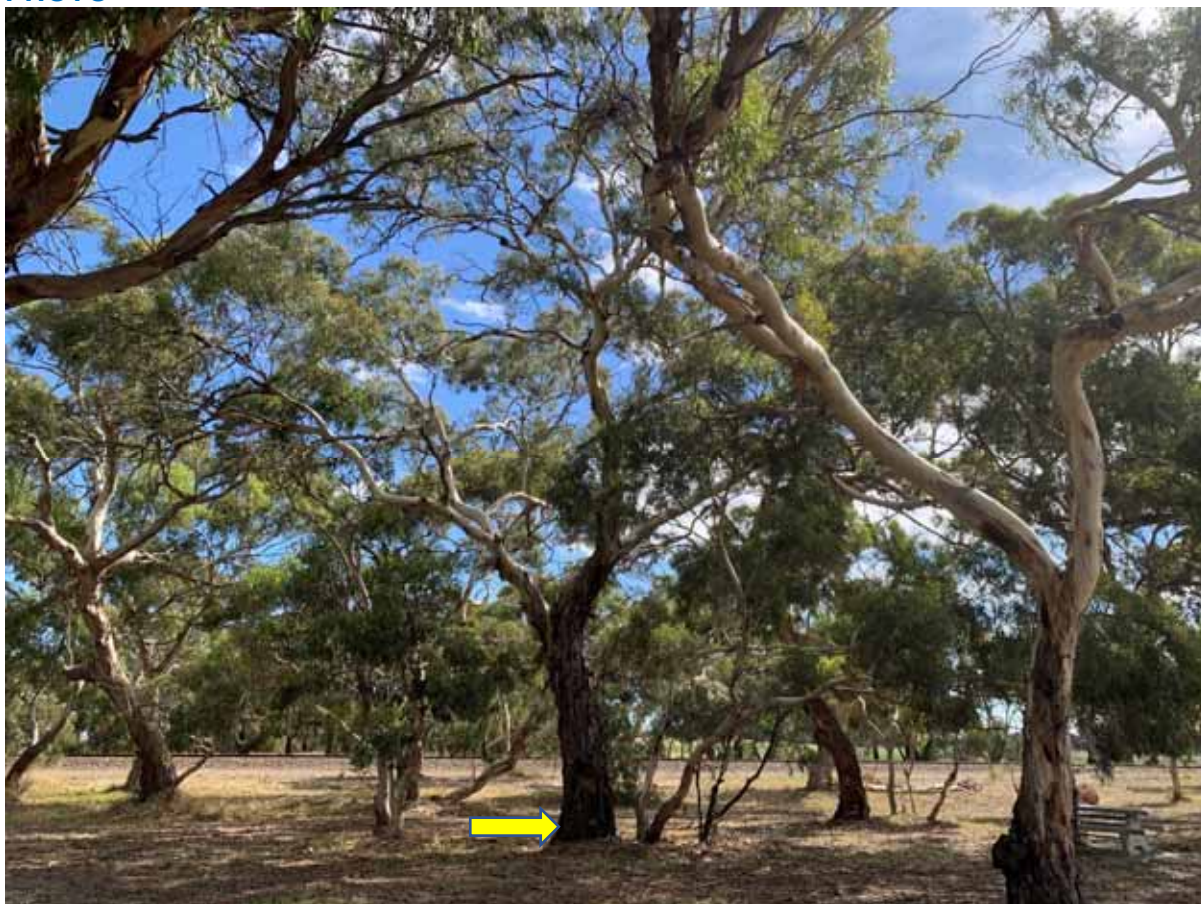
This SA Blue gum is much like many of the trees in this area, the tree has grown well but needs to have its deadwood removed as it's within the vicinity of the general rest area. The overall condition of the tree is good and is currently in a active growth cycle where it is putting on new growth.

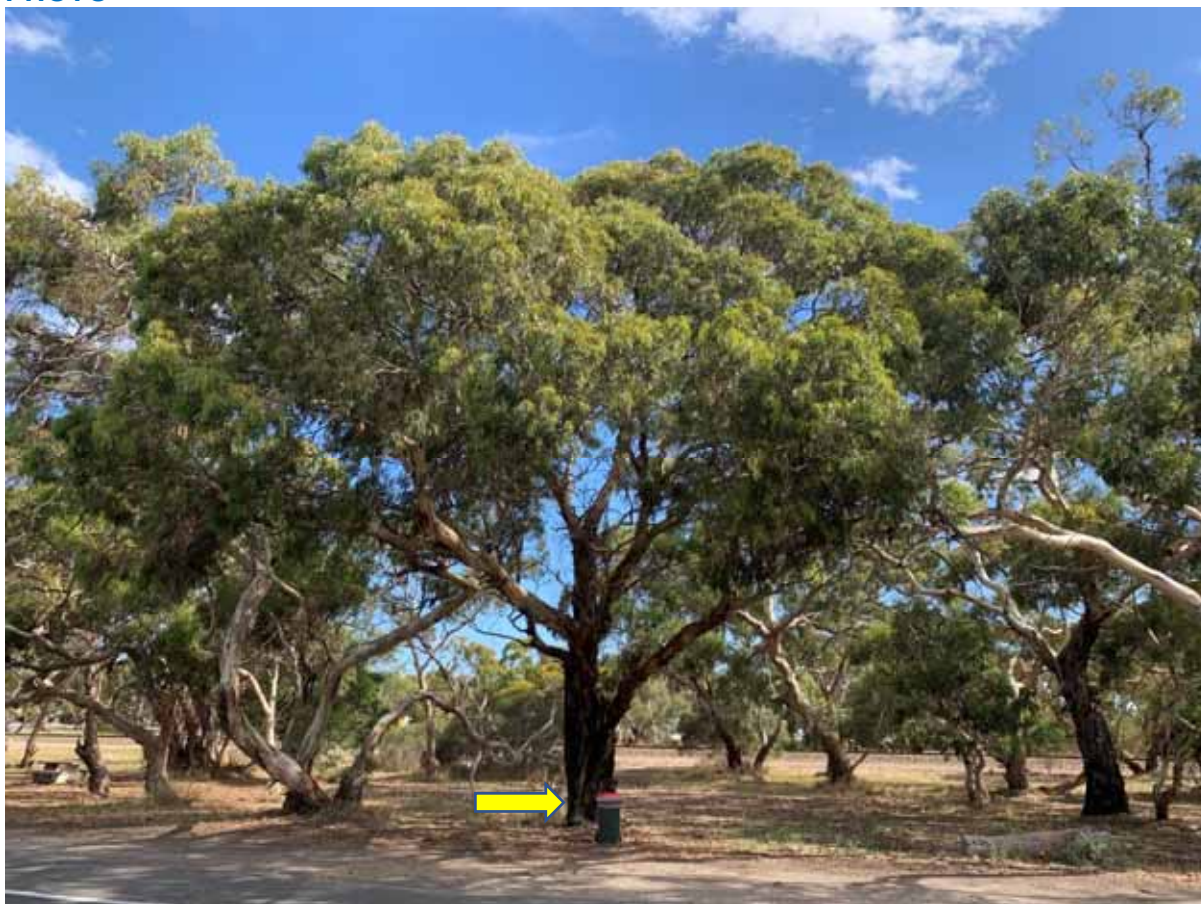
This SA Blue gum is in good condition with a single trunk extending up into a well-developed scaffold branch system, there are areas of deadwood which are due to both natural progressive dieback and partial sacrificial dieback. The tree is roadside in a concentrated area of vehicle parking. The area is a planted natural type woodland setting, the area and the trees should be left as natural as possible, however as this area has a bin and is of higher use than many other roadside areas, the larger deadwood only needs to be removed

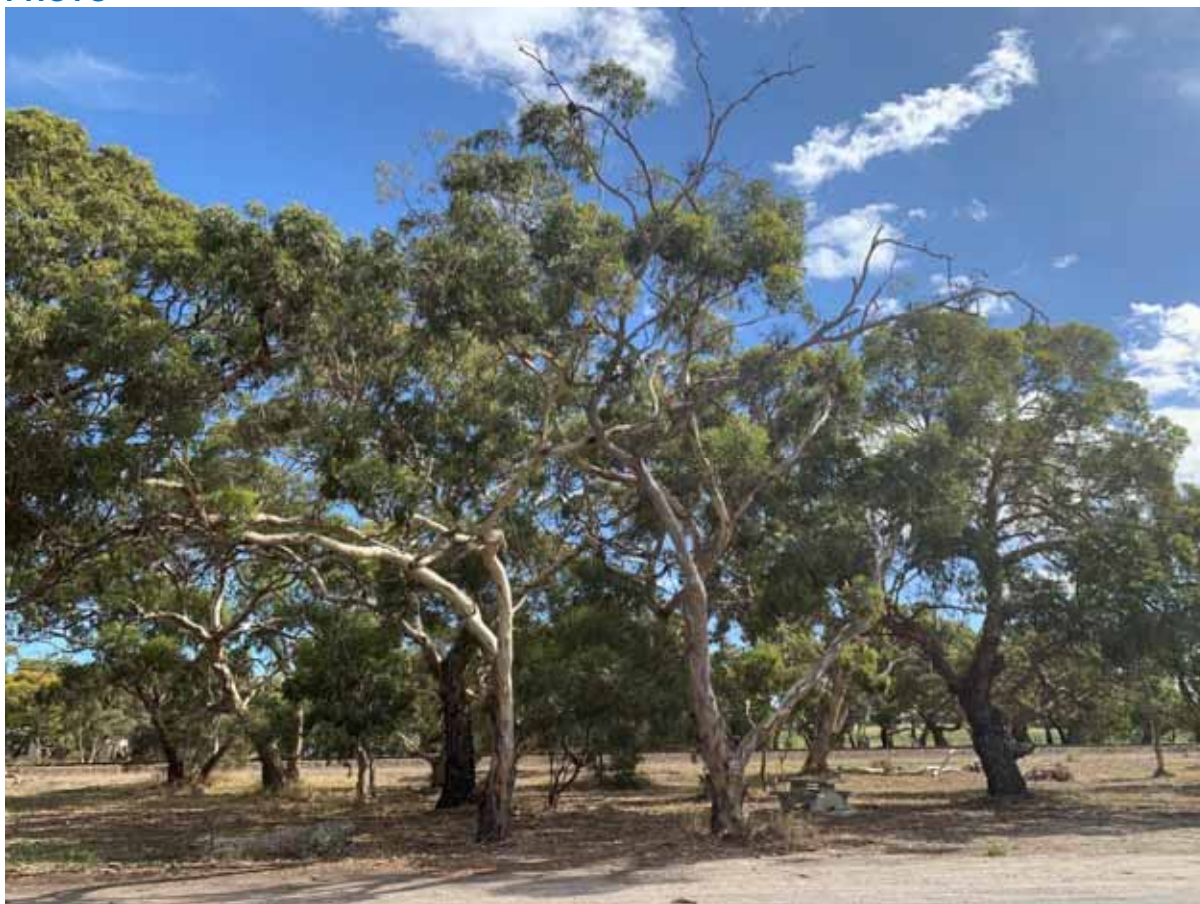
This Pink gum has suffered from the overcrowding of the surrounding vegetation, the canopy has grown to the greater light (Phototropism) and now when there are past drought conditions, the overcrowding has caused some of the limbs to be sacrificed and have died back. Deadwood removal is recommended due to this being a roadside.
