COONALPYN TOWN PARK & STREET TREES

Tree Inspection – November 2020

Coonalpyn Town

TREE AUDIT

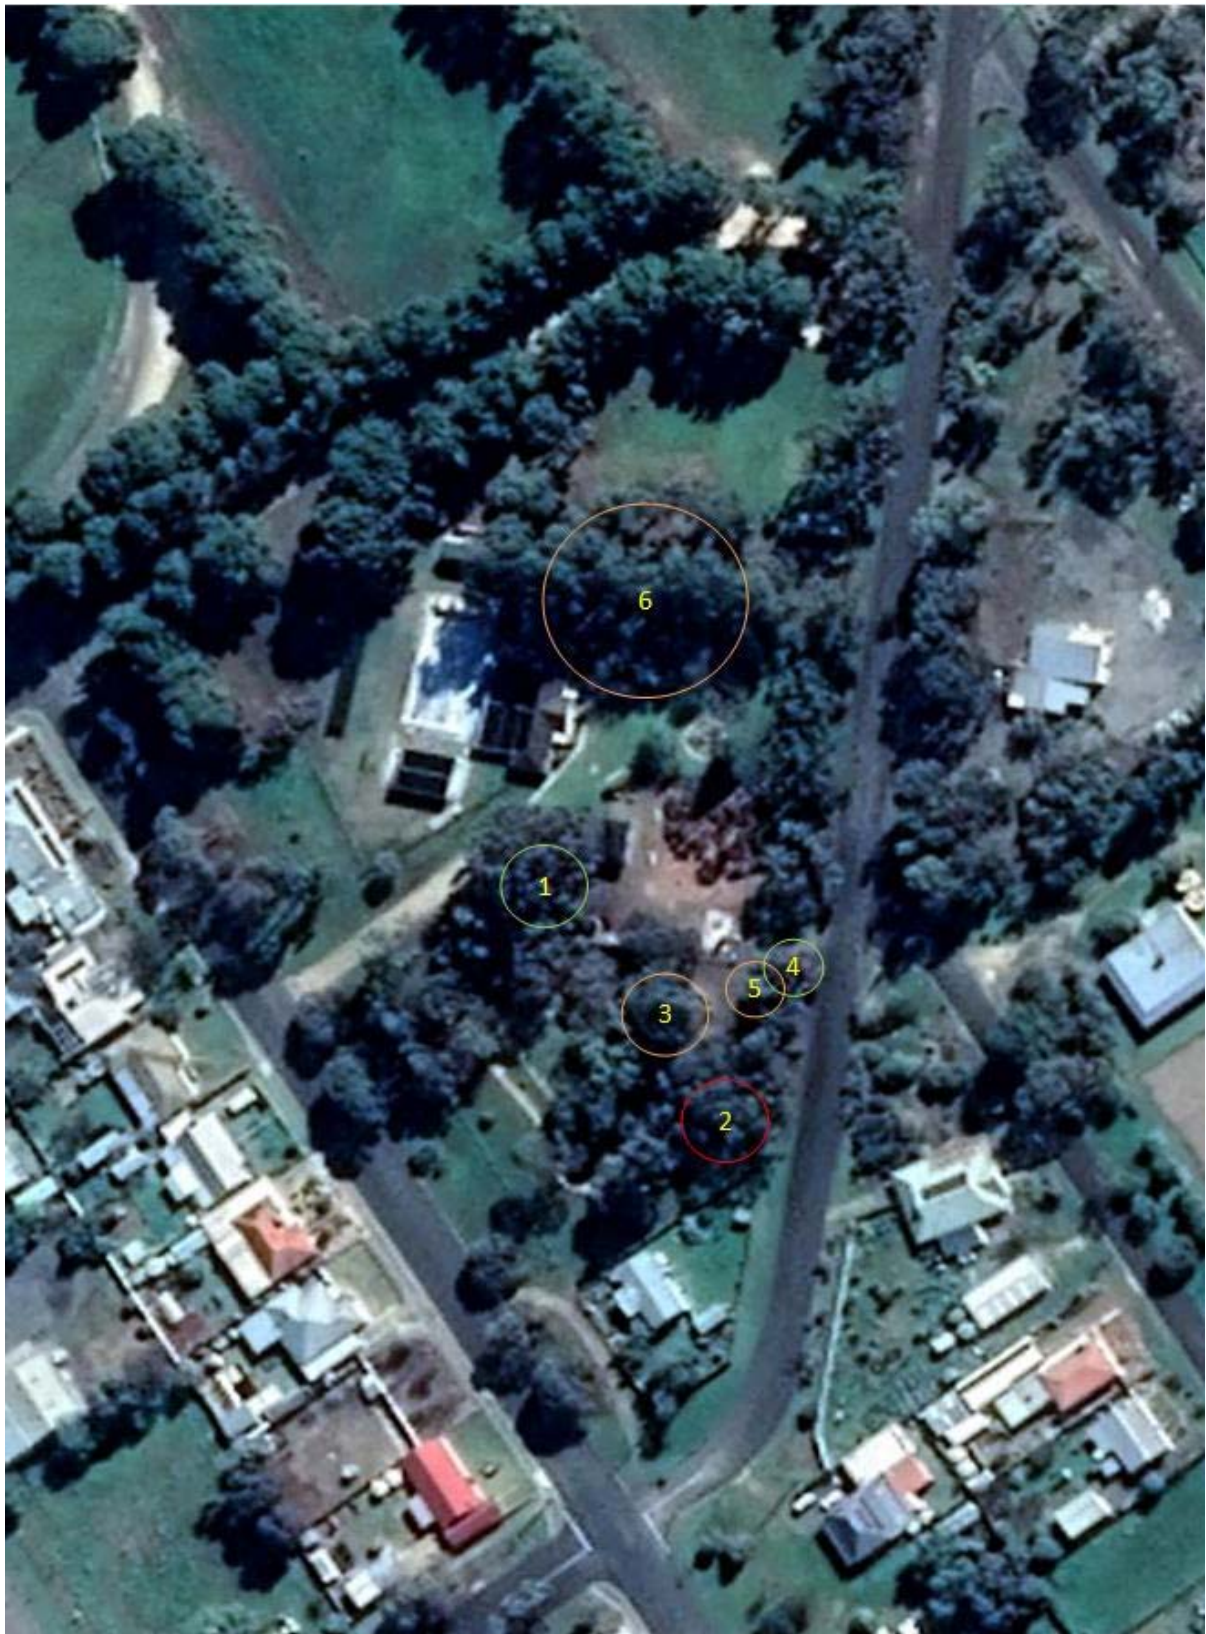
1. Eucalyptus leucoxylon

LOW RISK

Condition of tree: Good

There are six areas of large deadwood that could be removed but with the amount of deadwood on the other trees this would seem to be impractical for this tree however I will be putting it down as a recommendation. The tree does have some discoloring in the upper secondary prosecution attachment point however the discoloration does not lead to any fires within the branch it's the Campion layer which has been injured but is not critical for a structural capacity.

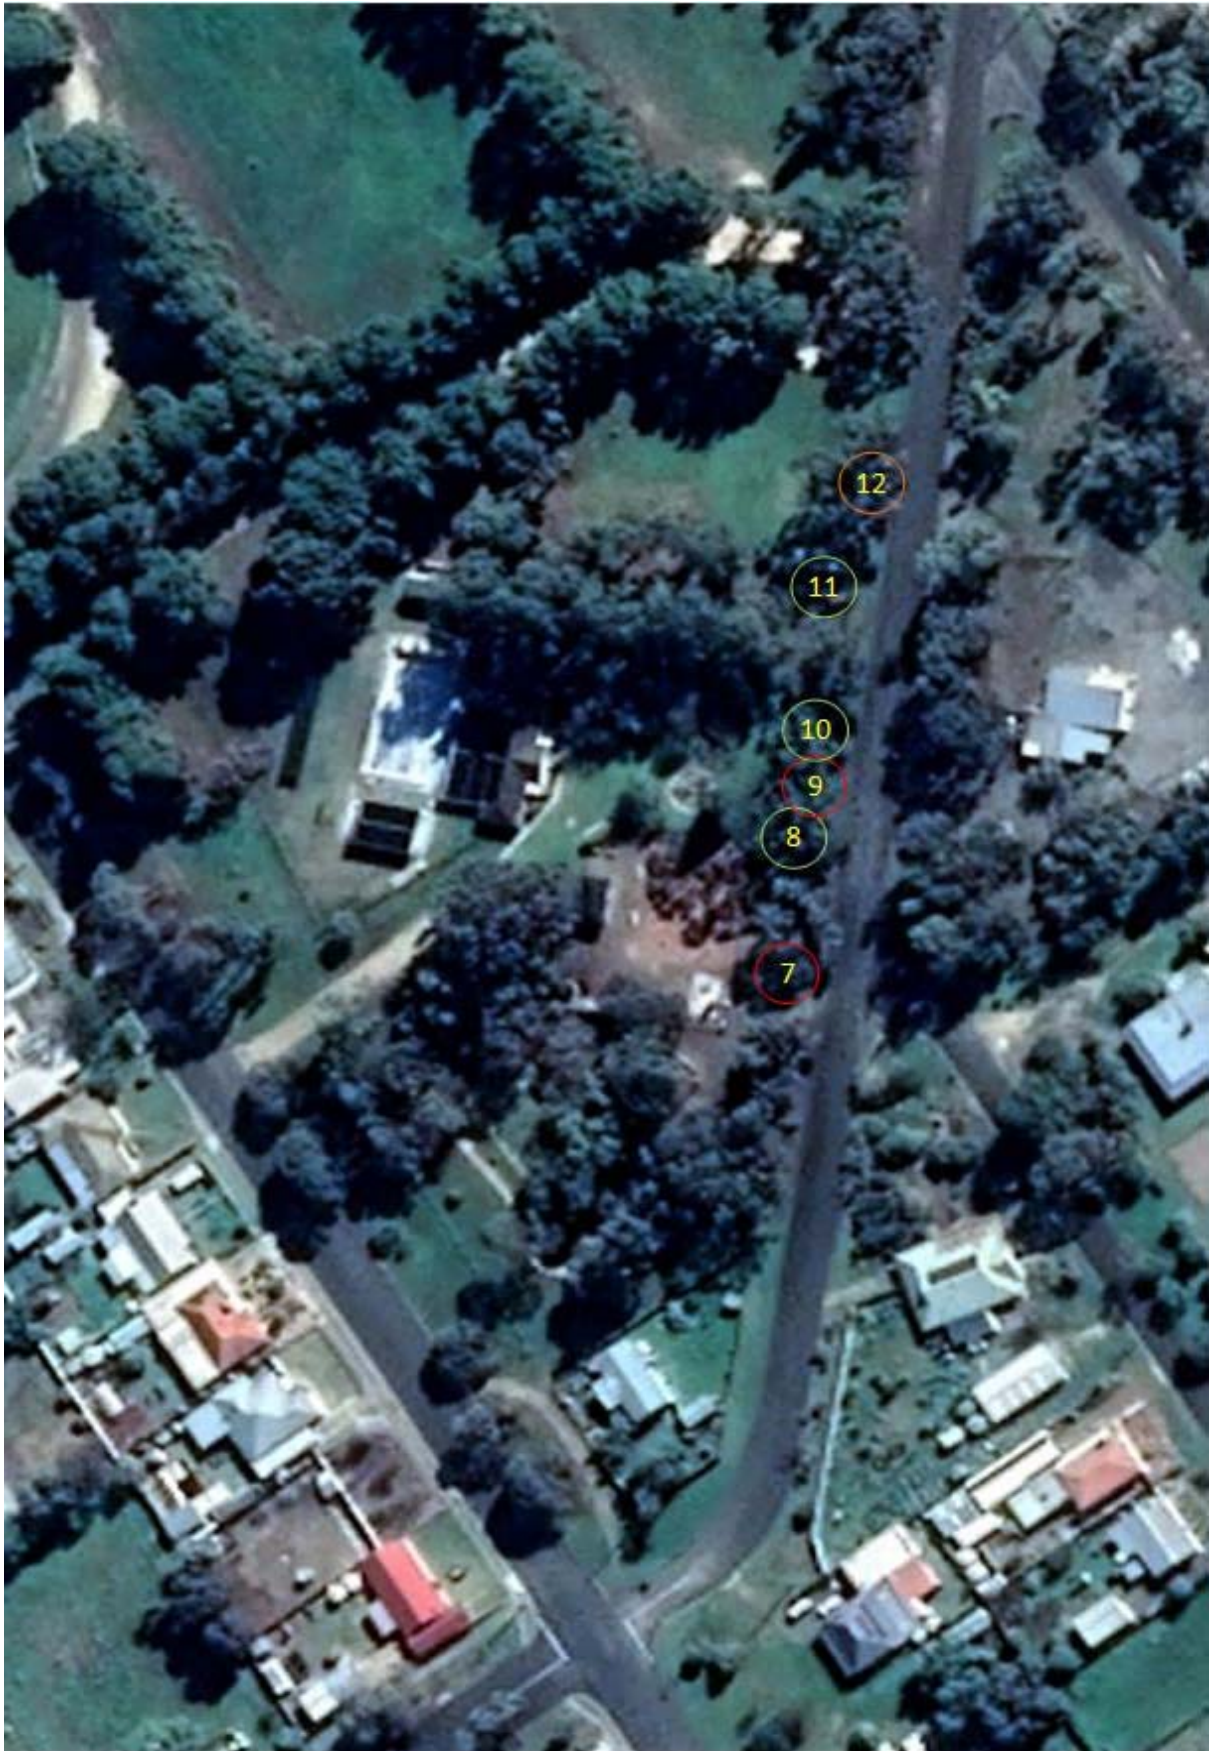
7. *Eucalyptus spathulata*

MEDIUM RISK

Condition of tree: Fair

This Swamp Mallet has had many failures both within the trunk and above the crown union with large amounts of visible deadwood and encroaching wound wood that is trying to rib the area to stabilise the breakout points. The tree shows traits of being a tree that drops limbs which is usually genetic and will continue to drop limbs over the time of its life. Having the lower limb hyperextended indicates that the limbs could fail at any time due to the pressure that is placed upon the area of deadwood and injured wood and I would recommend removing the whole tree as remedial pruning will not remove the risk of failure in this case.

Removal is recommended.

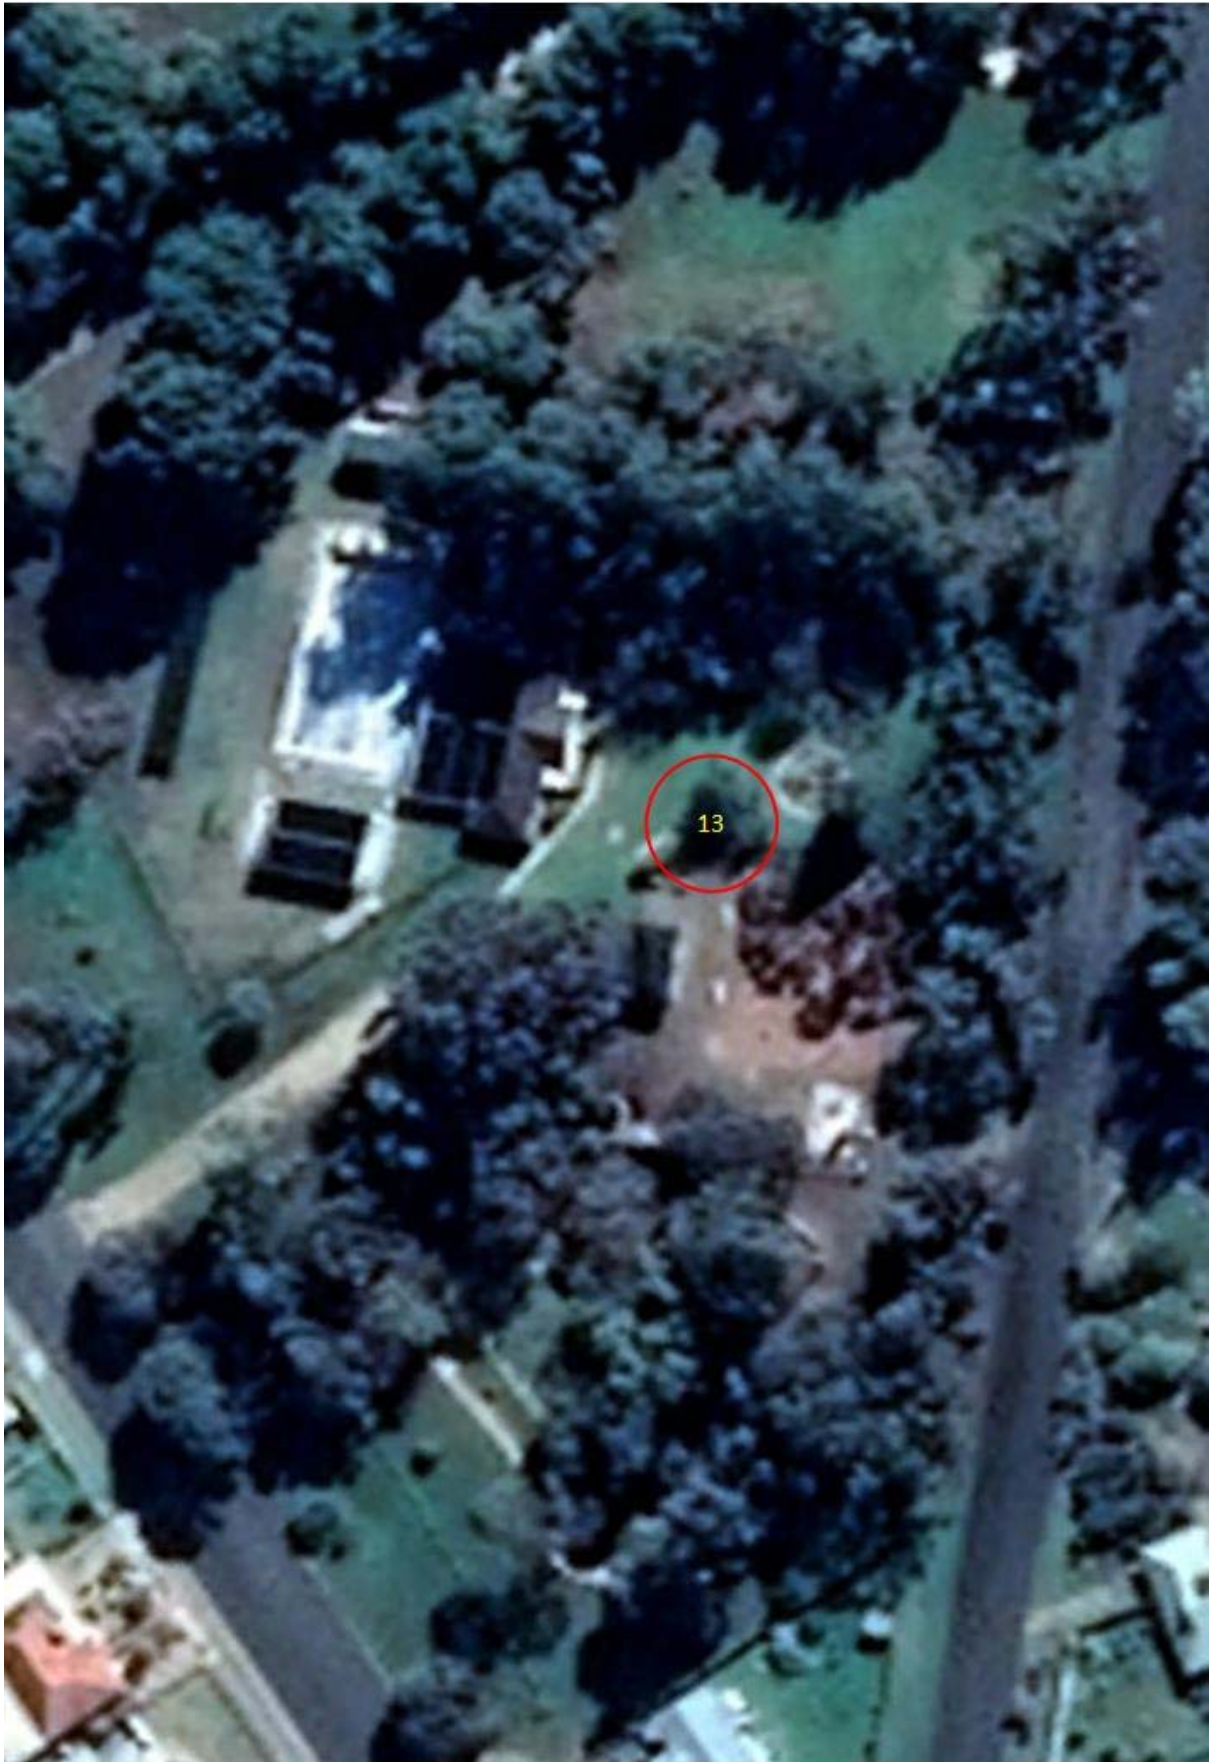
13. *Cupressus macrocarpa*

MEDIUM RISK

Condition of tree: Poor

This Pine tree has lost a lot of its foliage due to dieback, a number of the lower branches which have been removed most likely were also dying. The tree does show signs of Cypress Canker which is present within the tree which causes a lot of the sap to extrude from the tree as it blocks the circulation of the SAP causing it to burst from the cells and is what you can see on the outside of the tree. The lower limbs which remain do have areas of exposed deadwood which reduces the amount of cambium which also reduces the amount of sap flow that makes it out to the foliage. On all Coniferous trees there are no blind buds where the tree can regenerate once those areas of foliage are removed, they will never regenerate again this is why care needs to be taken with pruning.

Removal is recommended as the tree is in serious decline and will most likely slowly die in the near future.

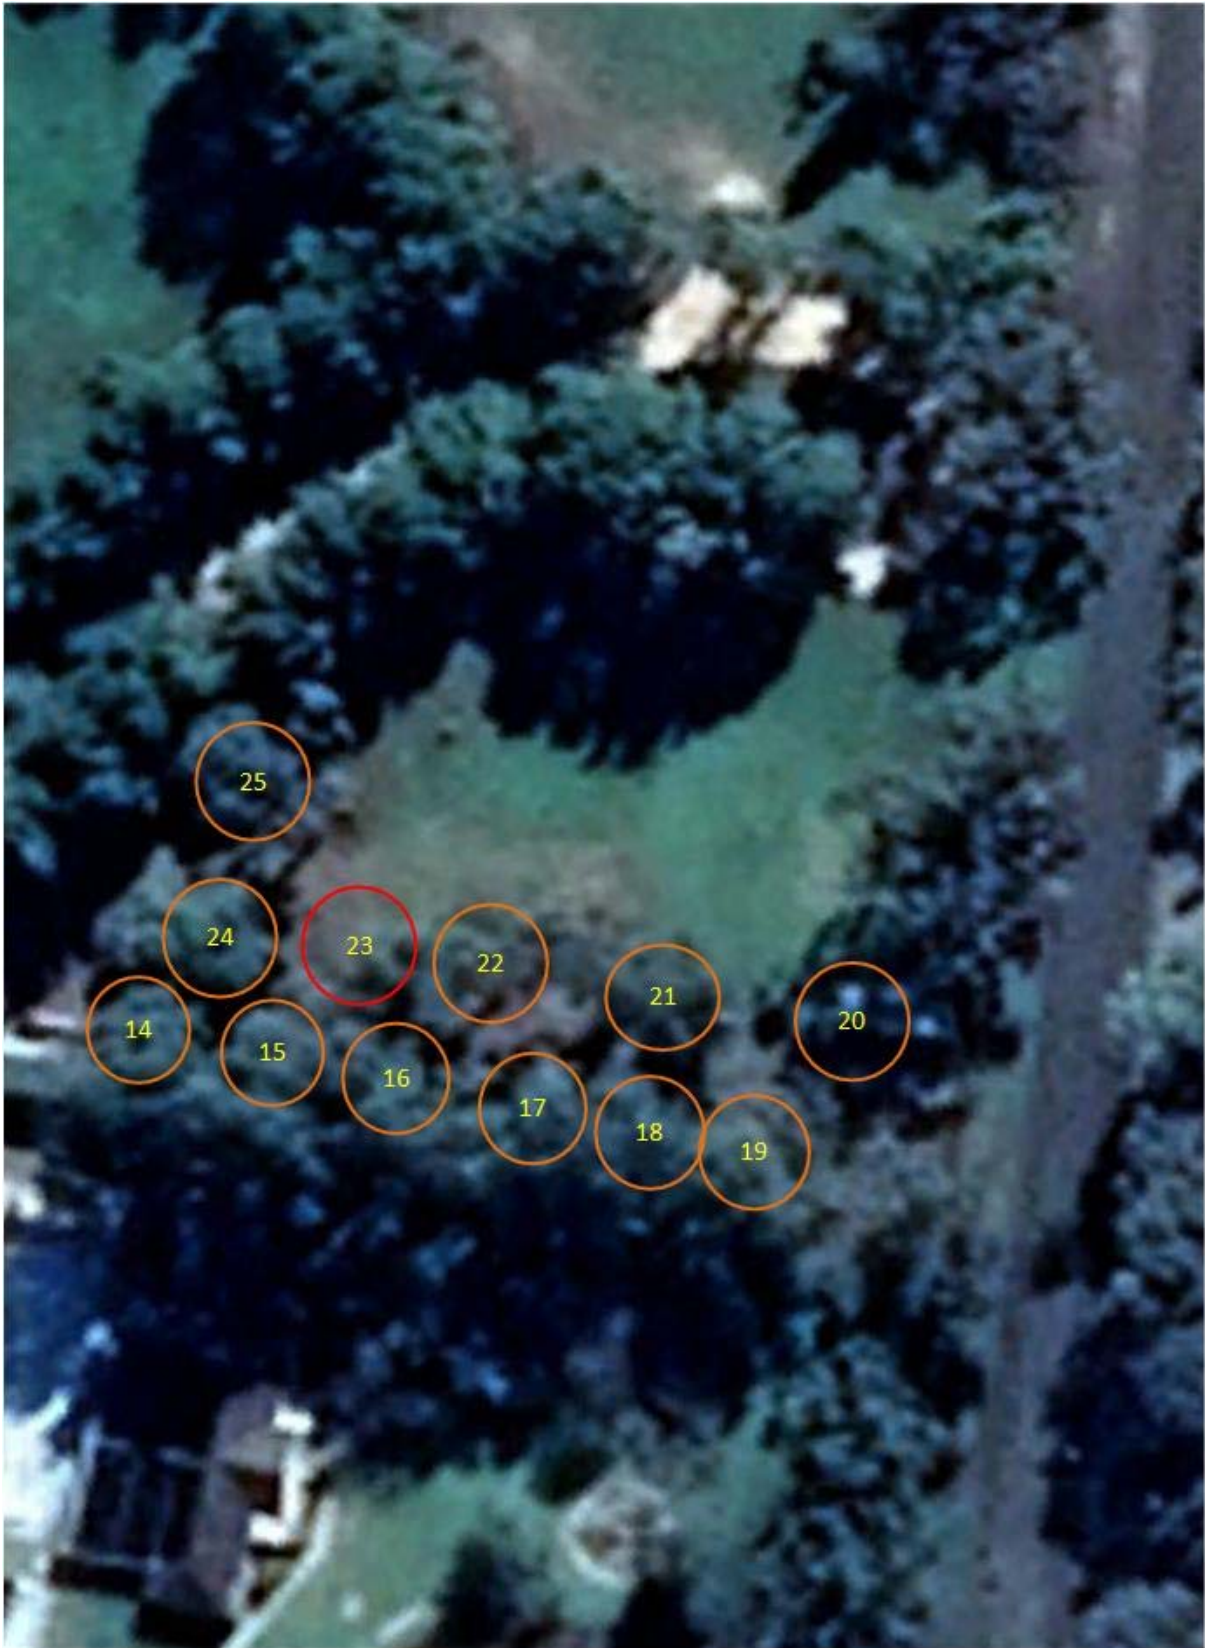
14. Eucalyptus globulus

MEDIUM RISK

Condition of tree: Good

This Tasmanian Blue gum is a large mature specimen, it does have Canker fungus up to approximately 10 metres, the lower branch also has signs of Canker within areas of the cambium liar, this extends up to approximately 6 metres but the upper canopy is void of Canker. The tree is healthy like most and the increase in available moisture this time of year allows for new growth in the terminal canopy.

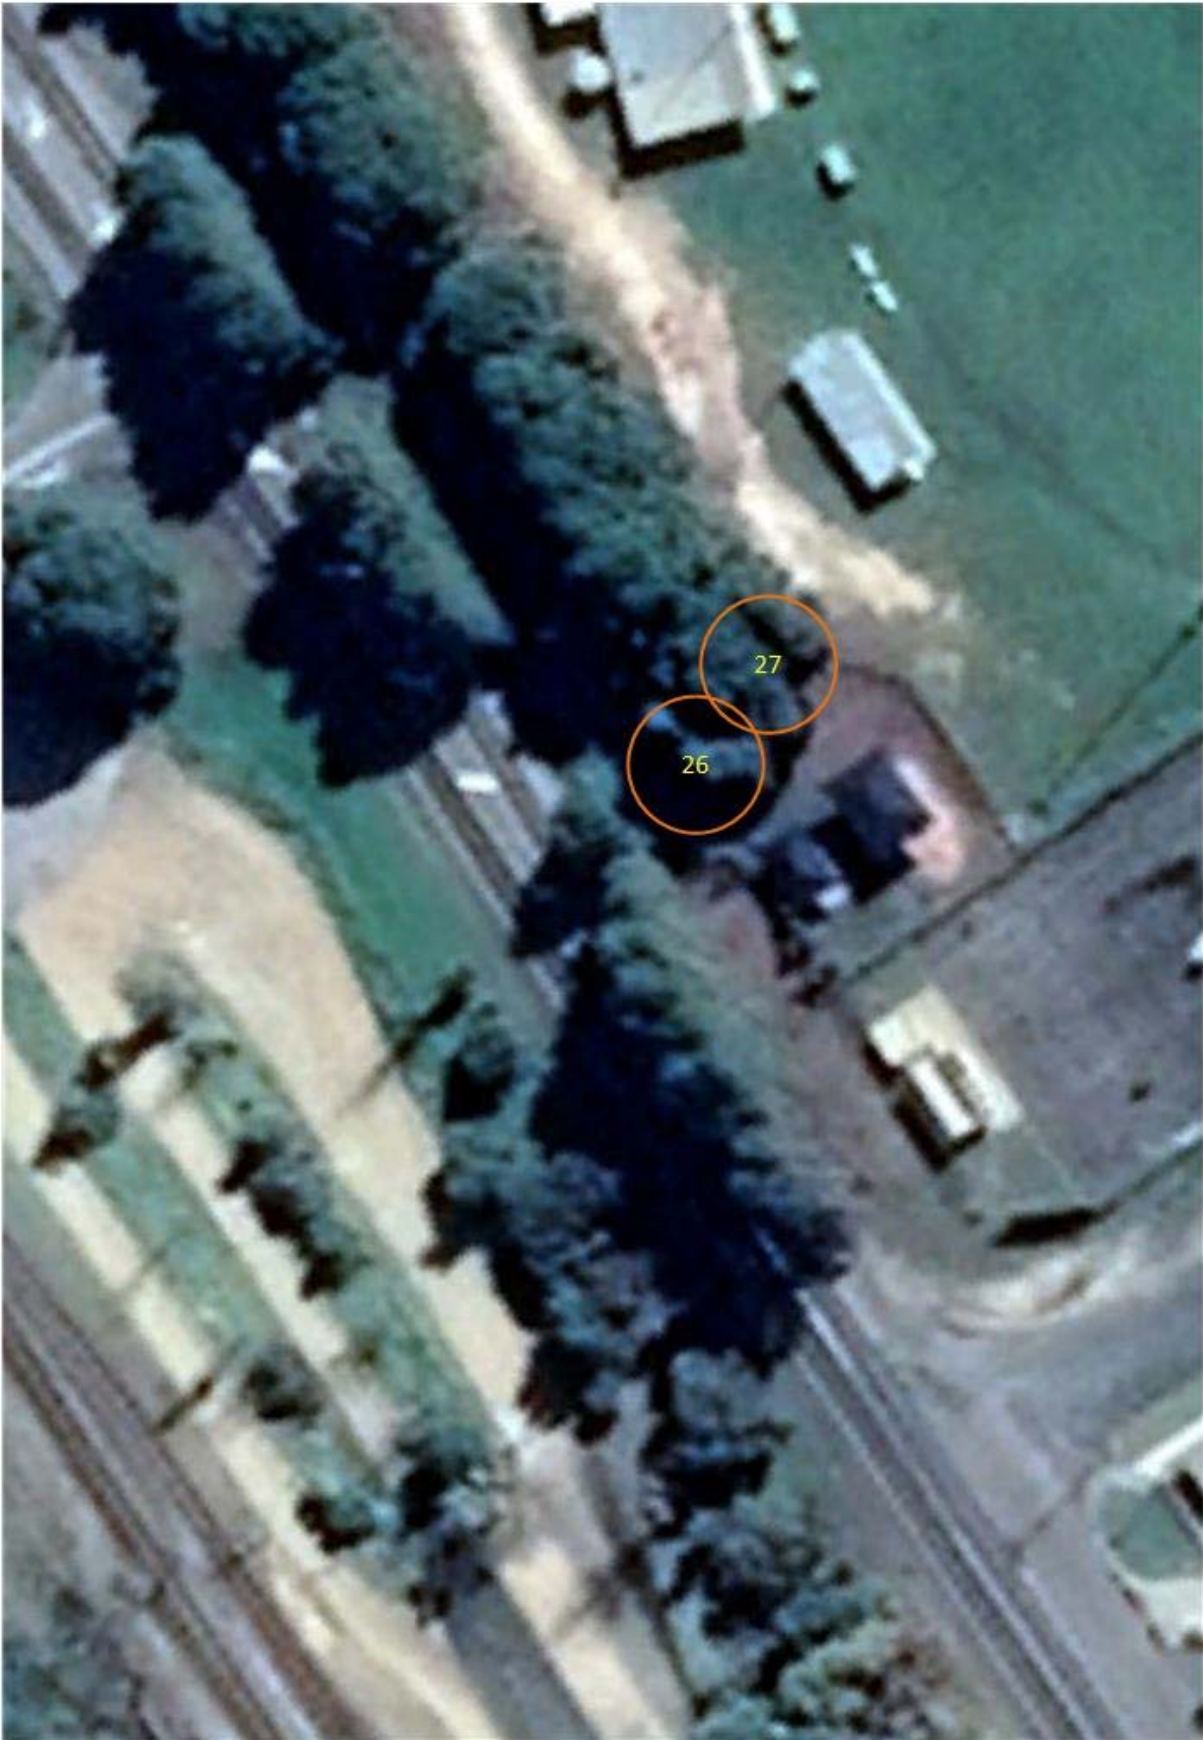
26. *Pinus halepensis*

MEDIUM RISK

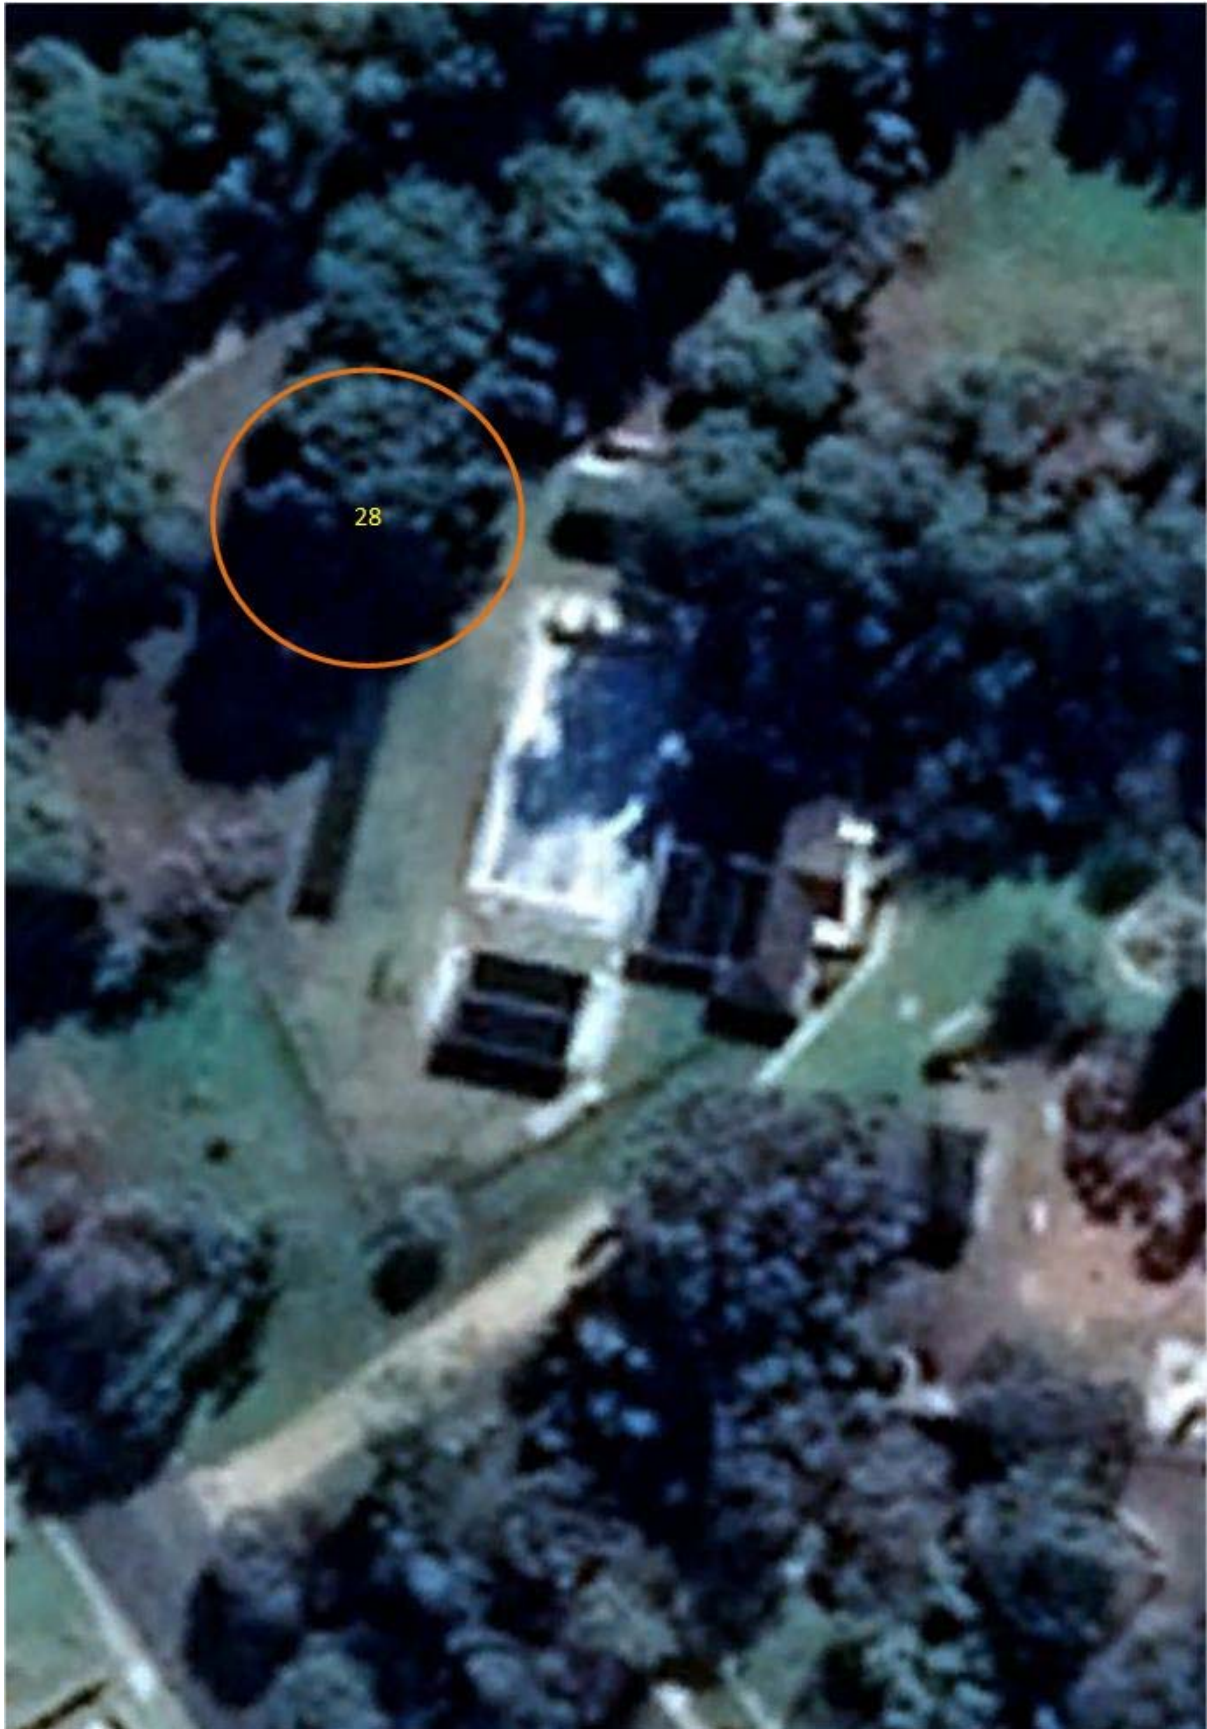
28. Eucalyptus globulus

MEDIUM RISK

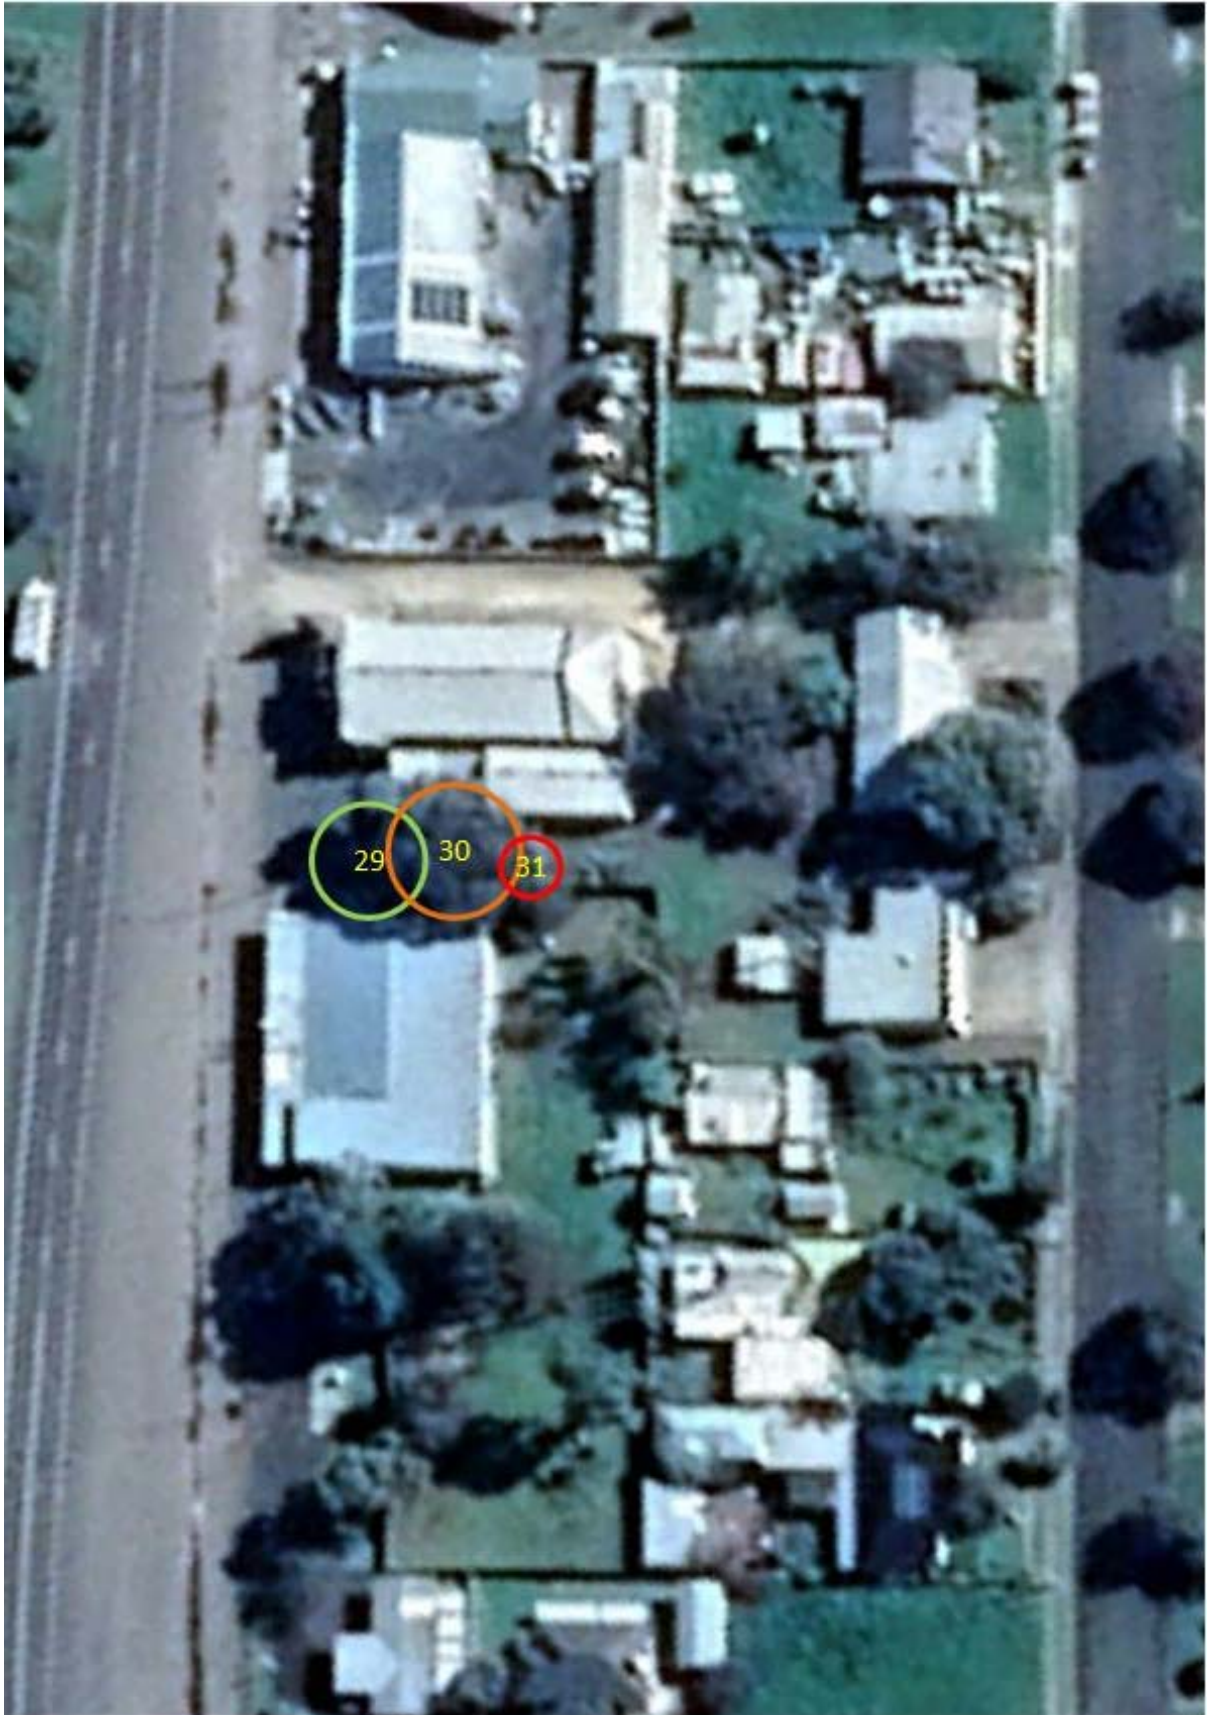
29. Eucalyptus

LOW RISK

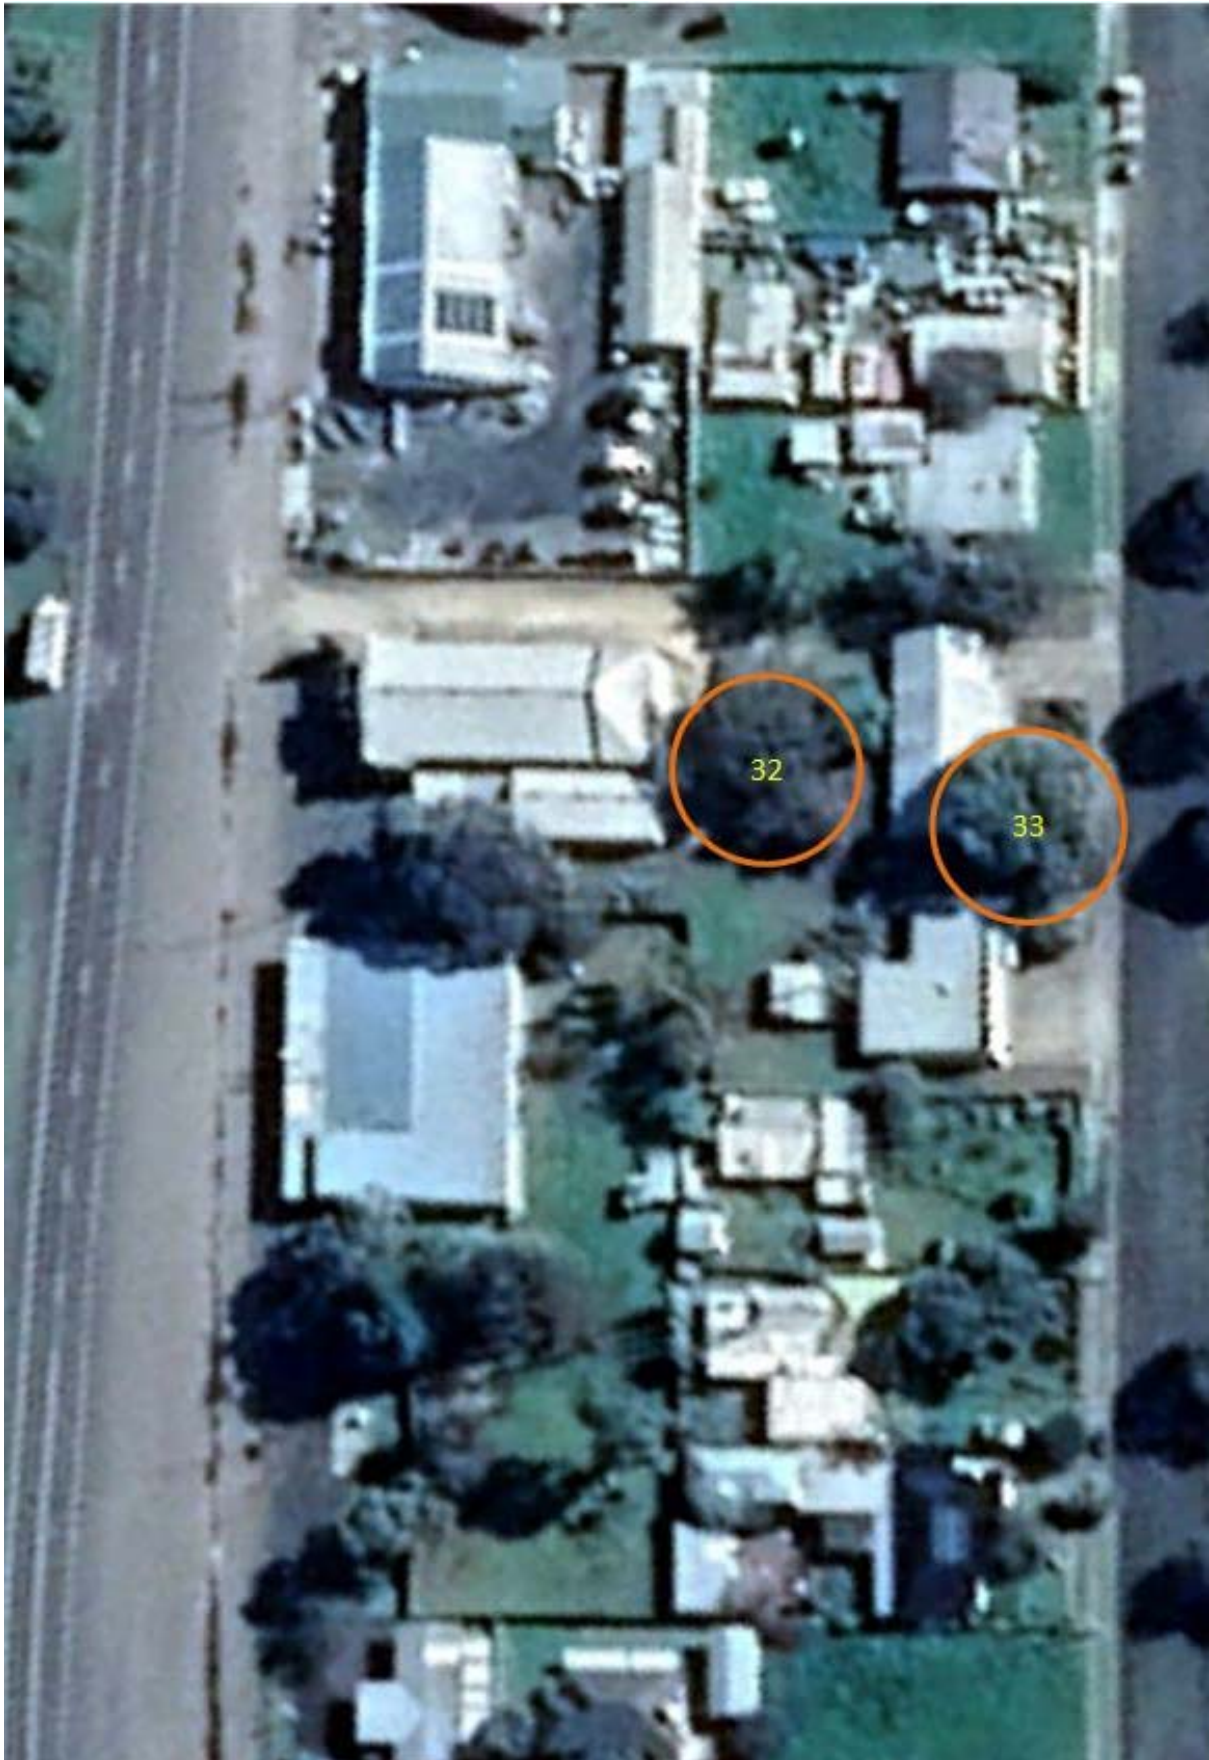
32. Eucalyptus leucoxylon

MEDIUM RISK

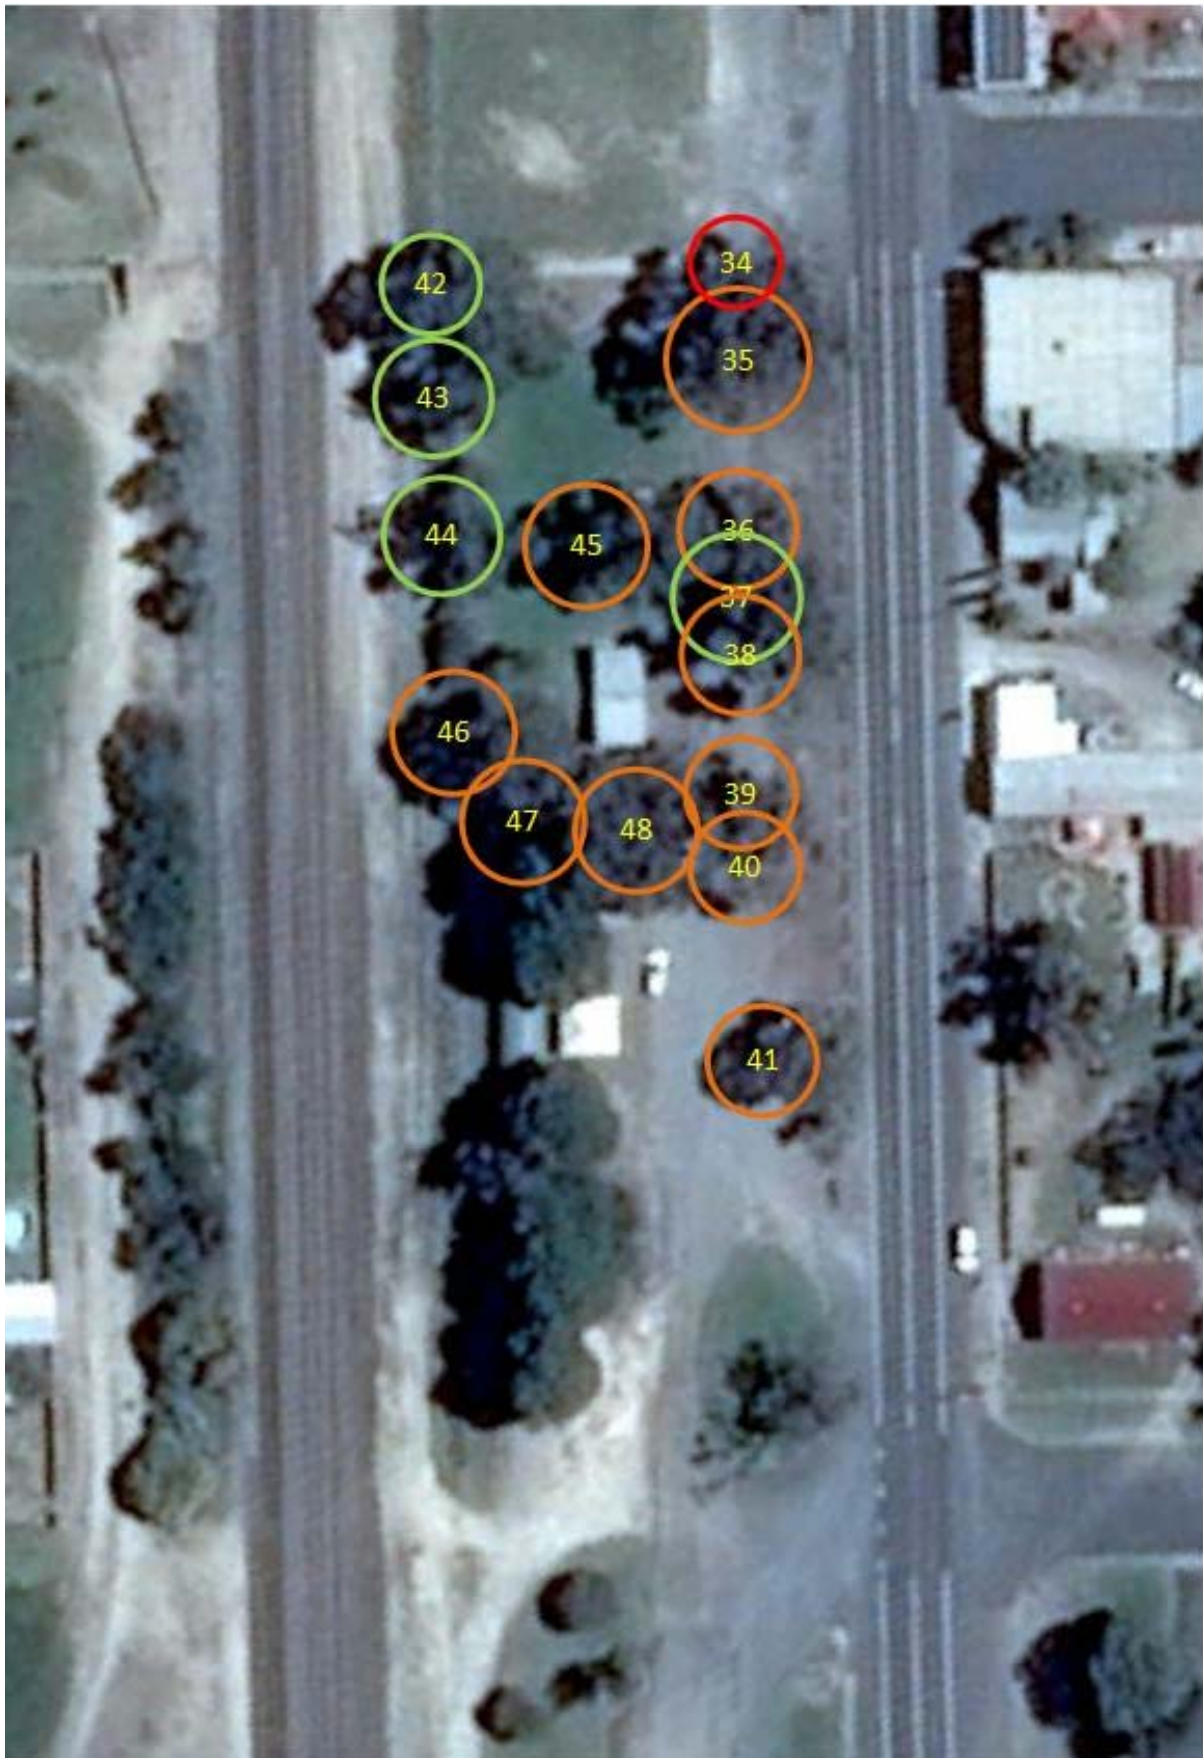
34. *Eucalyptus cladocalyx*

MEDIUM RISK

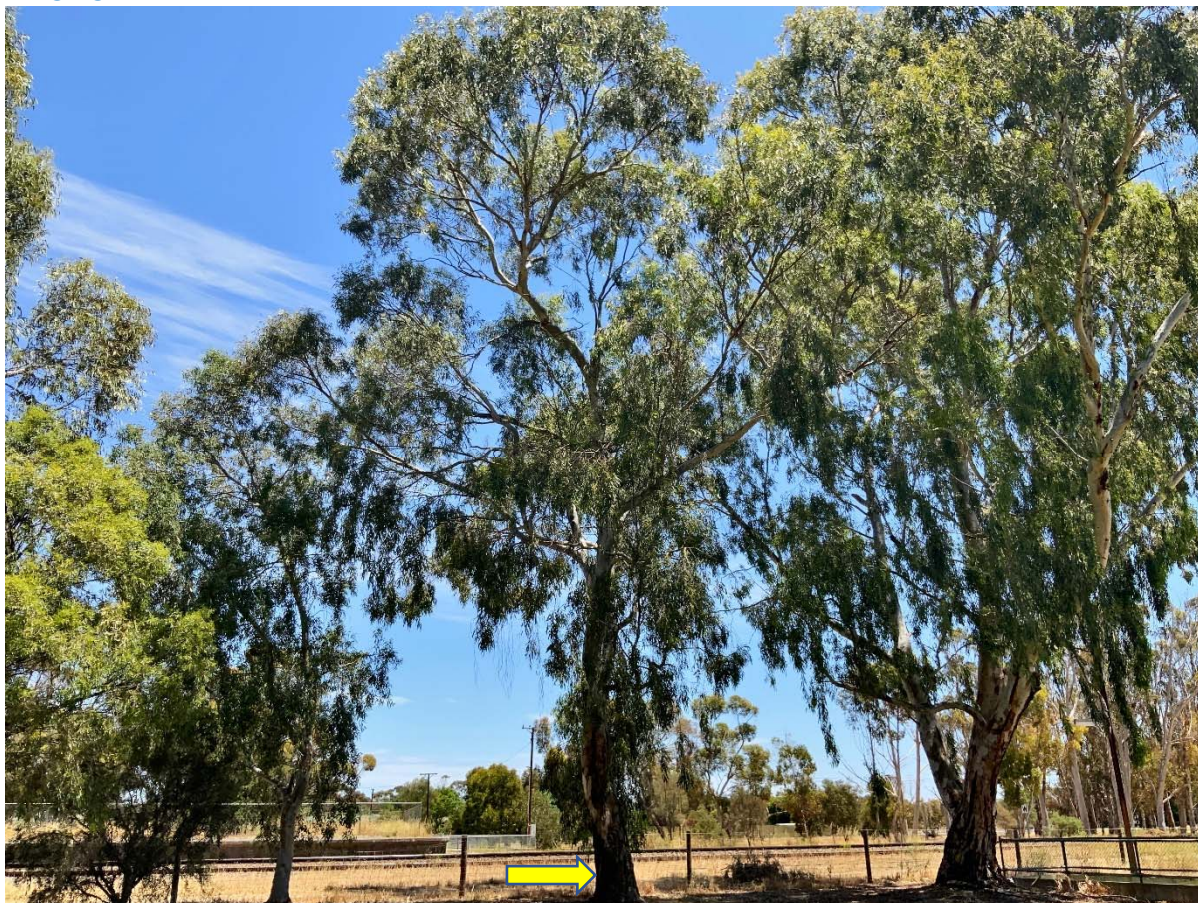
This tree has also had some scarring on one side which is healed over by scar tissue almost closing up the whole of the scar. This will eventually cover it altogether and will be unseen in the years to come as the cambium layers grow over it. This tree does have areas of scarring in the upper canopy also where limbs have failed, there is also one area of bird damage, as this is in the garden bed at the rear of the park the chance of any limbs falling on hitting someone are quite low and in that case the tree can remain as it is, if this tree was in an area of high traffic use I would recommend its removal as it does have a tendency for failed limbs.

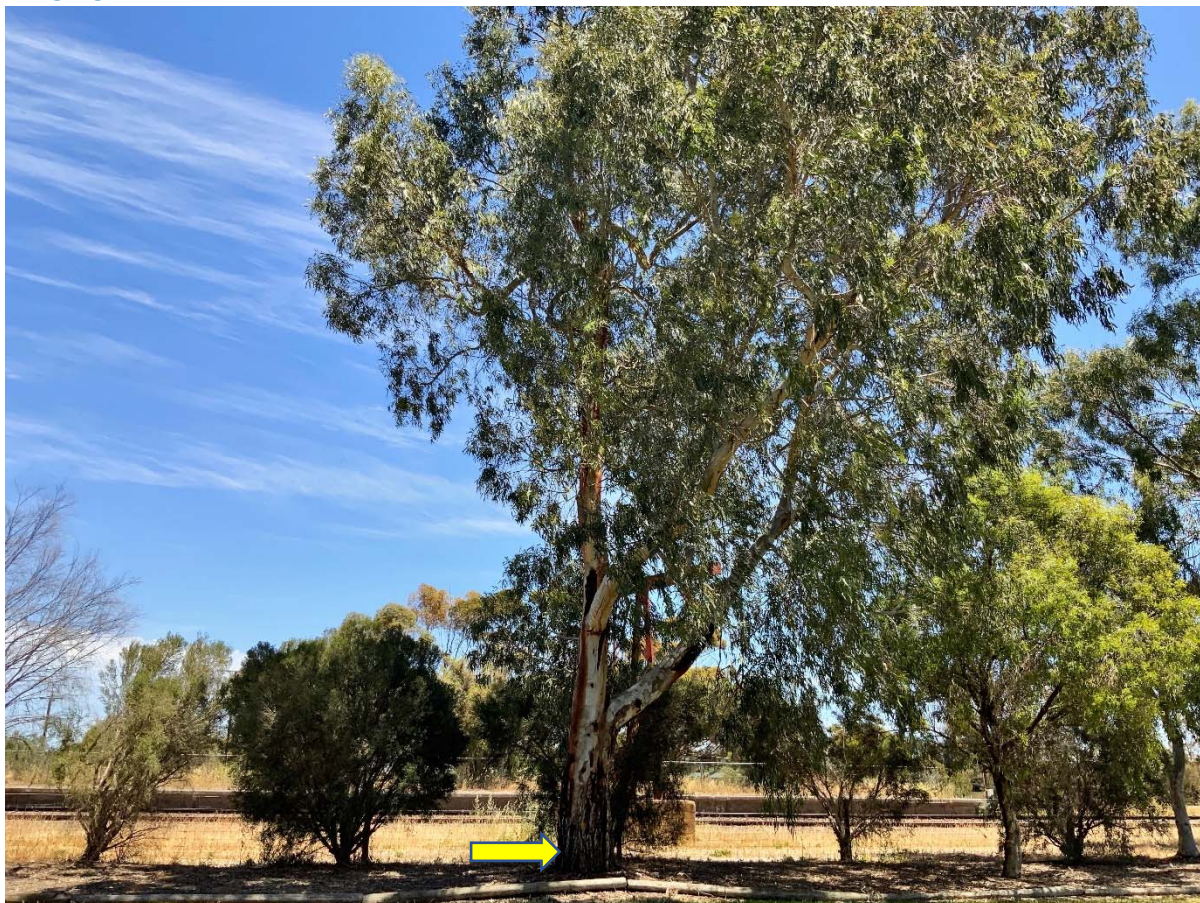
River red gum this tree has multiple areas of canker within several areas of scarring and cambium splits producing a copious amount of staining found the main limbs. The tree has had them for years in the past and also looks to be a tendency for failed limbs. Most of these River Red gums probably won't live to be old mature specimen and will require removal most likely over the next 10 to 20 years so a succession of planting should be introduced in this area to allow them to become the trees that replace these trees once they are removed without a great deal of void within the area.

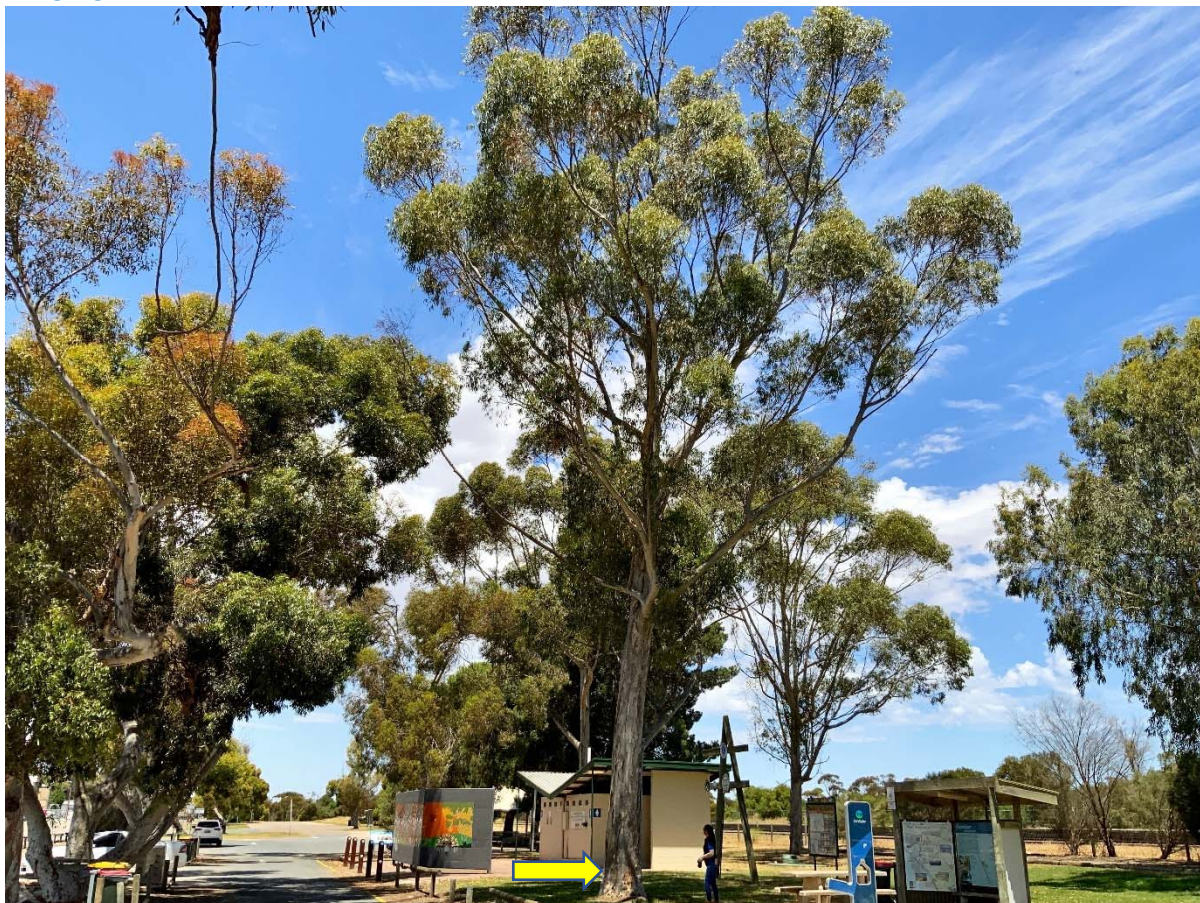
This Sugar gum is growing within the area of turf and is a singular trunk upright specimen of narrow form much like a forest form free but has started to produce scaffold branches that will widen the canopy area. This tree has deadwood throughout and will require removal of the deadwood due to its location.
