COONALPYN TOWN PARK & STREET TREES

Tree Inspection – November 2020

Coonalpyn Town

TREE AUDIT

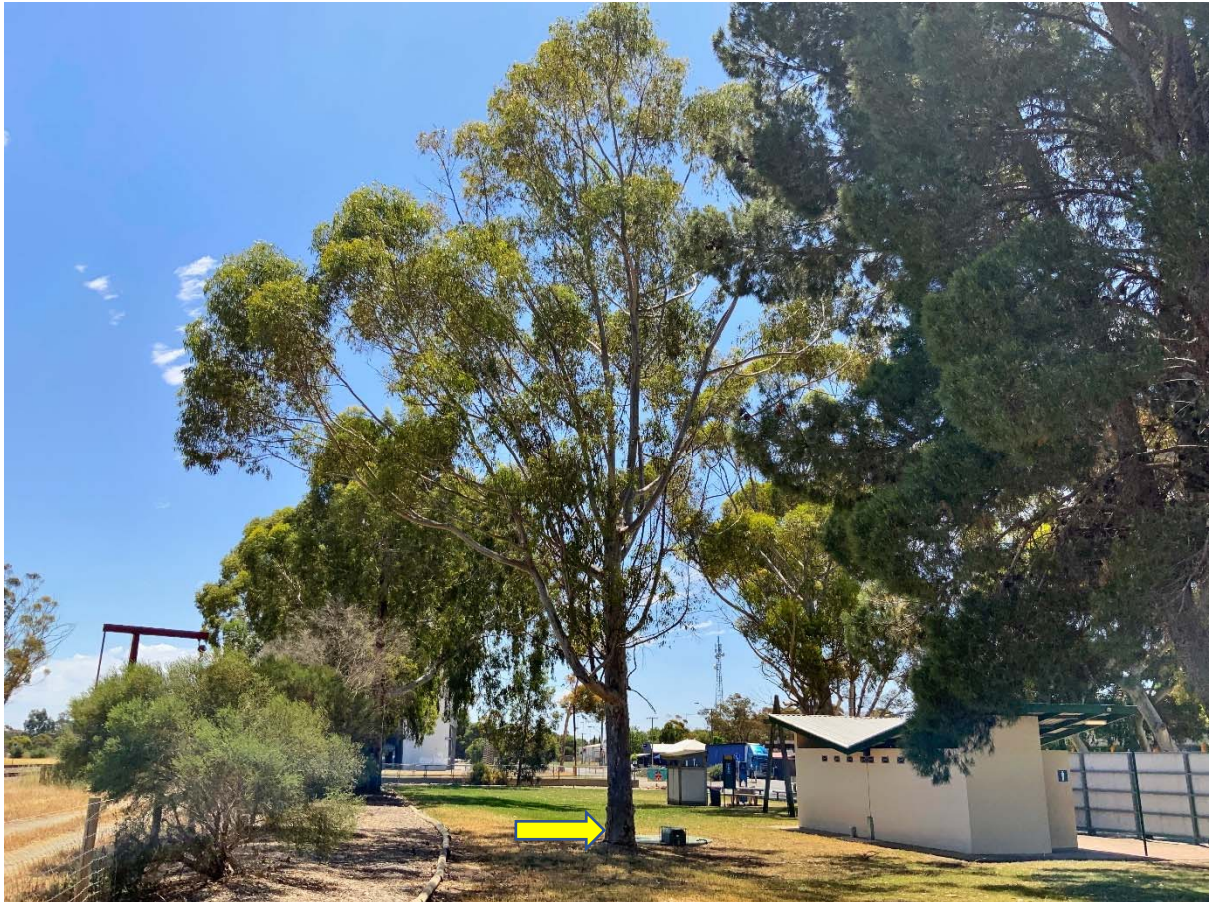
This Sugar gum has grown to the environment and has developed mostly out to one side of the tree is expansive in the mid to upper canopy with good transition from the branches down into the trunk. There are areas of minimal deadwood mostly on one side which is near the toilet block these will need to be pruned off.

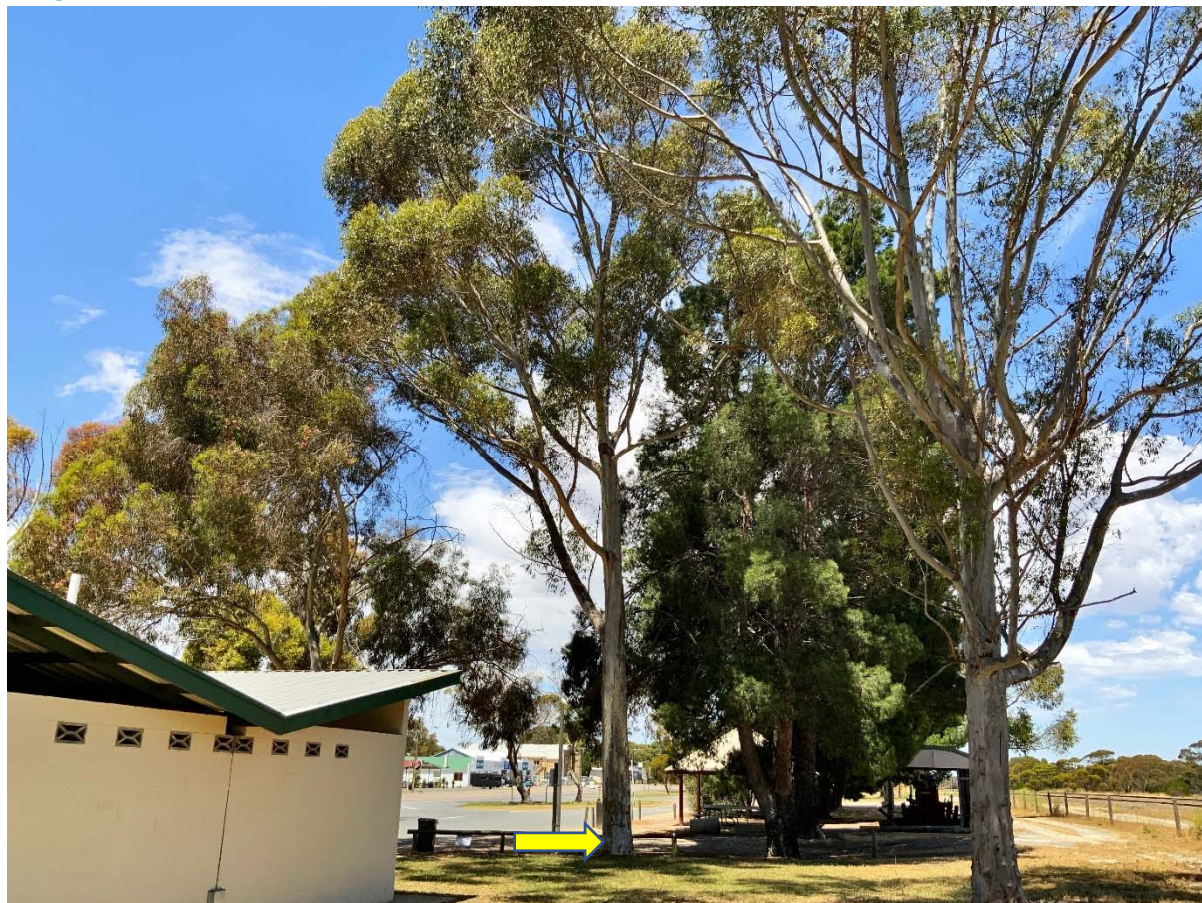
This Sugar gum is an upright forest form tree due to the crowded nature of the surrounding trees. The upper canopy has one hanger that is resting in the crutch of the upper canopy this will need to be removed as it is so close to the entrance to the toilets. There are very few dead branches and there will be no requirement to remove any other limbs from this tree apart from the hanger.

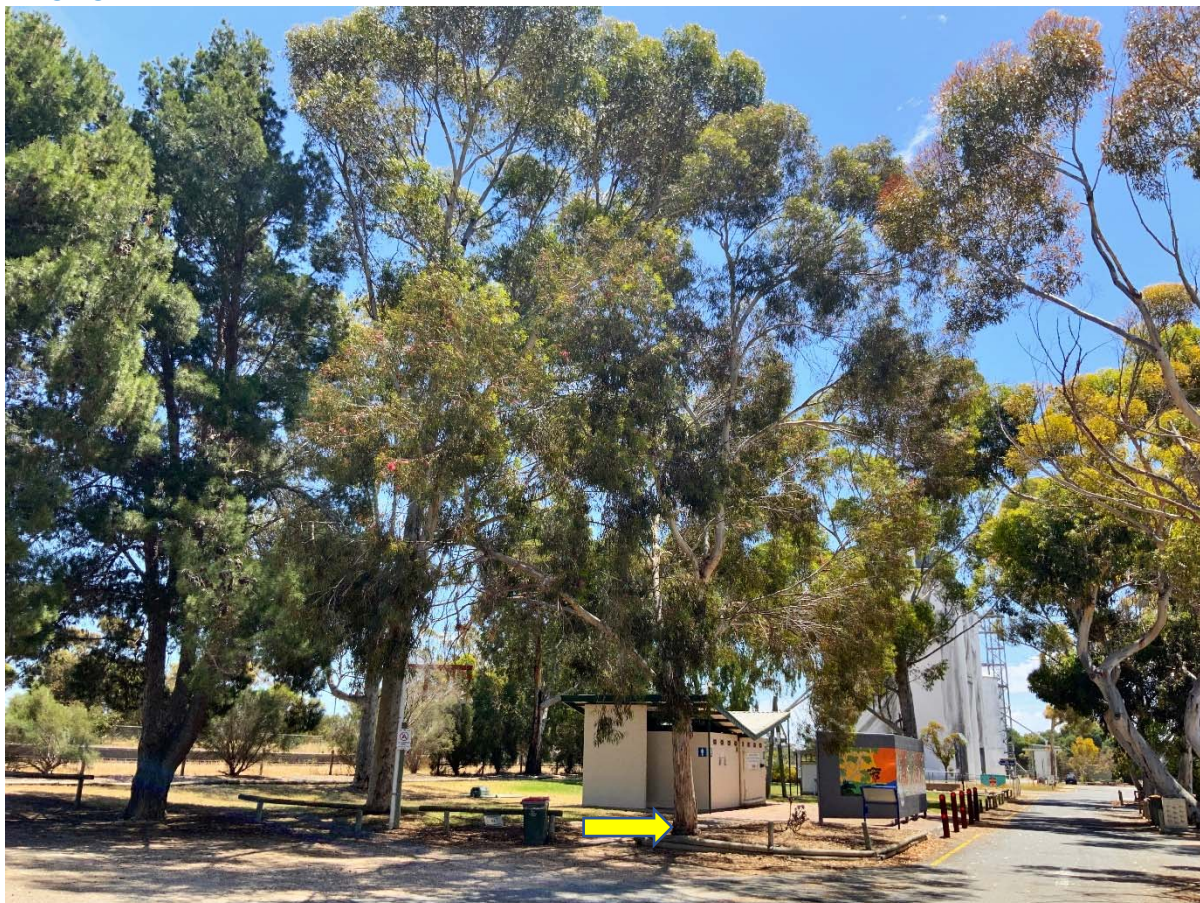
This tree is a healthy specimen that is currently in an active growth cycle, the tree has in the past had water stress and does have deadwood throughout which will require removal as it is over the entranceway of the toilets and there are many smaller limbs that have dropped from this tree already. I am also recommending on the area over the car park in the area close to the mural to be weight reduction within the canopy which will lift the canopy in these areas and will allow the limb to progress in its growth without the weight of the in canopy.

Removal of deadwood and weight reduction of the limbs near the mural and carpark to allow for greater access.

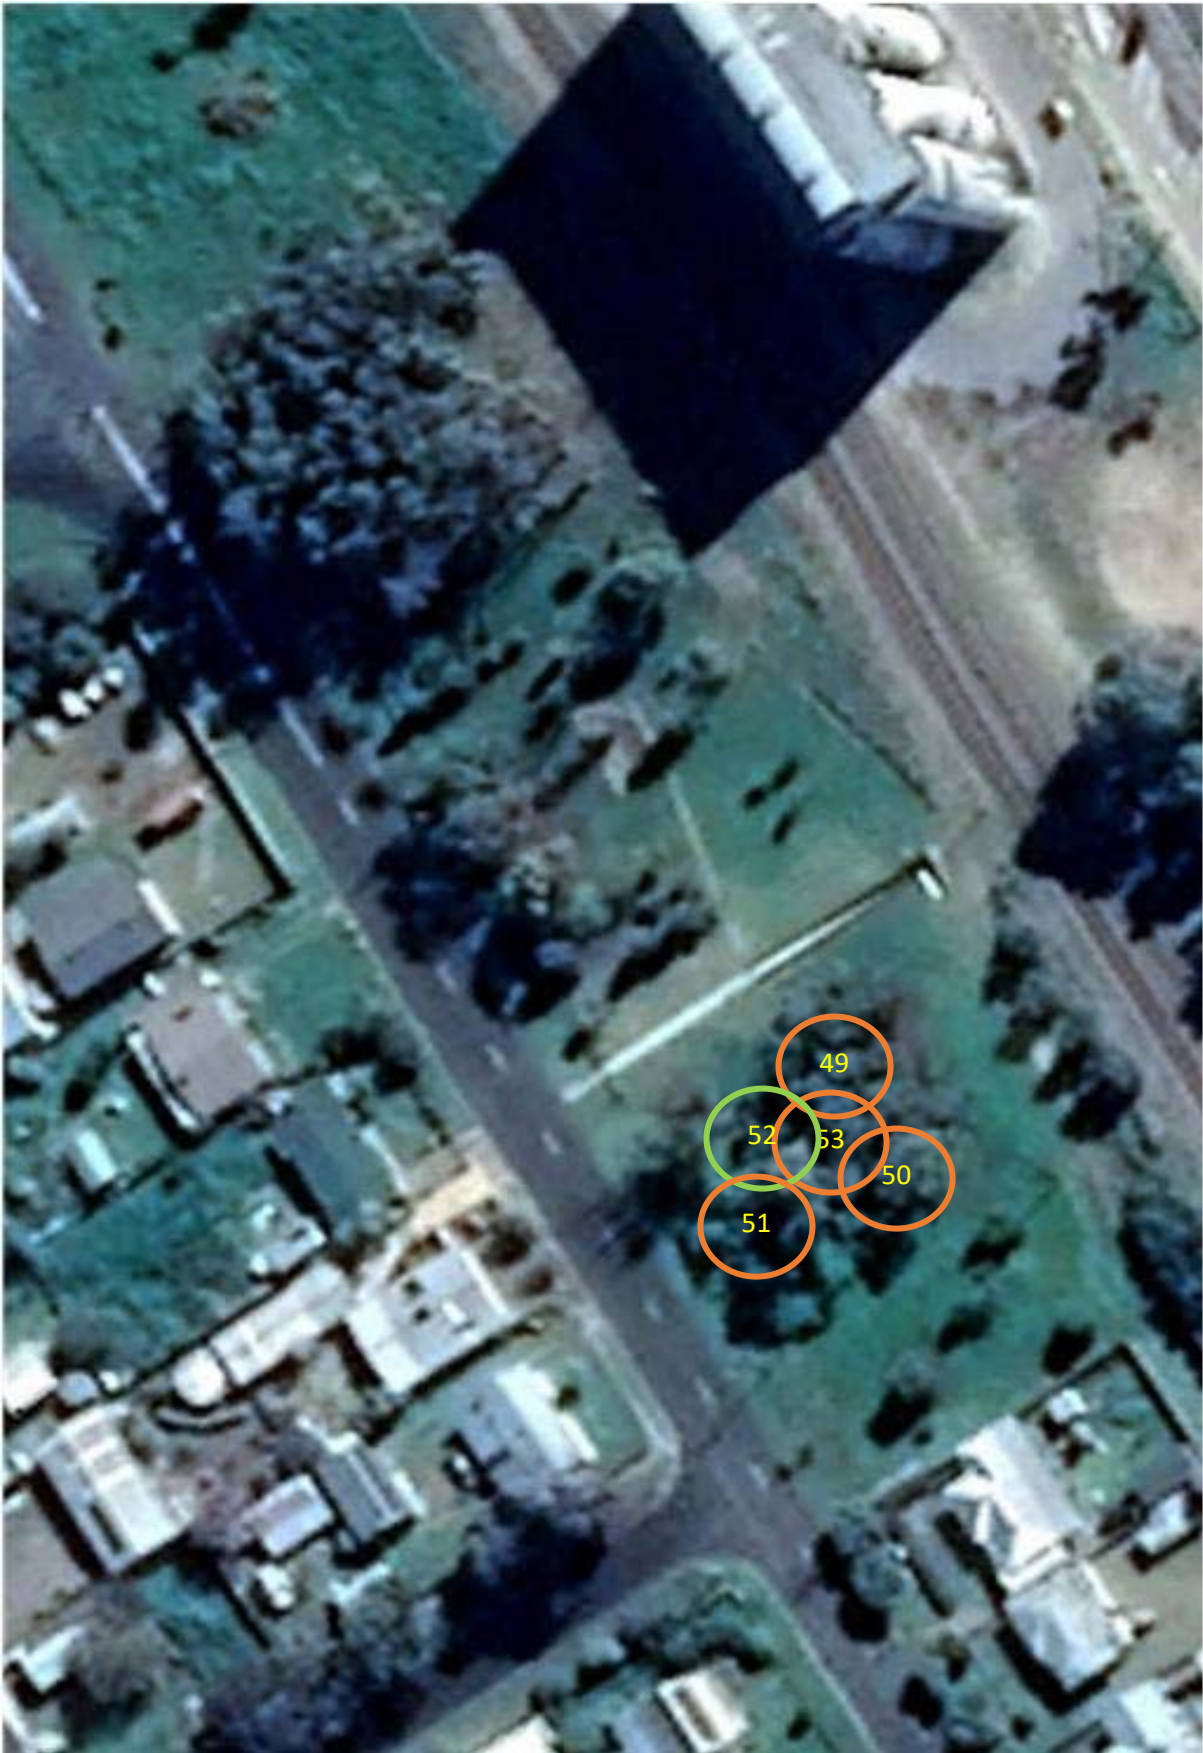
49. Eucalyptus spathulata

MEDIUM RISK

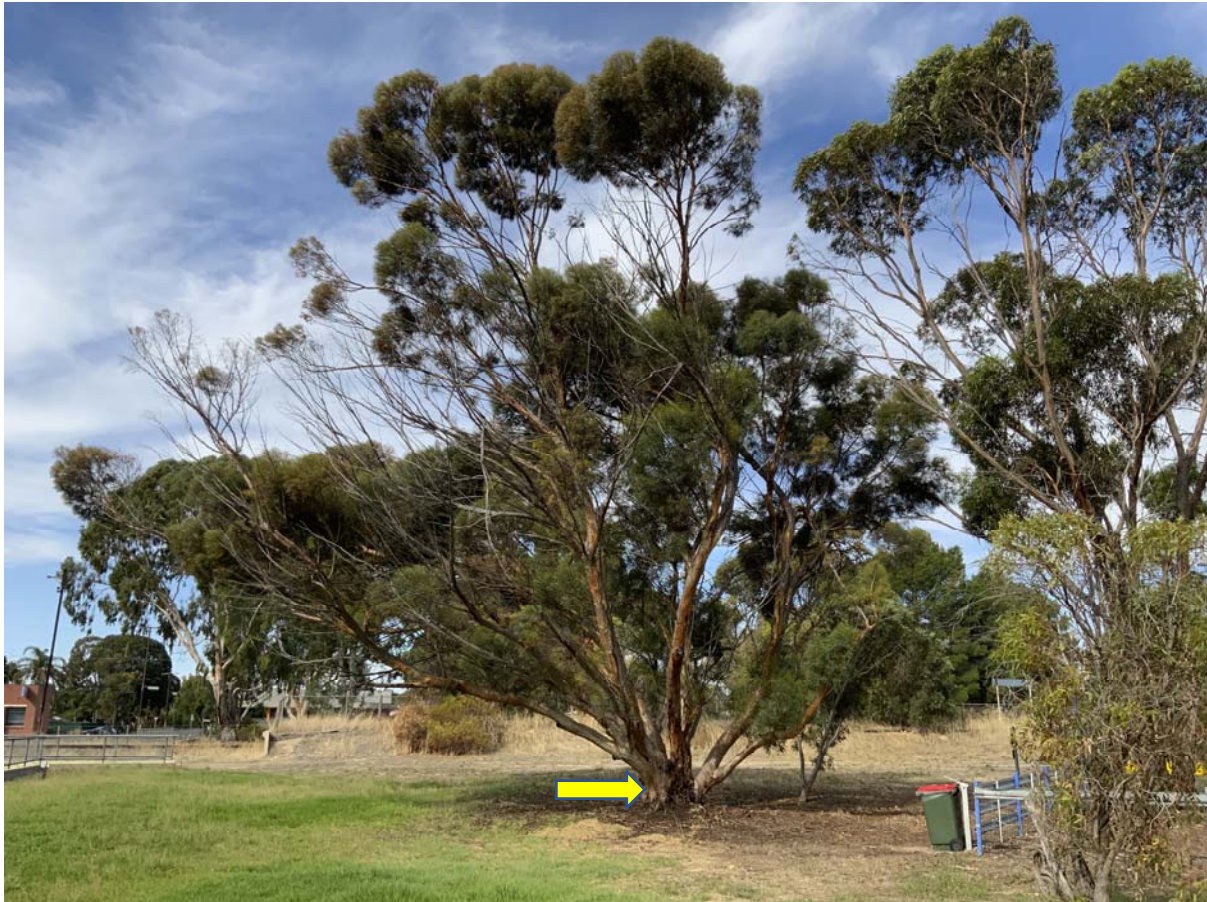
This species of tree is highly susceptible to dieback when the tree is water stressed, they will often like in this case, die back to the main attachment points also reduces the protective nature of the foliage against the remaining foliage. The deadwood is prolific in this tree and will require removal as its close to the entrance.

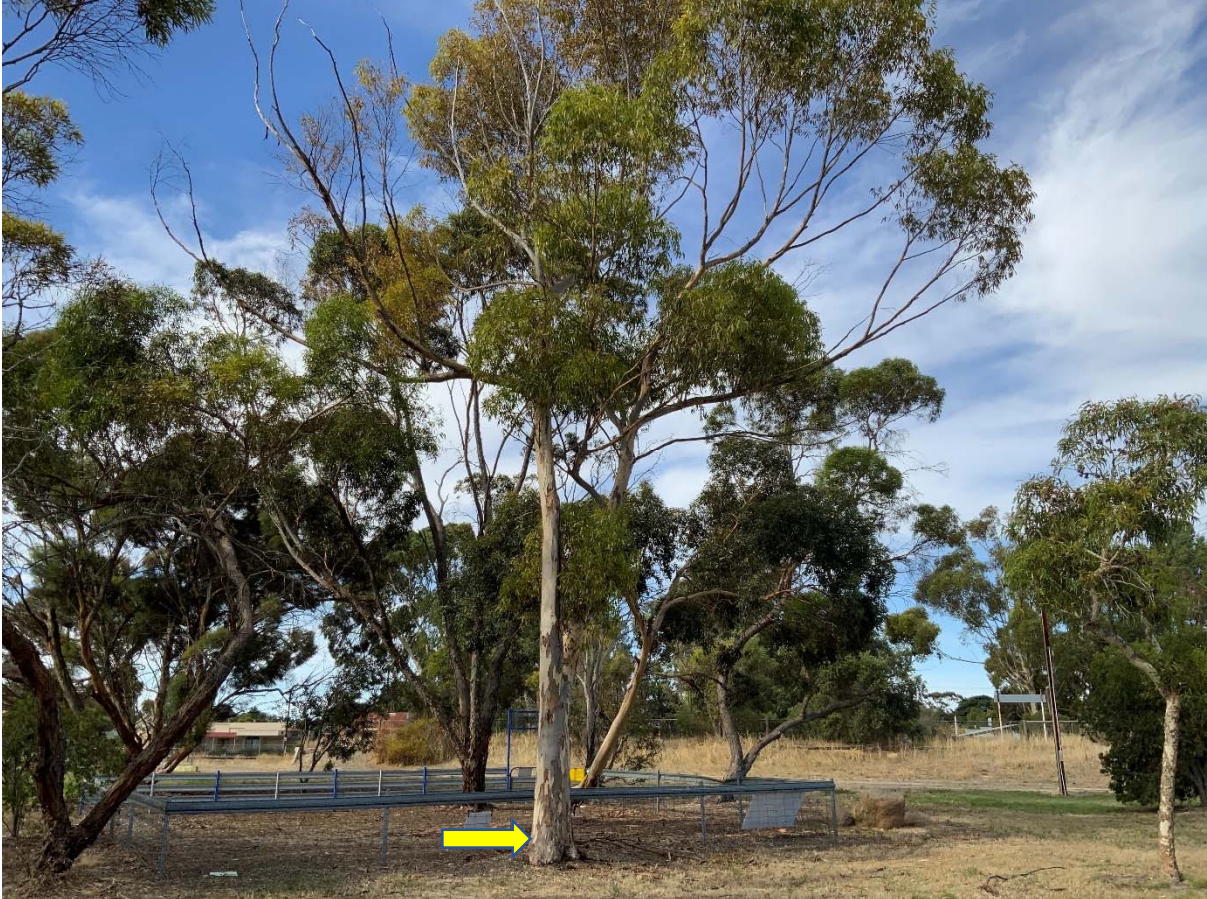
This tree is in good condition and does not have a great deal of deadwood. The upper canopy has several large pieces of deadwood which will require removal. The overall health of the tree is good and is rebounding after long periods of dry which has caused die back in the canopy.

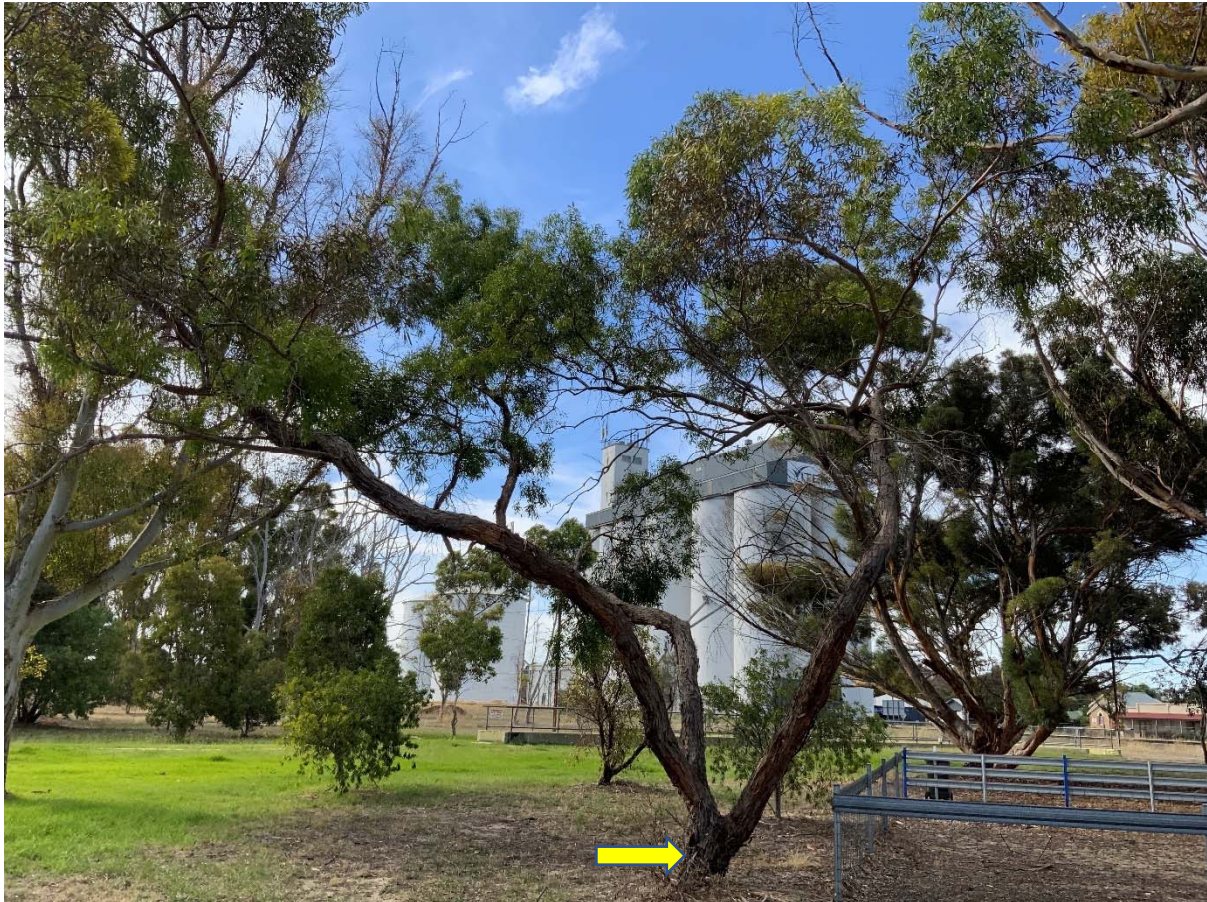
This tree has clean trunk areas up to the canopy, the main canopy does have areas of deadwood from water stress which will require removal. Most of the time, the Mallee trees survive better due to having a store lignotuber which allows for retention of sap that is produced during growth cycles.

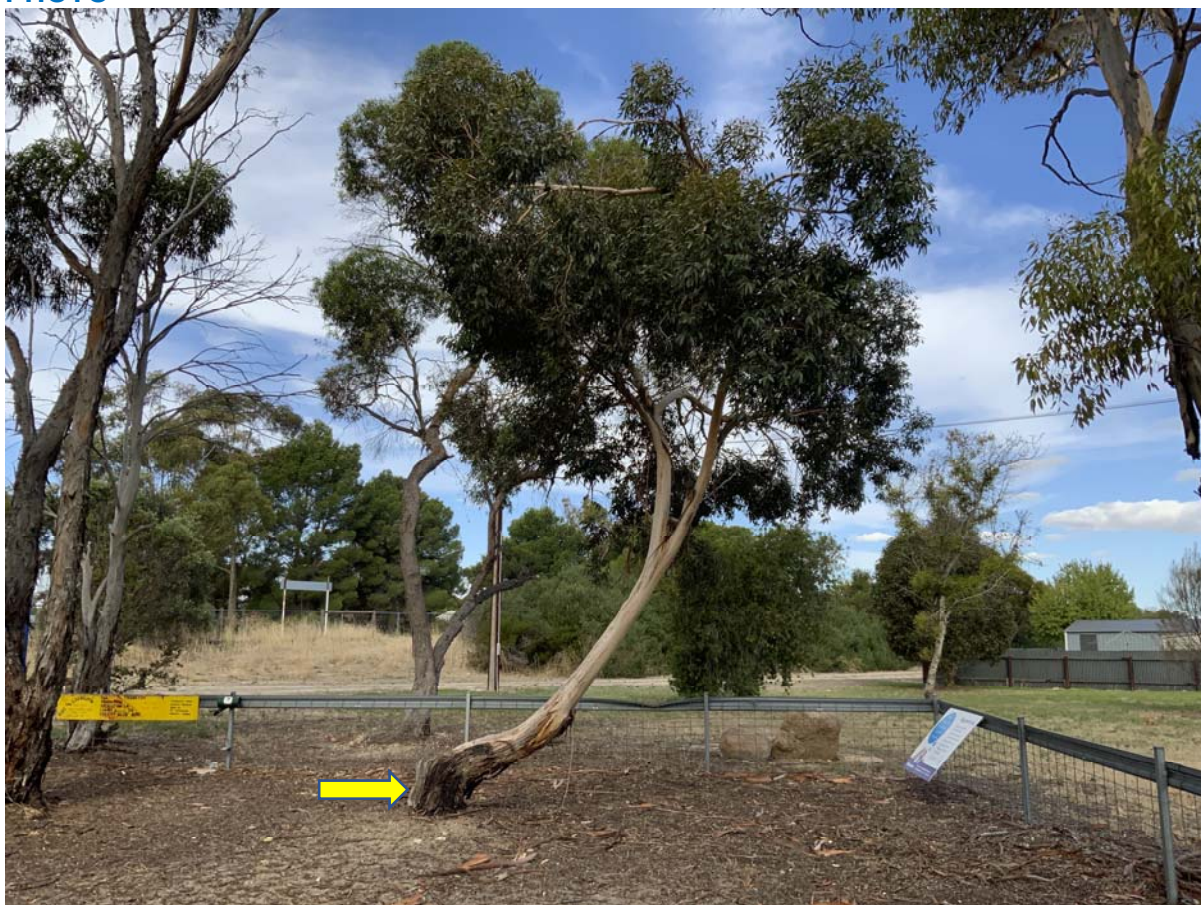
This tree while growing on an angle, does have good structural adhesion to the soil, the canopy is in a good growth cycle with new foliage throughout the canopy. The tree has grown like this most likely due to phototropism that has cause the tree to seek the greater light and is now self-correcting.

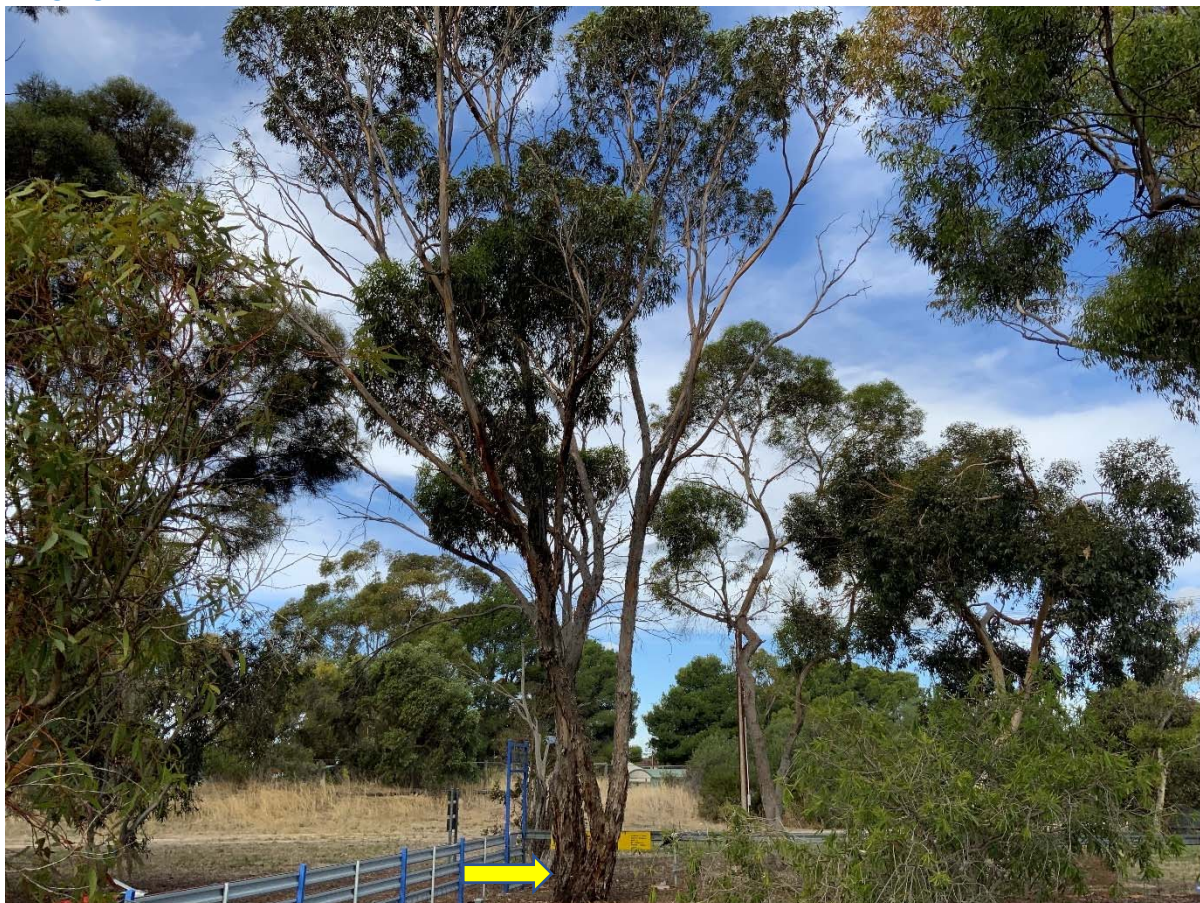
This tree is a multi-trunk specimen that has grown in an upright form, the tree is currently in a good growth cycle with sap flow throughout the tree. The tree does have areas of deadwood and because its within the dog yard, it will require removal.
