Open Space Services

WELLINGTON EAST CEMETARY TREES

Tree Inspection – March 2021

Wellington East

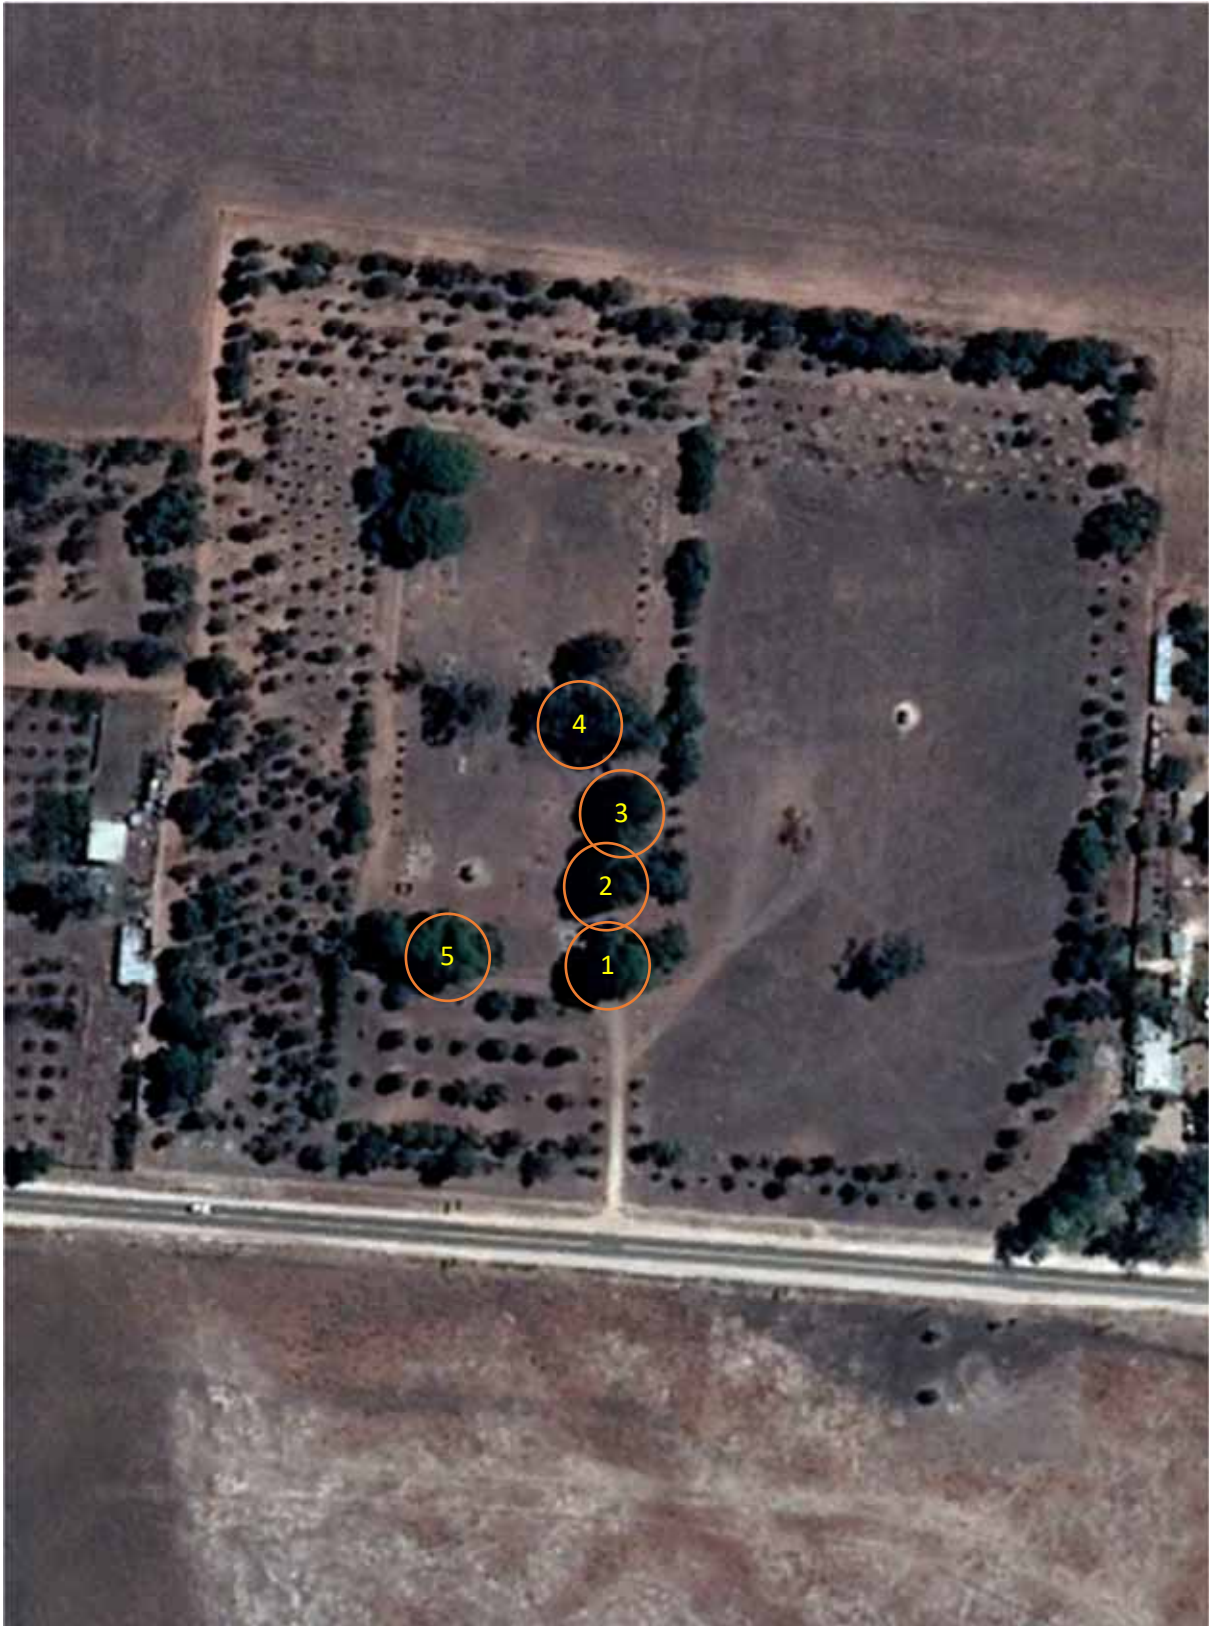
1. Eucalyptus species

MEDIUM RISK

Condition of tree: Regenerating

This large eucalypt has suffered in the past from both water stress and from the encroachment of the large Aleppo pine. The tree has grown out on an angle due to phototropism and the confined area of planting that has occurred throughout its growing life. The tree is regenerating which indicates that the passed problems are due to water stress. As the tree is regenerating it should continue to grow back especially over the winter months when the rejuvenation of soil moisture becomes adequate to sustain the tree. The amount of deadwood will need to be removed back to the point where regeneration has occurred. This is due to it being in the entrance way and in a high traffic area for this situation which is not as high as it would be in some other places but still significant. There are some larger Deadwood approximately halfway up which will need to be removed as it is quite large and does not look to have habitat hollows within them.
