# Groundwater and Rainfall Trends *continued*

**Chris Henschke**– Senior Consultant Hydrogeology  
**PIRSA Rural Solutions**

## Coomandook Landcare Network

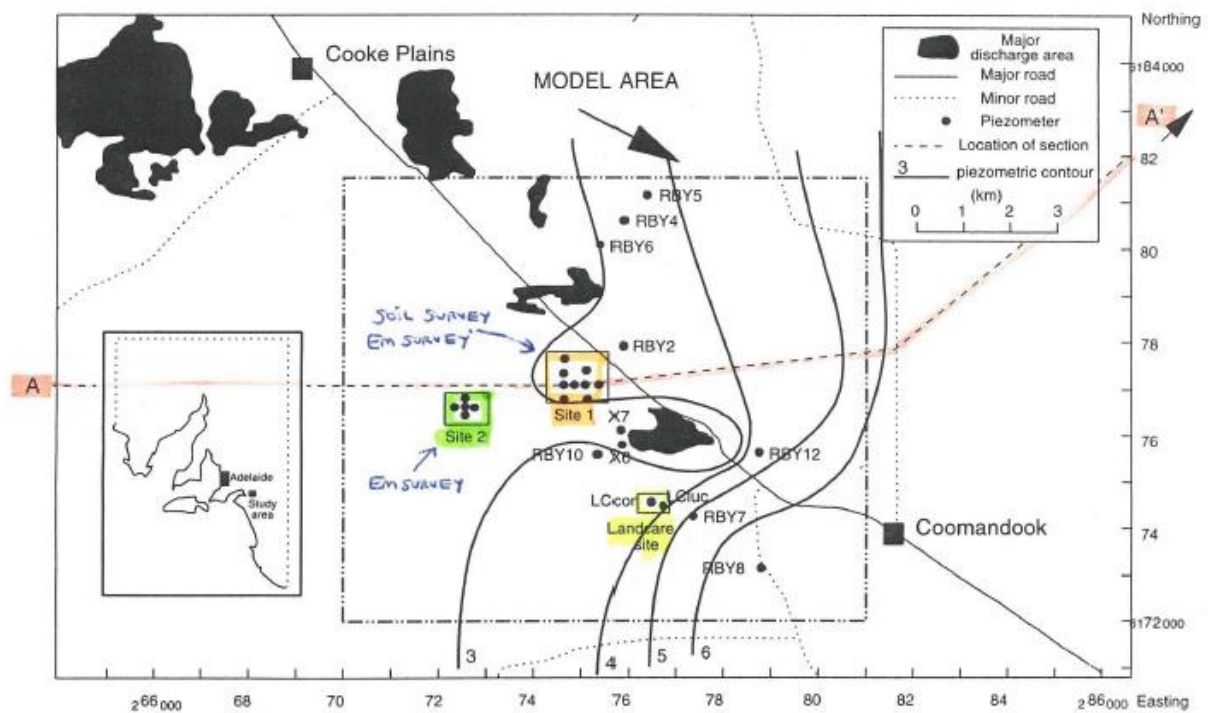
The Coomandook Landcare Network comprises 25 shallow wells up to 5.5m deep that were drilled in April 1994. The Landcare network is not part of the official DEW WaterConnect network. The location of the sites is shown on a map over the page. The map below shows the location of a revegetation Landcare site and the location of two CSIRO experimental sites which were the subject of instrumentation and groundwater flow modelling during the early 1990s.

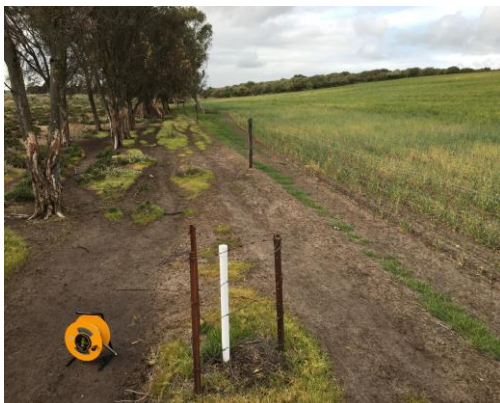
*A Coomandook Landcare Piezometer*

The wells / 'piezometers' were routinely monitored during the 1990s but are now monitored on an ad-hoc basis. The following table provides some data and current status of the wells.

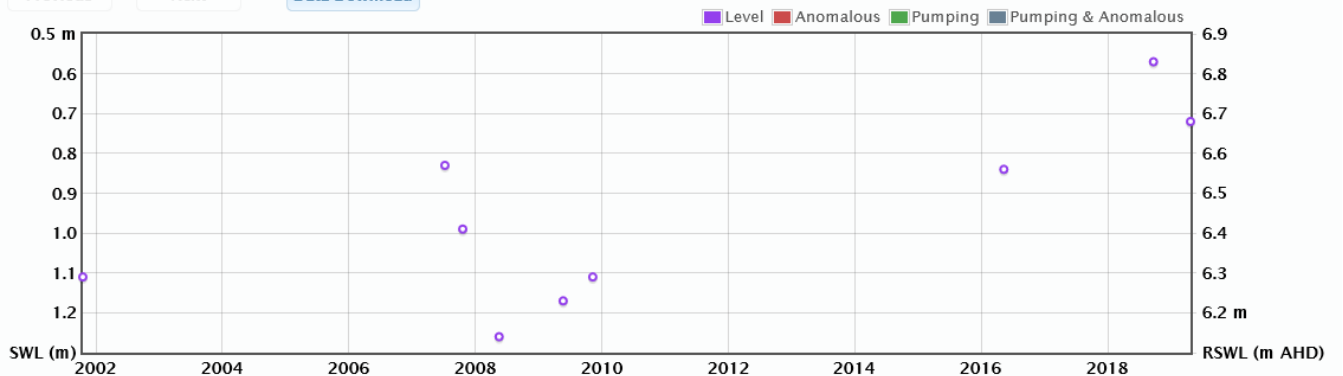
## Water Level: 6827-1703

Drillhole No. [142246](#)  
Name CL 01 Permit No. 31428  
Class WW Status  
Obswell No. Network  
Purpose INV Aquifer

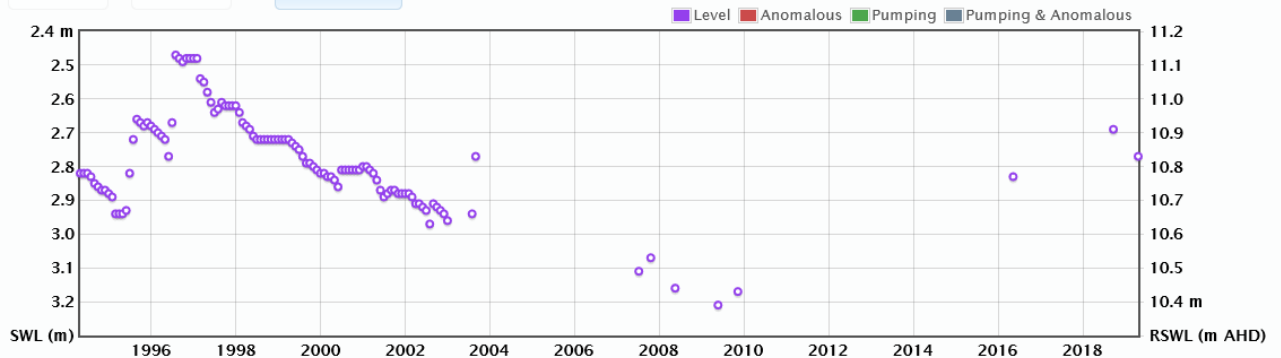
## Water Level: 6827-1708

Drillhole No. [142251](#)  
Name CL 06 Permit No. 31433  
Class WW Status  
Obswell No. Network  
Purpose INV Aquifer

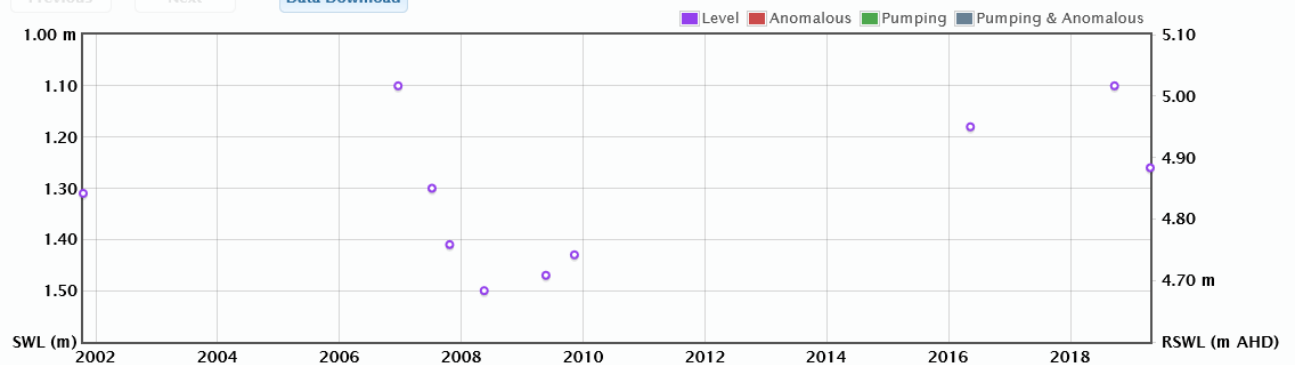
## Water Level: 6827-1713

Drillhole No. [142256](#)  
Name CL 11 Permit No. 31438  
Class WW Status  
Obswell No. Network  
Purpose INV Aquifer
