USE OF REMOTE MONITORING SYSTEMS

to improve knowledge and decision making around dryland salinity management

REPORT PREPARED BY FELICITY TURNER FOR THE COORONG TATIARA LAP

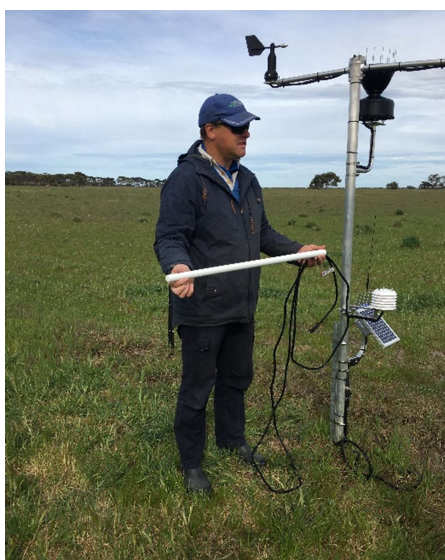
Fig 1. Shane Oster, Alpha Group Consulting installing automated weather station and probe at Elephant Lake, 2020

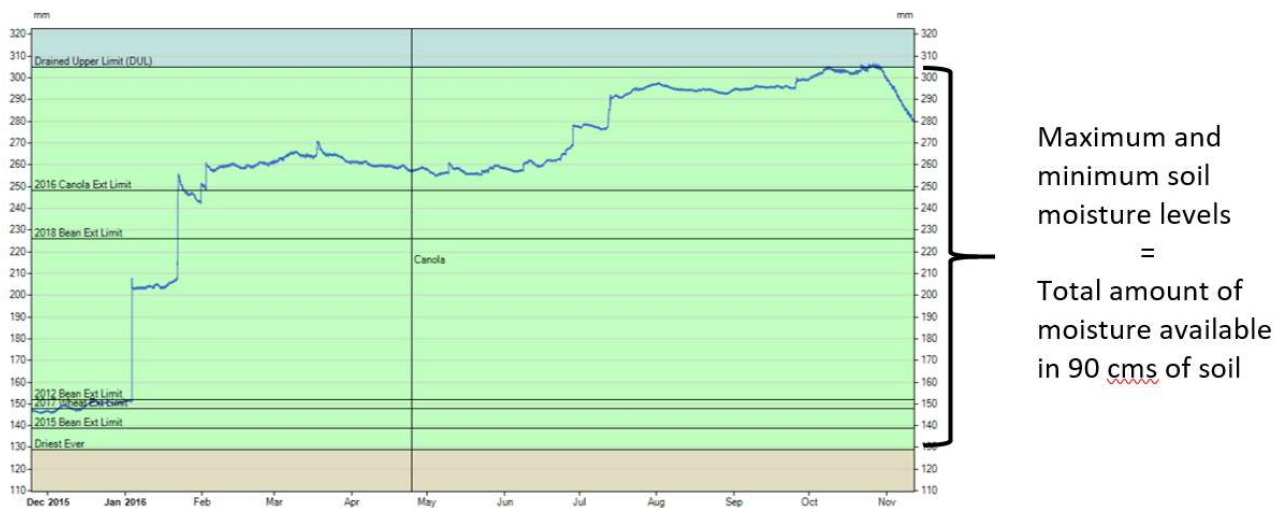
The summed graphs provide information around the total amount of water in the profile at any point in time. Where soil moisture probes have been in for several years (>5) e.g. soil moisture probe at Pine Hill¹ (Figure 2), we have built up an understanding around the "wettest point" – as close to full capacity as has been observed and the "driest point" observed – beyond which the crop or pasture can't extract any additional moisture. The difference between the wettest point and driest point is the maximum amount of water available to the plant within the observed depth (in this case 90 cms). This maximum amount of water should be thought of as % full as opposed to absolute numbers.

Figure 2. Summed soil moisture data at Pine Hill (2016)

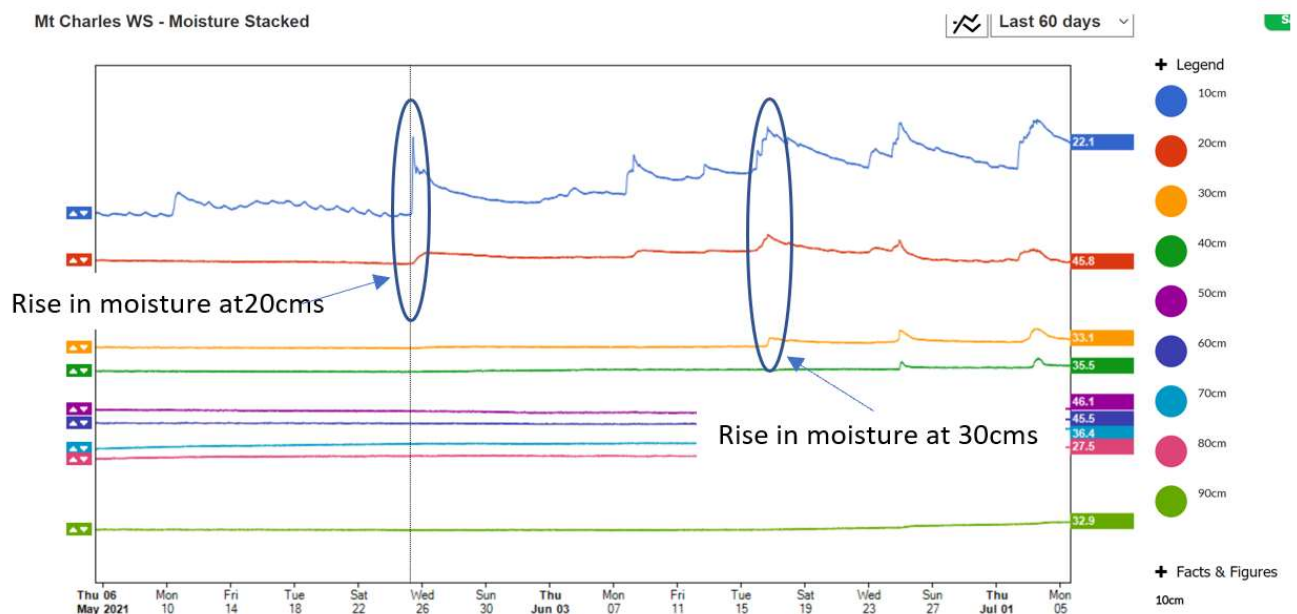
Figure 3 shows a summed graph from the Mount Charles site where it can be seen that a rainfall event in late May has pushed the soil moisture down to 20cms, with the next major rainfall event on the 16th June pushing the moisture down to 30cms.

Crop extraction at a certain depth will be represented by diurnal stepping (where the sensor drops during the day while the crop is extracting moisture and then flattens at night).

Figure 3. Stacked soil moisture at Mount Charles (June 2021)

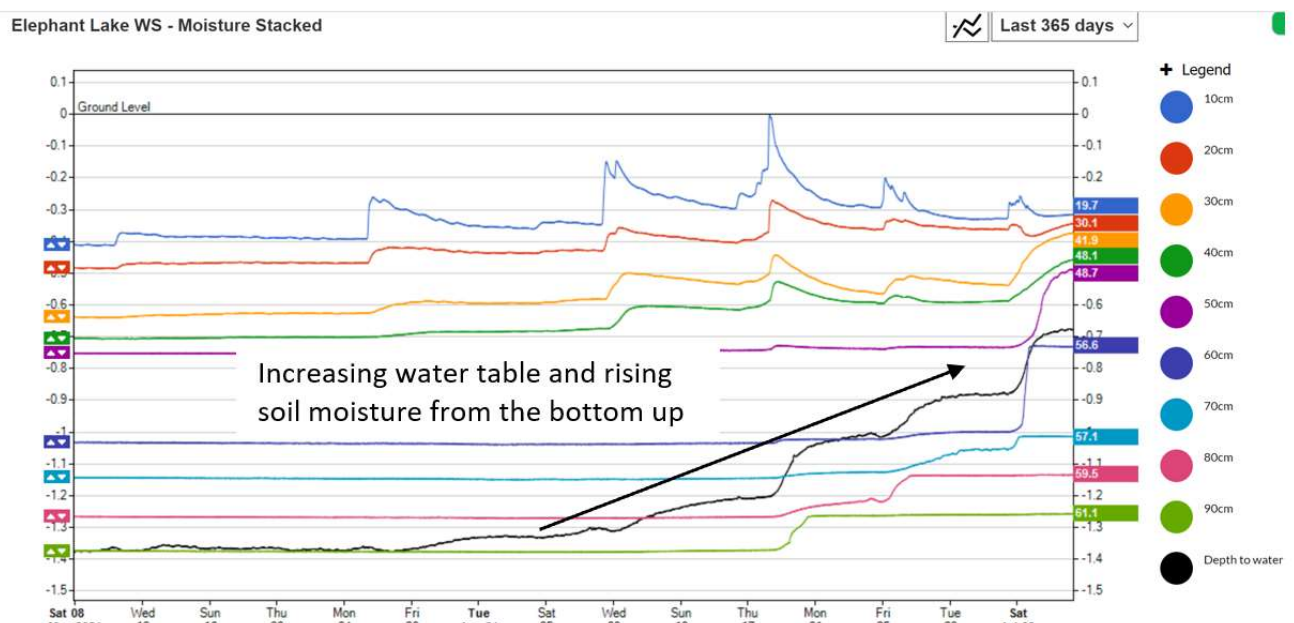
Mount Charles and Elephant Lake both appear to be sites that are impacted directly by a rising water table that brings groundwater closer to the surface with the potential for soil inundation and waterlogging to occur. The water table then recedes later in the season leaving some of the dissolved salts from the saline groundwater behind. This process can be seen in Figure 4 where the observation site at Elephant Lake shows the increase in the water table in mid-June and a subsequent filling of the soil profile from the bottom up. The black line represents the water table depth and as it rises from -1.4m below surface depth to -0.7 below surface depth, the soil moisture also increases at depth with the soil moisture levels increasing up the profile through the wetting front. This process has been referred to as rising water table. A similar pattern appears to be emerging at Mount Charles (although not yet as pronounced) where the water table has just started to rise in June 2021. This will continue to be monitored to ensure that the correct process is identified at this site.

Figure 4. Stacked soil moisture and water table data, Elephant Lake (June 2021)

From the data that has been generated since the projects inception (September 2020) there appears to be some really interesting relationships between soil moisture, soil salinity through the profile and its relationship with the groundwater with some sites (Elephant Lake) having strong correlations, and another (Coomandook) appearing to have little or no relationship with the groundwater levels.

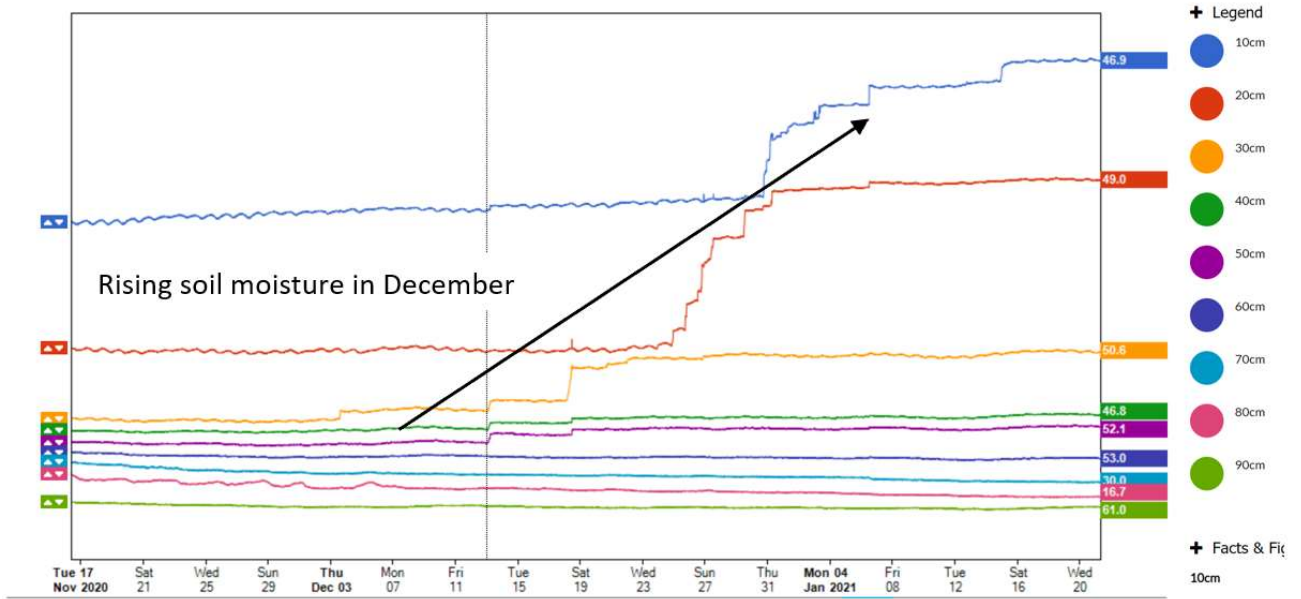
Coomandook has a very different process occurring with the water table appearing to be relatively stable throughout the season (although this is only an initial finding that will continue to be monitored). The salinity at this site appears to be driven by warm conditions over summer and wicking of the soil moisture up through the profile (in the event of no rainfall or rising water table events). This is shown in Figure 5 and is referred to as the Wicking Effect (a similar process to wax or oil moving up a candle wick). As the water rises to the surface, it brings with it salts that are deposited as the profile dries out. As more data is collated, it will be interrogated against climatic conditions, and the overall processes will become better understood. The depth that the soil water is rising from is quite surprising, but after installation the site may have been bared out slightly at the surface with the disturbance from the probe placement. As groundcover is re-established at this site, it is hoped that the wicking effect will not be as pronounced.

Figure 5. Stacked soil moisture graph, Commandook (December 202)

The depth from which the groundwater is wicking over summer was also surprising, as it rose over 1m on what is a loamy soil. Further investigation may be required to determine the maximum height that the water will rise to on these soils and explore what is happening on sites that are more slightly elevated in the landscape to see if the process changes.

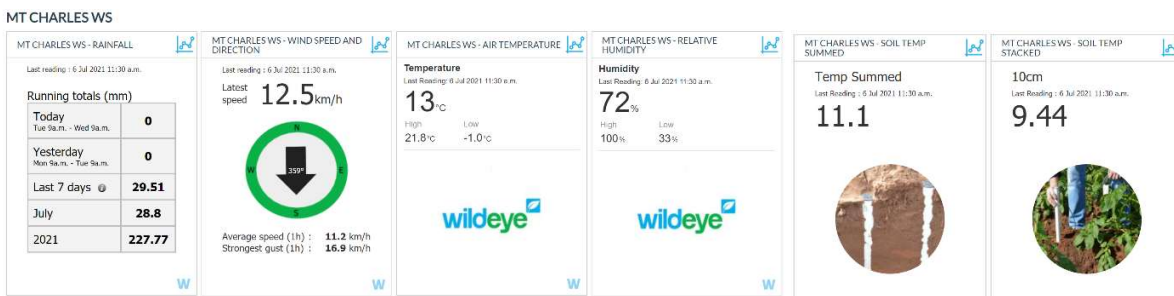
Additional data being collected includes rainfall, wind speed and direction, air temperature, soil temperature and relative humidity as well as other environmental derivatives (Figure 6). It is hoped that as more data is collected some of these indicators like soil or air temperature may be linked to the wicking of water through the soil allowing the data to be transferrable across to other locations.

Figure 6. Environmental data being collected at Mt.Charles
