Coomandook / Cooke Plains Landcare Monitoring Network – Maintenance 22/05/2023 to 22/05/2023

Coomandook Landcare Network Piezometer Maintenance

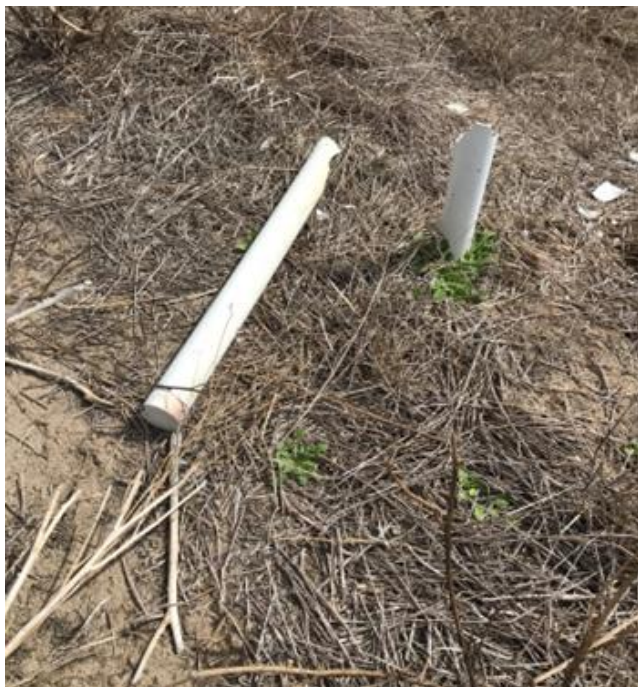
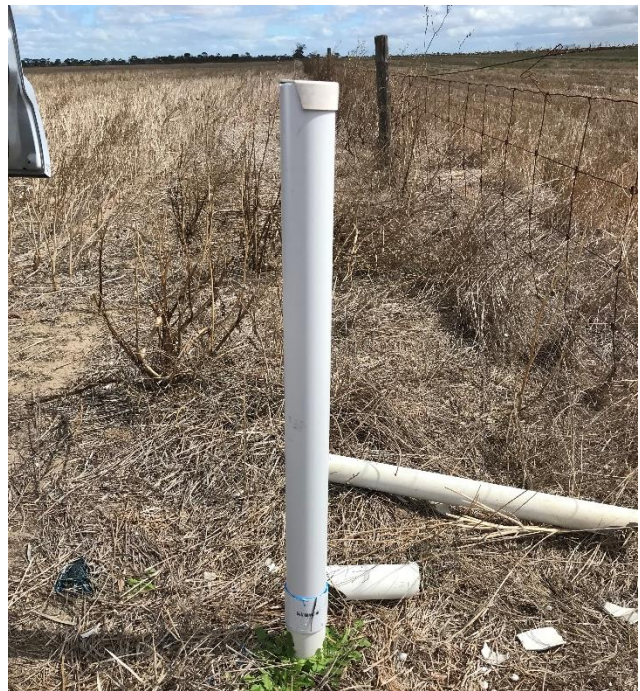
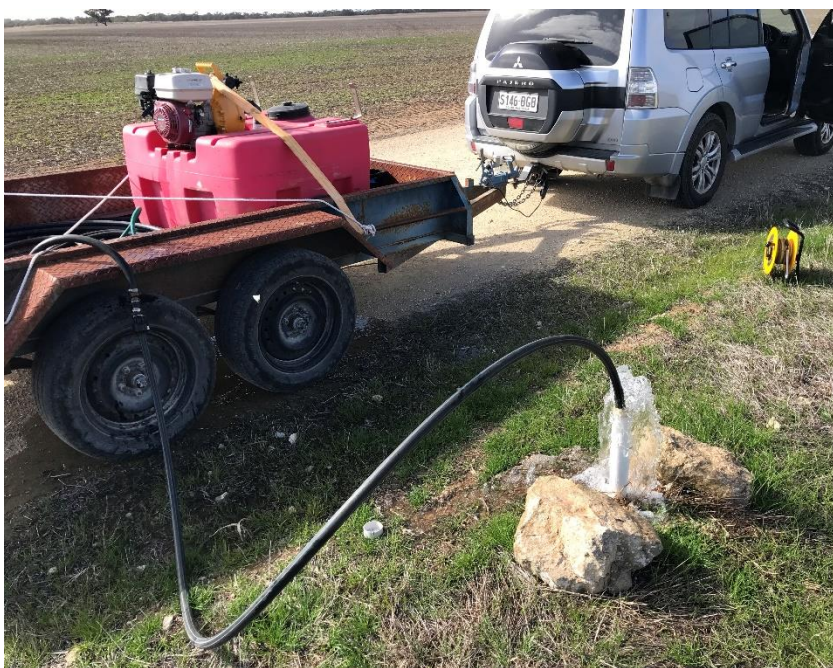
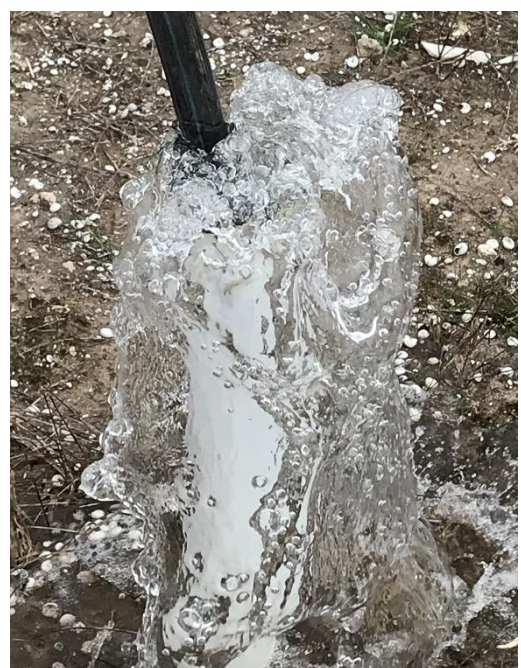
The Coomandook Landcare Network comprises 25 shallow wells that were drilled in April 1994. In that time, some have silted up, particularly in the swampy areas or blocked with white snails, and several had been damaged.

A repair and maintenance run was carried out on 22nd May and 23rd May 2023

- 17 piezometers cleaned out using a fire fighter. 20mm blueline poly pipe (without a nozzle) slowly pushed to bottom of the 50mm poly casing. The bottom of the casings were capped, so it was easy to know when the bottom was reached.
- 2 piezometers were completely blocked with snails, so caps were placed on all piezometers.
- 2 piezometers repaired that were broken off at ground level.
- 1 piezometer was broken off about 0.3m below ground level not repairable.
- 6 piezometers broken off at or below ground level and not located.
- 2 piezometers not cleaned out – clear to bottom of casing and had telemetry installed.
